PRELIMINARY SITE INVESTIGATION
119A COSGRAVE ROAD
PAPAKURA
AUCKLAND

Reference: FES 1804.005 December 2023

Project Name Preliminary Site Investigation
119A Cosgrave Road, Papakura, Auckland
Project Number 1804.005
File Reference M:\2023 Jobs\Winton\Sunfield Development\119A Cosgrave Road\01
Report\1804.005_PSI_MT.docx
Date December 2023

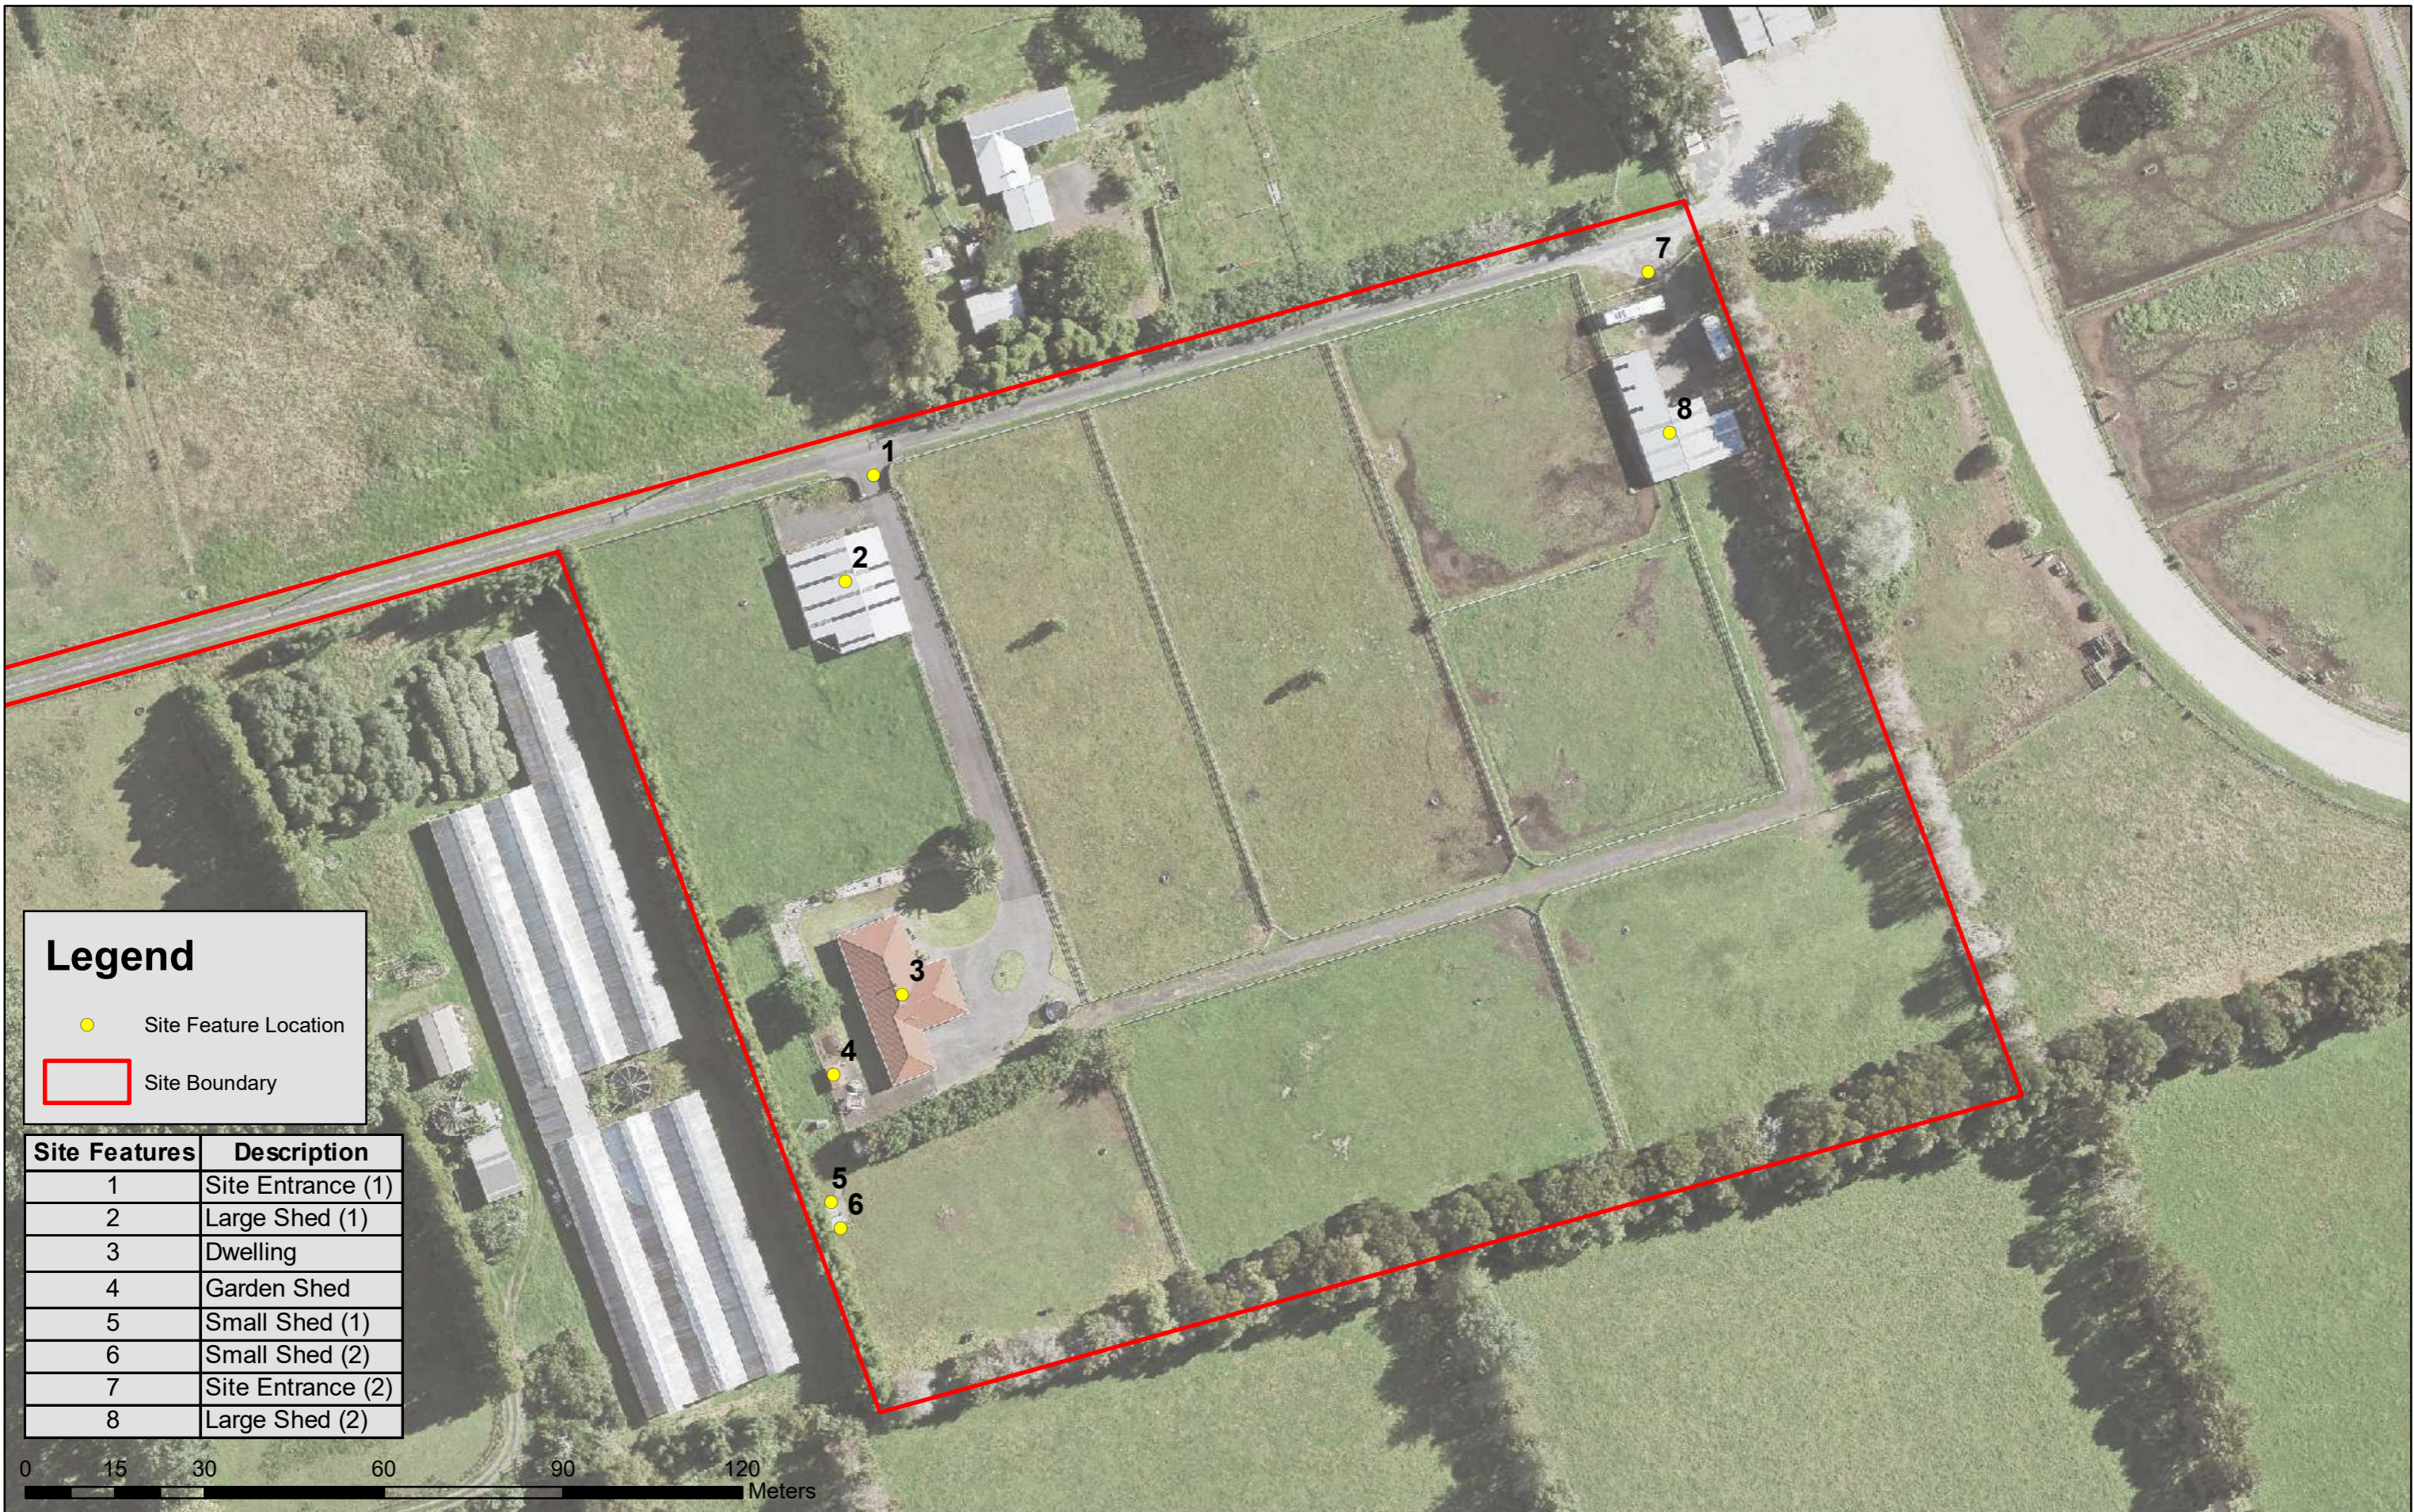
Figure 2 - Site Features Plan

The surrounding environment appeared to be predominantly in use for rural and rural-residential purposes. A racing oval is observed to the east of the site. Residential properties were observed further south-west in the wider area.

A large greenhouse is observed on the westerly neighbouring property. However, a shelter belt is present along the boundary between the properties. Given this, it is considered that potential contamination associated with the greenhouse is reduced regarding its impact to the subject site.

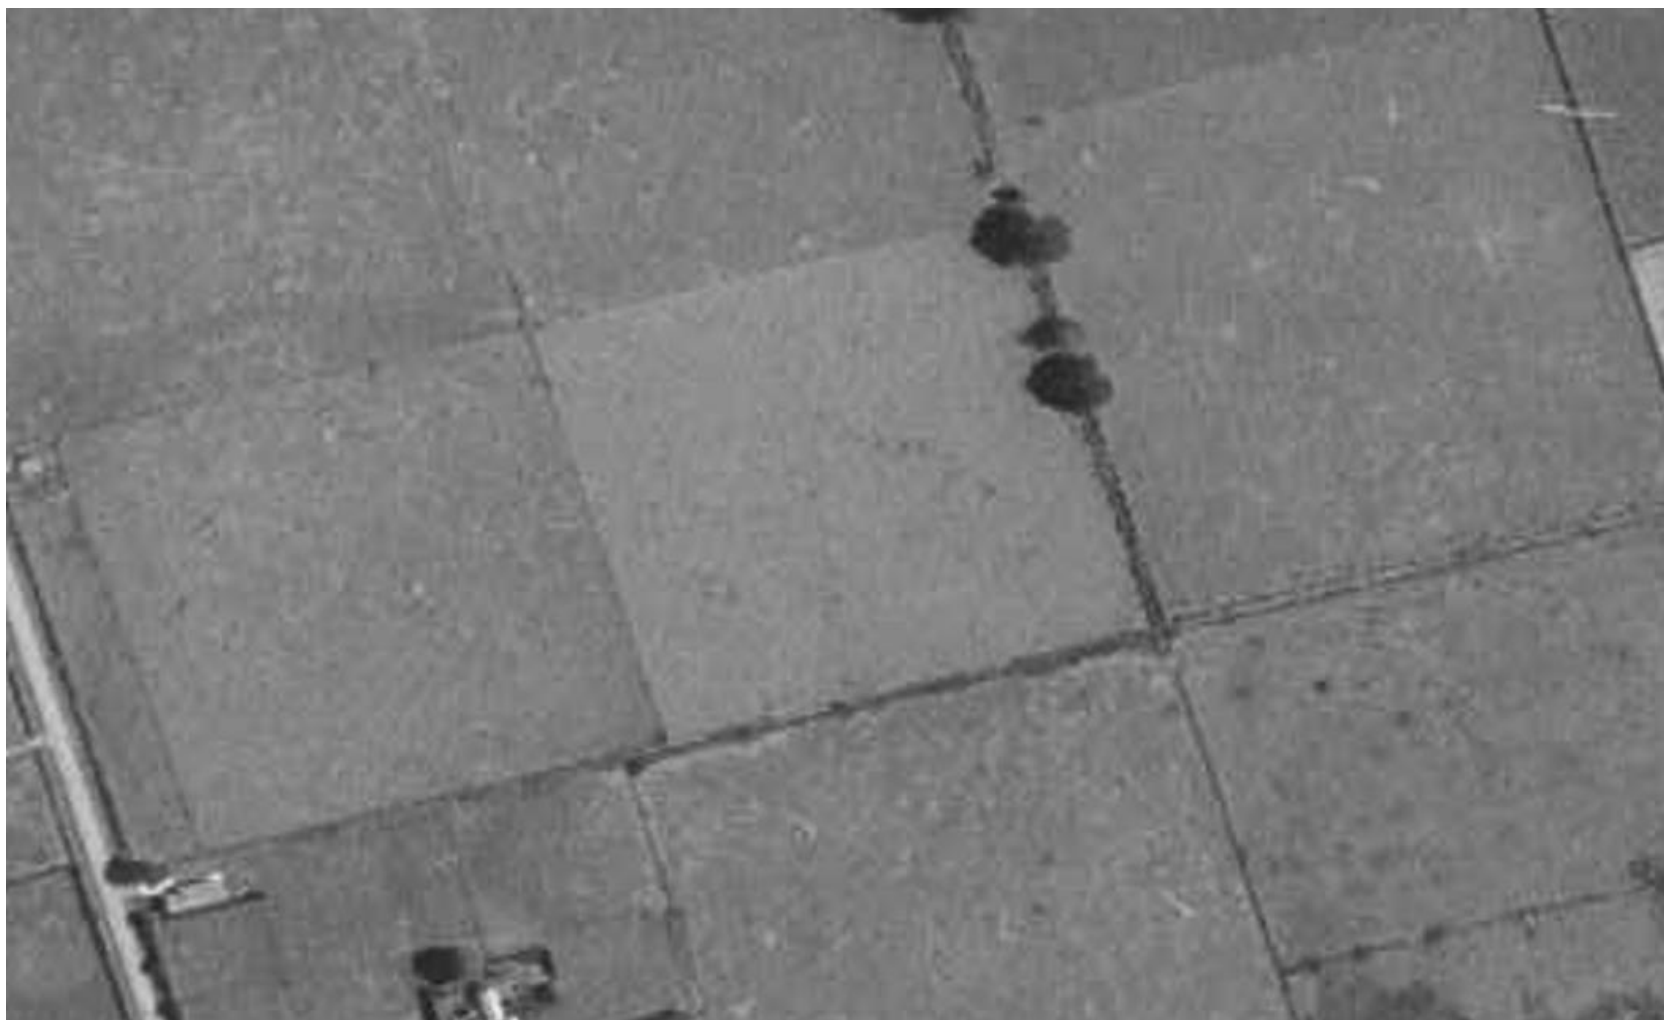
1975 Historical Photograph

Date	Description
1960 - 1980	The 1960 - 1980 historical photographs show the subject site is part of a larger parcel of land in use for rural purposes. No structures are visible on the subject site throughout this time period. The surrounding properties are in use for rural and rural-residential purposes.
1988	The 1988 historical photograph shows the subject site is relatively unchanged from the 1980 historical photograph. However, a shed (1) can be observed in the north-western corner of the site. A shared driveway is now visible to the north of the site. The surrounding properties remain in use for rural and rural - residential purposes. A racing oval has been constructed to the east of the site.
1996 - 2017	The 1996 - 2017 historical photographs show the subject site having been subdivided from the larger parcel of land. The site is now in use for rural - residential purposes. A dwelling has been constructed near the western boundary of the site. An additional shed (2) is observed in the north-eastern corner of the subject site. The 2001 historical photograph shows that a driveway has been constructed across the centre of the site. In addition, a large greenhouse is now present on the westerly neighbouring site. However, a shelter belt is present along the western boundary. The neighbouring properties remain in use for rural and rural - residential purposes.

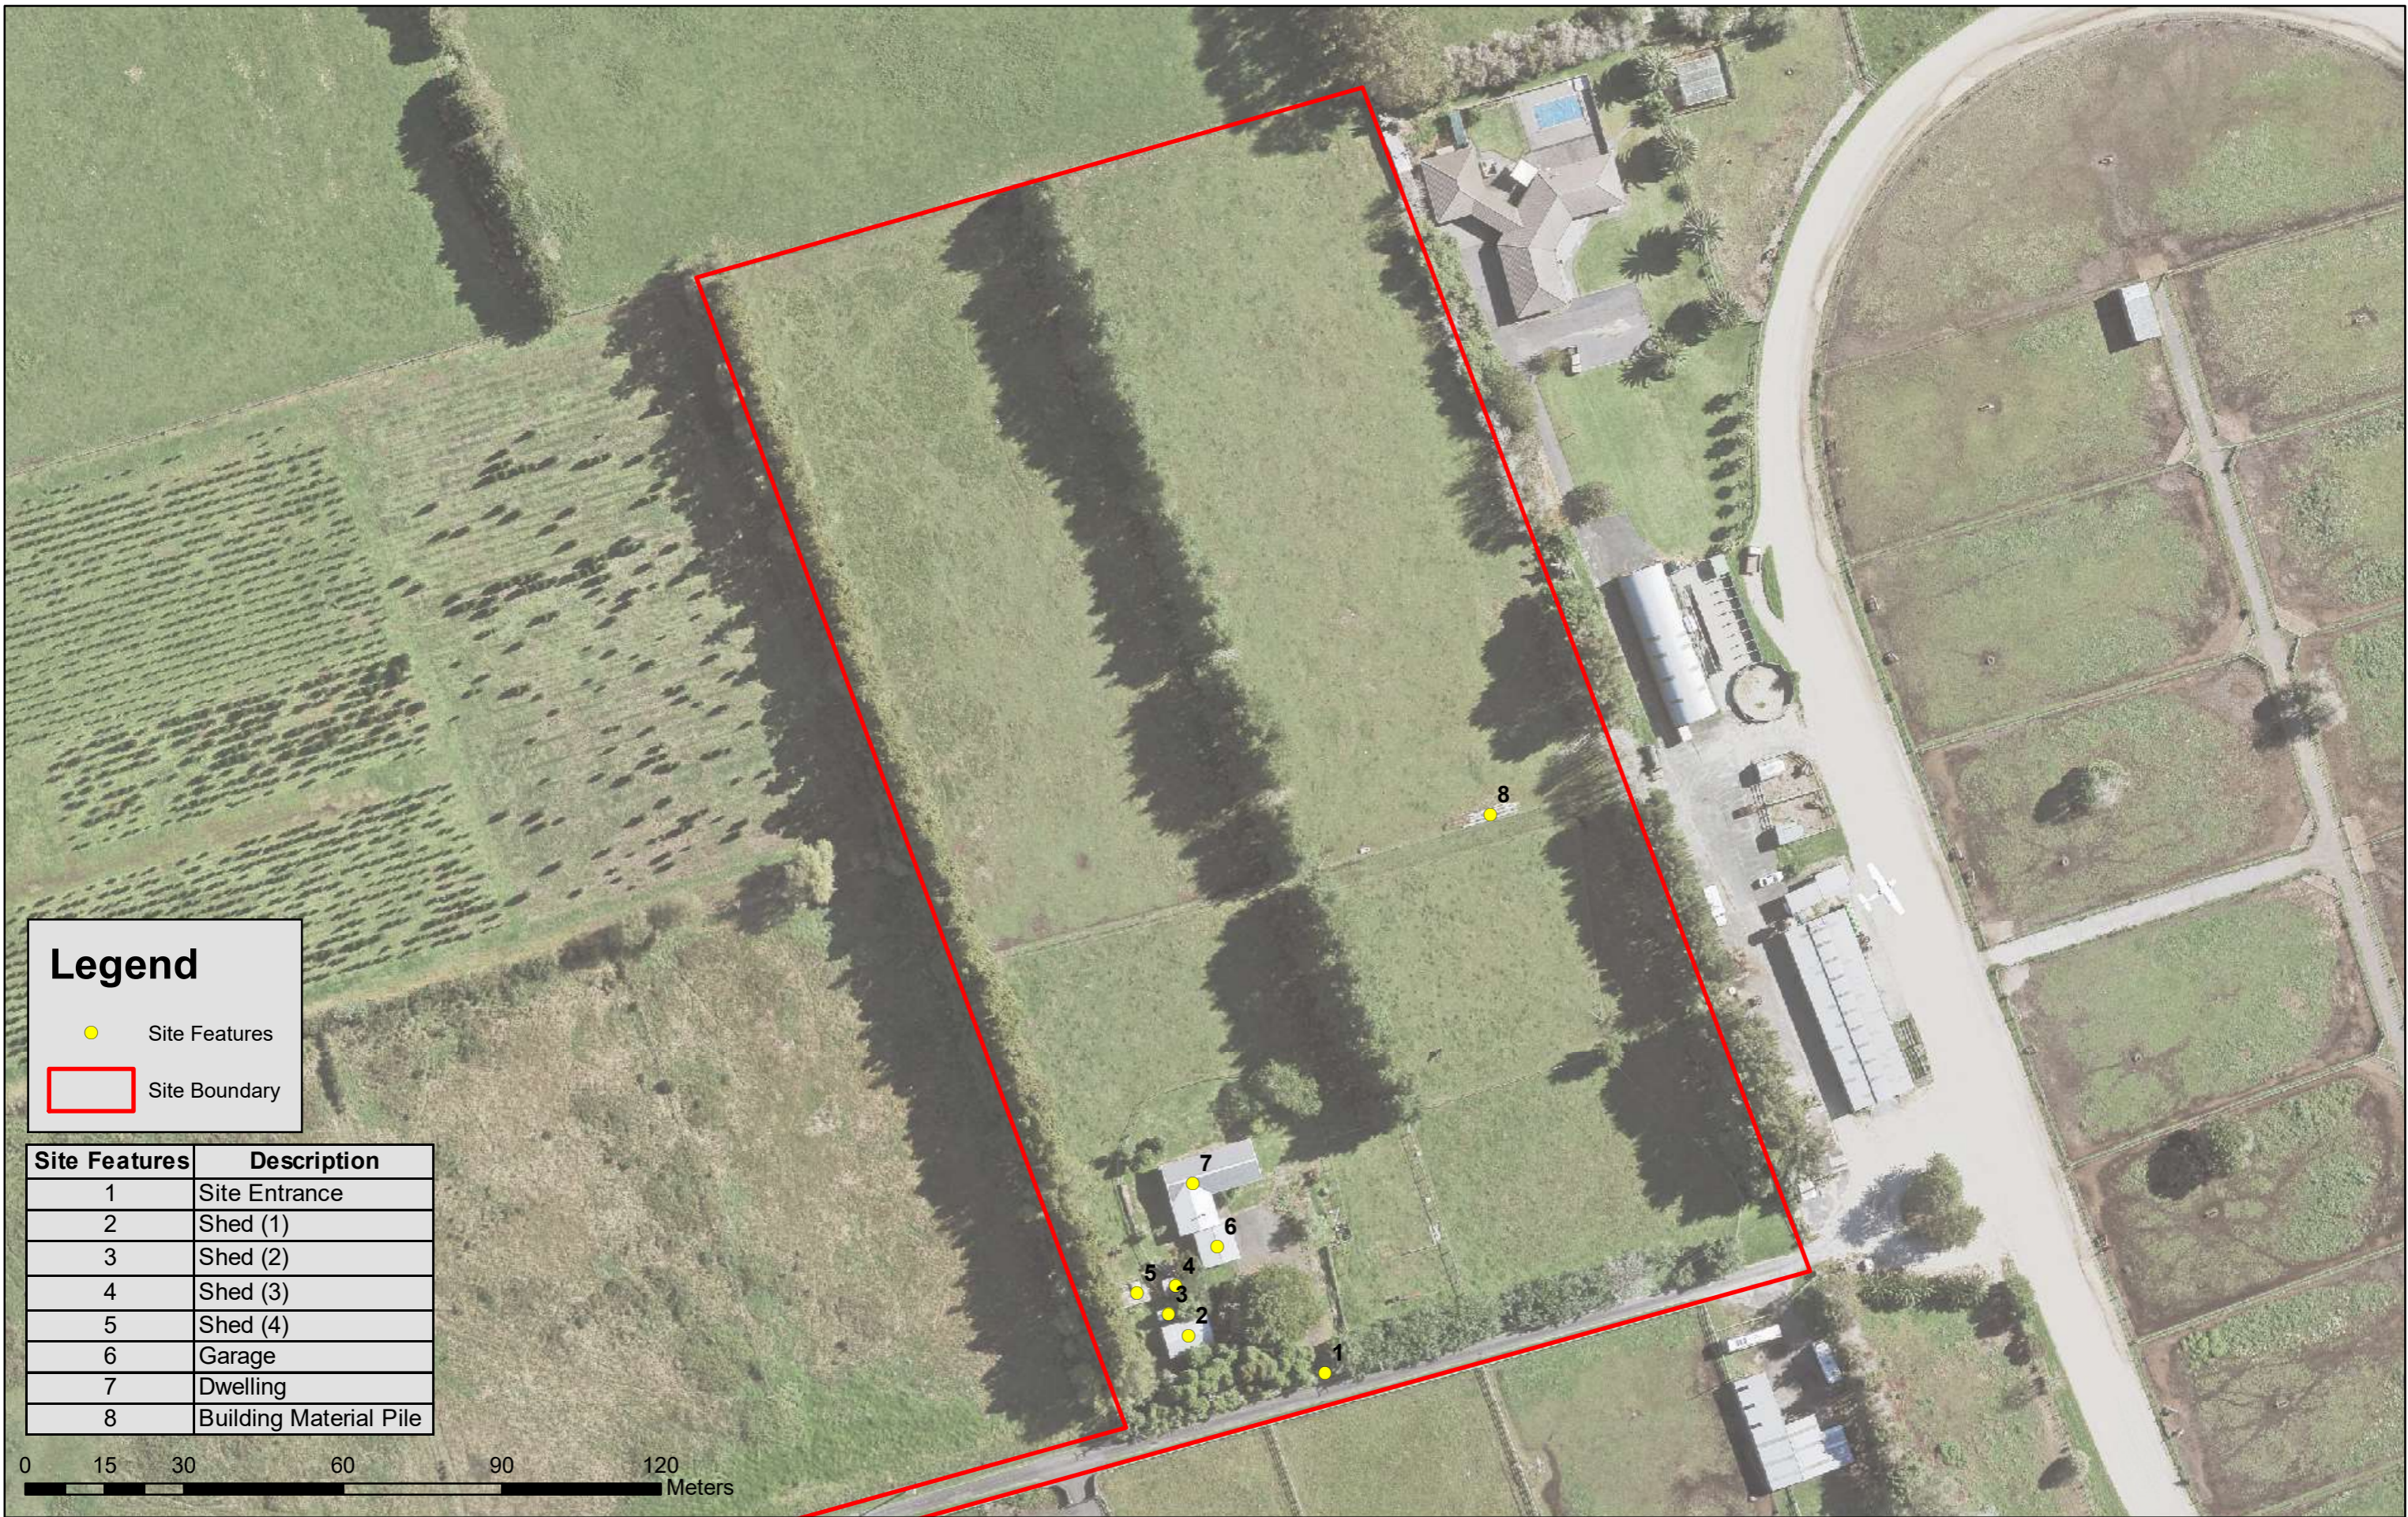
Figure 2 - Site Features Plan

The surrounding environment appeared to be predominantly in use for rural and rural-residential purposes. A racing oval is observed to the east of the site. Residential properties were observed further south-west in the wider area.

An area of horticulture is observed on the westerly neighbouring property. However, a shelter belt is present along the boundary between the properties. Given this, it is considered that potential contamination associated with the horticultural activities is reduced regarding its impact to the subject site.
