Proposed Solar Farm - The Point, Mackenzie Basin
Appendix 2: Visual Simulations

25 May 2023

**ASSESSMENT OF ECOLOGICAL EFFECTS FOR
THE PROPOSED ŌHAU C SOLAR FARM BETWEEN
THE LOWER REACHES OF THE TEKAPO AND
TWIZEL RIVERS, MACKENZIE DISTRICT**

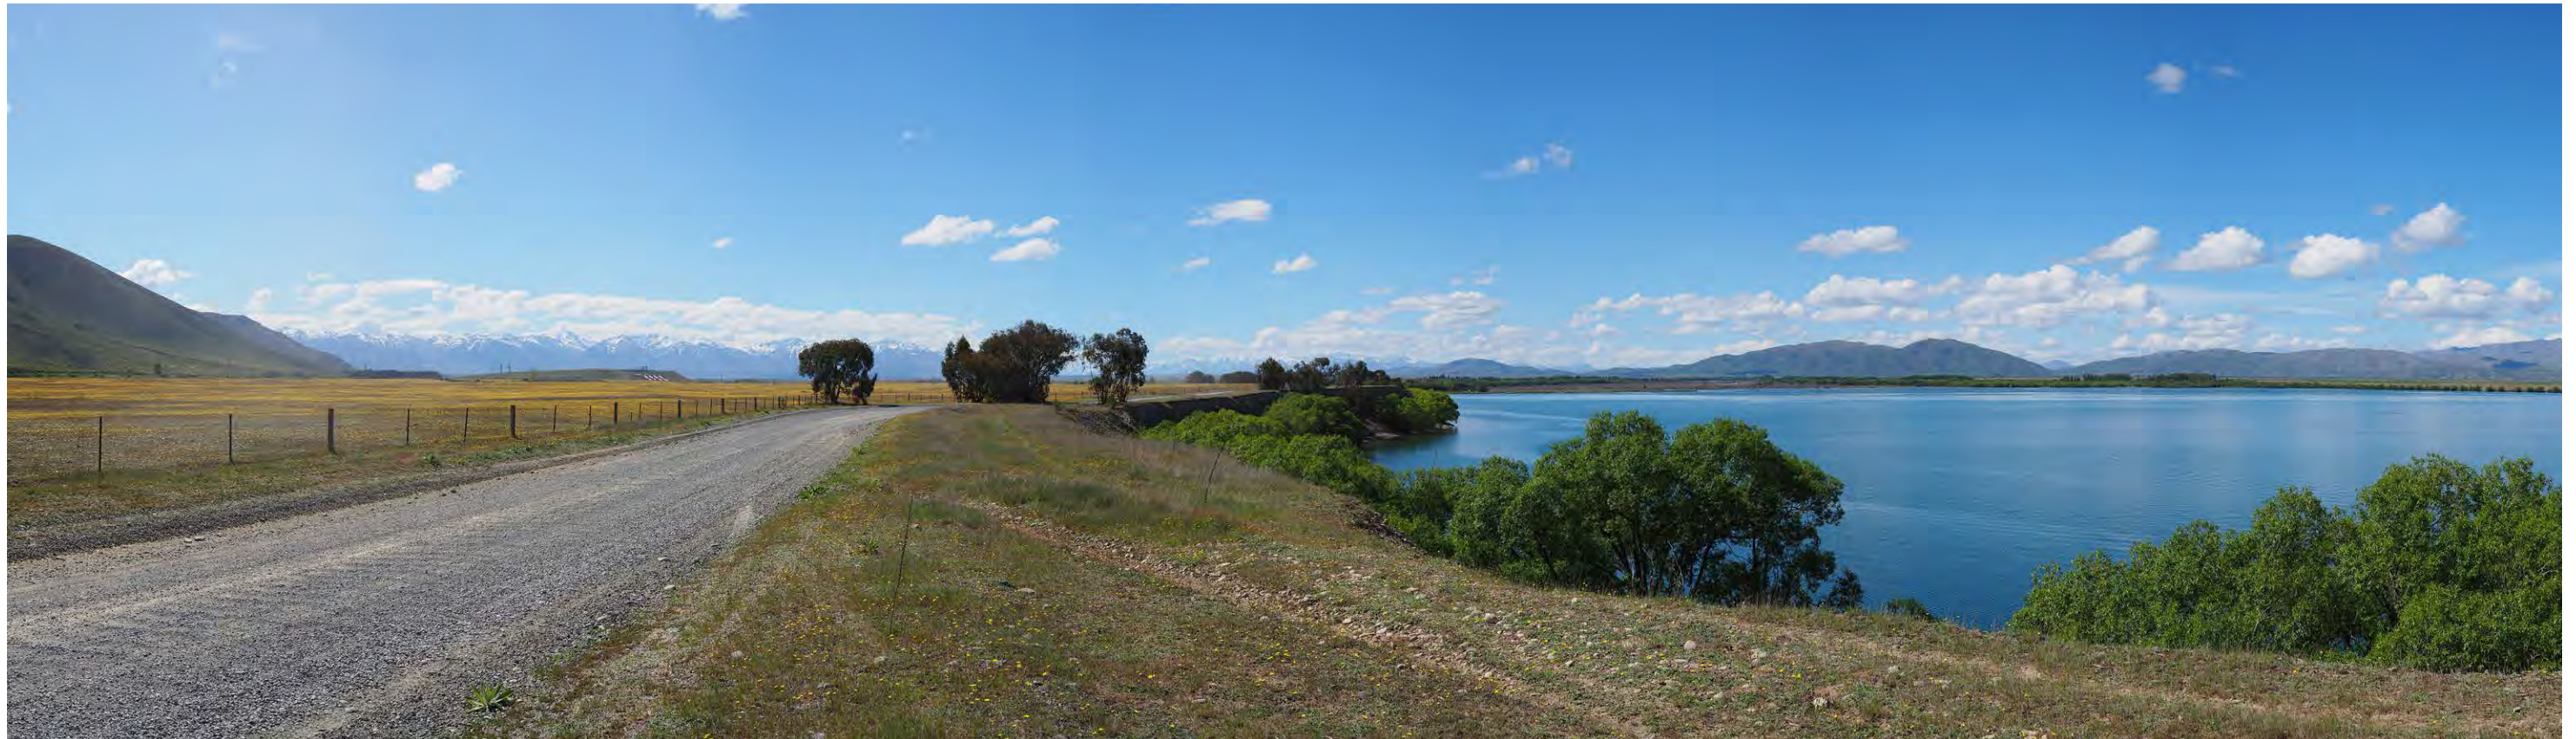
Viewpoint Location Photograph 13: Located along Falston Road, north of shelterbelt located along the western side of the road. This photo illustrates the view over the top end of Lake Benmore towards the site and the surrounding mountains, with the solar farm being 1.9kms away.

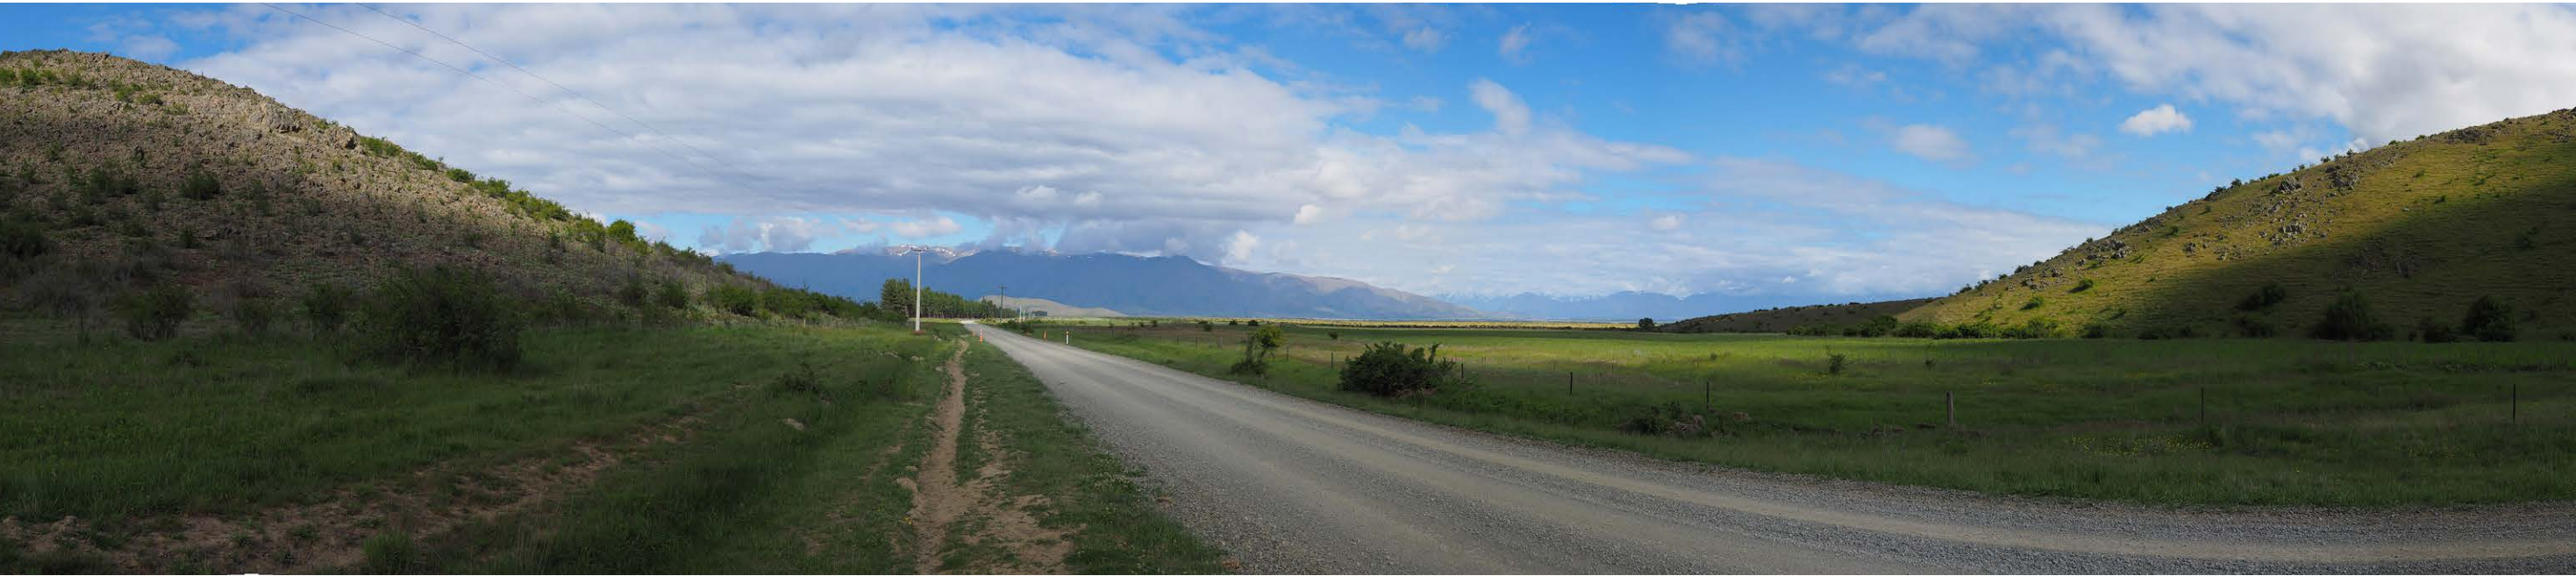
Viewpoint Location Photograph 14: Located along Haldon Road at the western end of Little Pass. This photo illustrates the first time a road user gains a view over this part of the basin when travelling along this road, with the solar farm being 9.8kms away.

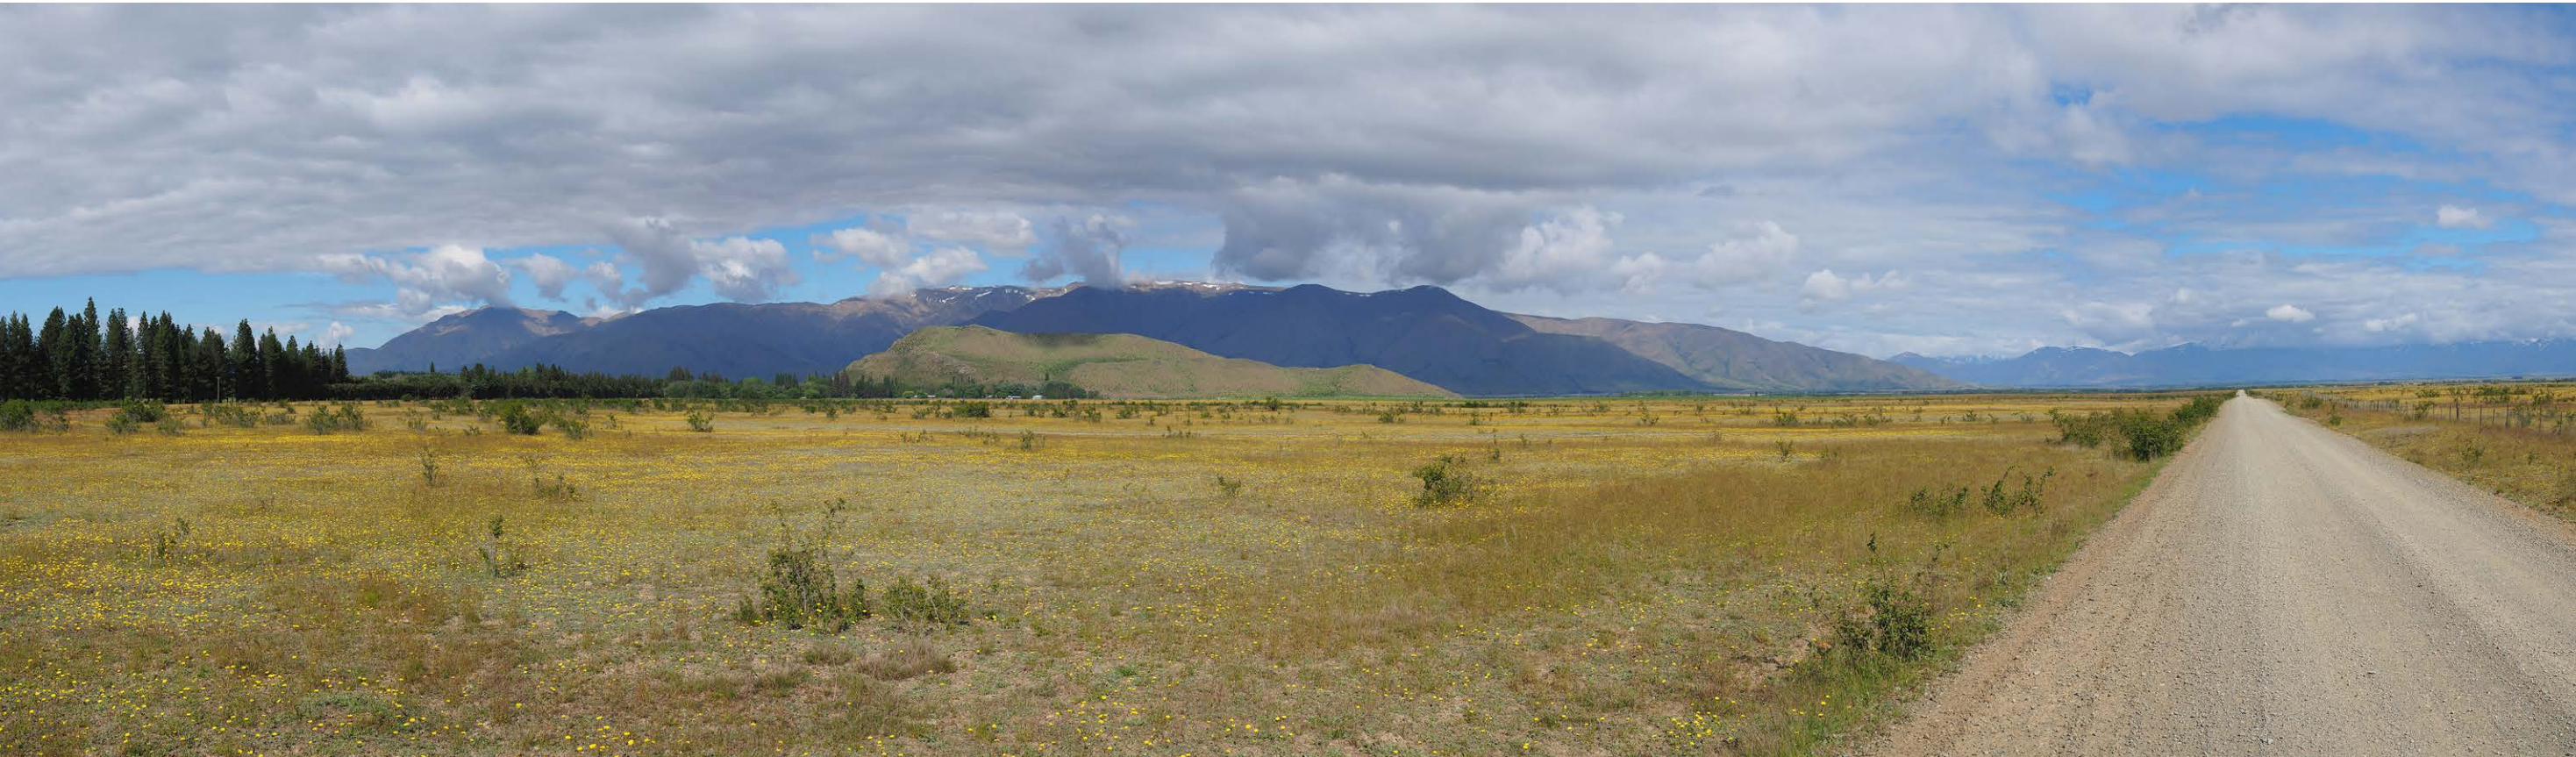
Viewpoint Location Photograph 15: Located near the intersection of Haldon Road and Haldon Arm Road. This photo illustrates the view over the dryland outwash plain towards the site and enclosing mountains, with the solar farm being 6.3kms away, on the far side of the Pukaki / Tekapo Rivers.

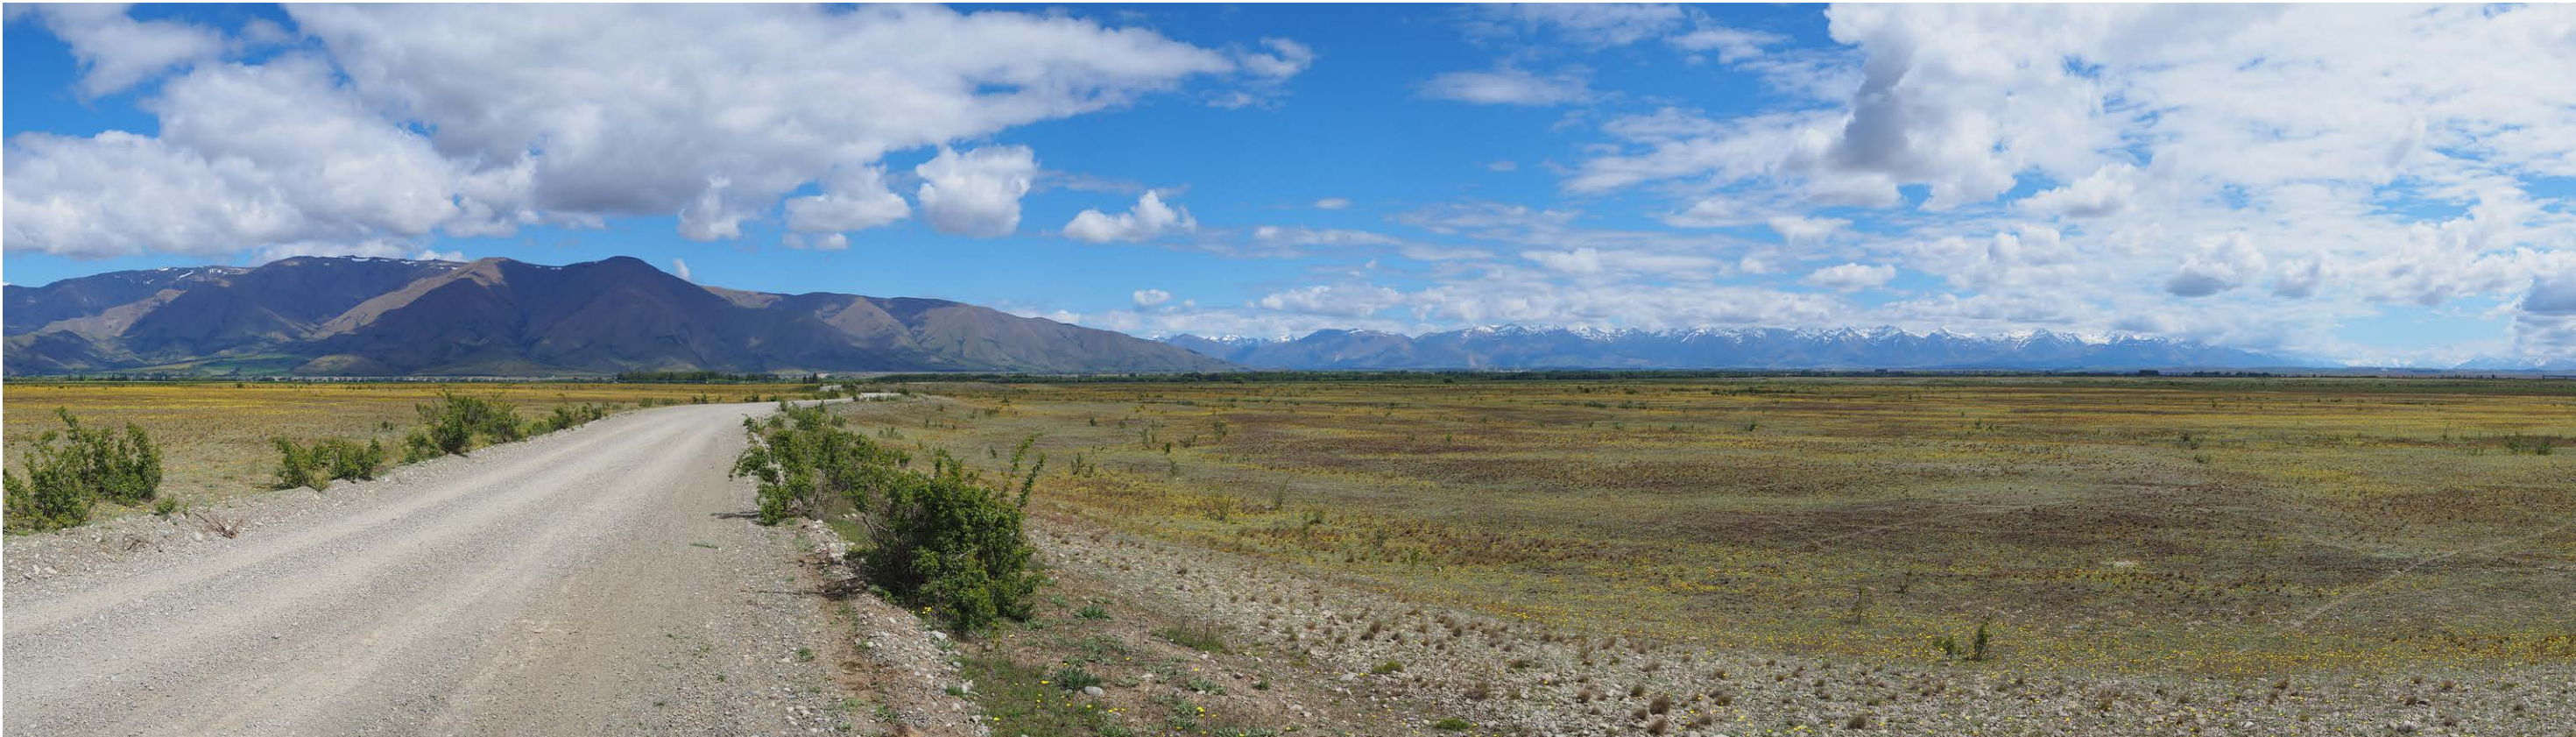
Viewpoint Location Photograph 16: Located along Haldon Arm Road. This photo illustrates the view over the dryland outwash plain towards the site and enclosing mountains, with the solar farm being 3.3kms away, on the far side of the Pukaki / Tekapo Rivers.

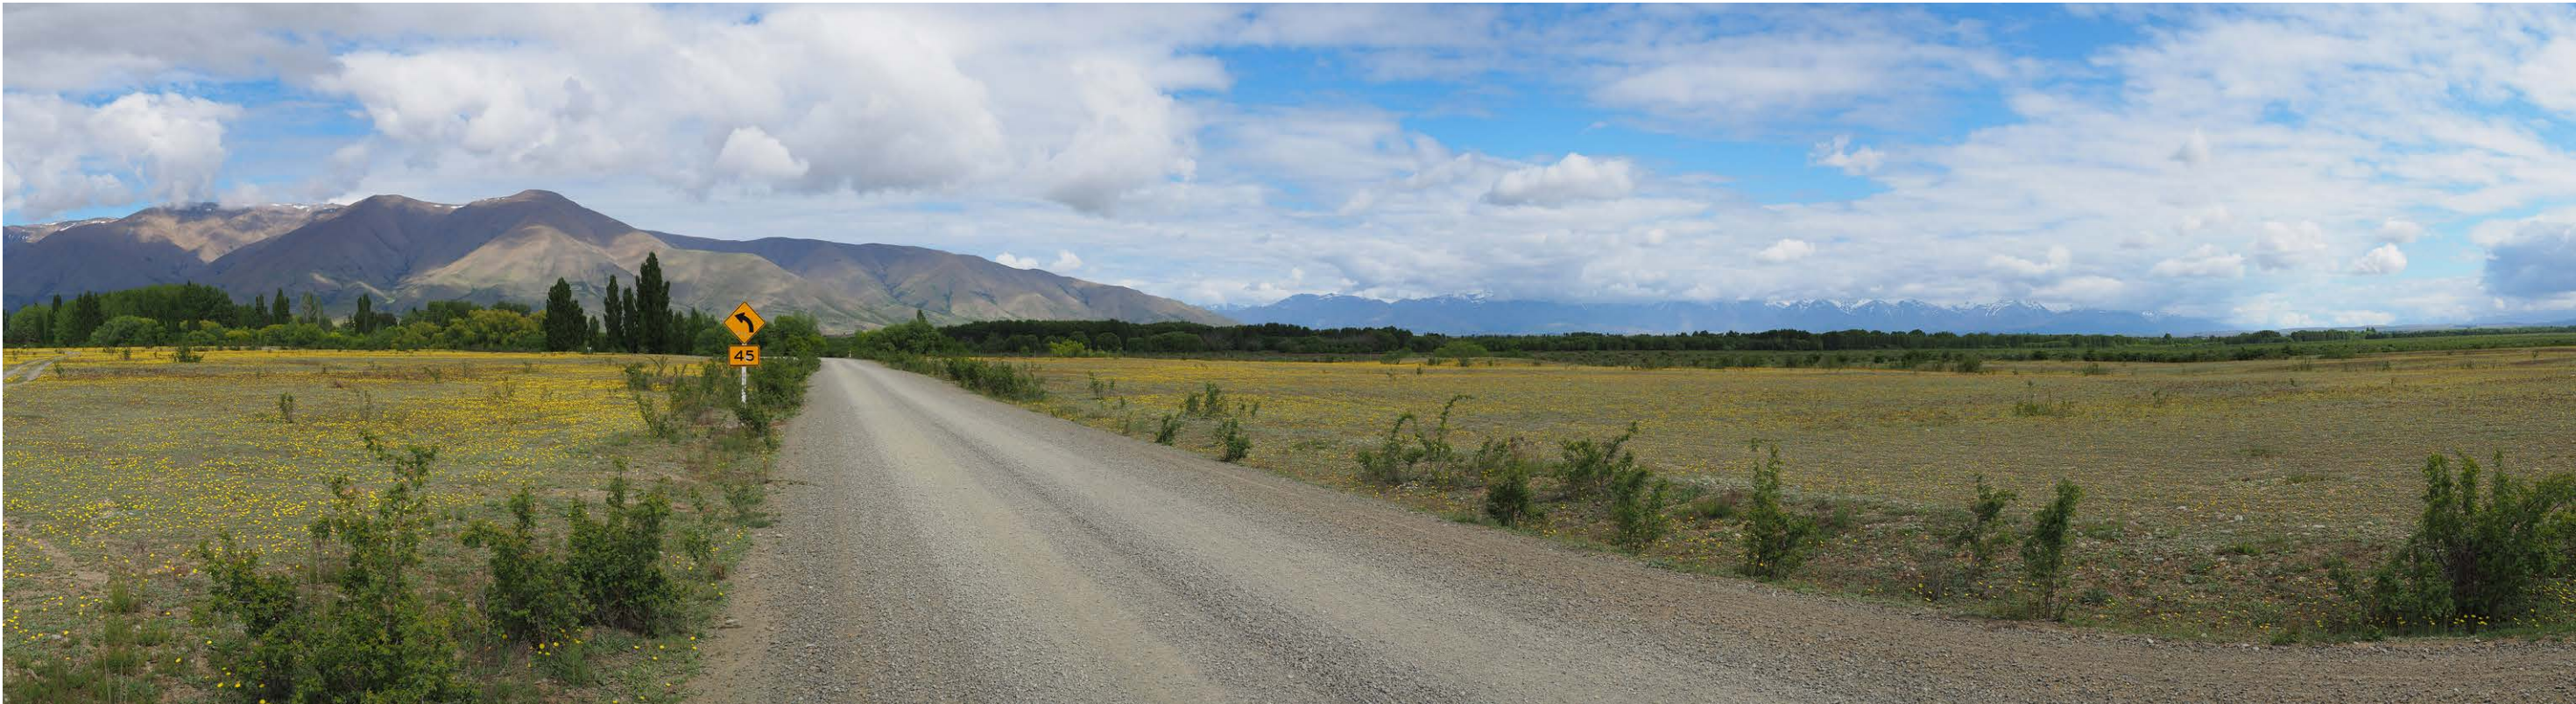
Viewpoint Location Photograph 17: Located along Haldon Arm Road, near the Tekapo River terrace edge. This photo illustrates the view over the dryland outwash plain towards the site and enclosing mountains, with the solar farm being 2.2kms away, on the far side of the Pukaki / Tekapo Rivers.

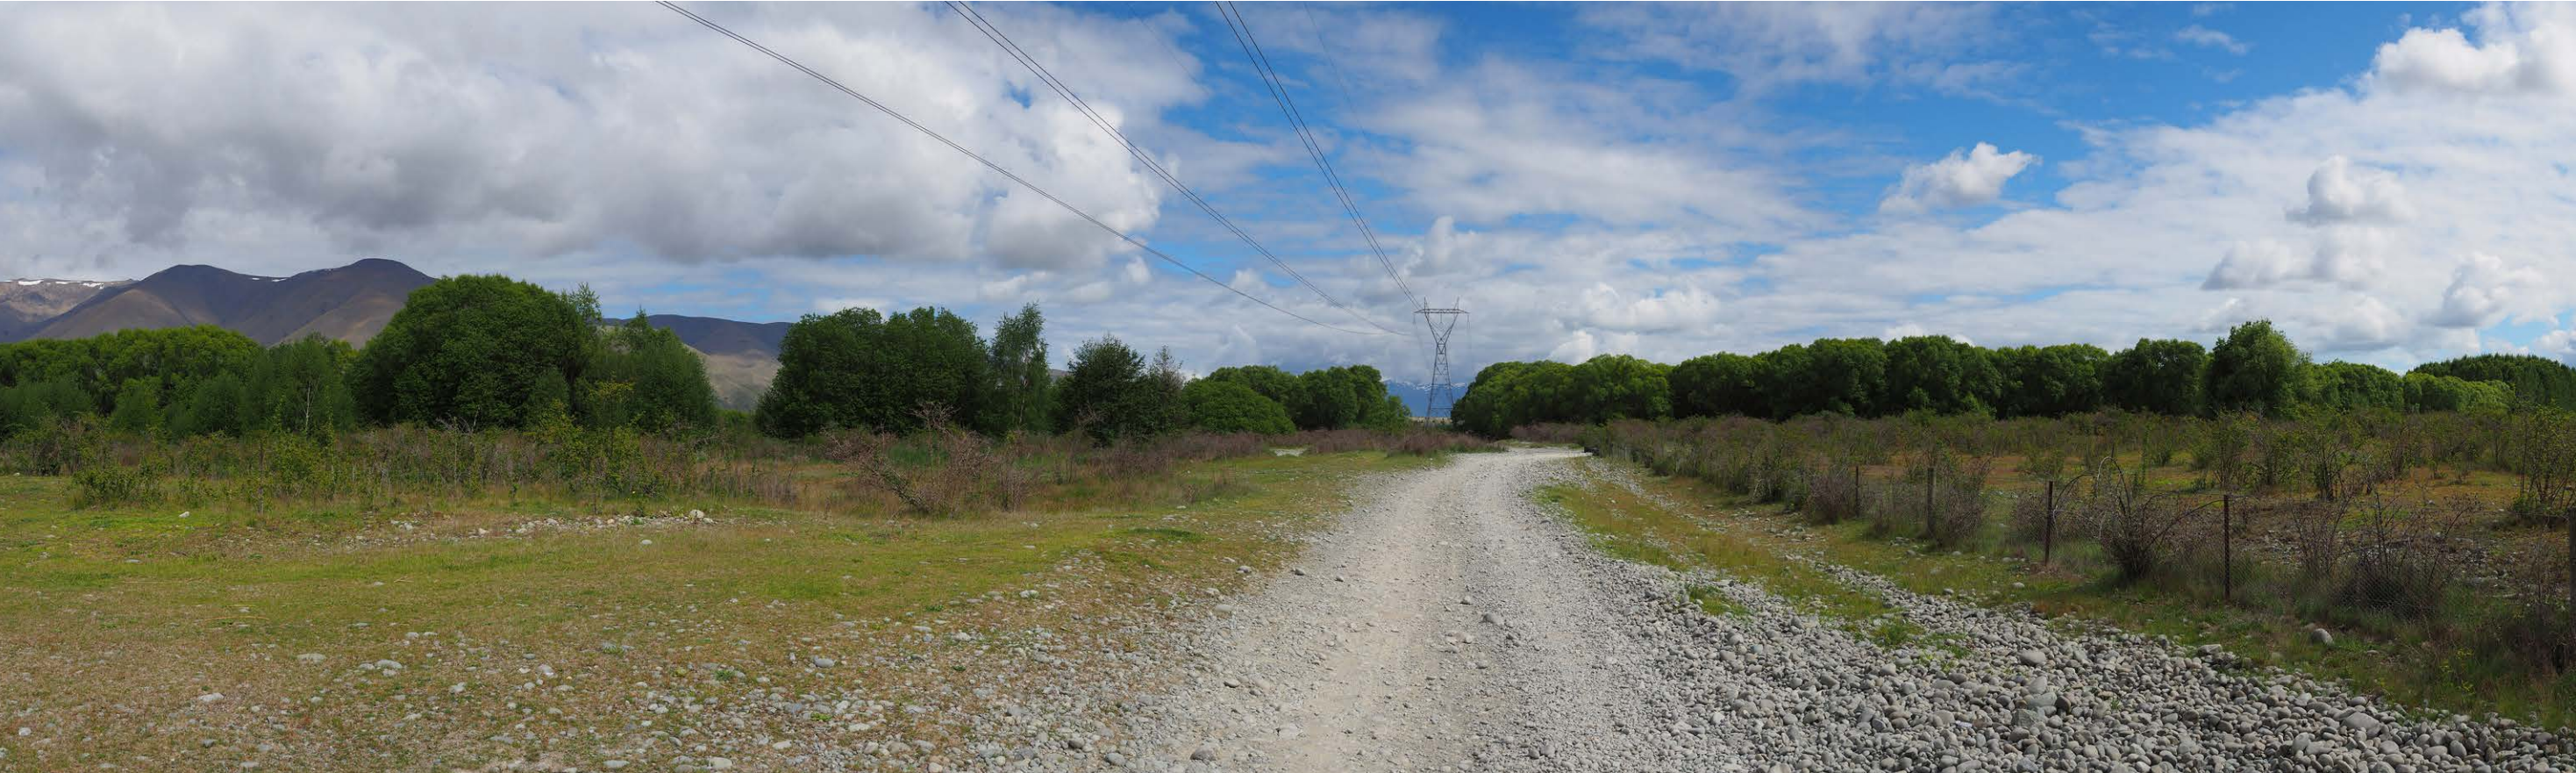
Viewpoint Location Photograph 18: Located along the four-wheel drive track section of Haldon Arm Road, immediately west of Haldon Arm Campground. This photo illustrates the limited long range views gained from these four-wheel-drive tracks alongside the Pukaki and Tekapo Rivers.

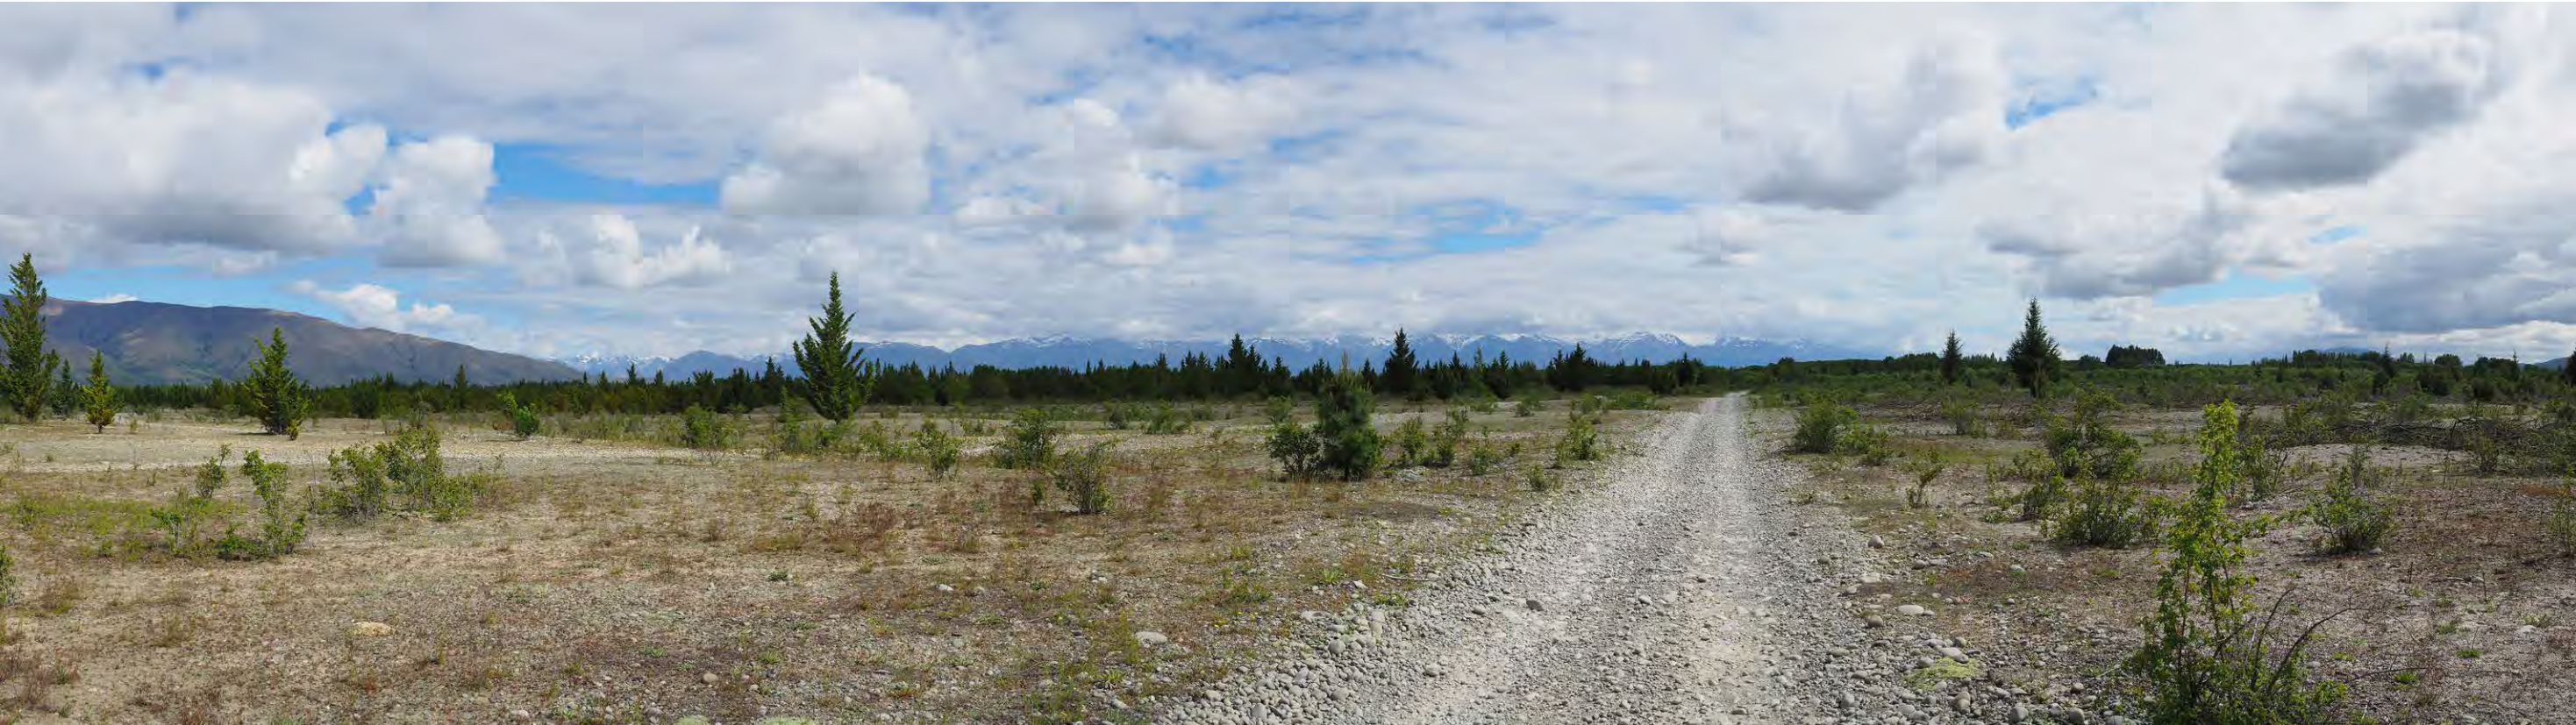
Viewpoint Location Photograph 19: Located along the four-wheel drive track west Haldon Arm Road, heading towards Old Iron Bridge. This photo illustrates the limited long range views gained from these four-wheel-drive tracks alongside the Pukaki and Tekapo Rivers.

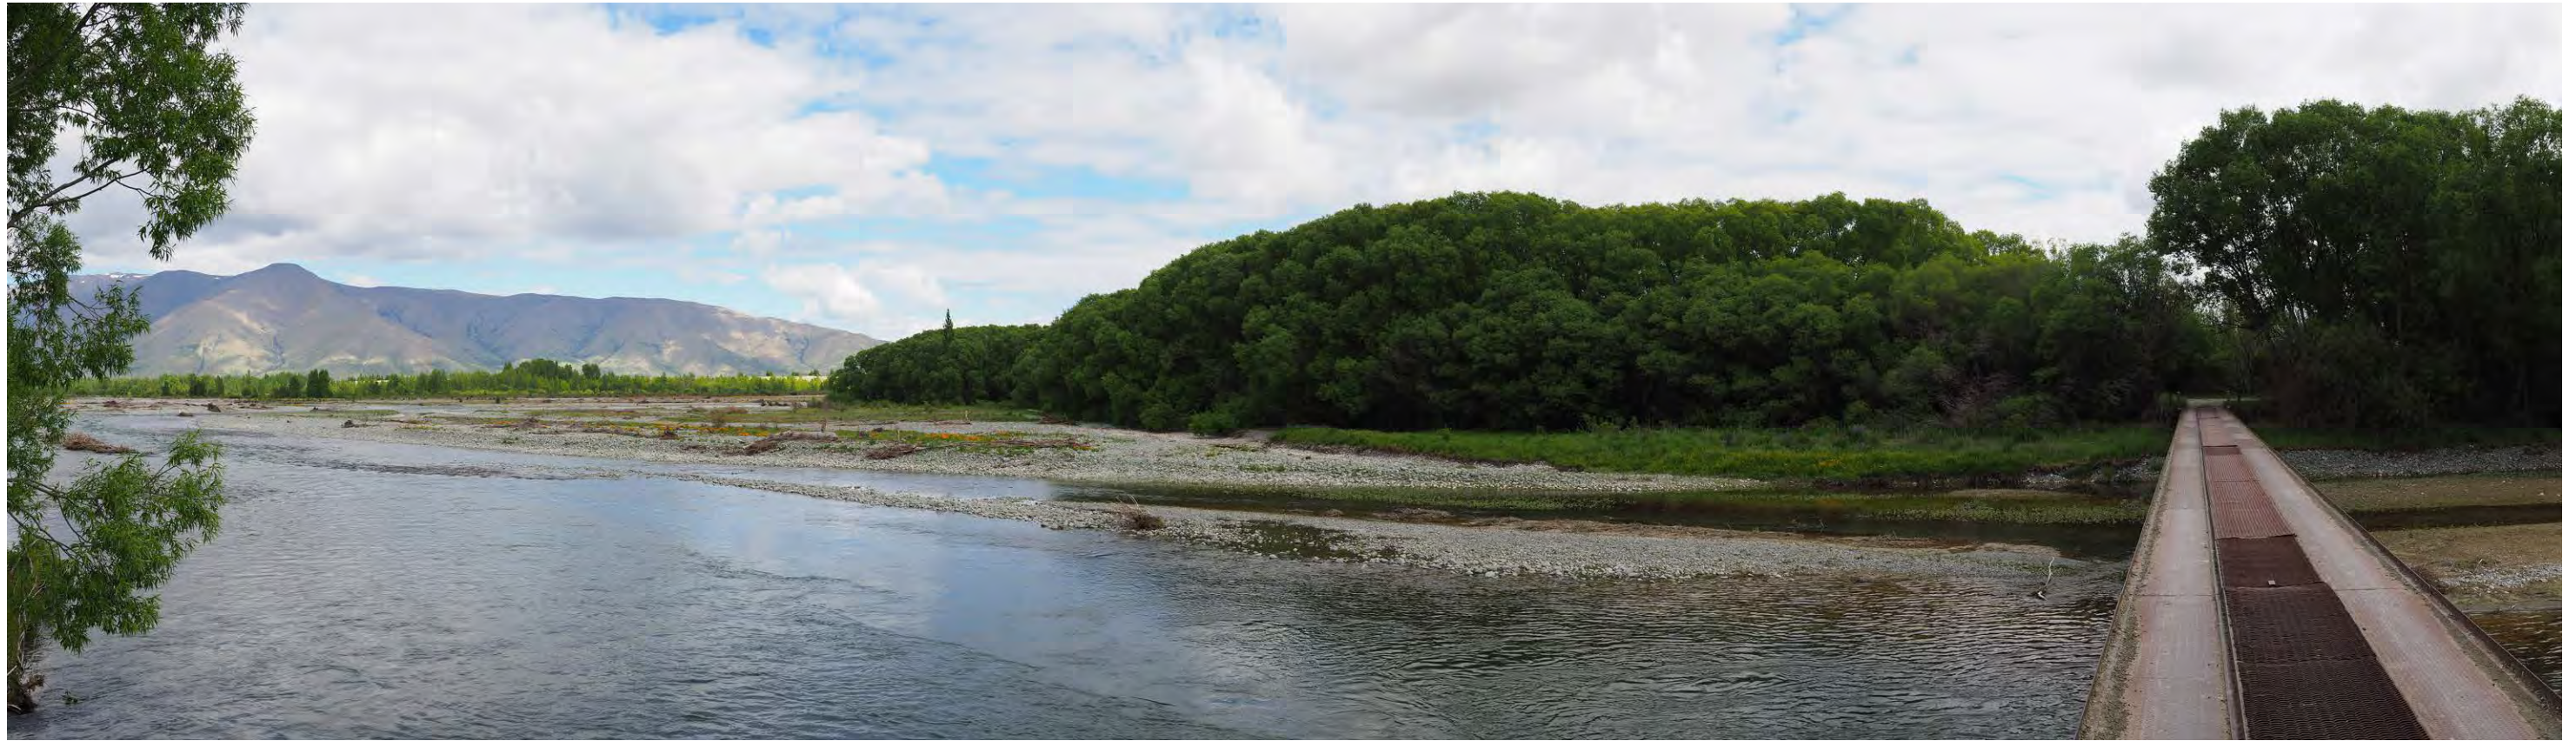
Viewpoint Location Photograph 20: Located on the eastern side of Old Iron Bridge. This photo illustrates the view along the Tekapo River towards the site and the Benmore Range.

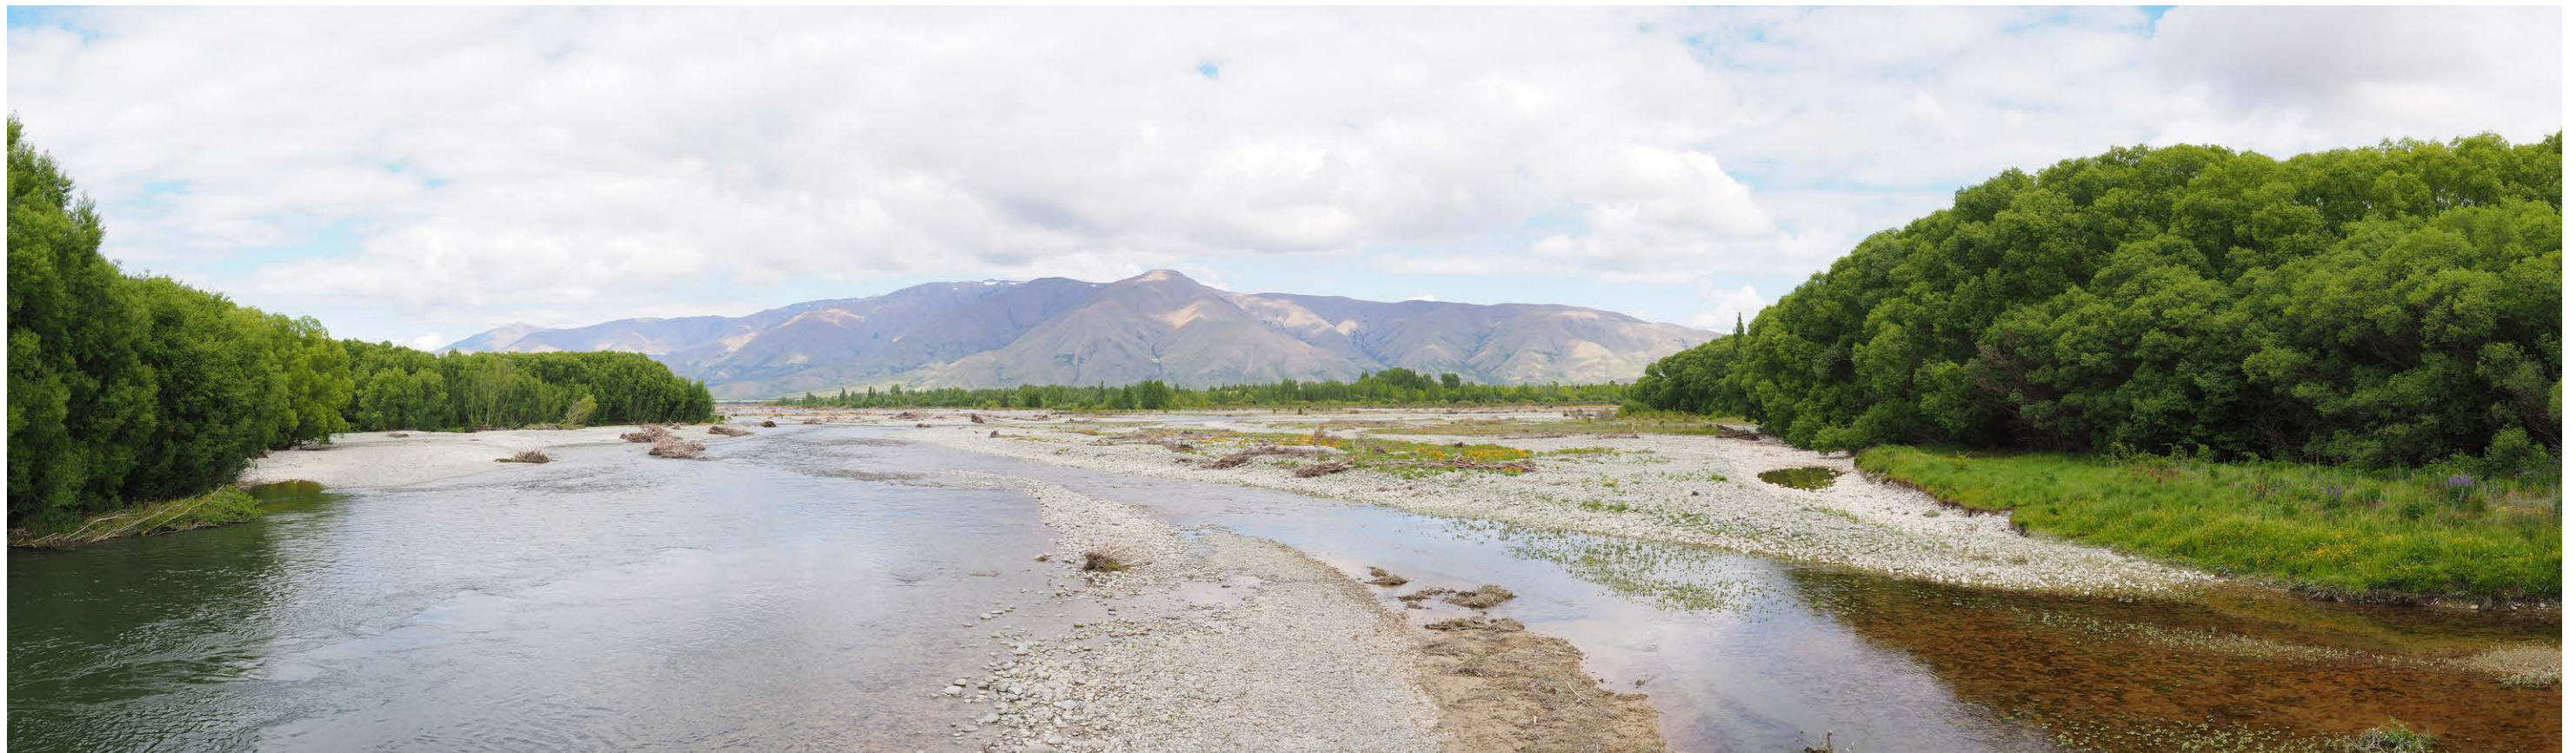
Viewpoint Location Photograph 21: Located in the middle of Old Iron Bridge. This photo illustrates the view along the Tekapo River towards the site, which cannot be seen, and the Benmore Range.

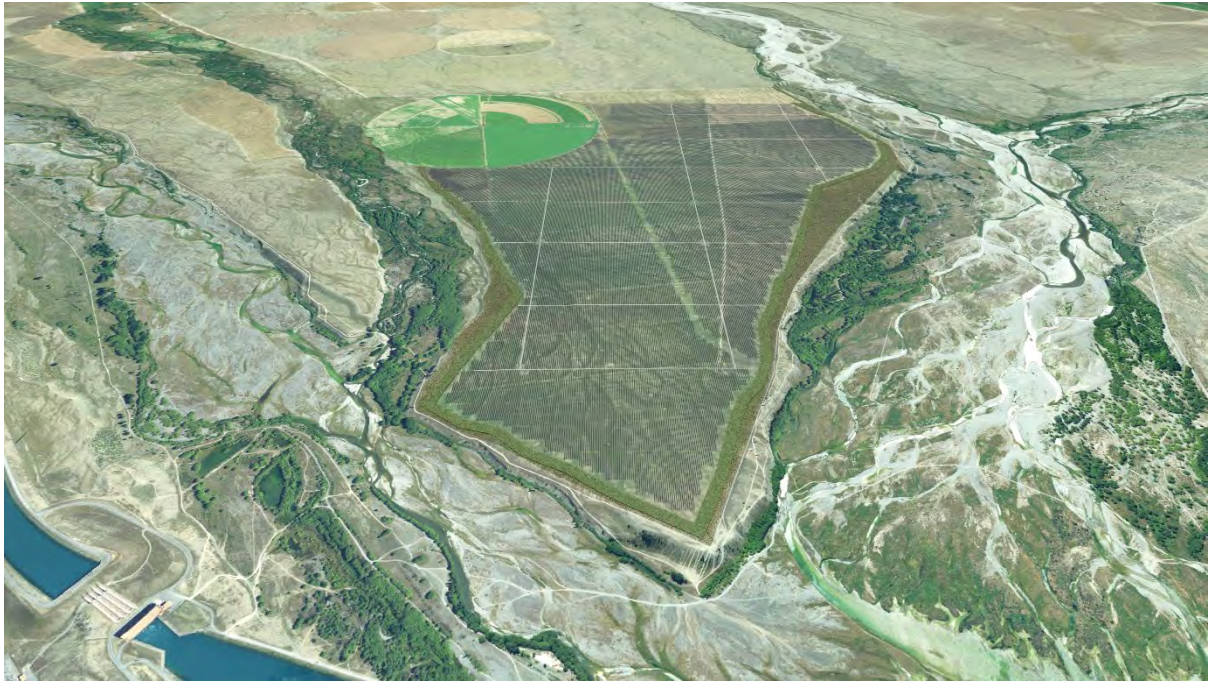
Overview of 3D model showing digital terrain model with solar panel layout and landscaping.

6. To achieve a photo simulation Virtual View Ltd firstly created a digital terrain model of the existing landform. A 3D model of the solar panel system was created to supplied specifications and duplicated across the site to match the site layout plan. Landscaping was then added to the model to supplied heights and locations. Simulations 09, 12 and 25 include proposed landscaping at years 2 and 5. All other simulations only include proposed landscaping at year 5 due to it being on the southern side of the site and less visible.

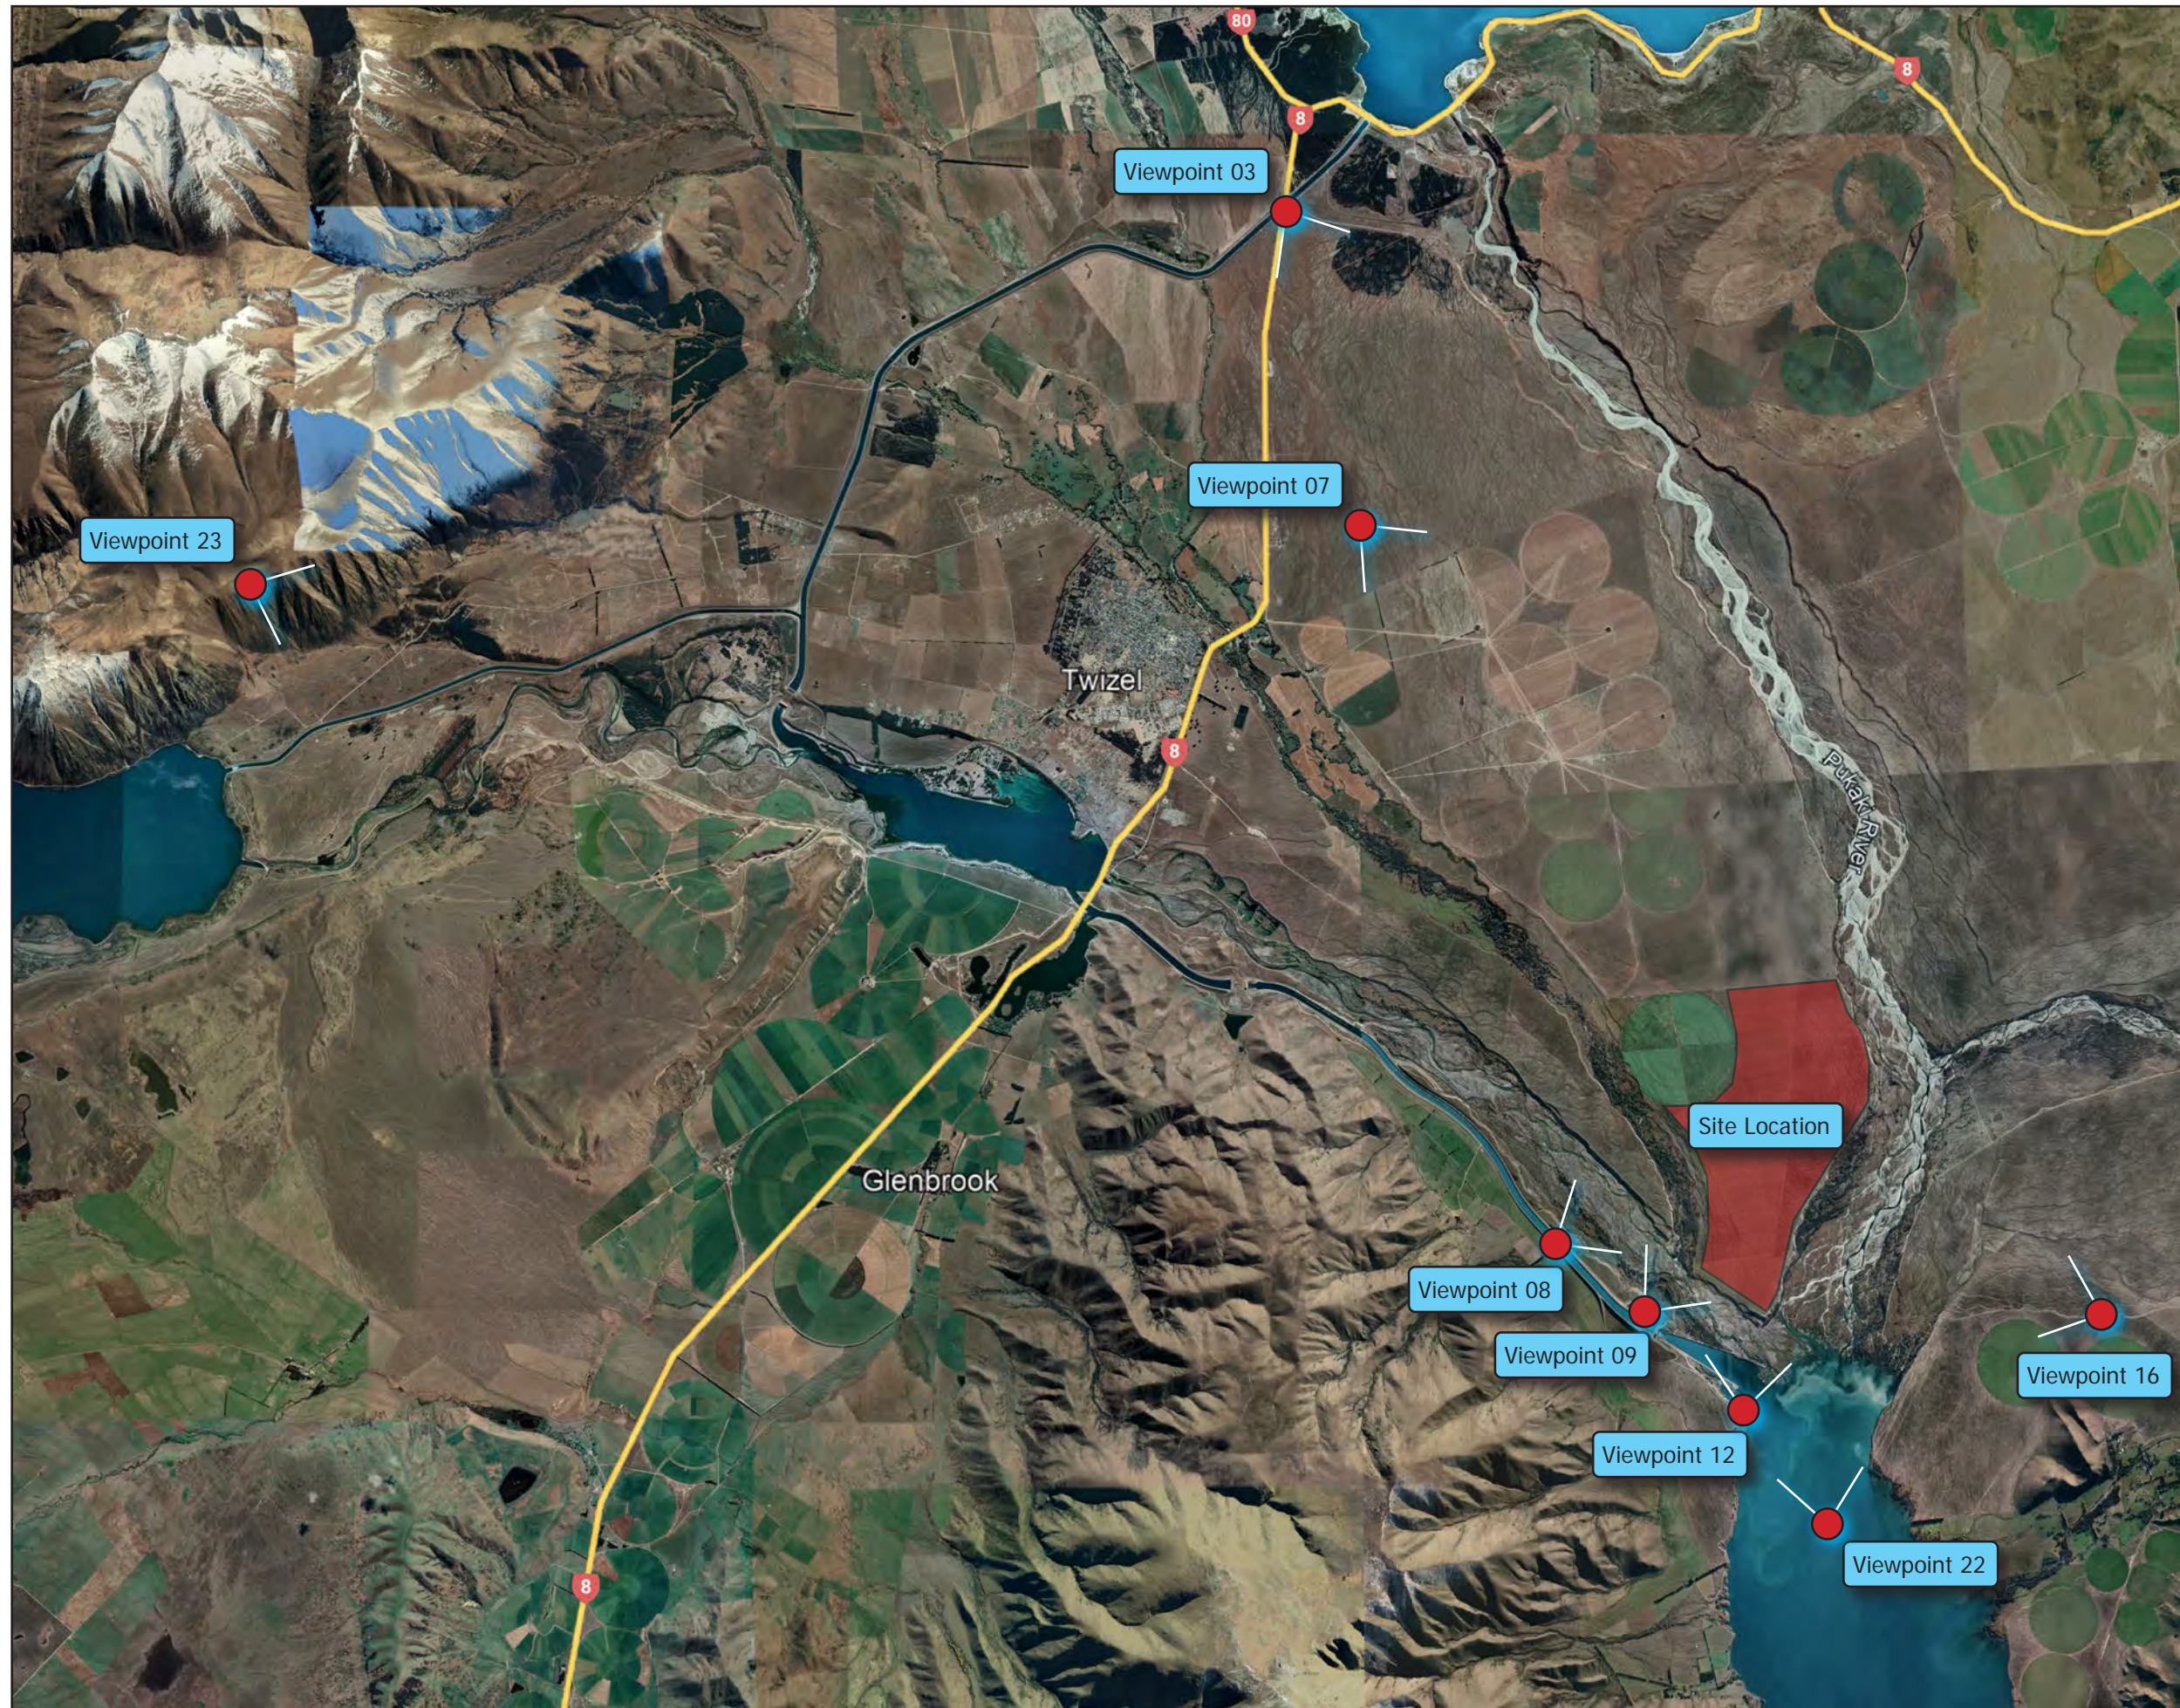
Viewpoint Location Map

- Viewpoint 03
Pukaki-Ohau Canal Bridge
(E)325079.674 (N)821851.055
- Viewpoint 07
Alps 2 Ocean Cycle Trail
(E)326193.695 (N)817334.755
- Viewpoint 08
McAughtries Road
(E)328893.156 (N)807397.243
- Viewpoint 09
McAughtries Road
(E)330081.513 (N)806497.075
- Viewpoint 12
Falston Road
(E)331419.215 (N)805168.442
- Viewpoint 16
Haldon Arm Road
(E)336283.141 (N)806562.820
- Viewpoint 22
Lake Benmore
(E)332530.098 (N)803795.977
- Viewpoint 23
Greta Track
(E)310818.826 (N)816197.524
