Proposed Solar Farm - The Point, Mackenzie Basin
Appendix 2: Visual Simulations

25 May 2023

**ASSESSMENT OF ECOLOGICAL EFFECTS FOR
THE PROPOSED ŌHAU C SOLAR FARM BETWEEN
THE LOWER REACHES OF THE TEKAPO AND
TWIZEL RIVERS, MACKENZIE DISTRICT**

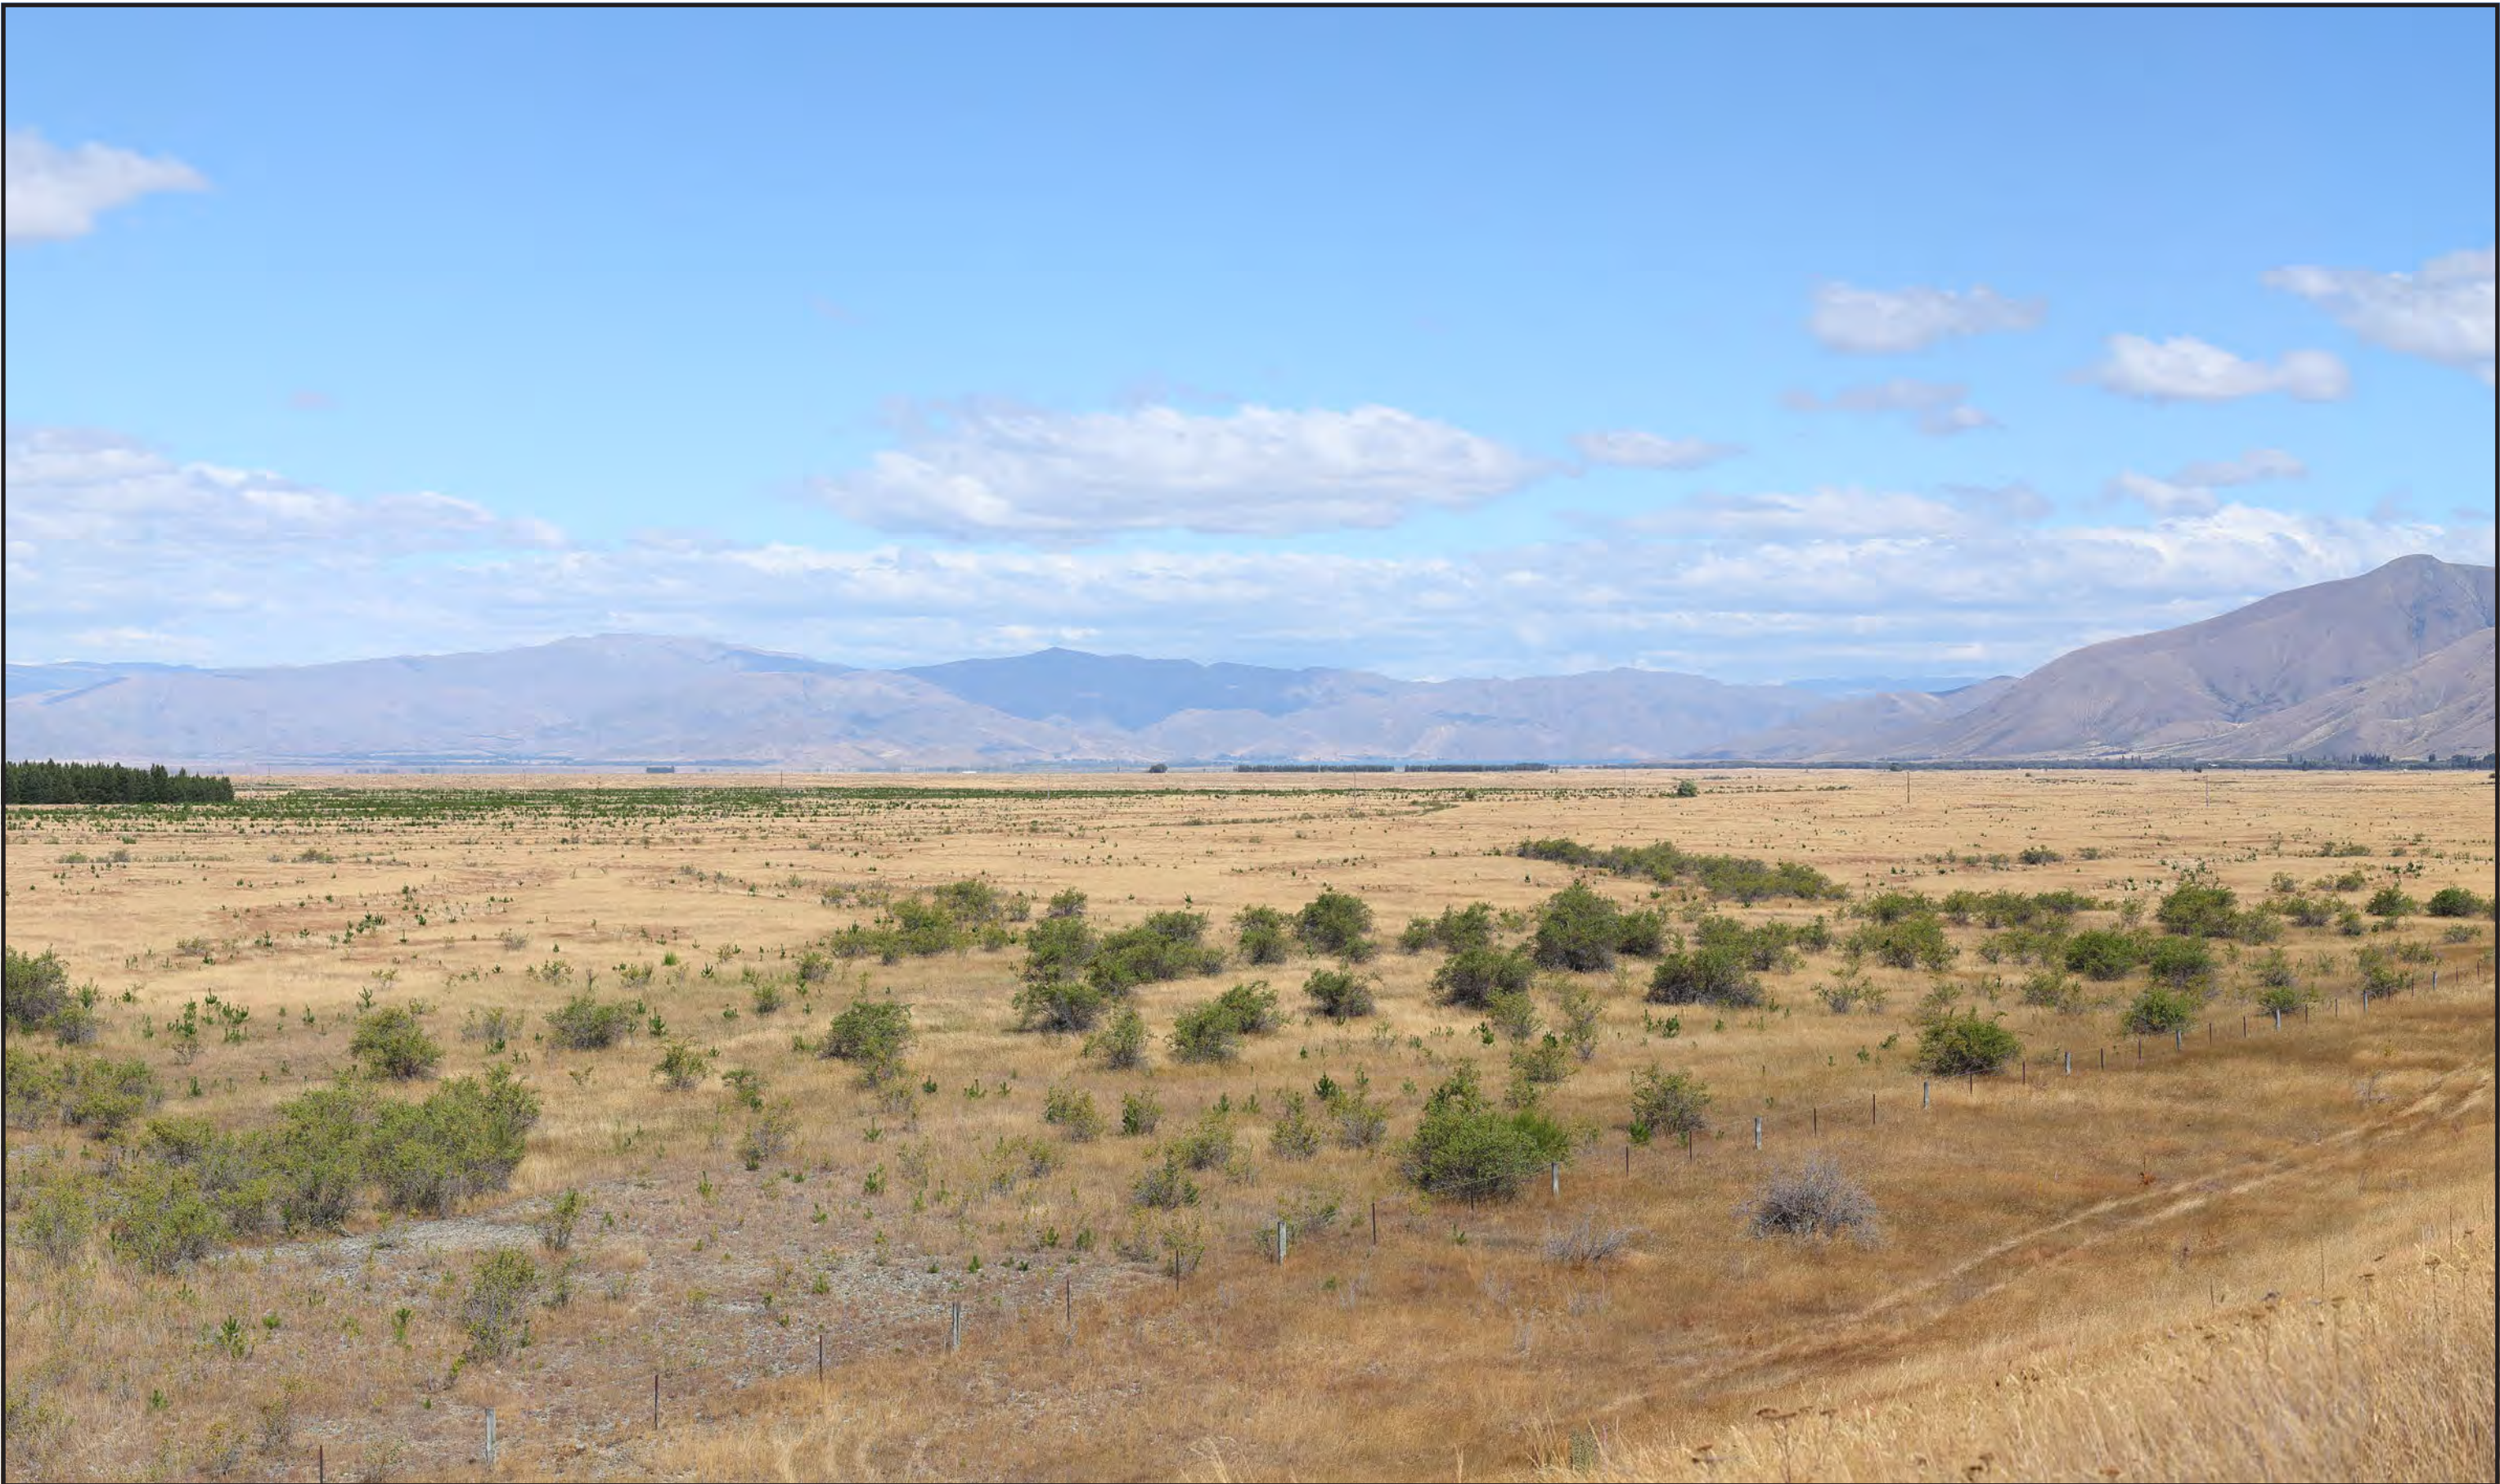
Viewpoint 03 - Existing

<p>VIRTUALVIEW 3D VISUALISATION SPECIALISTS</p>	<p>Easting: 325079.674 Northing: 821851.055 Elevation : 521.628m Height of Camera : 1.4m Orientation of View : SE Date of Photography : 08 Feb 2023 Time of Photography : 16:08pm</p>	<p>Far North Solar Farm Ltd - Ohau C</p> <p>Viewpoint 03 - Pukaki-Ohau Canal Bridge</p>	<p>NOTES: All photos were taken by Virtual View with a Canon 5Dmk2 and a 50mm lens. Photo positions were surveyed by Virtual View.</p> <p>Version info: 0002 Date Printed: 17-05-2023</p>	 
--	---	---	---	---

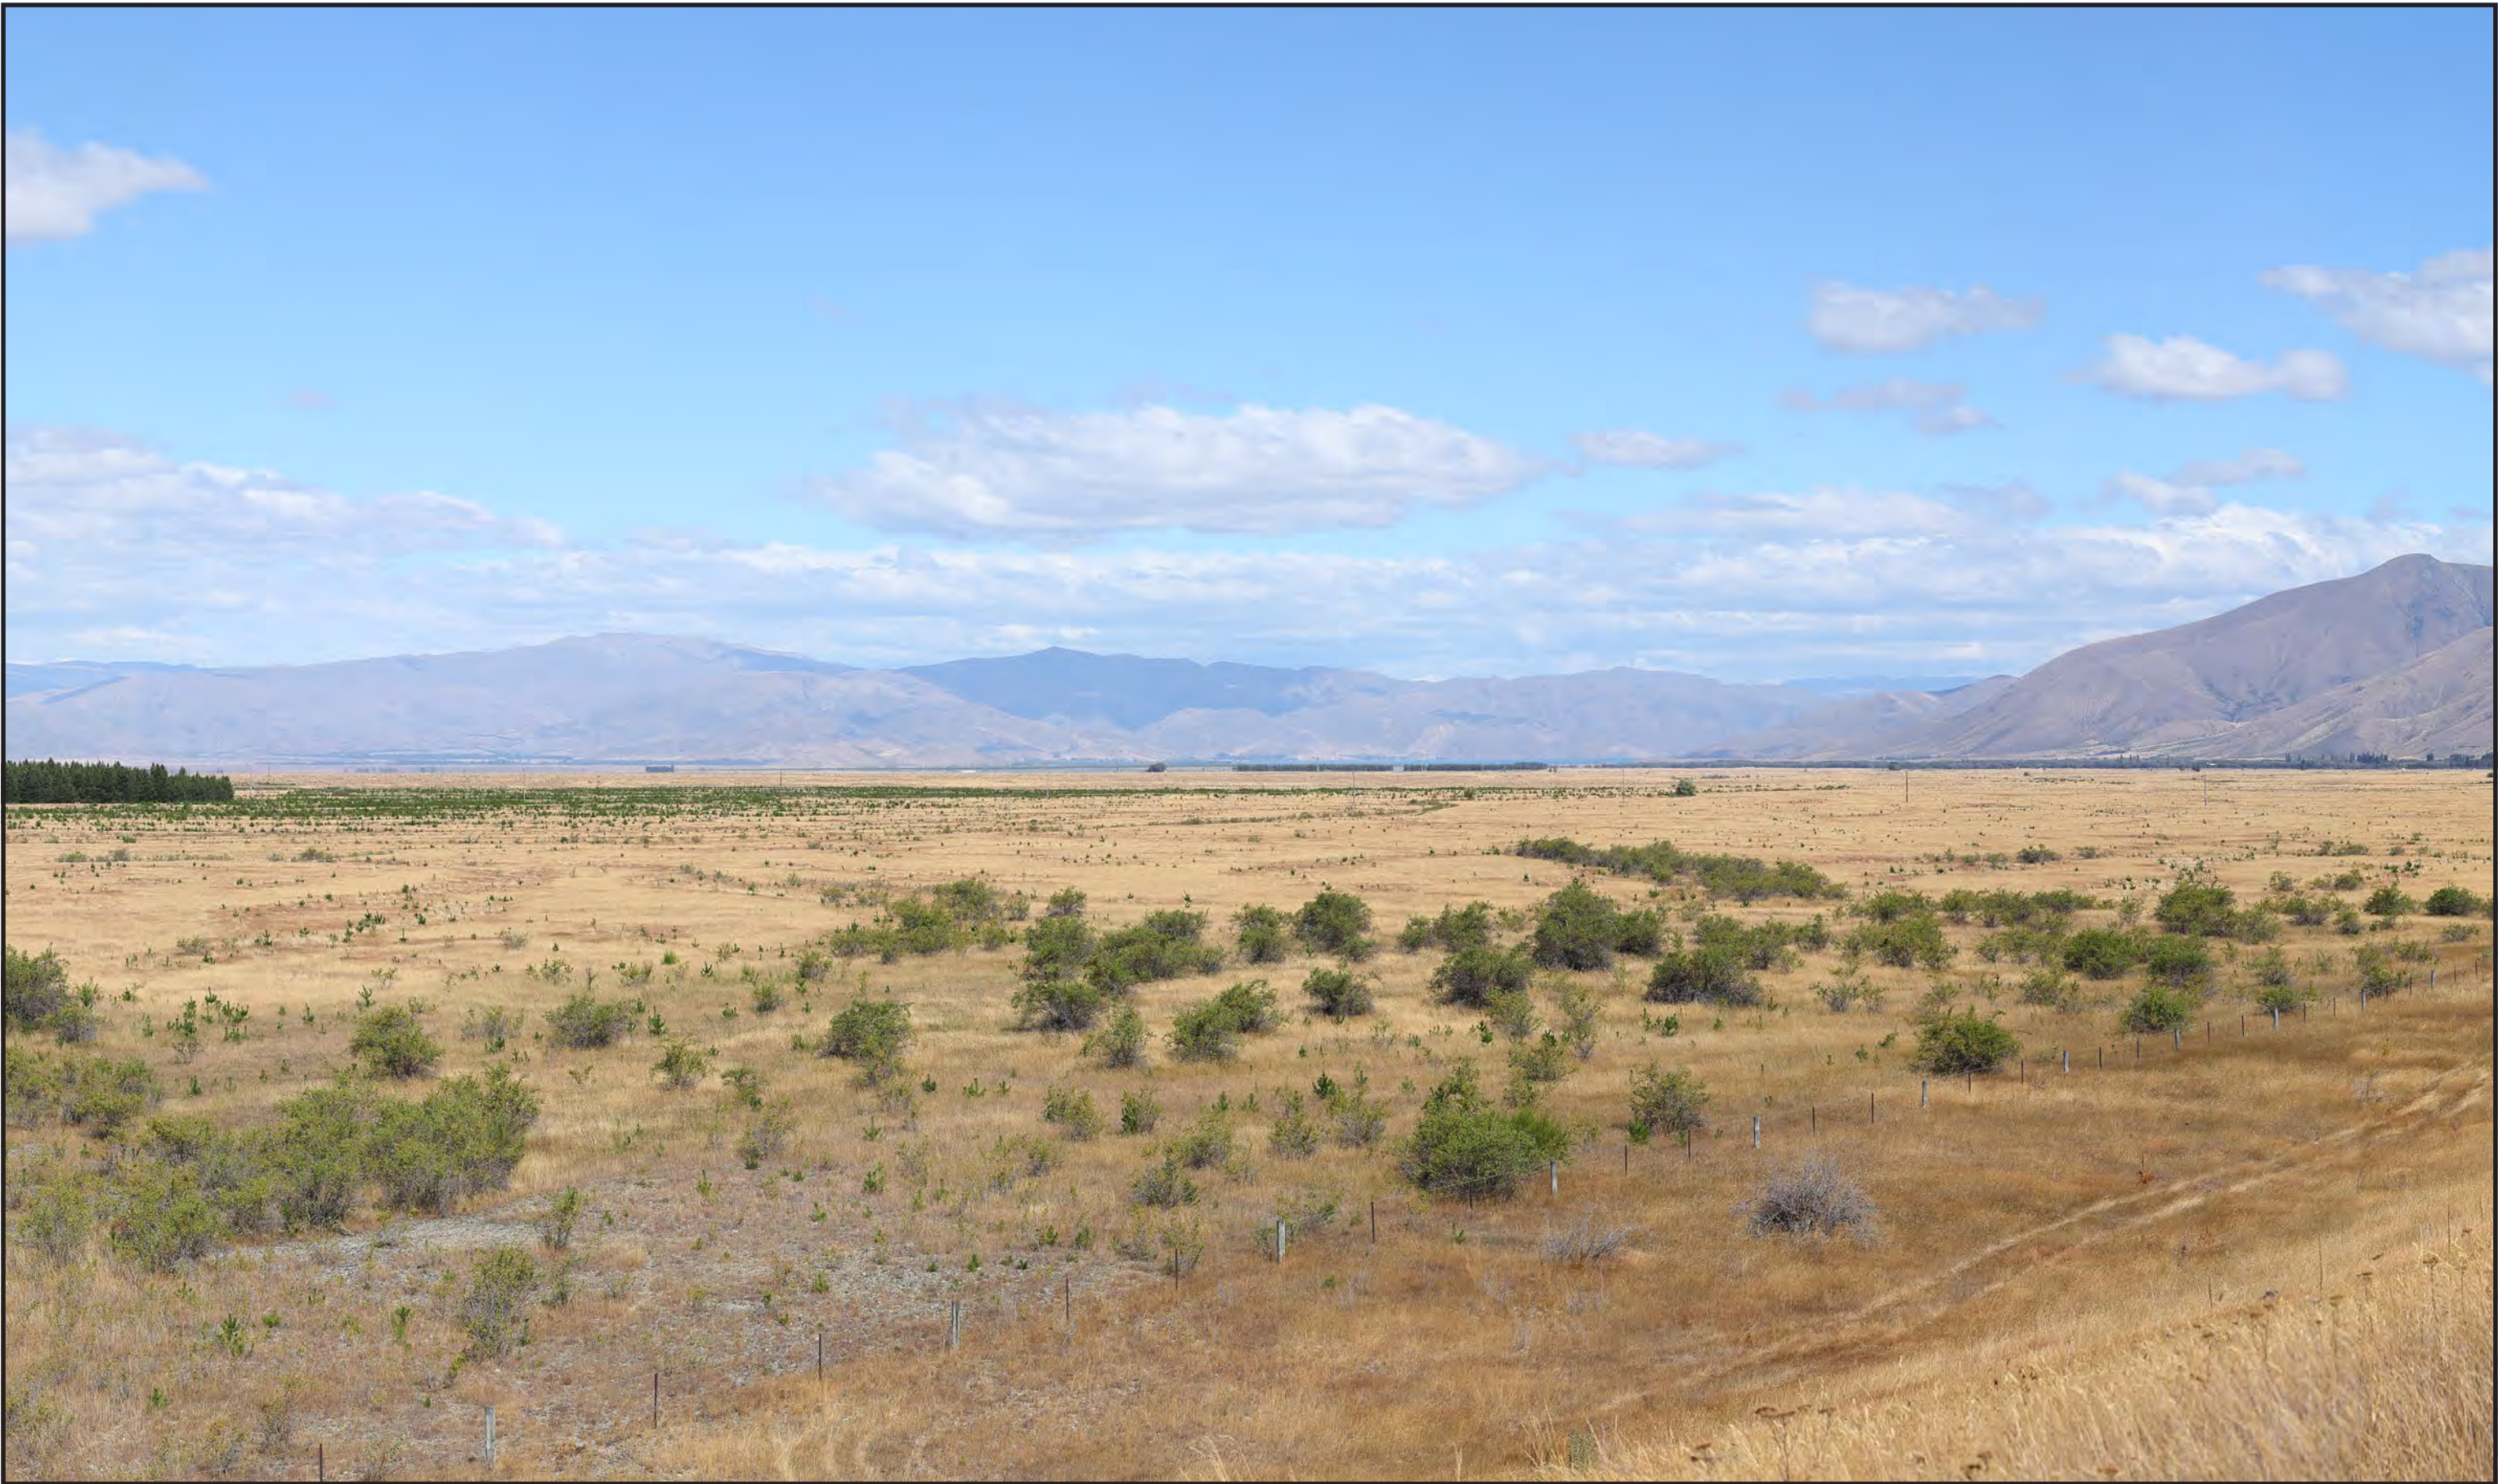
Viewpoint 03 - Proposed

<p>VIRTUALVIEW 3D VISUALISATION SPECIALISTS</p>	<p>Easting: 325079.674 Northing: 821851.055 Elevation : 521.628m Height of Camera : 1.4m Orientation of View : SE Date of Photography : 08 Feb 2023 Time of Photography : 16:08pm</p>	<p>Far North Solar Farm Ltd - Ohau C</p> <p>Viewpoint 03 - Pukaki-Ohau Canal Bridge</p>	<p>NOTES: All photos were taken by Virtual View with a Canon 5Dmk2 and a 50mm lens. Photo positions were surveyed by Virtual View.</p> <p>Version info: 0002 Date Printed: 17-05-2023</p>	 
--	---	---	---	---

- Viewpoint 03 = -40 degrees
 - Viewpoint 07 = -50 degrees
 - Viewpoint 08 = -30 degrees
 - Viewpoint 09 = -5 degrees
 - Viewpoint 12 = -20 degrees
 - Viewpoint 16 = +35 degrees

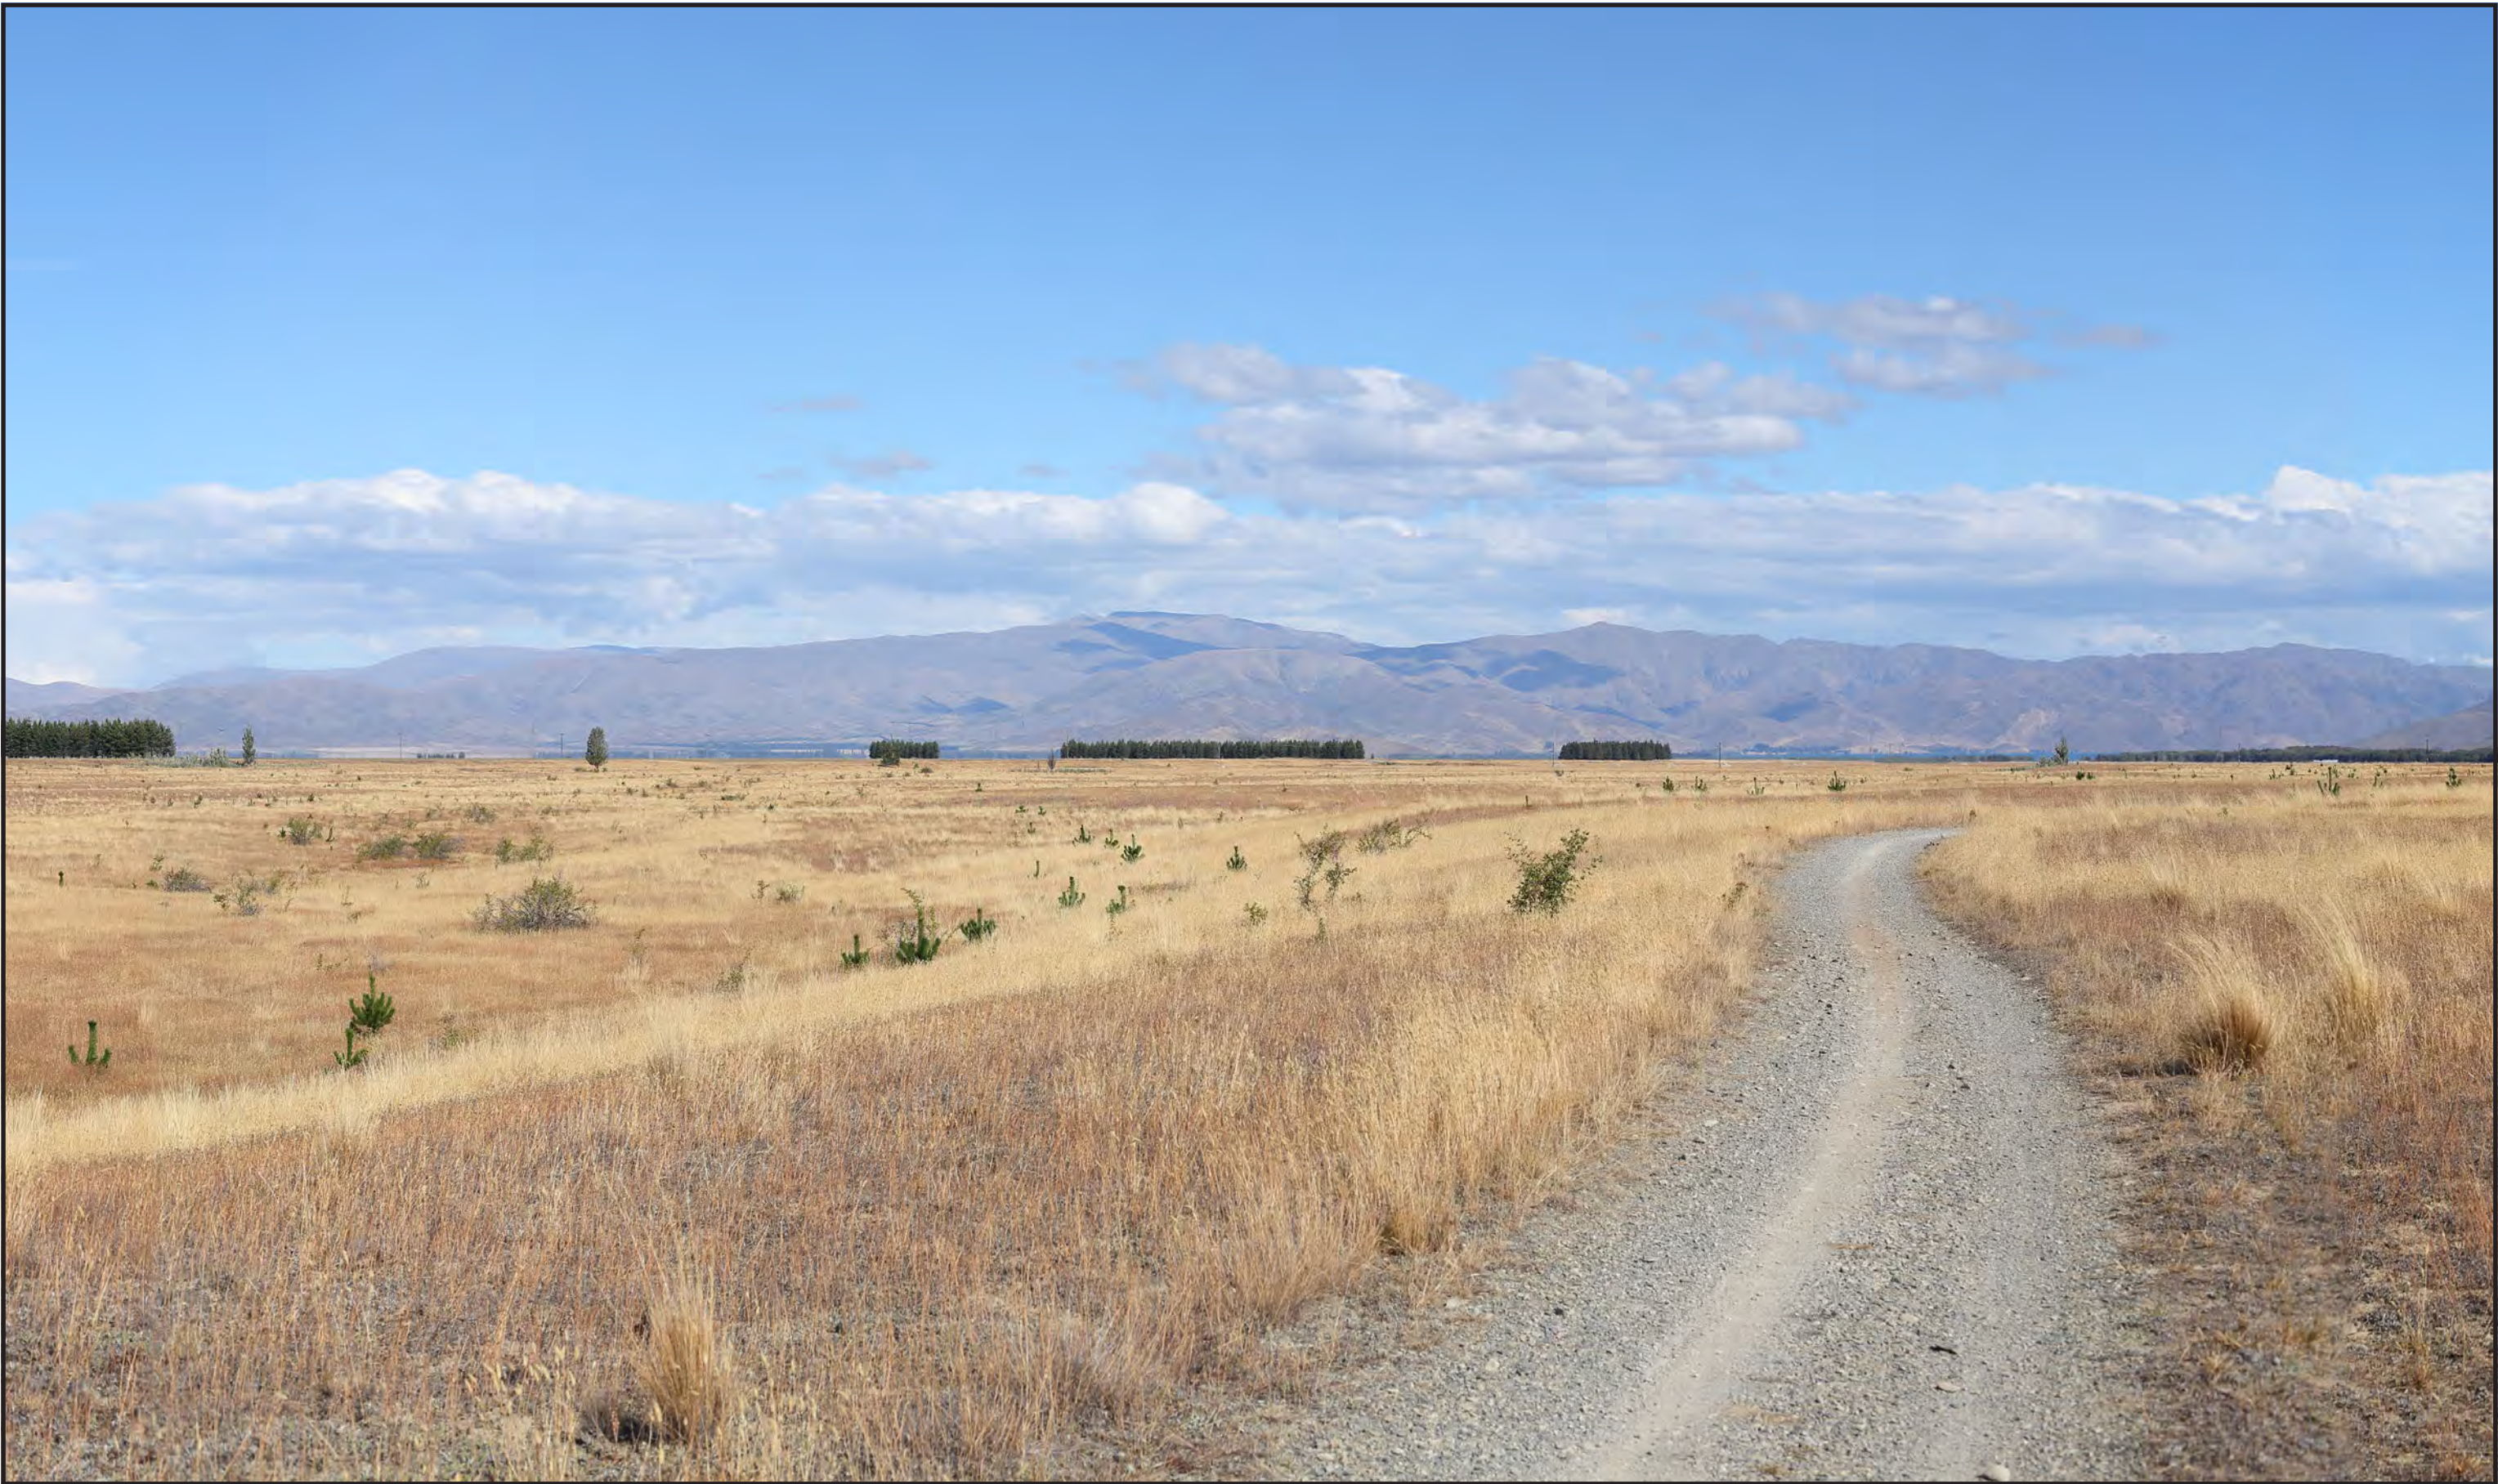
Viewpoint 07 - Proposed

Easting: 326193.695
Northing: 817334.755
Elevation : 466.593m
Height of Camera : 1.4m
Orientation of View : SE
Date of Photography : 08 Feb 2023
Time of Photography : 17:11pm

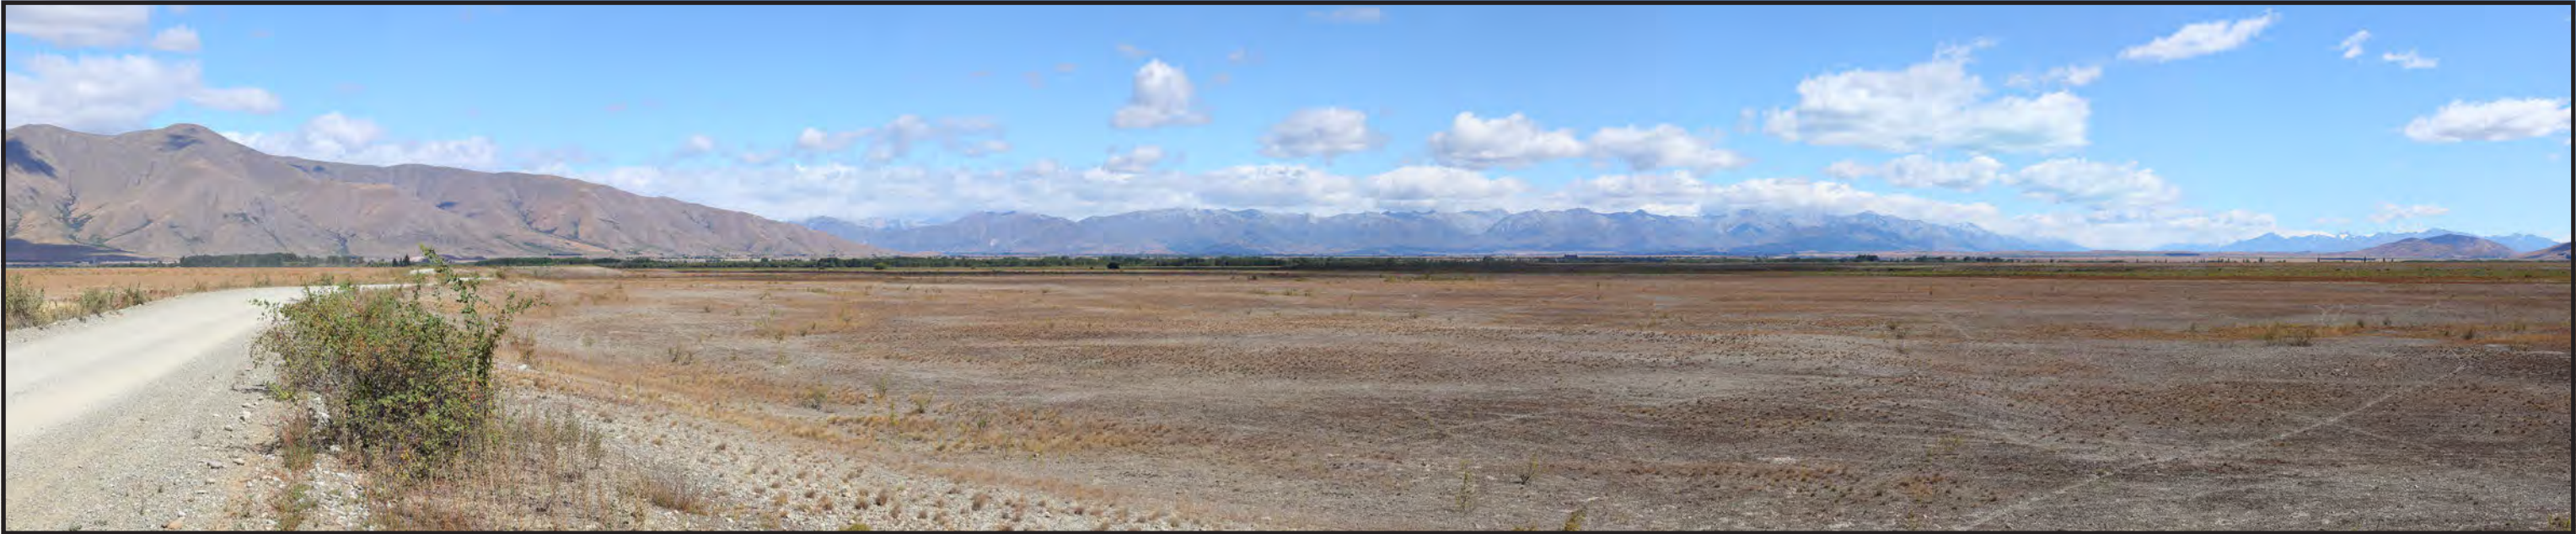
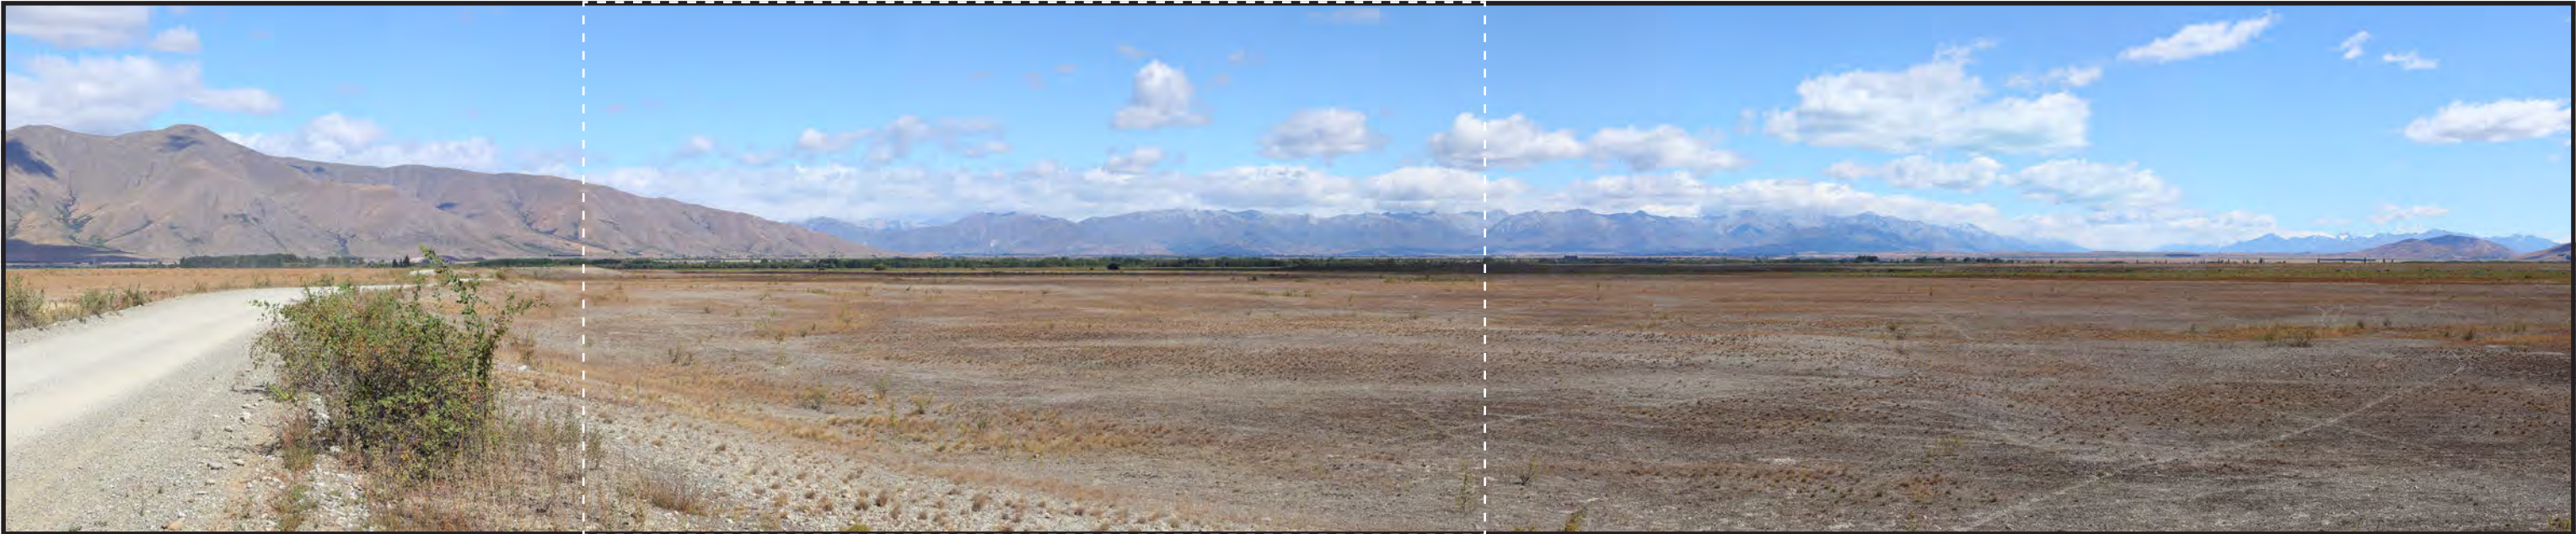
Viewpoint Location Photograph 16: Located along Haldon Arm Road. This photo illustrates the view over the dryland outwash plain towards the site and enclosing mountains, with the solar farm being 3.3kms away, on the far side of the Pukaki / Tekapo Rivers.

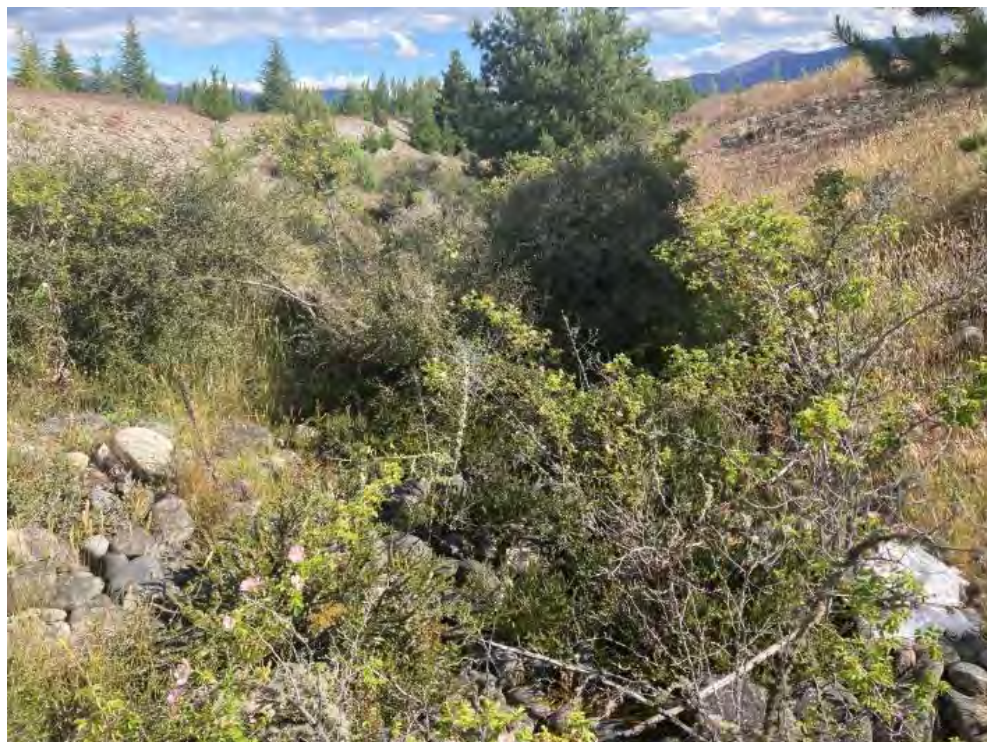
Plate 1: Sweet briar-matagouri shrubland.

This type is confined to two small patches in shallow gullies on the eastern edge of the site. Vegetation in these areas is dominated by exotic sweet briar (*Rosa rubiginosa*) with indigenous tūmatakuru/matagouri (At Risk – Declining), porcupine shrub (*Melicytus alpinus*) and mingimingi (Plate 1). Scattered exotic pines (mostly *Pinus contorta*) are emergent in places above the shrubs. There are also open areas, rocky ground, and exotic weeds, including mouse-ear hawkweed (*Pilosella officinarum*) and haresfoot trefoil (*Trifolium arvense*). Indigenous hard tussock and creeping pōhuehue (*Muehlenbeckia axillaris*) are also locally common.

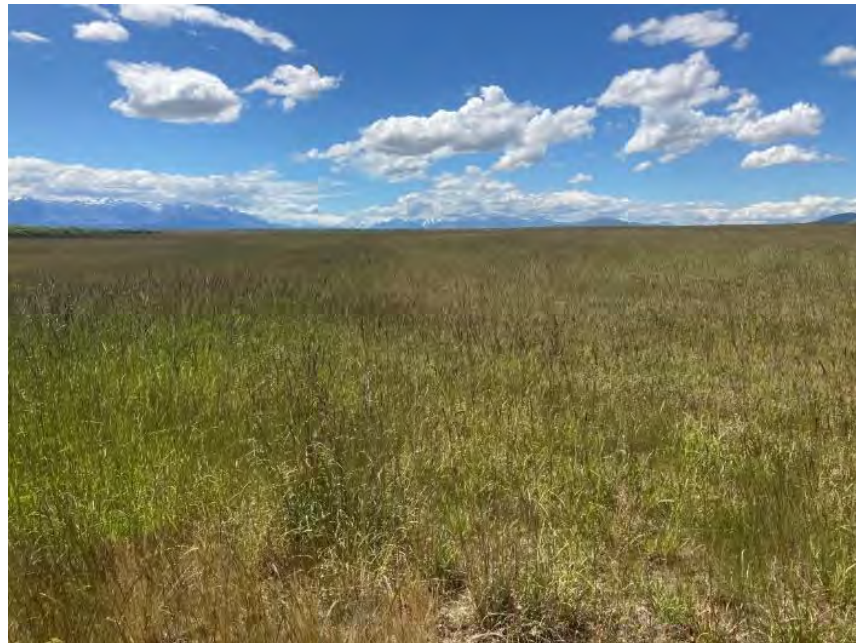
Plate 2: Cocksfoot-dominant grassland, which covers much of the site.

Cocksfoot (*Dactylis glomerata*) grassland is the most extensive vegetation type on the site and appears to have been sown mostly for hay and baleage production (Plate 2). The type is dominated by exotic species. It varies in height and composition across the site, in some paddocks the grass is over one metre tall where it is dominated by cocksfoot. In other areas it is shorter and comprises a mixture of exotics such as clovers (mostly *Trifolium repens* and *T. pratense*), lucerne (*Medicago sativa*) and other grasses including ryegrass (*Lolium perenne*) sweet vernal (*Anthoxanthum odoratum*) and red fescue (*Festuca rubra*). Around the margins, haresfoot trefoil and sheep's sorrel (*Rumex acetosella*) are also abundant and there are occasional patches where sweet briar is common.

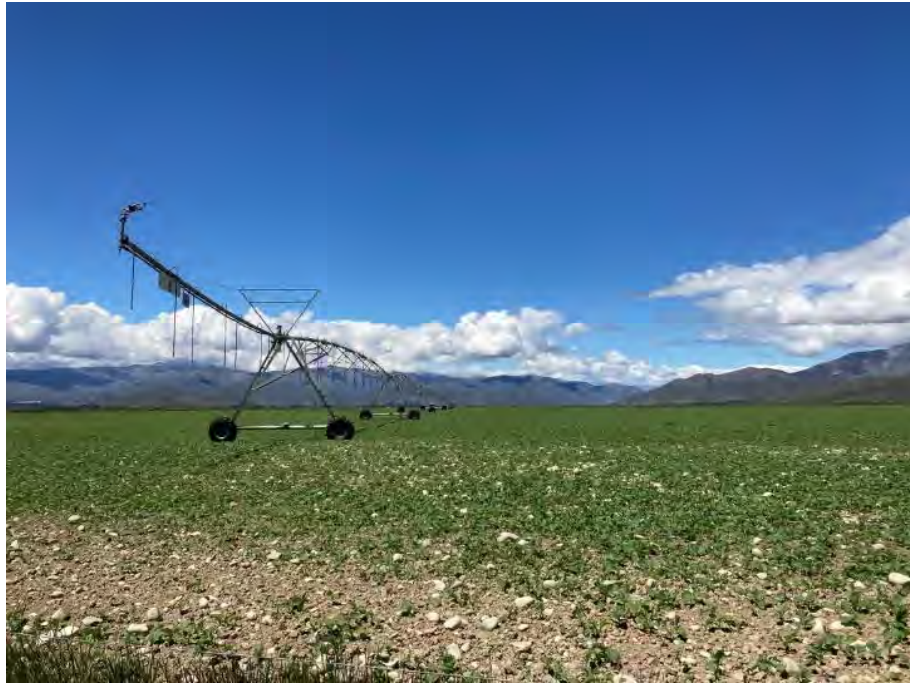
Plate 3: Irrigated brassica cropland, in the northern part of the site.

In the northwest corner of the site there is a circular area of cropland under a centre-pivot irrigator which, at the time of the survey, was planted with a brassica crop. Little else appeared to be growing in this area. Stones and bare ground were abundant between crop plants (Plate 3).

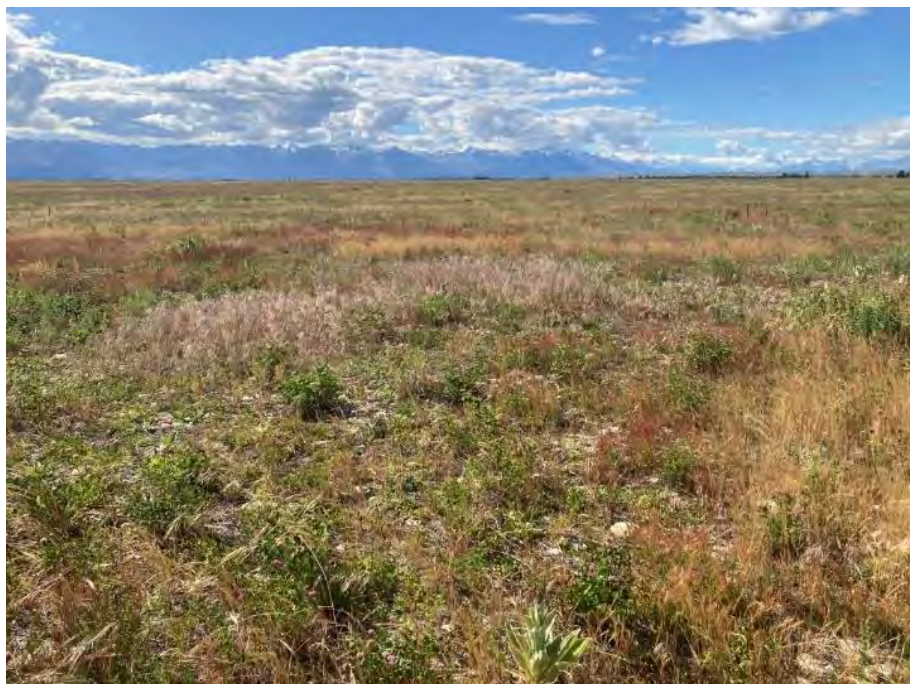
Plate 4: Brome-hawkweed-sheep's sorrel grassland/herbfield, which covers an extensive part of the site.

On the eastern side of the site there are numerous paddocks with exotics such as mouse-ear hawkweed, sheep's sorrel, and brome grasses (*Bromus tectorum* and *B. hordeaceus*) that are dominant (Plate 4). These areas appear to have been cultivated in the past but have not been resown recently. Cocksfoot, ryegrass, sweet vernal, clovers, and lucerne are all common exotics, along with herbaceous weeds such as haresfoot trefoil, viper's bugloss (*Echium vulgare*), and chicory (*Cichorium intybus*).

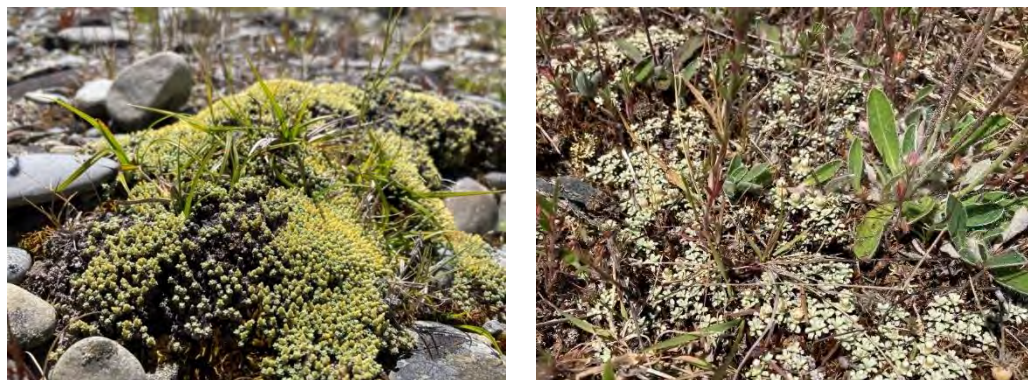
Plate 5: Indigenous dryland vegetation with mat daisies (left) and scabweed (right) growing in stonefield dryland habitat on the margins on the site.

Areas of stonefield and indigenous dryland vegetation are confined to the tops of old river terraces on the margins of the site. These areas are generally dominated by exotic weeds and grasses with mouse-ear hawkweed and haresfoot trefoil both abundant. However, local pockets of indigenous dryland vegetation persist on stony ground (Plate 5). Indigenous species observed in these areas included

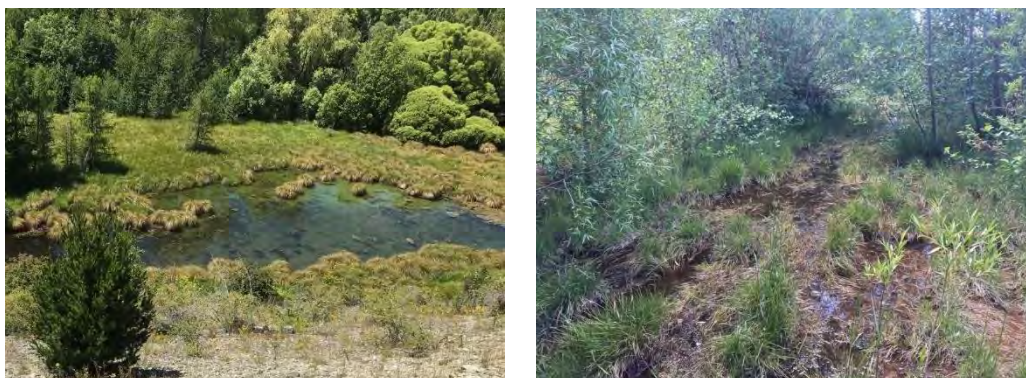
Plate 6: Wetland habitats within 100 metres of the site boundary. Large swamp wetland on margins of the Takapō River to the east of the site (left) and a small seepage wetland in the Twizel River, to west of the site (right).

Wetlands in both rivers are dominated by an exotic canopy of crack willow and alder (*Alnus glutinosa*) trees, but indigenous sedges and rushes are common beneath the canopy and around the margins of open water. Indigenous species observed in these areas include rautahi (*Carex maorica*), raupō (*Typha orientalis*), sedge (*Carex diandra*), spike sedge (*Eleocharis acuta*), and pūkio (*Carex secta*). Although no Threatened or At Risk species were observed,

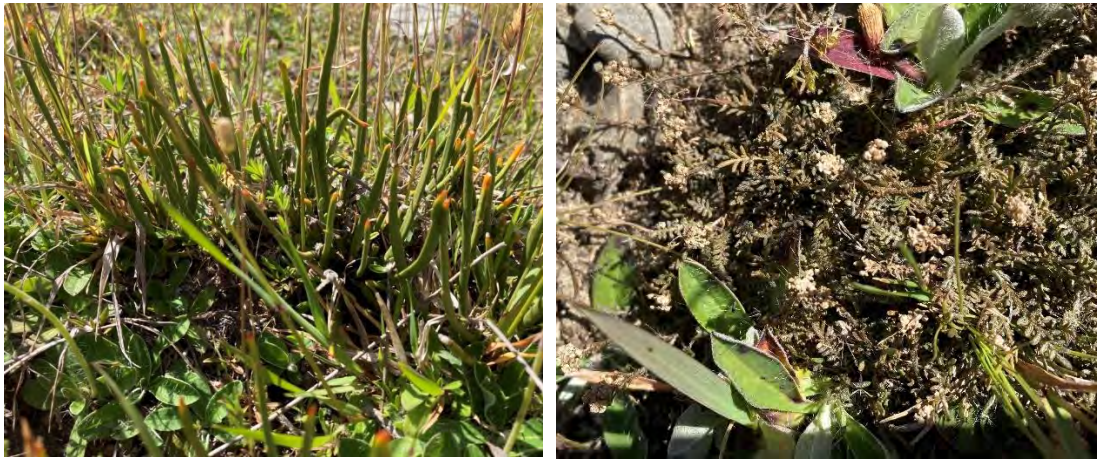
Plate 7: Stout dwarf broom (At Risk – Declining) (left) and Maniototo peppergrass (Threatened – Nationally Critical) (right).
