Date: 26 August 2022
Job No: 65601

SURF PARK FAST TRACK REFERRAL APPLICATION – PRELIMINARY ECOLOGY ASSESSMENT

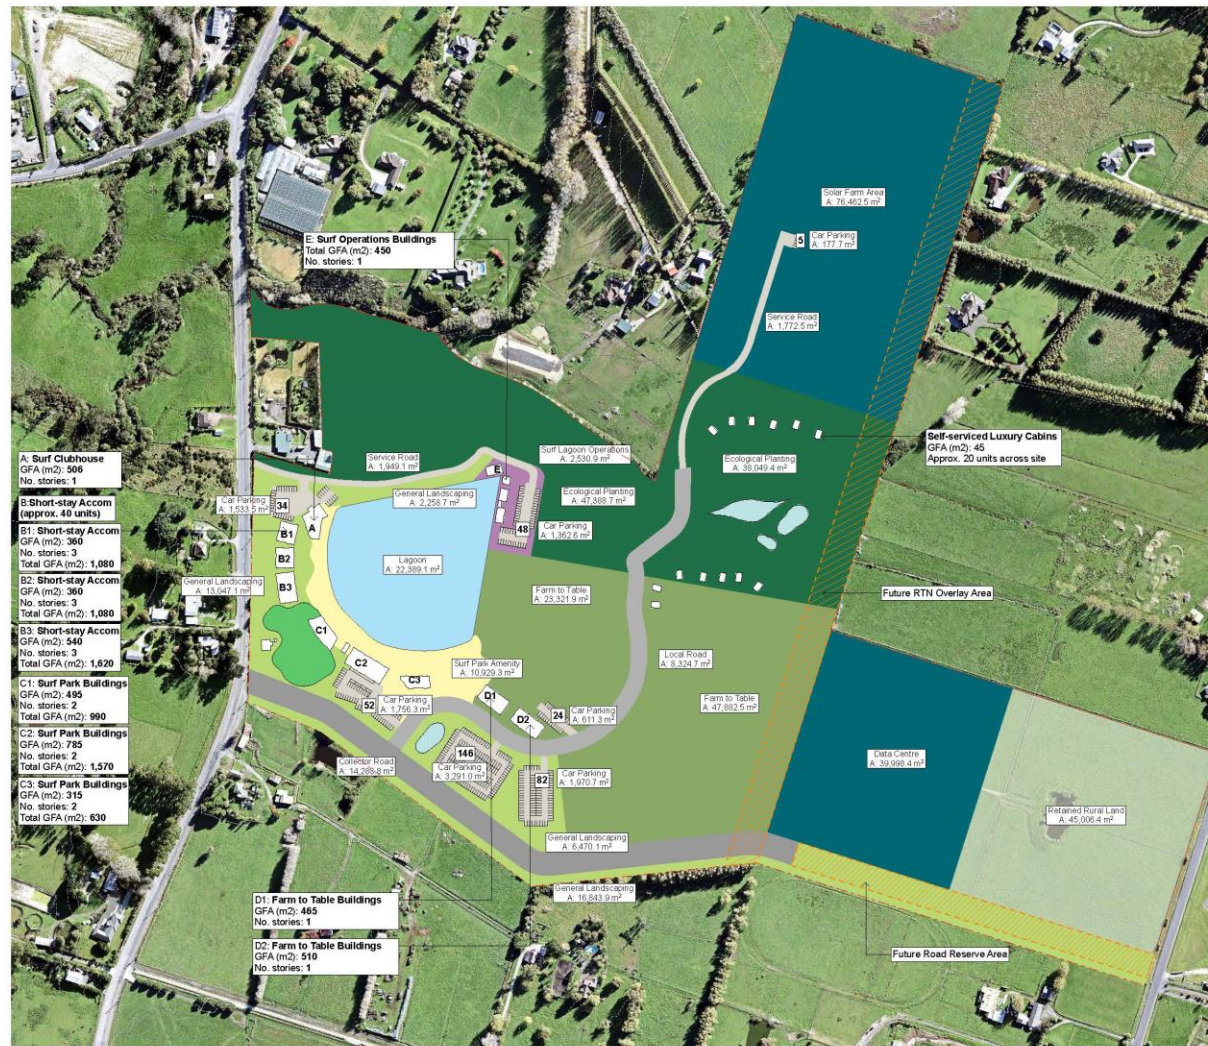
Appendix I: Master Plan (Sourced from Studiopacific Architecture)

The proposed development comprises of a surf academy, short-stay accommodation as well as residential and light industrial development (Appendix I).

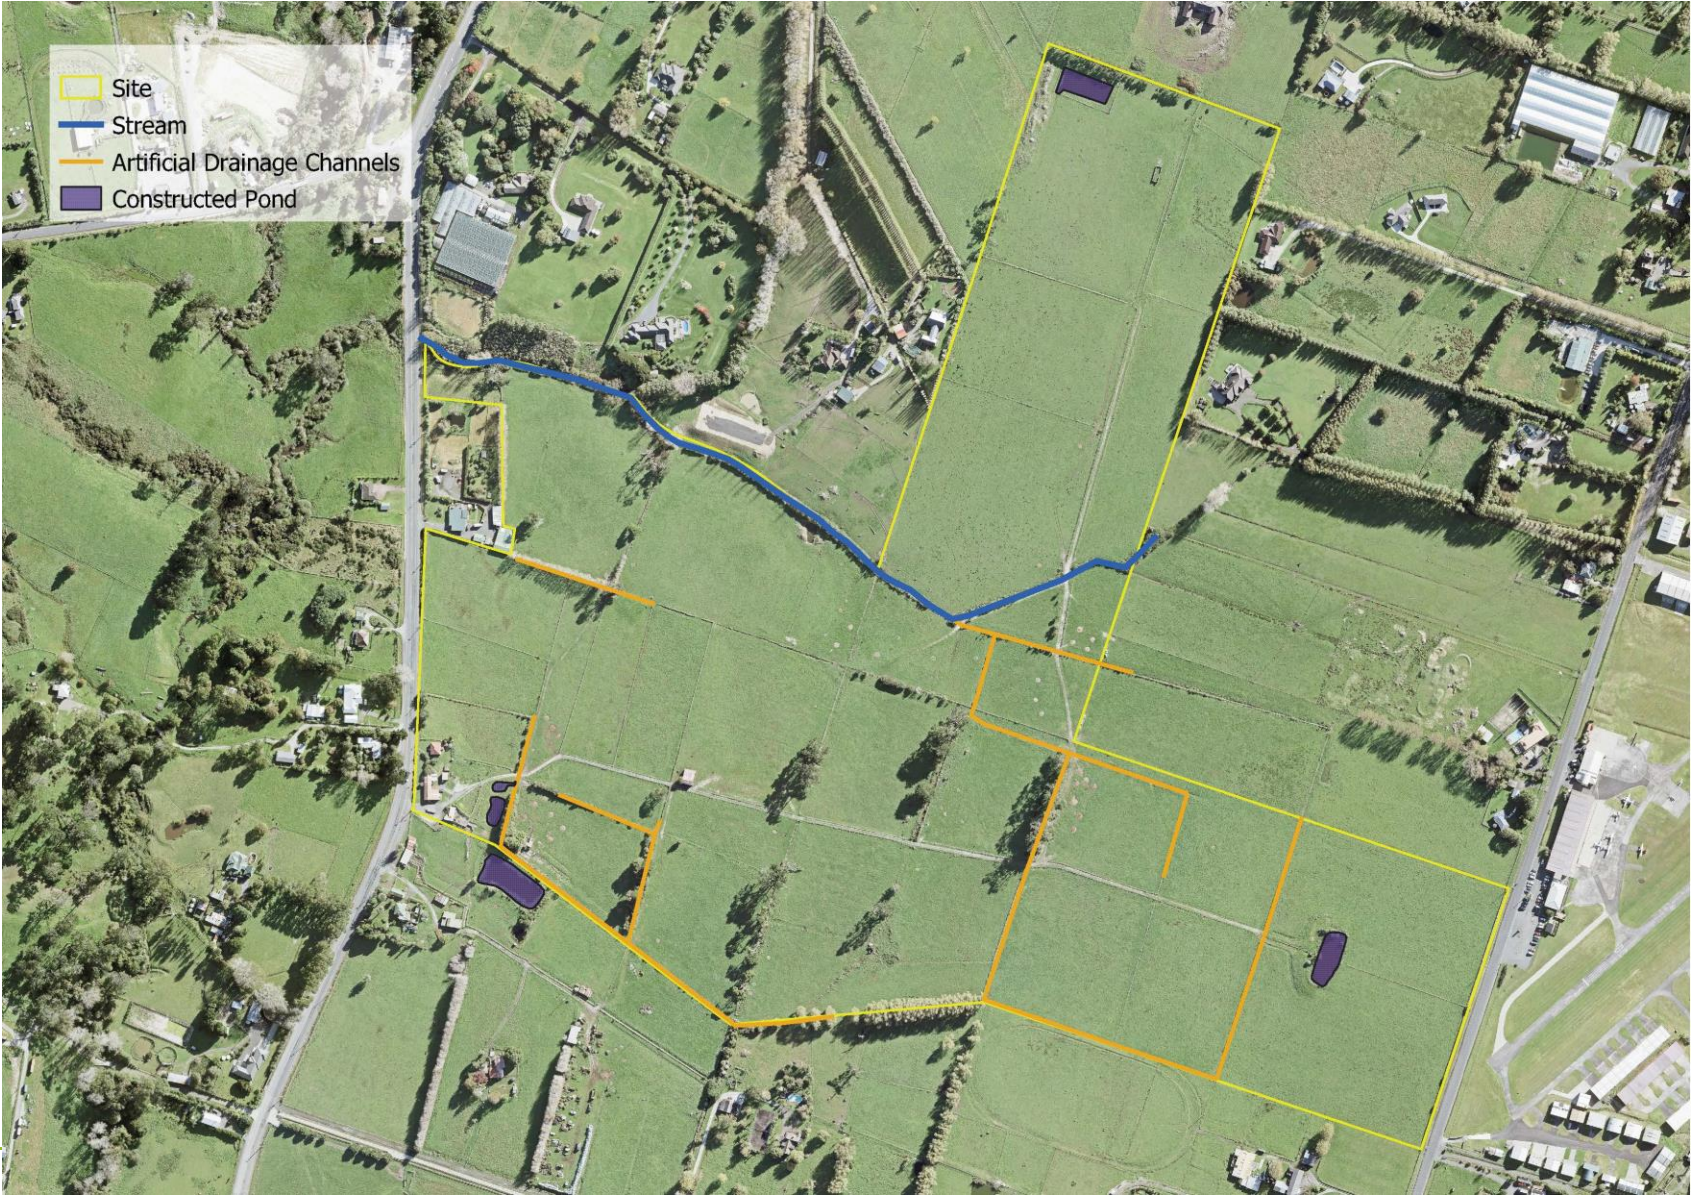
Appendix II: Identified Ecological Features

Any potential aquatic habitat was then qualitatively assessed. Identified ecological features within the Site are presented in Appendix II and photos of these features are provided in Appendix III.

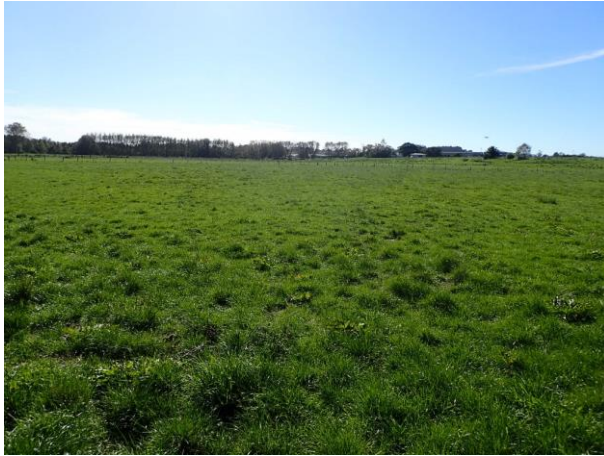
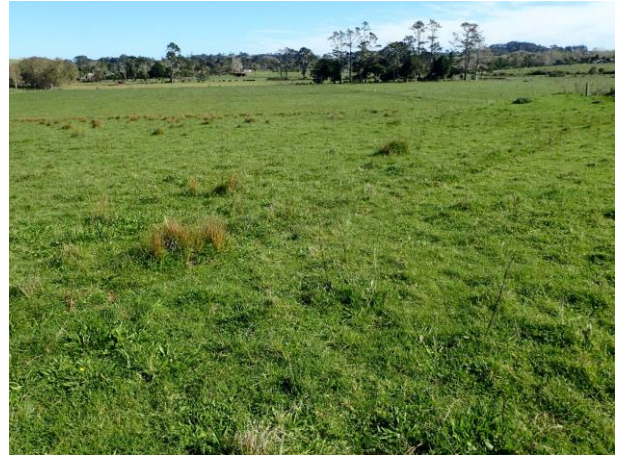
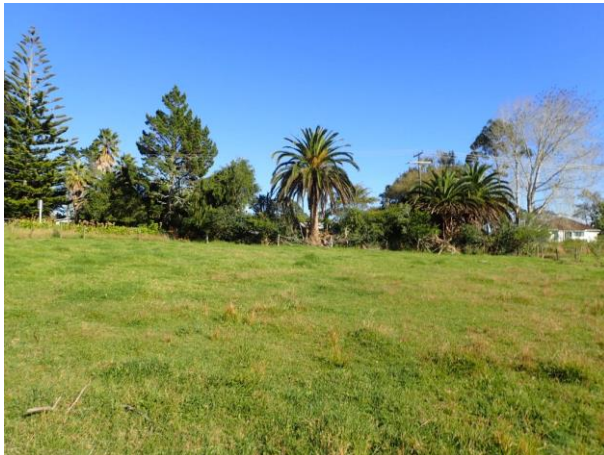
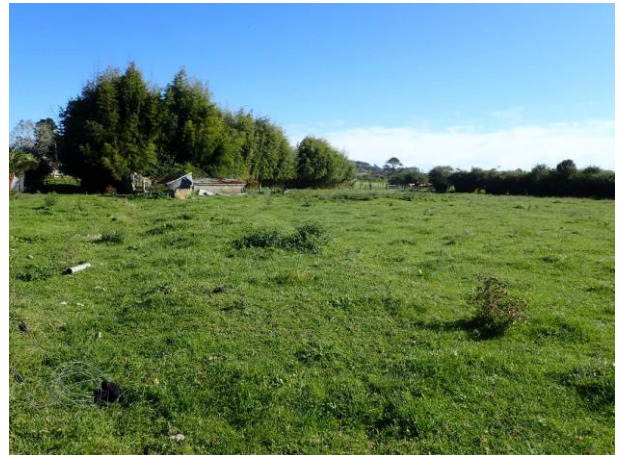
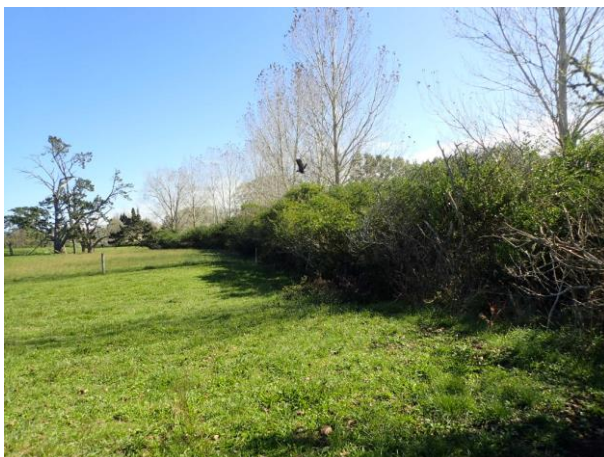
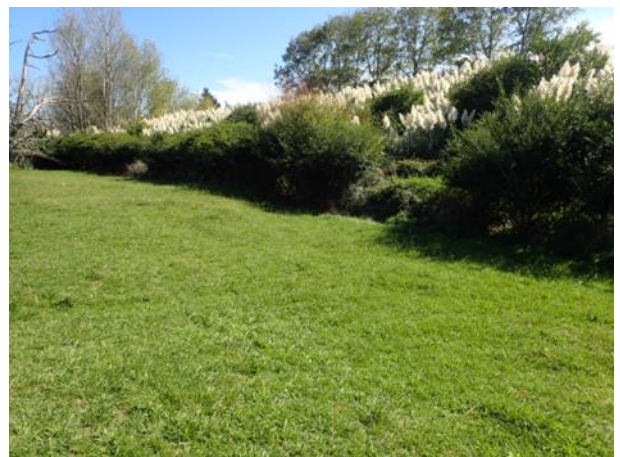
The Site almost entirely consists of pasture grasses. There are a group of exotic trees and shrubs associated with the existing dwelling, along the roadside and around the western stock pond. Along some fence lines, drainage channels and the stream, listed pest plant species barberry (*Berberis glaucocarpa*), arrow bamboo (*Pseudosasa japonica*), blackberry (*Rubus fruticosus agg.*), pampas (*Cortaderia selloana*), Chinese privet (*Ligustrum sinense*) and the tree privet (*Ligustrum lucidum*) form hedgerows. A few sporadic tī kōuka (cabbage tree, *Cordyline australis*) are scattered through some of the hedgerows. Mature Monterey cypress (*Cupressus macrocarpa*) and Monterey pine (*Pinus radiata*) form old, degraded and sporadic shelterbelts between some paddocks.

The botanical value of the vegetation within the Site was assessed as negligible, being predominately pasture with a few isolated exotic trees and hedgerows consisting of listed pest plant species. Only very few sporadic common native species were identified, namely tī kōuka.

Photos 1 – 6: Vegetation with the Site.

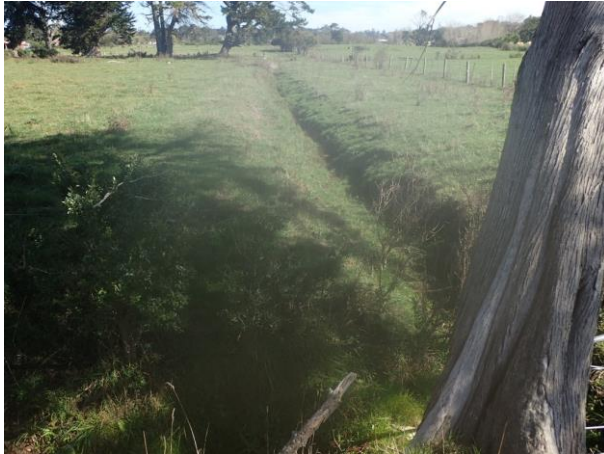
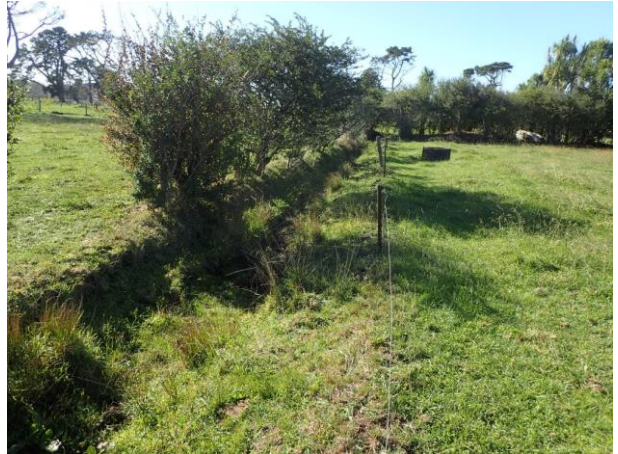
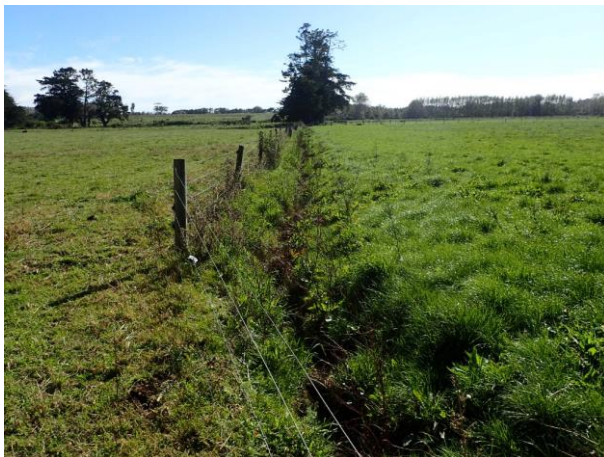
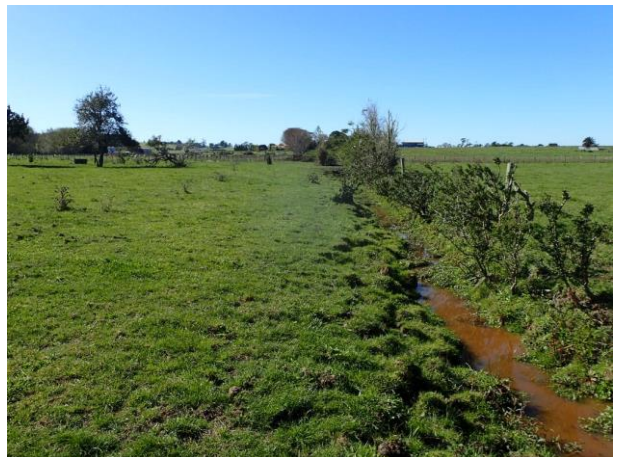
With the exception of the stream that runs along the northern border of Pt Allot 189 SO 1118A and through the southern section of Lot 15 DP 65979, all the watercourses were very straight and uniformed, representing artificial drainage channels. The formation of drainage channels is consistent with the contours of the land, which is very flat and would have required drainage channels to effectively drain the land for use as productive agriculture land. Historical aerials, as far back as possible, were reviewed to help inform whether these drainage channels were completely artificial or once were potentially natural streams. The 1940 and 1957 aerials show, in the locations of the current drainage channels, either no channelisation (natural or artificial) or show straight uniform artificial channels. As such, there is no evidence to suggest that these drainage channels were once natural and accordingly were classified as artificial drainage channels.

Photos 7 – 10: Drainage channels within the Site.

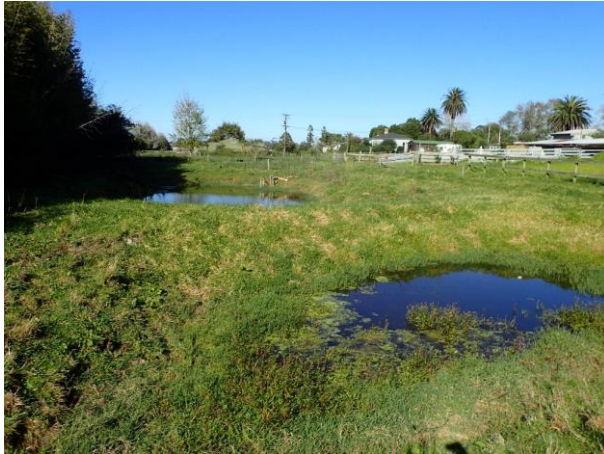
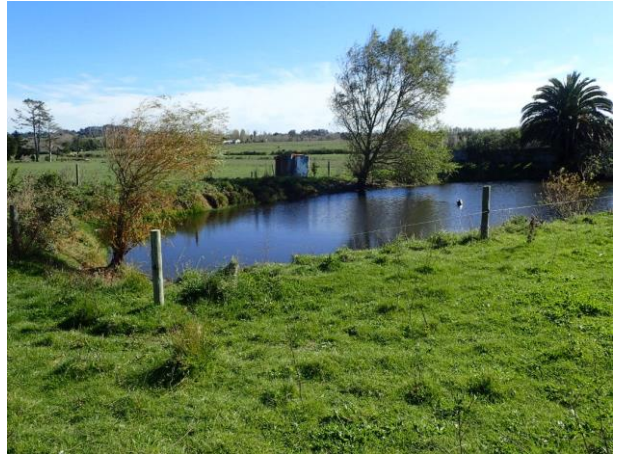
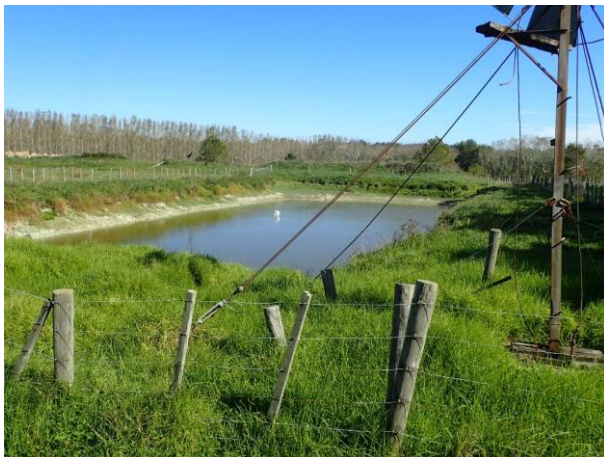
Four artificial ponds were located within the site. These ponds were clearly constructed for the purpose of agricultural and as such are not considered natural wetlands under the NPS-FM.

Photos 11 – 13: Stock ponds within the Site.

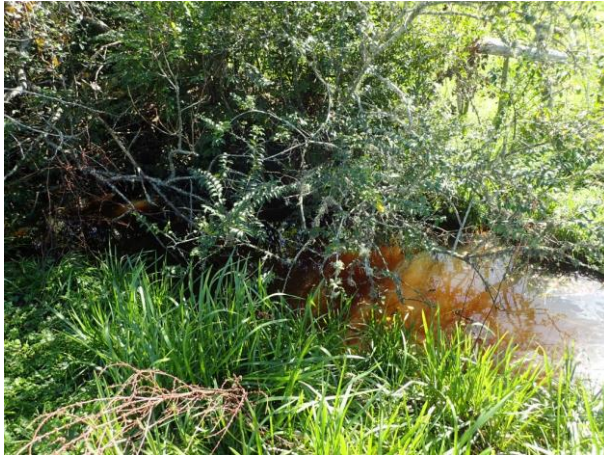
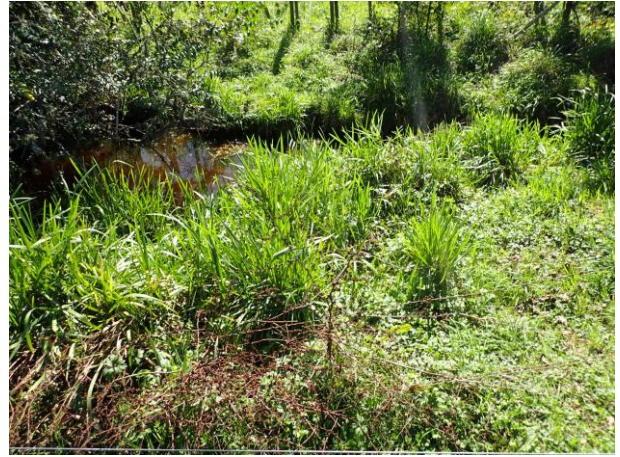
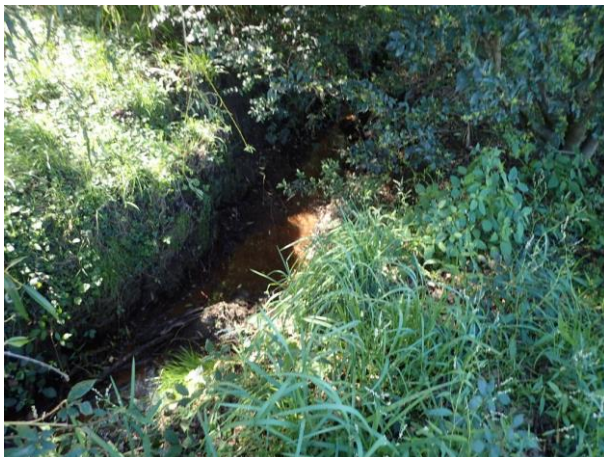
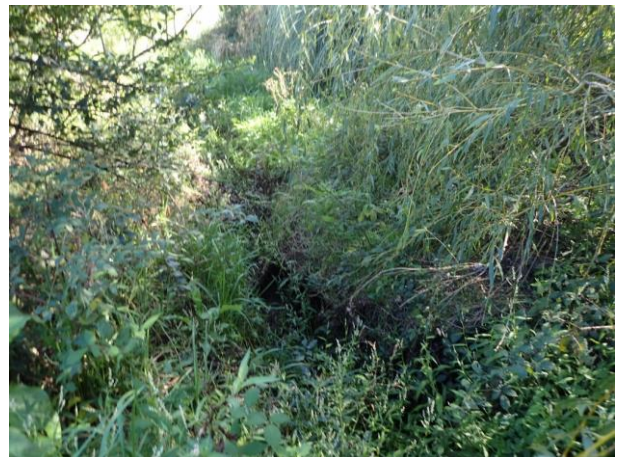
The stream that runs through the Site has been highly modified through straightening and deepening to help better drain the surrounding land. Flow is sluggish and the substrate consists of a high loading of soft sediments. Natural pools, riffles and undercut banks were largely absent which provided for minimal aquatic habitat diversity and hydrologic heterogeneity. Shading levels provided by pest plant species ranged from moderate to high. Overall, the stream was considered of low ecological value.

Photos 7 – 10: Drainage channels within the Site.

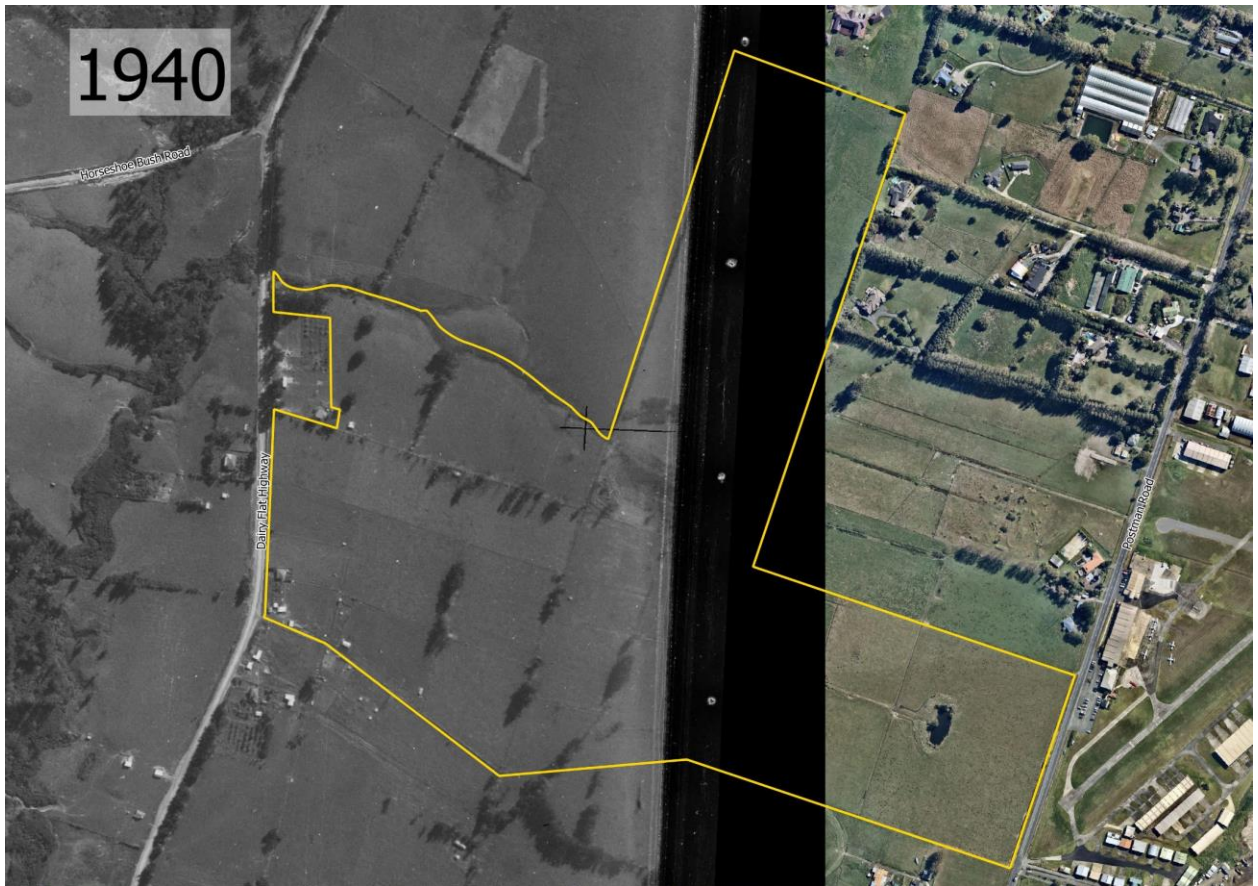
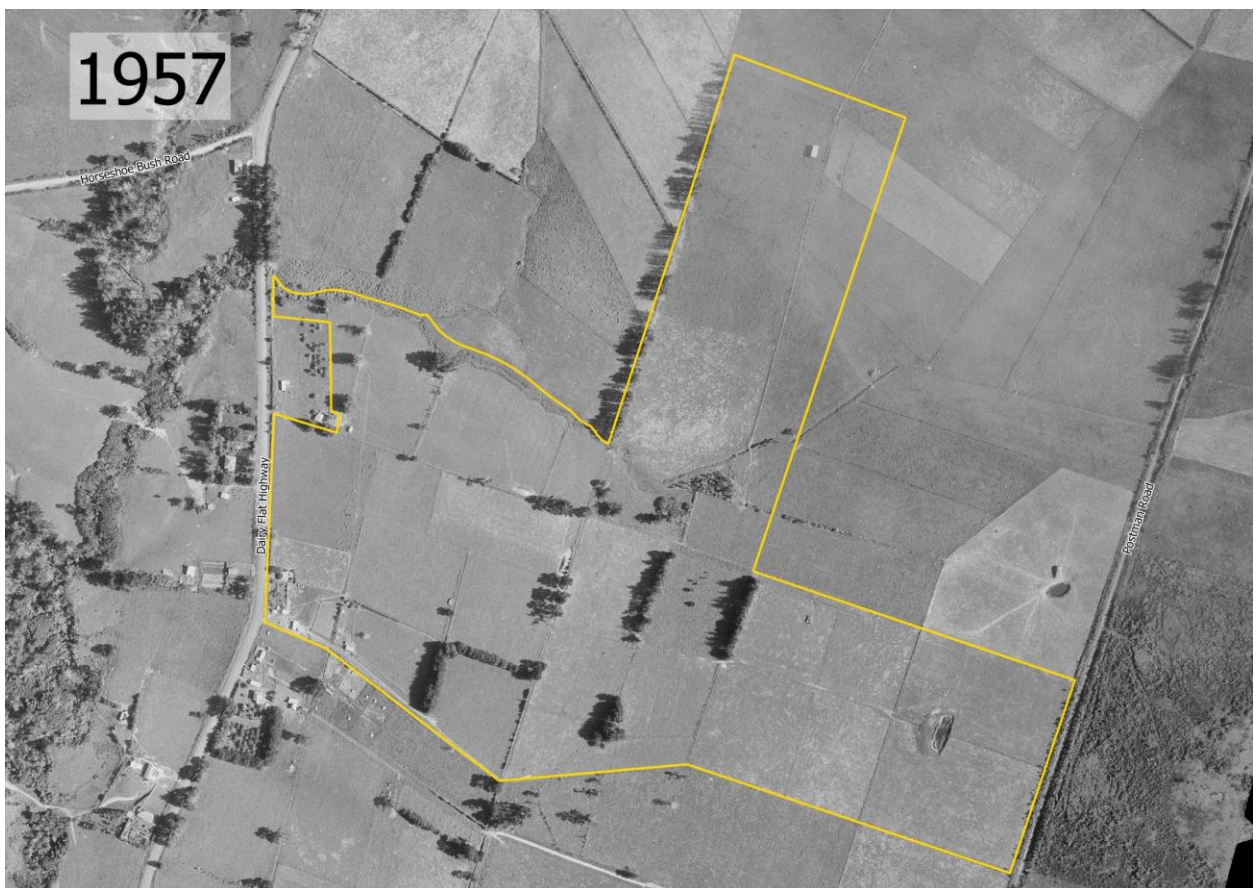
Appendix IV: Historical Aerial Image

The Site is within the Rodney Ecological District of the Auckland Region. Historically (pre-human), the area would have comprised the forest ecosystem type of pūriri forest (WF7-3) and would have supported a diverse range of invertebrates, amphibians, reptiles, birds and bats (Singers et al., 2017). Earliest historical aerials available, indicate that the Site and much of the surrounding landscape has been devoid of native vegetation and managed as agricultural land for at least the last 80 years (Appendix IV).
