# 109 Beachlands Road, Beachlands: Assessment of Ecological Effects

September 2020

| <b>Prepared for:</b> | Neil Construction Ltd |

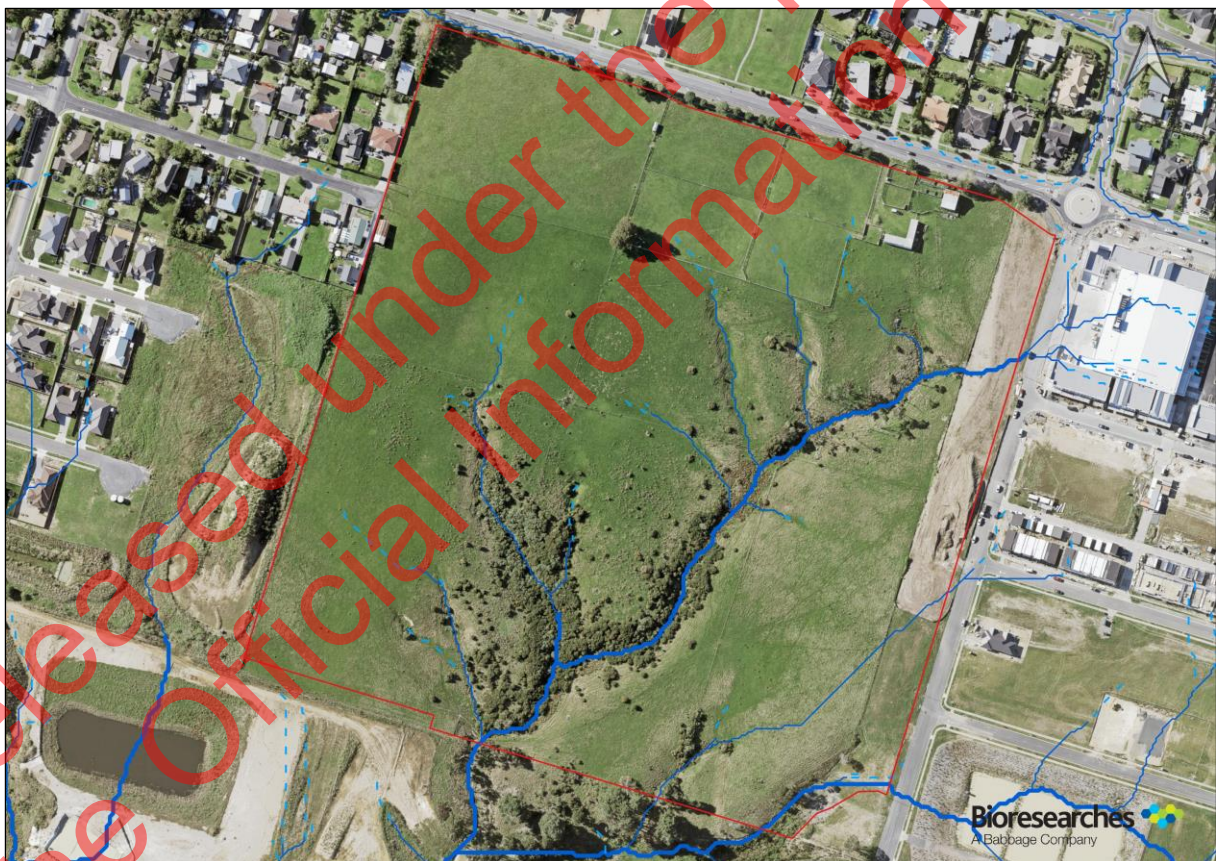
**Figure 1.** *The Site at Beachlands Road (red polygon), showing predicted overland flow paths (blue lines) from Auckland Council's GIS viewer.*

Bioresearches was engaged by Neil Construction Ltd, to undertake an ecological assessment for a proposed development at 109 Beachlands Road, Beachlands (Site, Figure 1).

The approximately 16.3ha site currently consists predominately of pasture grasses. Multiple tributaries are predicted to flow through the Site.

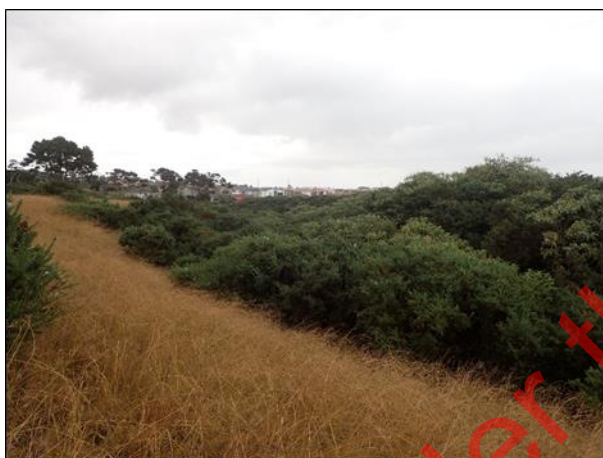
Photo 1. Riparian vegetation observed in January, 2020.

The predominate vegetation type within the Site was pasture. During the first site assessment (January 2020) riparian vegetation was present along the watercourses within the southern half of the Site (Photo 1). During the second site assessment (July 2020) it was observed that all the riparian vegetation had been cleared (Photo 2), with the exception of the riparian vegetation associated with the watercourse in the south-west corner of the Site (S6, Figure 4). The cleared riparian vegetation had consisted of exclusively of gorse (*Ulex europaeus*), blackberry (*Rubus fruticosus agg.*), plumeless thistle (*Carduus acanthoides*) and woolly nightshade (*Solanum mauritianum*), all of which are considered pest plants. Pest plant removal is a permitted activity under the AUP OP (Table E15.4.1 (A6)) and as such this riparian vegetation removal is not further assessed within this report.

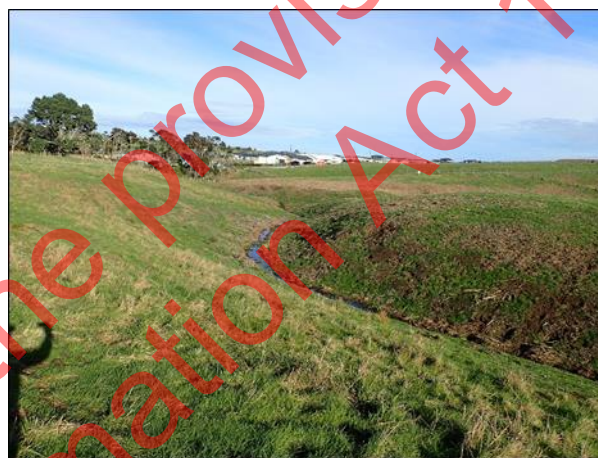
Photo 2. Same reach observed in Photo 1 following vegetation clearance (July, 2020).

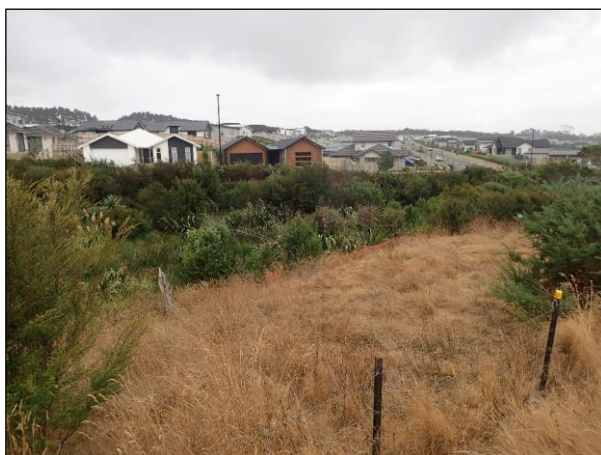
Photo 3. Riparian vegetation associated with the Watercourse S6.

The riparian vegetation associated with S6 consisted of fairly recently (approximately 4 years) planted native restoration plantings (Photo 3). The upper reach of this watercourse, in particular, had a high abundance of pest plant species, namely gorse and pampas (*Cortaderia selloana*).

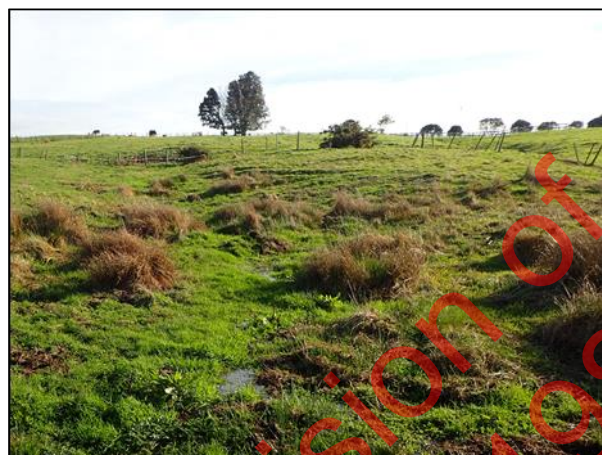
Photo 4. Three mature trees in background..

Outside of this riparian vegetation, the only other vegetation of note were three mature trees grouped together but isolate from any other vegetation (Photo 4).

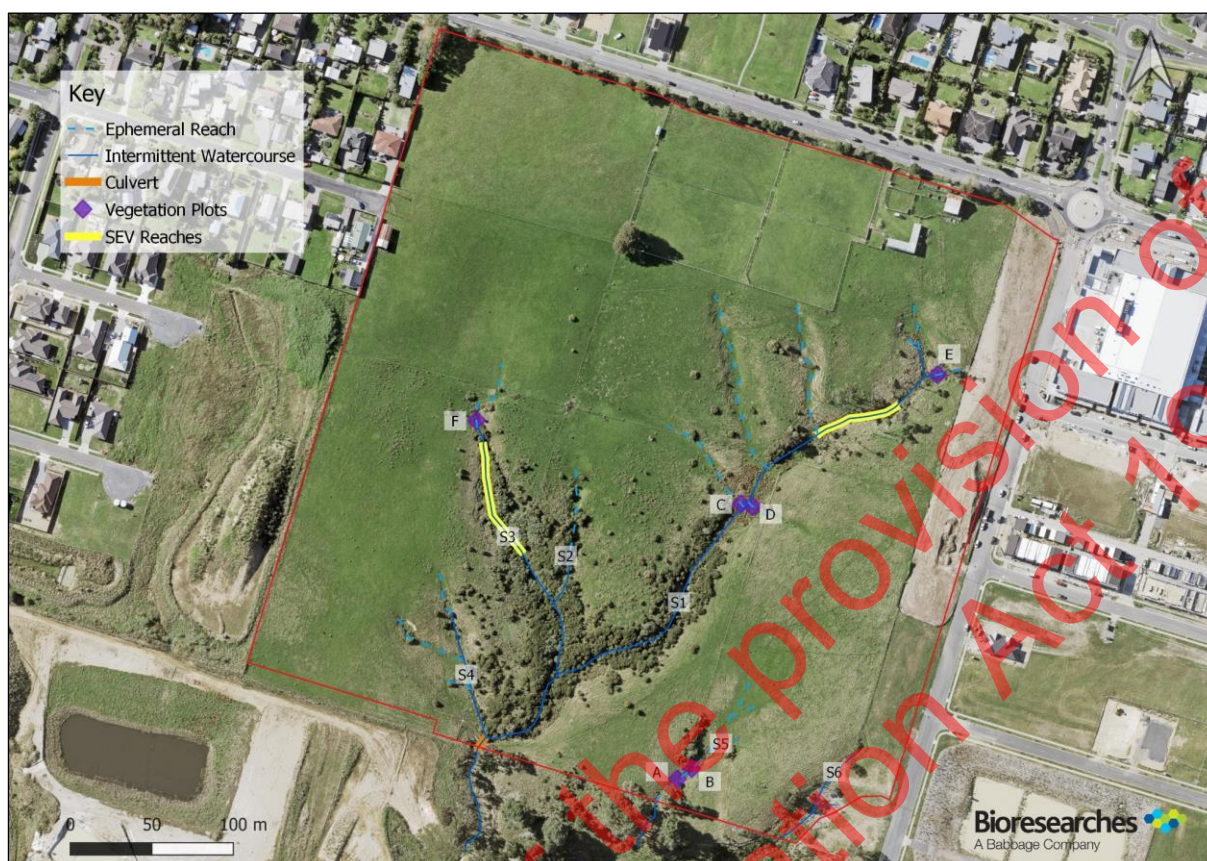
**Figure 4. Bioresearches stream classification, SEV locations and vegetation plots within the Site.**

Six potential wetland areas within the Site were identified (Figure 4) and assessed to ascertain whether these areas should be classified as natural wetlands as per the definition in the Resource Management Act 1991 (RMA).

SEVs, including the fish and macroinvertebrate surveys were undertaken on July 17<sup>th</sup>, 2020, along two representative reaches within the Site (Figure 4).

Overall, the watercourses were considered of very low current ecological value due to the poor aquatic habitat quality and abundance, lack of riparian vegetation functions and stock access that had degraded the stream. Figure 4 presents the ground-truthed watercourse classifications undertaken by Bioresearches.

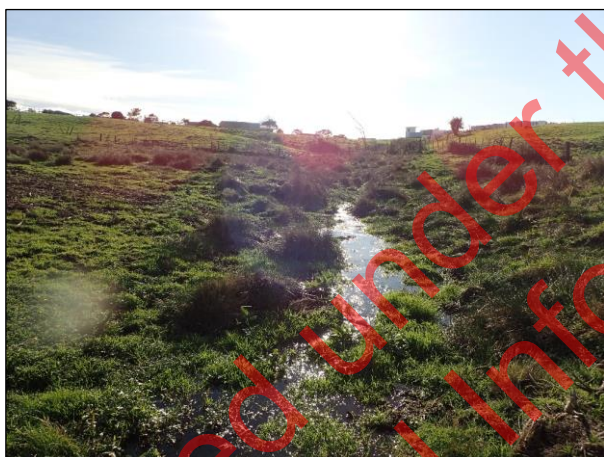
Photo 11. Stream 1 middle reach.

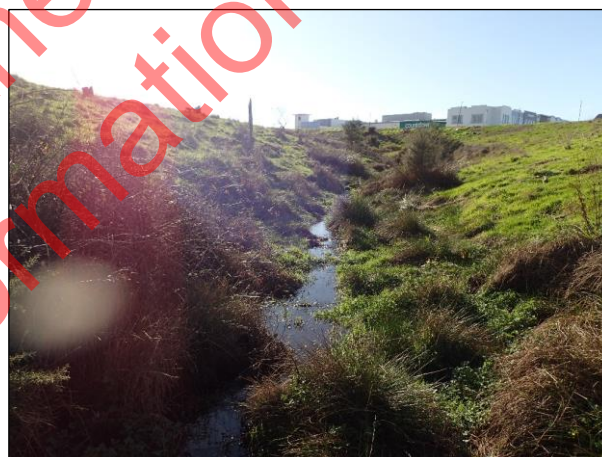
Photo 12. Stream 1 upper reach & location of SEV.

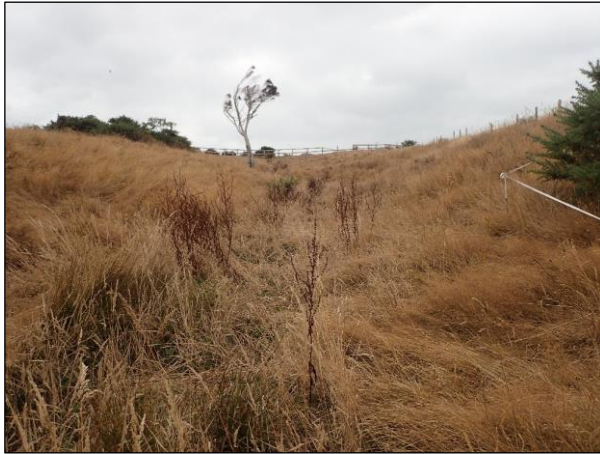
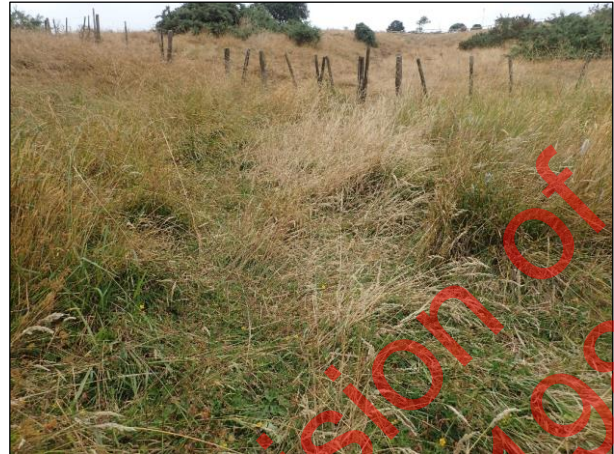
Photo 13. Ephemeral reach associated with Stream 1

Photo 14. Ephemeral reach associated with Stream 1.

The Auckland Council GIS Viewer indicated multiple tributaries draining to the upper reach Stream 1. These watercourses had no; defined channel, natural pools or evidence of substrate sorting processes. Additionally, the watercourses had terrestrial vegetation established across their widths. As such, these watercourses were classified as ephemeral under the AUP OP definitions.

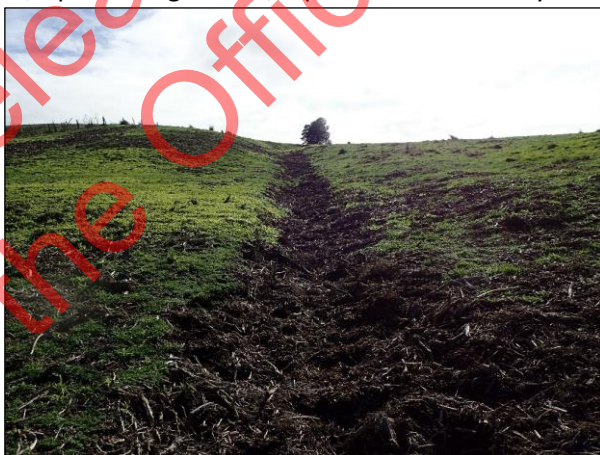
Photo 15. Mid reach of with Stream 2.

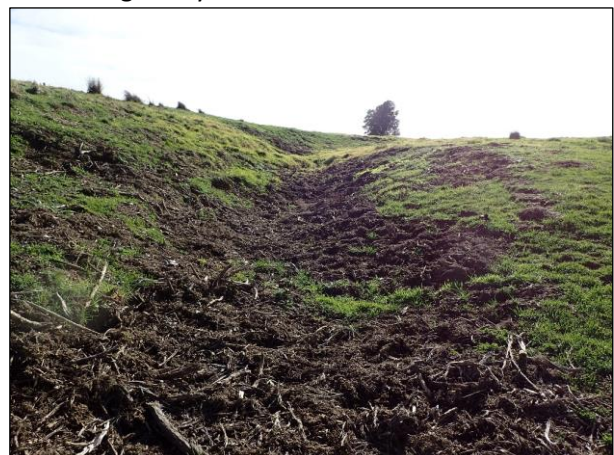
Photo 16. Upper reach with ephemeral reach in background of Stream 2.

The upper reach of Stream 2 had no; defined channel, natural pools or evidence of substrate sorting processes. Additionally, the upper reach had terrestrial vegetation established across its widths. As such, the upper reach was classified as ephemeral under the AUP OP definitions.

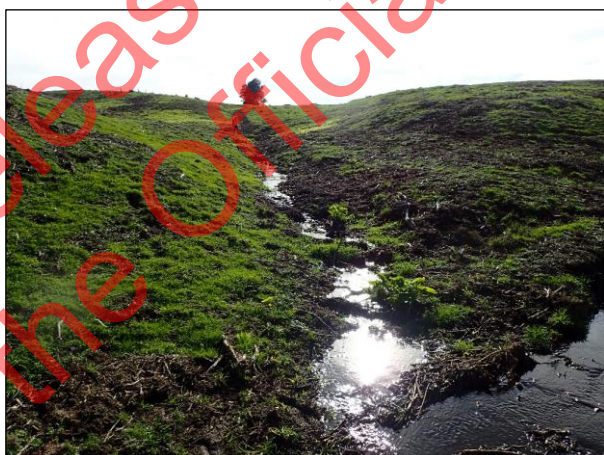
Photo 17 Lower-mid reach of Stream 3.

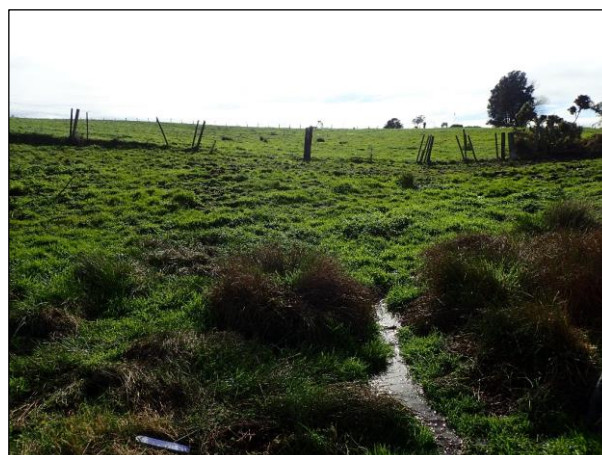
Photo 18. Upper reach with ephemeral reach in background of Stream 3.

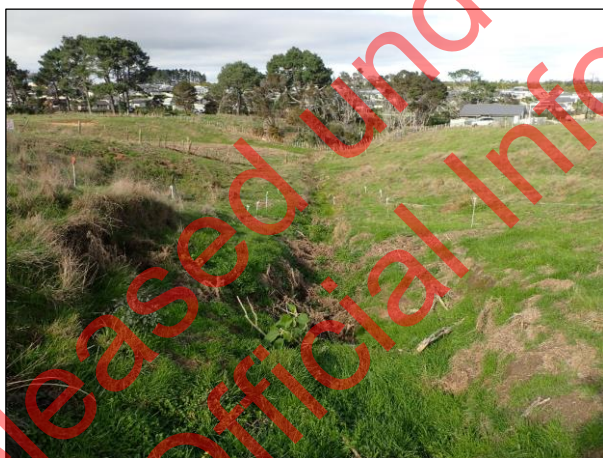
*Photo 19 Upper reach of Stream 4 looking downstream.*

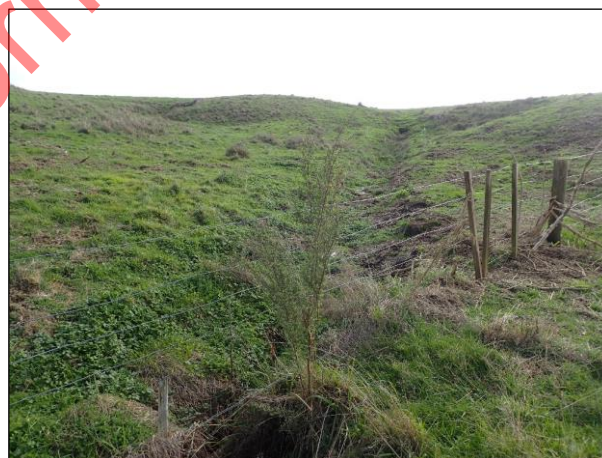
*Photo 20. Lower reach of Stream 4 looking upstream, showing an area of subterranean flow and an ephemeral reach (left).*

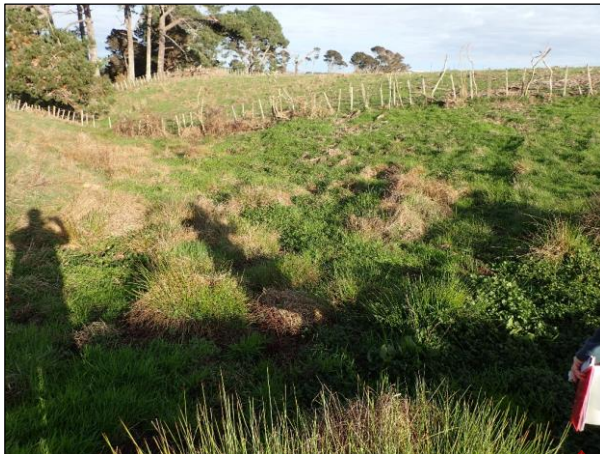
*Photo 21 Upper reach of Stream 5.*

Stream 5 had no; defined channel, natural pools, surface water which resulted in a stream flow 48hrs after a rain event or evidence of substrate sorting processes. Additionally, Stream 6 had vegetation established across its widths. As such, Stream 6 was classified as ephemeral under the AUP OP definitions.

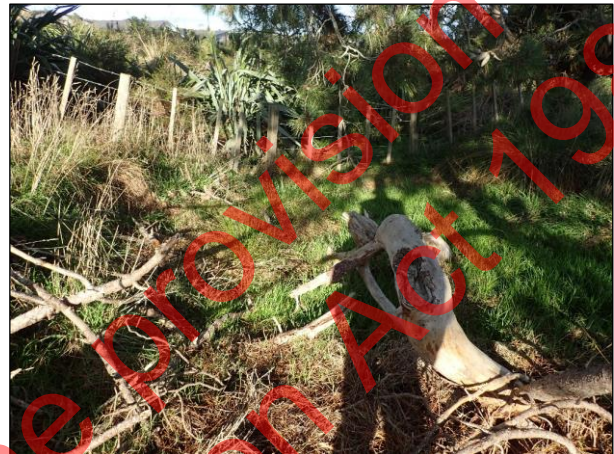
*Photo 22. Lower reach of Stream 5.*

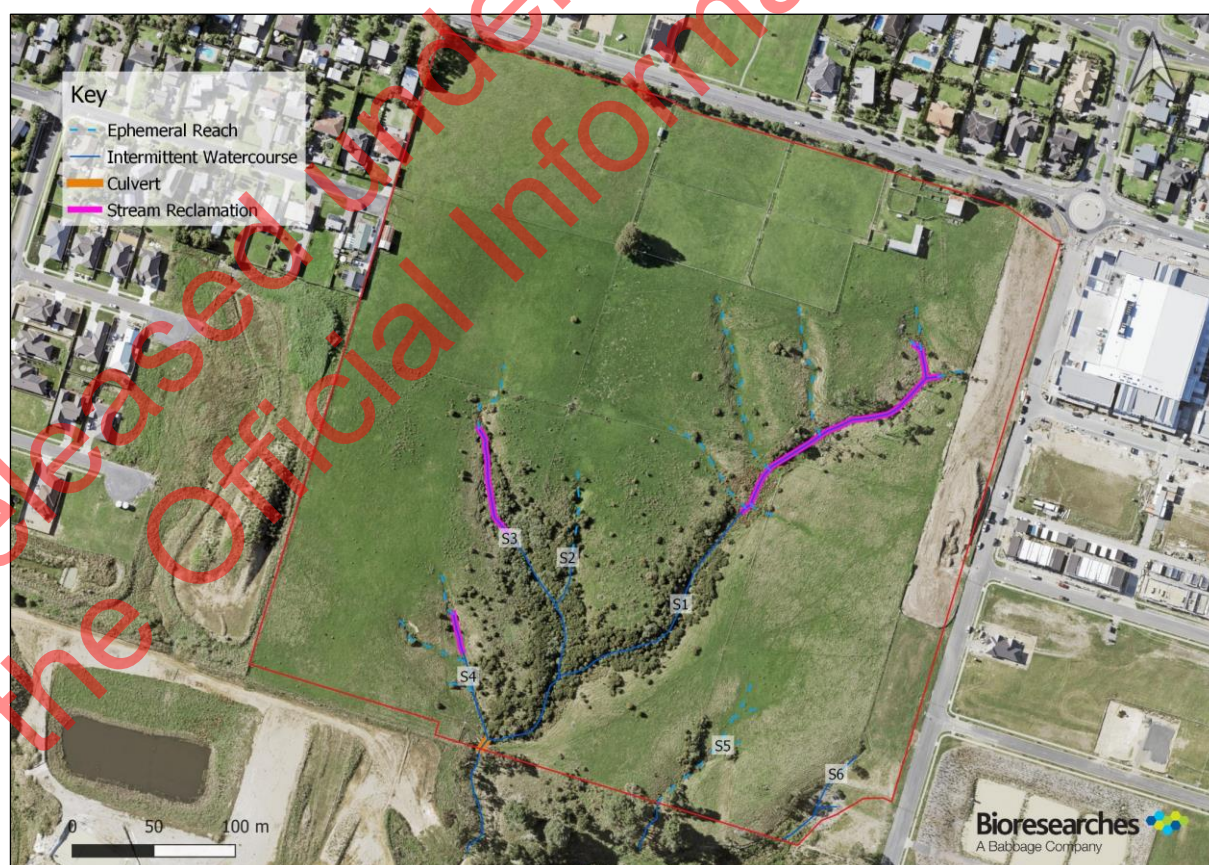
**Figure 5. Proposed intermittent stream reclamations within the Site within the Site.**
