# PRELIMINARY SITE INVESTIGATION

109 BEACHLANDS ROAD, BEACHLANDS

**Reference Number:** REP-1441/PSI/JAN20

**PREPARED FOR:** NEIL CONSTRUCTION LIMITED

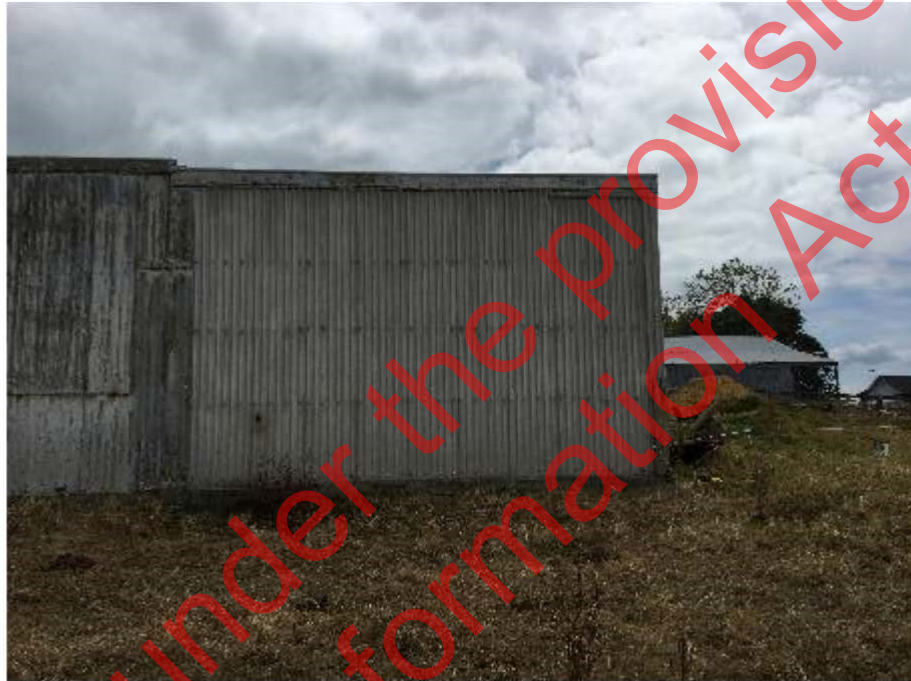
**PLATE 21: REAR OF STABLE BLOCK, NEWER ADDITION TO BLOCK**

The stable block was noted to be constructed on a concrete foundation slab and clad on the exterior (south and east) faces with corrugated iron, while the interior faces of the L-shape were timber weatherboards, and corrugated iron roofing material. The concrete slab is noted to extend under the awning on the interior faces of the L-shape

In order to assess the potential impacts of historical lead based paint use, GSL recommends that further investigation around the remaining structures on site and the former residential dwelling be undertaken. If necessary, a site management plan / remediation action plan may be required as a result of the findings of that investigation, should concentrations of lead be present in soil at levels which present a potential risk to human or environmental health.

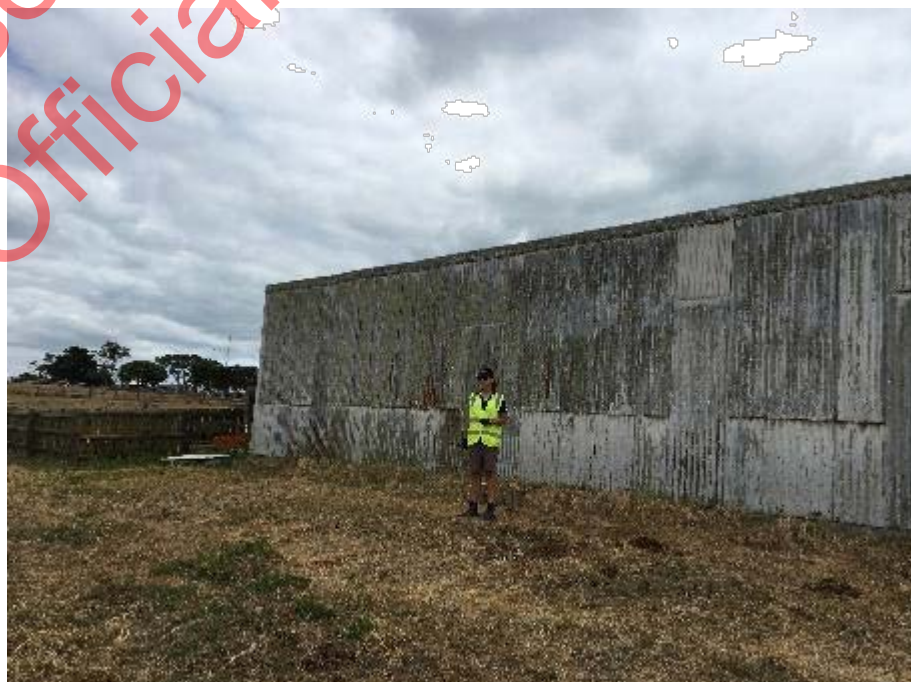
**PLATE 22: REAR OF STABLE BLOCK, ORIGINAL SECTION WITH RESIDUAL PAINT ON EXTERIOR SURFACE**

Potentially asbestos containing materials were noted in the soffit boards of the awning; however, all boards were in good condition and well painted. Exterior surfaces of the stable building were painted, however the paintwork was noted to be in deteriorated condition, especial on the inside of the L-shaped block, any potential impacts from potential lead based paint in this instance would be mitigated to an extent by the concrete footpath under the awning.
