TO: Neil Construction Ltd
COPY TO: David Page, Senior Development Manager
FROM: Mark Delaney, Senior Ecologist

Date: 15 March 2021
Job No: 63284

109 BEACHLANDS RD – FAST TRACKING RFI FRESHWATER ECOLOGY RESPONSE

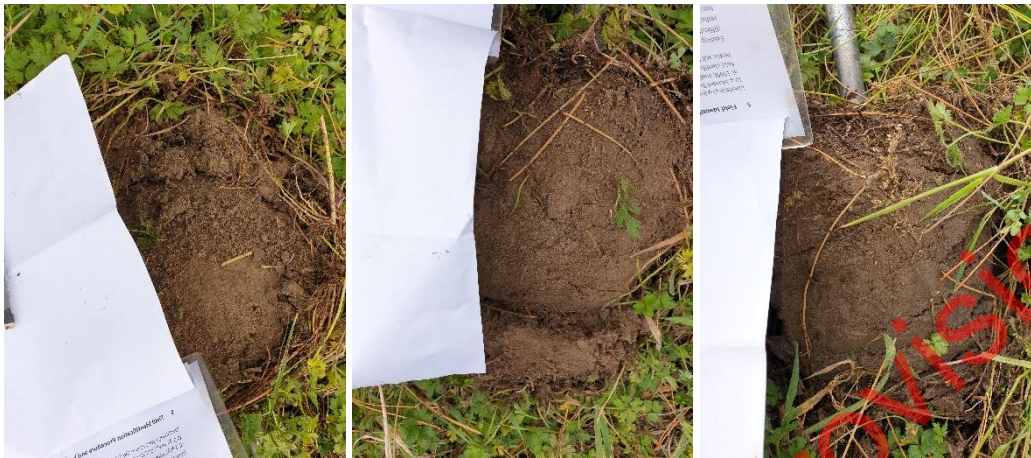
Photos 1-3: Soil profiles from Area A.

In regards to the soil samples (Photos 1-3), no peaty soils were observed in the top 30cm⁶. No pale low chroma colours⁷ or dark low chroma colours⁸ that occupy 50% of the matrix exposed were observed. No mottles of any colour or reddish root channels were observed. As such, there was no evidence of hydric soils in Area A.

In regards to hydrology, no water seepage was observed within the soil sample holes⁹, indicating a low water table during a normal wet season and non-wetland hydrology. Additional indicators of wetland hydrology (surface water, drift lines, sediment deposition and watermarks) were not observed during the site assessment.

Following the flowchart presented in Figure 1 of the Wetland Delineation Protocols (Appendix 1), Area A: Fails the Rapid Test → PO\asses the Dominance Test → Most dominants are FAC¹⁰ → No indicators of hydric soil or wetland hydrology present → Non-wetland vegetation.

As such, Area A was assessed as not a natural wetland.

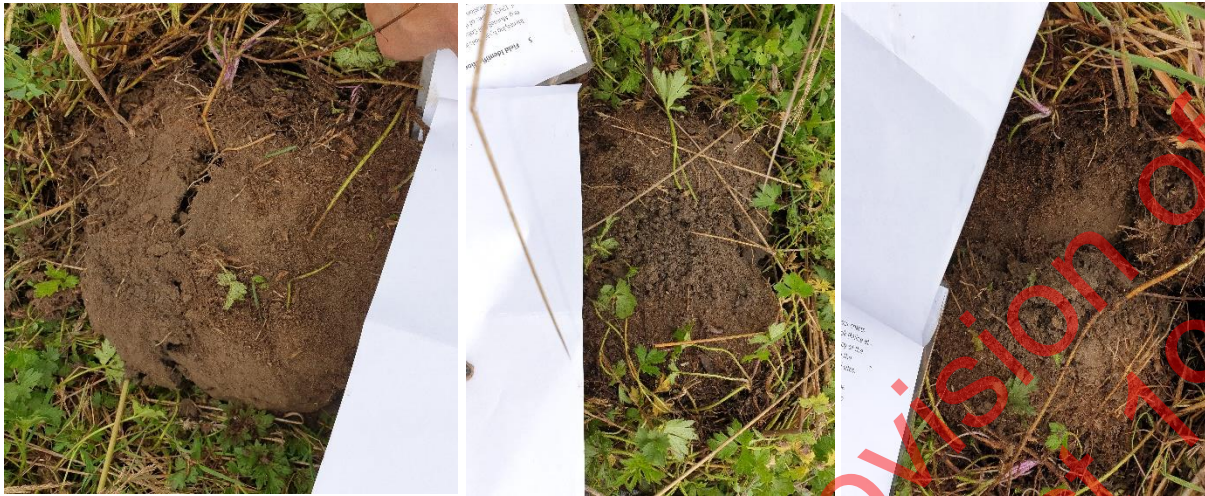
Photos 4-6: Soil profiles from Area B.

In regards to the soil samples (Photos 4-6), no peaty soils were observed in the top 30cm. No pale low chroma colours or dark low chroma colours that occupy 50% of the matrix exposed were observed. No mottles of any colour or reddish root channels were observed. As such, there was no evidence of hydric soils in Area B.

In regards to hydrology, no water seepage was observed within the soil sample holes (which were greater than 30cm deep), indicating a low water table during a normal wet season and non-wetland hydrology. Additional indicators of wetland hydrology (surface water, drift lines, sediment deposition and watermarks) were not observed during the site assessment.

Following the flowchart presented in Figure 1 of the Wetland Delineation Protocols (Appendix 1), Area B: Fails the Rapid Test → Passes the Dominance Test → Most dominants are FAC → No indicators of hydric soil or wetland hydrology present → Non-wetland vegetation.

As such, Area B was assessed as not a natural wetland.

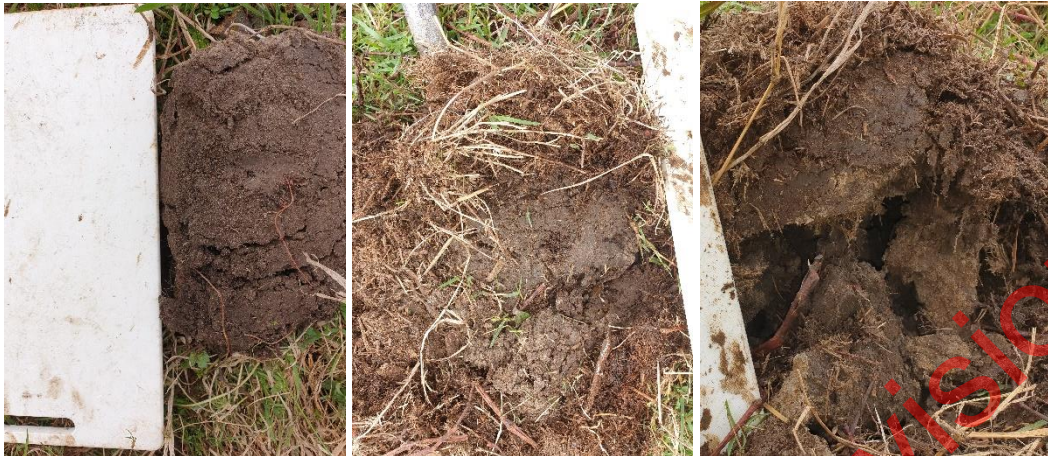
Photos 7-9: Soil profiles from Area C.

In regards to the soil samples (Photos 7-9), no peaty soils were observed in the top 30cm. No pale low chroma colours or dark low chroma colours that occupy 50% of the matrix exposed were observed. No mottles of any colour or reddish root channels were observed. As such, there was no evidence of hydric soils in Area C.

In regards to hydrology, no water seepage was observed within the soil sample holes (which were greater than 30cm deep), indicating a low water table during a normal wet season and non-wetland hydrology. Additional indicators of wetland hydrology (surface water, drift lines, sediment deposition and watermarks) were not observed during the site assessment.

Following the flowchart presented in Figure 1 of the Wetland Delineation Protocols (Appendix 1), Area C: Fails the Rapid Test → Fails the Dominance Test → No indicators of hydric soil or wetland hydrology present → Non-wetland vegetation.

As such, Area C was assessed as not a natural wetland.

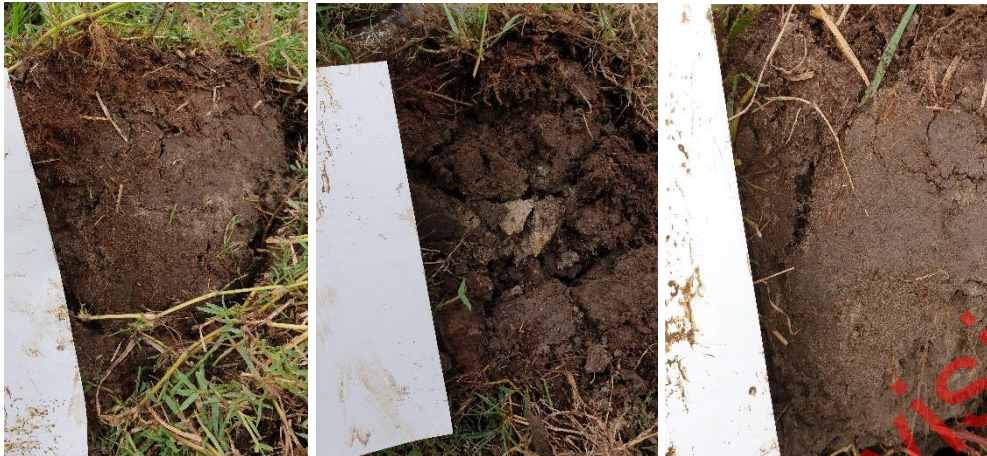
Photos 10-12: Soil profiles from Area D.

In regards to the soil samples (Photos 10-12), no peaty soils were observed in the top 30cm. No pale low chroma colours or dark low chroma colours that occupy 50% of the matrix exposed were observed. No mottles of any colour or reddish root channels were observed. As such, there was no evidence of hydric soils in Area D.

In regards to hydrology, no water seepage was observed within the soil sample holes (which were greater than 30cm deep), indicating a low water table during a normal wet season and non-wetland hydrology. Additional indicators of wetland hydrology (surface water, drift lines, sediment deposition and watermarks) were not observed during the site assessment.

Following the flowchart presented in Figure 1 of the Wetland Delineation Protocols (Appendix 1), Area D: Fails the Rapid Test → Fails the Dominance Test → No indicators of hydric soil or wetland hydrology present → Non-wetland vegetation.

As such, Area D was assessed as not a natural wetland.

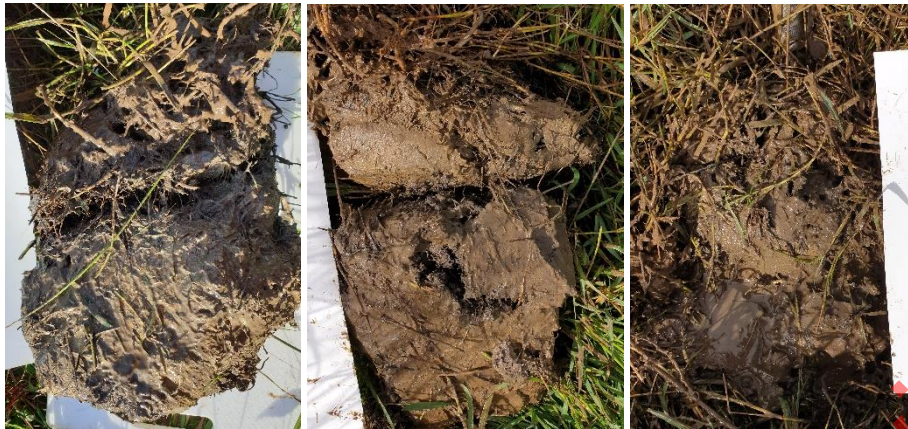
Photos 13-15: Soil profiles from Area E.

In regards to the soil samples (Photos 13-15), no peaty soils were observed in the top 30cm. No dark low chroma colours that occupy 50% of the matrix exposed were observed. No mottles of any colour or reddish root channels were observed. However, pale low chroma colours were evident in one of the soil samples (Photo 13), showing evidence of gley soils which indicates the presence of hydric soils in Area E. Although, it should be noted that the potential presence of hydric soils was constrained to a narrow band within the centre of Area E, as indicated by the gley soils being only evident in one of the three soil samples.

In regards to hydrology, water seepage was observed within the soil sample holes, indicating a higher water table during a normal wet season. All soils samples appeared saturated, which is an indicator for wetland hydrology or for ephemeral/intermittent stream reaches. Additional indicators of wetland hydrology (surface water, drift lines, sediment deposition and watermarks) were not observed during the site assessment.

It should be noted that the reach in which Area E is located has been highly modified and the upper reach has previously been reclaimed, which in turn has affected the hydrology of the Area E (Figure 2 of the Report, 1962 aerial). Based on the historical aerials, Area E, and its upper reaches, appeared to be an old intermittent stream channel, which may explain the present hydrology observed. Additionally, indicators of hydric soils can persist within the ground for decades and the gley soils present may have formed as a result of the historic stream/current stream system. Hydric soils can also be present within intermittent or ephemeral reaches where macrophytes and/or plants adapted to wet soils area able to grow. A historic stream/current stream system is consistent with the fact that potential presence of hydric soils was constrained to a narrow band (stream channel) within the centre of Area E.

Following the flowchart presented in Figure 1 of the Wetland Delineation Protocols (Appendix 1), Area D: Fails the Rapid Test → Passes the Dominance Test → Most dominants are FAC → Indicators of

hydric soil or wetland hydrology present → Fails the Prevalence Index. The flowchart then does not conclude that wetland vegetation is present or does not conclude that the area is a wetland.

After consideration of the assessments, the relevant information available and the fact that the area has been highly modified/alterd over the years, Area E was assessed as not a natural wetland due to the following:

- Did not meet the Prevalence Test.
- Did contain any native plant species.
- Was dominated by creeping buttercup, an exotic 'Facultative' species commonly found outside of wetlands.
- Only contained one 'Facultative Wetland' species (the exotic soft rush), which is also commonly found in non-wetland areas.
- No other 'Facultative Wetland' or any 'Obligate Wetland' species were identified.
- A 'Facultative Upland' species was present.
- No surface aquatic habitat was present (even in the wet season) and no fish, birds or aquatic macrofauna adapted to wet conditions were present.
- Represent pugged floodplains and/or stream margins rather than wetlands.
- Is currently utilised as pasture for stock.
- More consistent with a degraded intermittent/ephemeral stream channel, which would show evidence of hydric soils and associated wet hydrology.

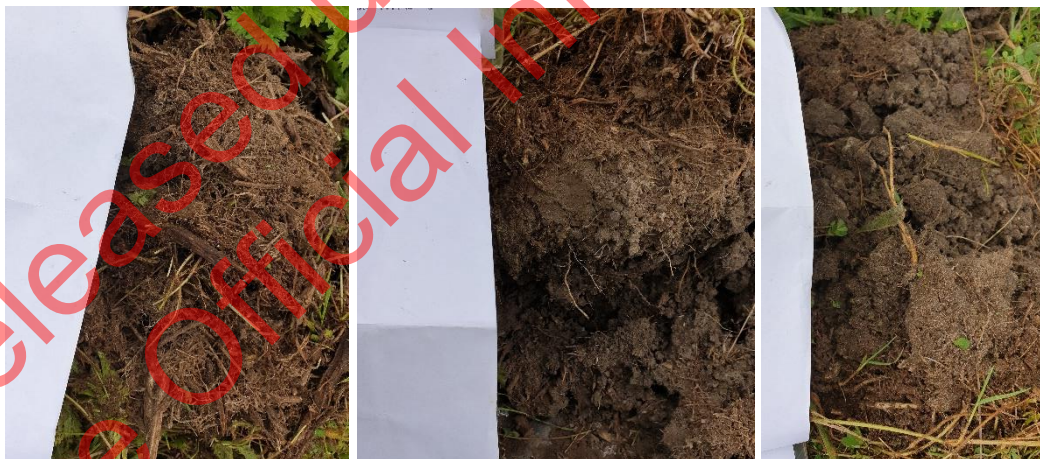
Photos 16-18: Soil profiles from Area F.

In regards to the soil samples (Photos 16-18), no peaty soils were observed in the top 30cm. No pale low chroma colours or dark low chroma colours that occupy 50% of the matrix exposed were observed. No mottles of any colour or reddish root channels were observed. As such, there was no evidence of hydric soils in Area D.

In regards to hydrology, no water seepage was observed within the soil sample holes (which were greater than 30cm deep), indicating a low water table during a normal wet season and non-wetland hydrology. Additional indicators of wetland hydrology (surface water, drift lines, sediment deposition and watermarks) were not observed during the site assessment.

Following the flowchart presented in Figure 1 of the Wetland Delineation Protocols (Appendix 1), Area F: Fails the Rapid Test → Fails the Dominance Test → No indicators of hydric soil or wetland hydrology present → Non-wetland vegetation.

As such, Area F was assessed as not a natural wetland.

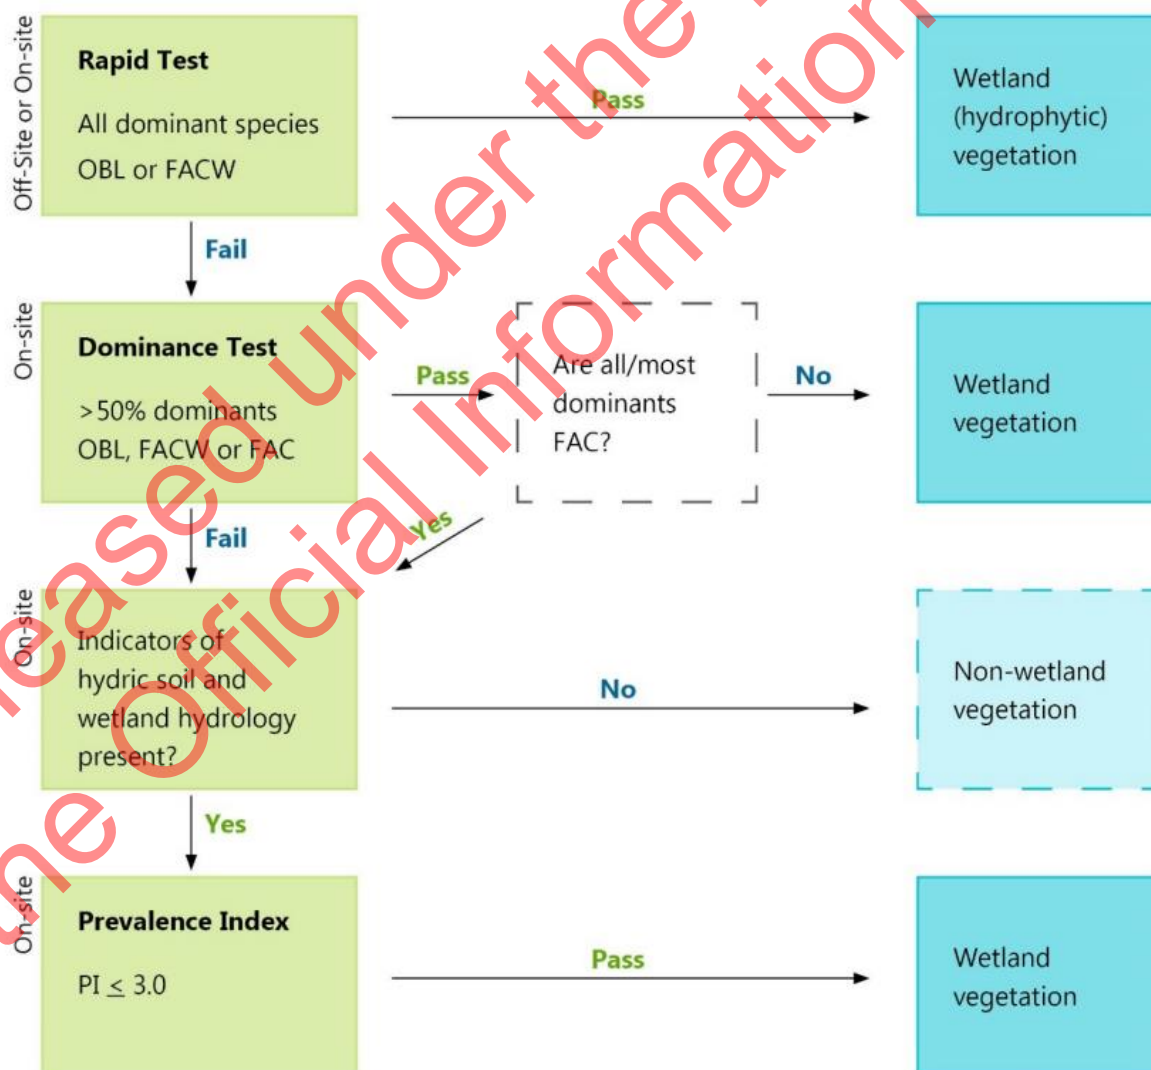
Appendix I: Figure 1 (Flowchart) of the Wetland Delineation Protocols

Figure 1: Flow chart of steps for hydrophytic (wetland) vegetation determination. Wetland indicator status abbreviations: FAC= facultative; FACW = facultative wetland; OBL = obligate wetland.
