# Watercourse Classifications & Freshwater Ecological Values Assessment

1 Silverwater Drive, Silverdale

| Status: DRAFT | Revision / version: 1 | Issue date: 23 July 2021 |

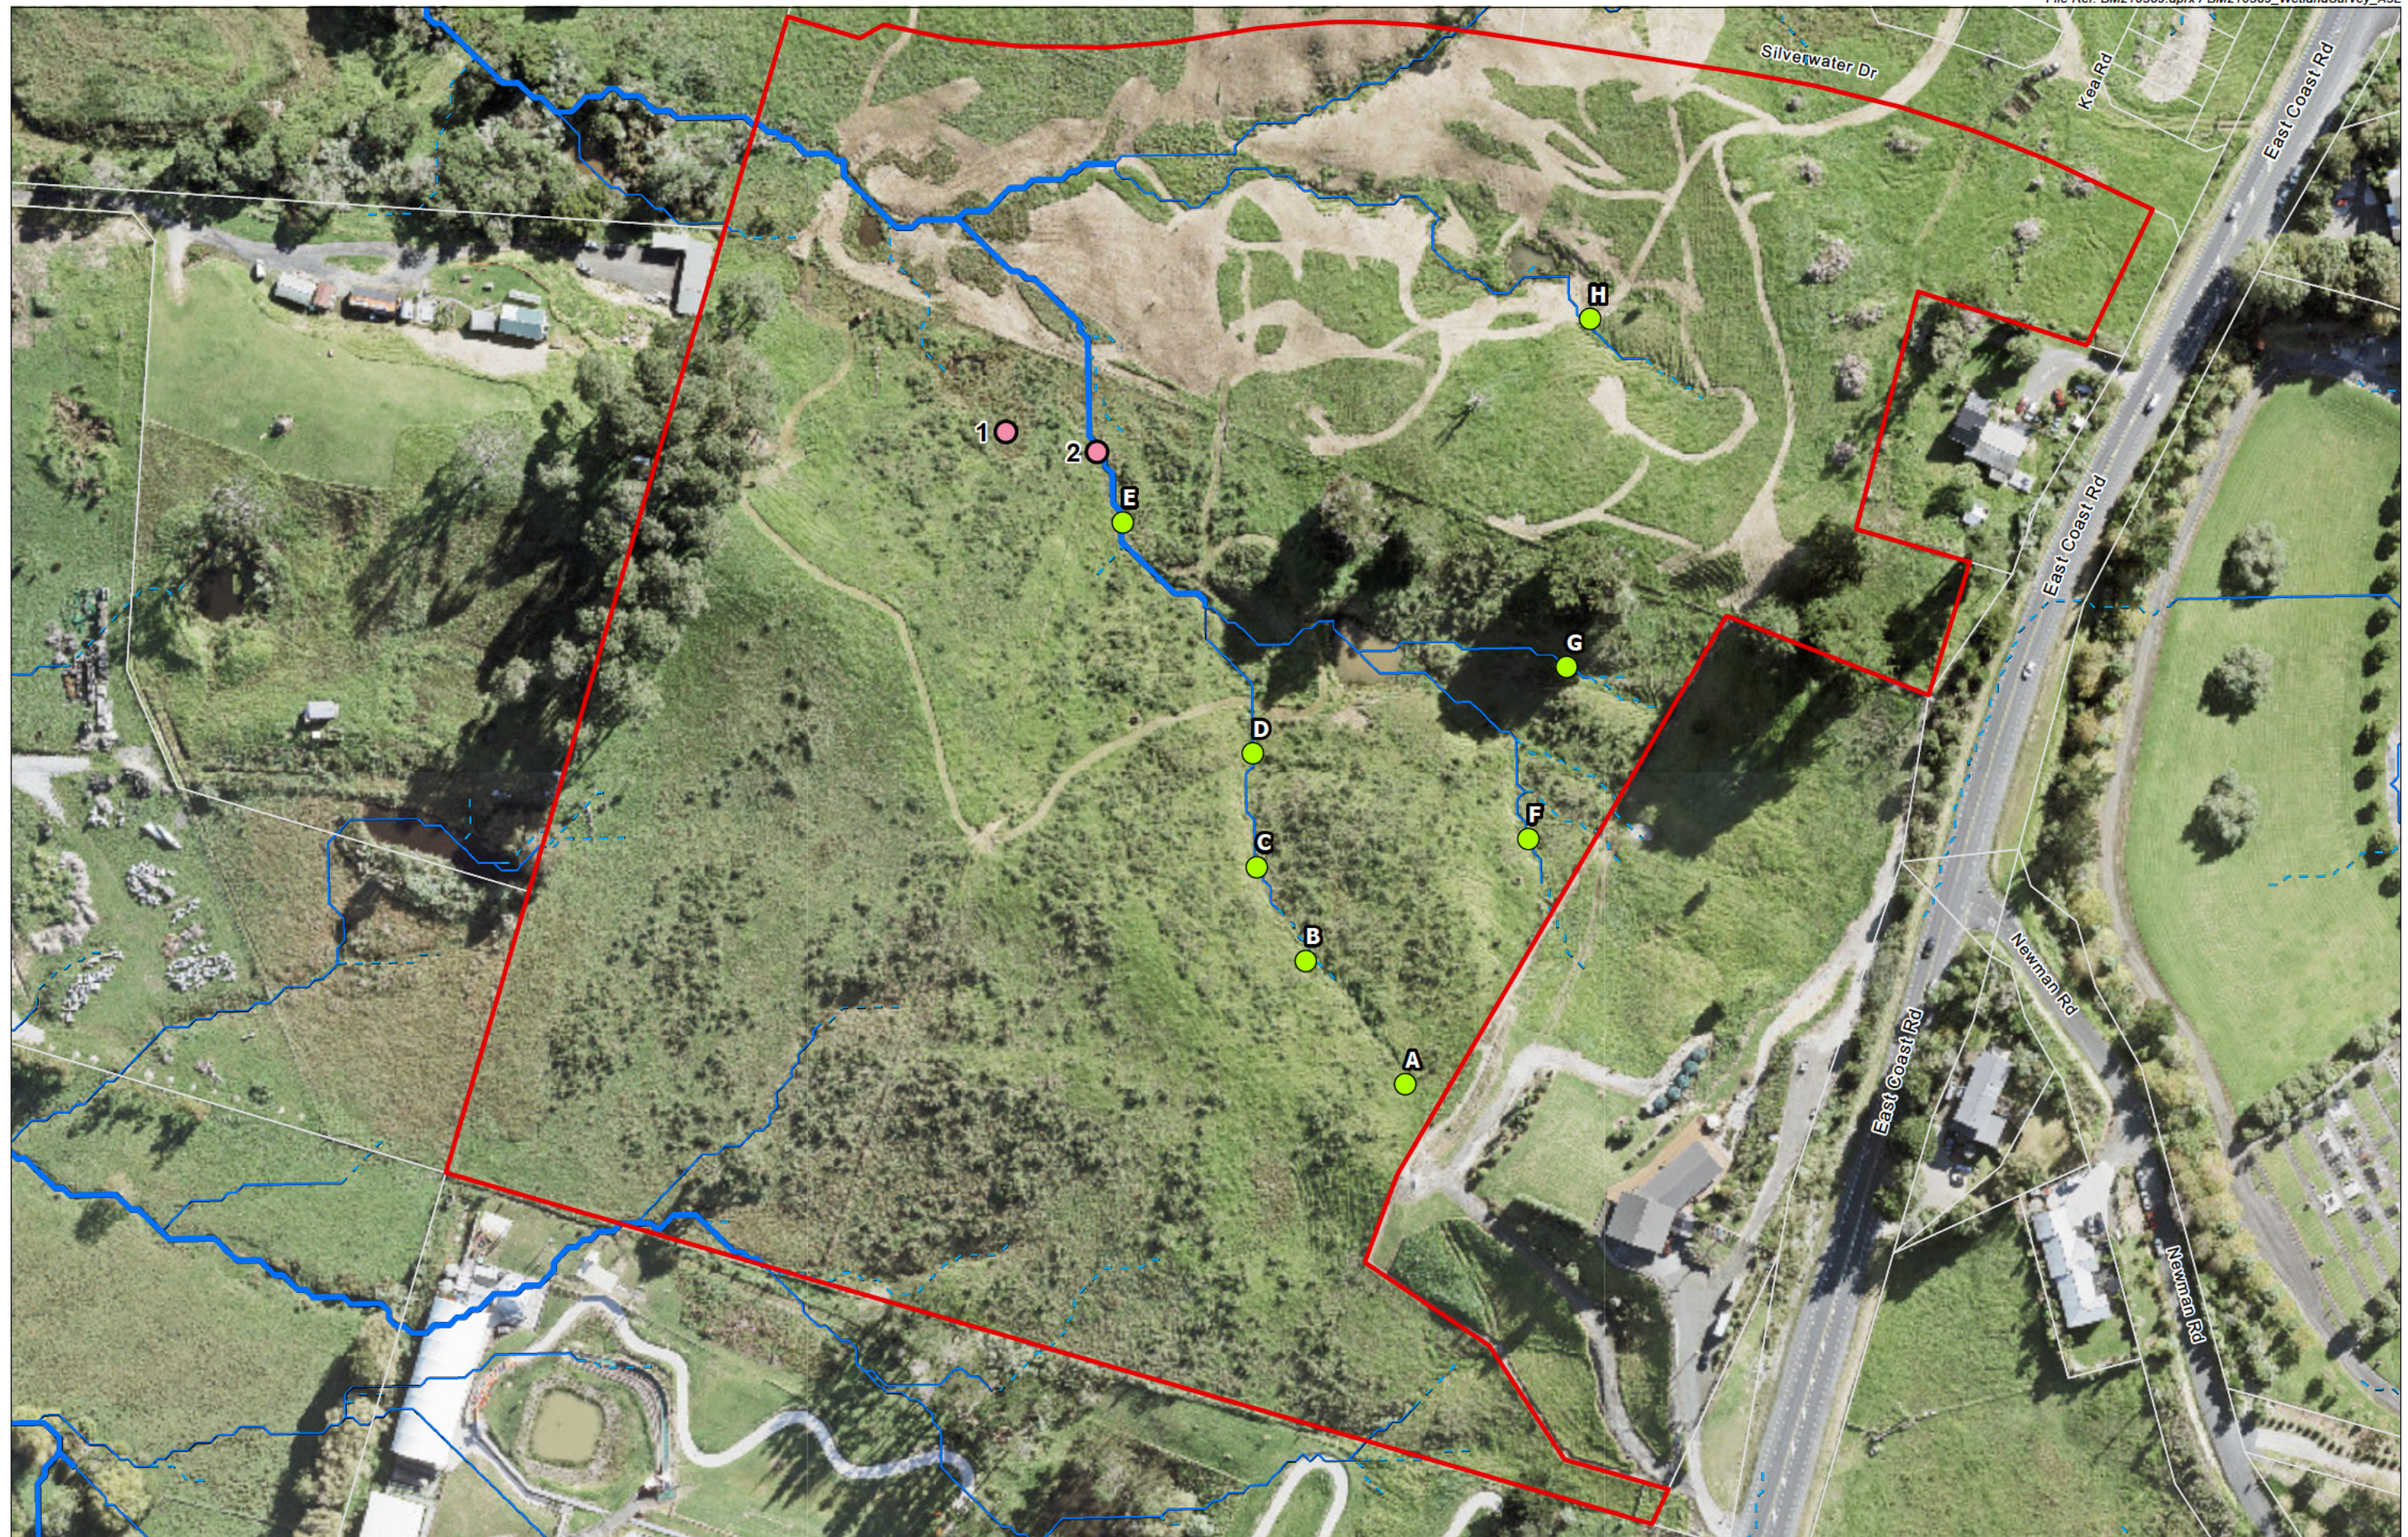
There are several small flow paths that run from the eastern boundary of the site and join a watercourse that extends from the centre of the subject site to the northern boundary (adjoining the area of consented earthworks) (Figure 1). All of the watercourses and flow paths within the site were investigated to classify them according to the AUP(OP) criteria for permanent intermittent rivers and streams and ephemeral streams (Table 1).

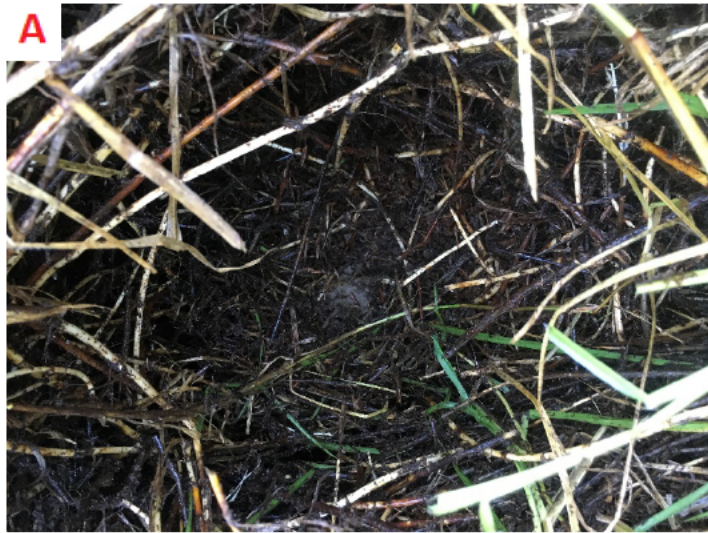
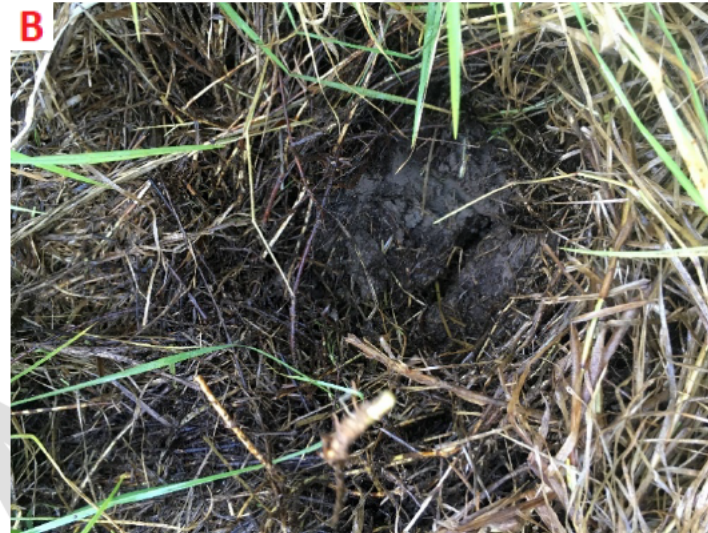
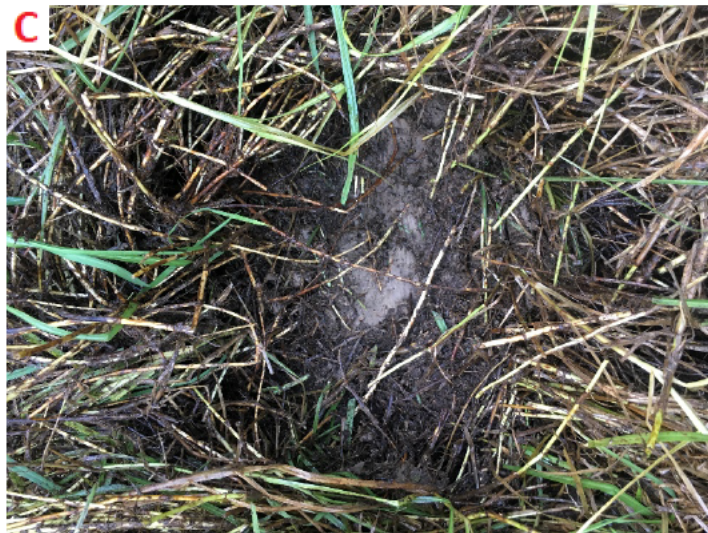
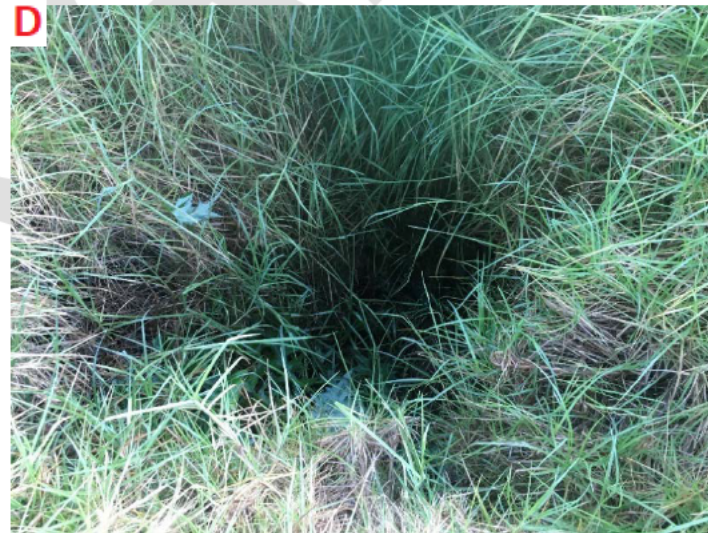
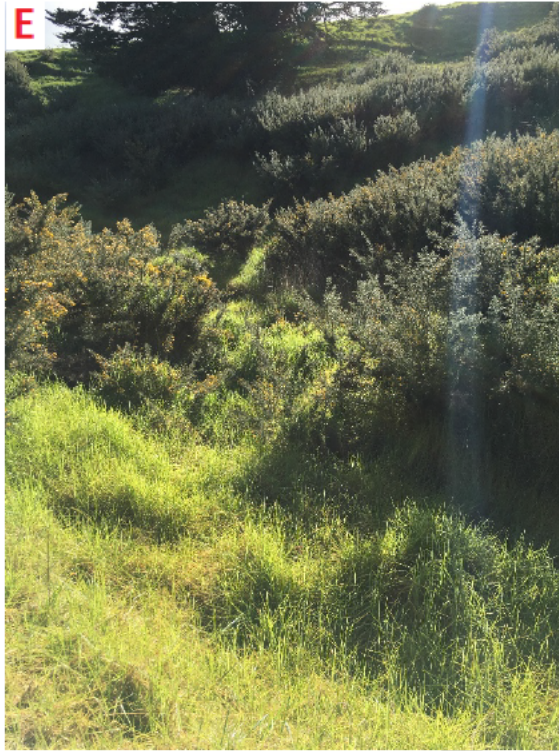
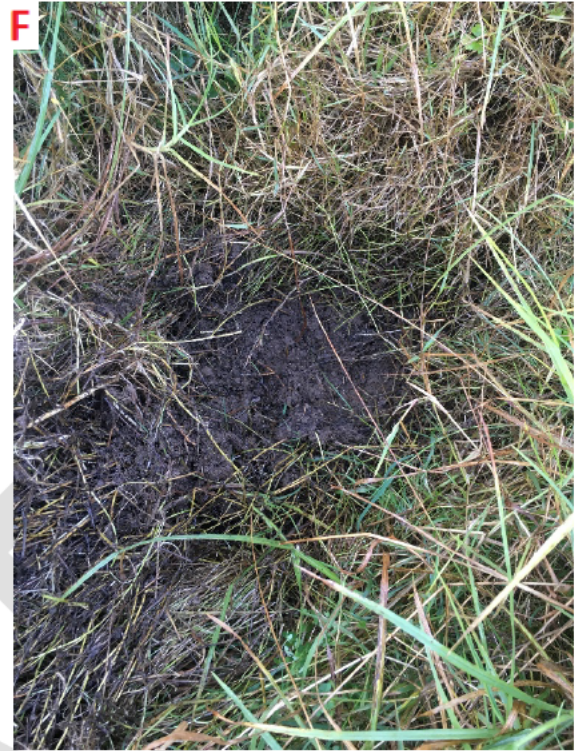
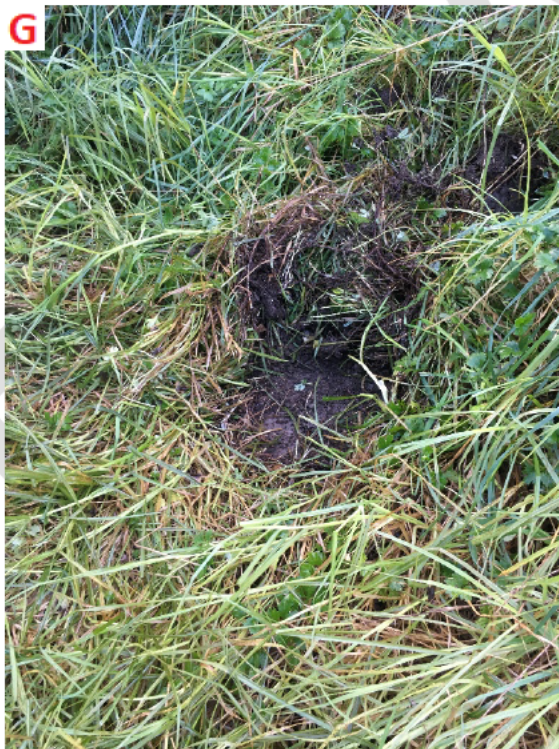
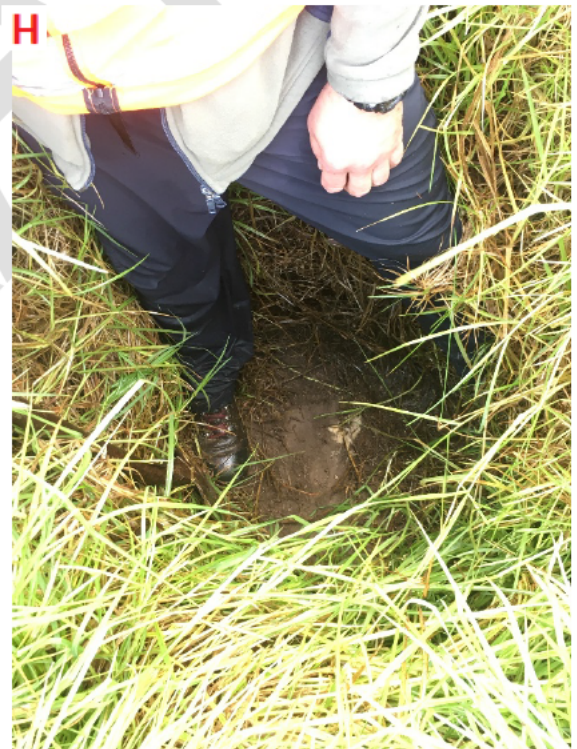
**Figure 2a-h:** Photos from watercourse investigations (locations on Figure 1) at 1 Silverwater Drive, Silverdale in July 2021

The watercourses and flow paths comprised well-defined to deeply incised channels overgrown with kikuyu and gorse the entire cross-sectional width, no water was found in any of these channels (See Figures 2 and 3). In several locations there were deep holes (>2 m deep) within the channel of the watercourse/flow path and these also had no water in them (Figure 2d). The watercourses and flow paths within the site were classified as ephemeral and this is due to the stream bed being above the water table at all times and they appear to only receive surface flows.

The watercourses and flow paths within the site were classified as ephemeral and this is due to the stream bed being above the water table at all times and they appear to only receive surface flows. It is also noteworthy that the artificial ponds that were previously noted have not persisted, while kikuyu and gorse has overtaken the site in the absence of grazing.

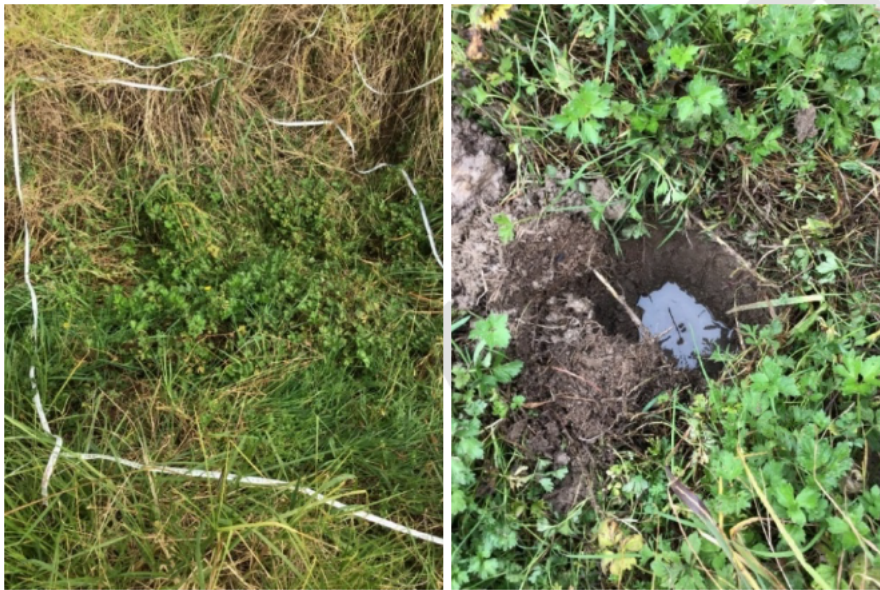
**Figure 5 (a & b).** Feature 1 vegetation and soil (high groundwater table)

Two small, discrete areas with prospective wetland characteristics in the north-western corner of the subject site were distinguished by visual observation. Feature 1 appears to be a short tributary or oxbow connected to the ephemeral stream channel (Figure 5). The feature itself is within a channel with banks, though vegetation covers the bed. Vegetation met the 'dominance test' (i.e., more than half the dominant species were OBL, FACW or FAC wetland plants, Figure. 4), and while soil investigations found no hydric soils present, water was present close to the soil surface within the channel. In addition, patches of standing water were found near the northern boundary of the subject site, amongst deep kikuyu and gorse scrub, though the overgrowth of vegetation obscured the extent of wet area.

A quadrat survey was undertaken in each feature to calculate the 'prevalence index' of wetland vegetation in accordance with NPS-FM protocols. Results are presented in summarised in Table 1. Both plots scored as wet-tolerant vegetation, though the score for Feature 1 was marginal (2.95 where the threshold is >3).

Two 'natural wetland' features were identified on the property using protocols set out in the NPS-FM, along with patches of standing water in the vicinity of the ephemeral stream channel's lower reaches. However, the status of these features should be further investigated, as Feature 1 may be induced through drainage modification associated with existing earthworks, while Feature 2 appears to have established from seed that was transferred in a patch of relocated soil, and may not be a functional wetland despite the occurrence of wet-tolerant species.

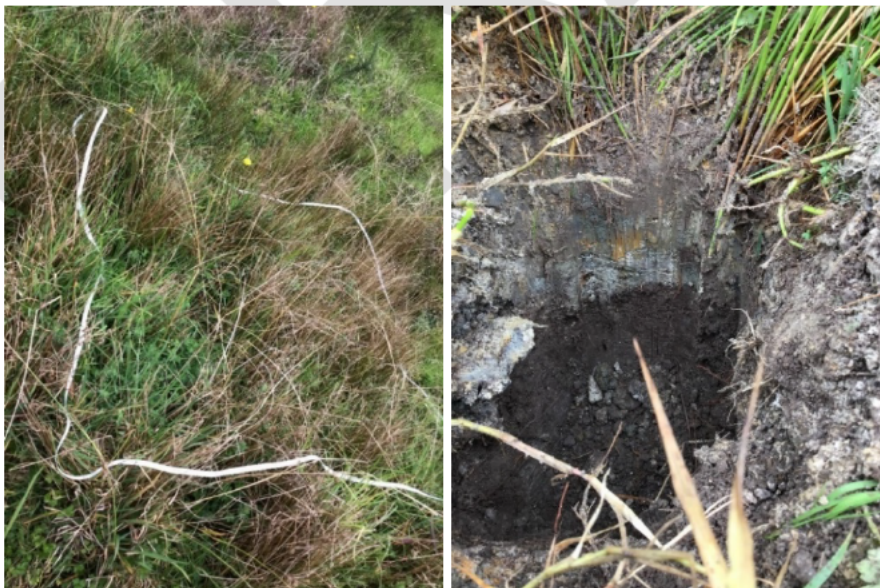
**Figure 6 (a & b).** Feature 2 vegetation and soil (hydric soil overlying organic soil)

Feature 2 was located in the vicinity of an artificial pond mapped in Bioresearches (2016). This site was completely dry, but contained a small (5 – 10 m<sup>2</sup>) patch of rushes and other wet tolerant vegetation (Figure 6). This feature also met the 'dominance test', though while a ~10 – 15 cm layer of hydric soil was found in the soil profile, organic topsoil was found beneath it, indicating that this feature is likely to have been induced through soil disturbance. It is likely the surface (hydric) soil deposit contained a seedbank from a previous wet site.
