# 1 Silverwater Drive

Earthworks Assessment of Ecological Effects  
Prepared for Build Rich Ltd

13 September 2021

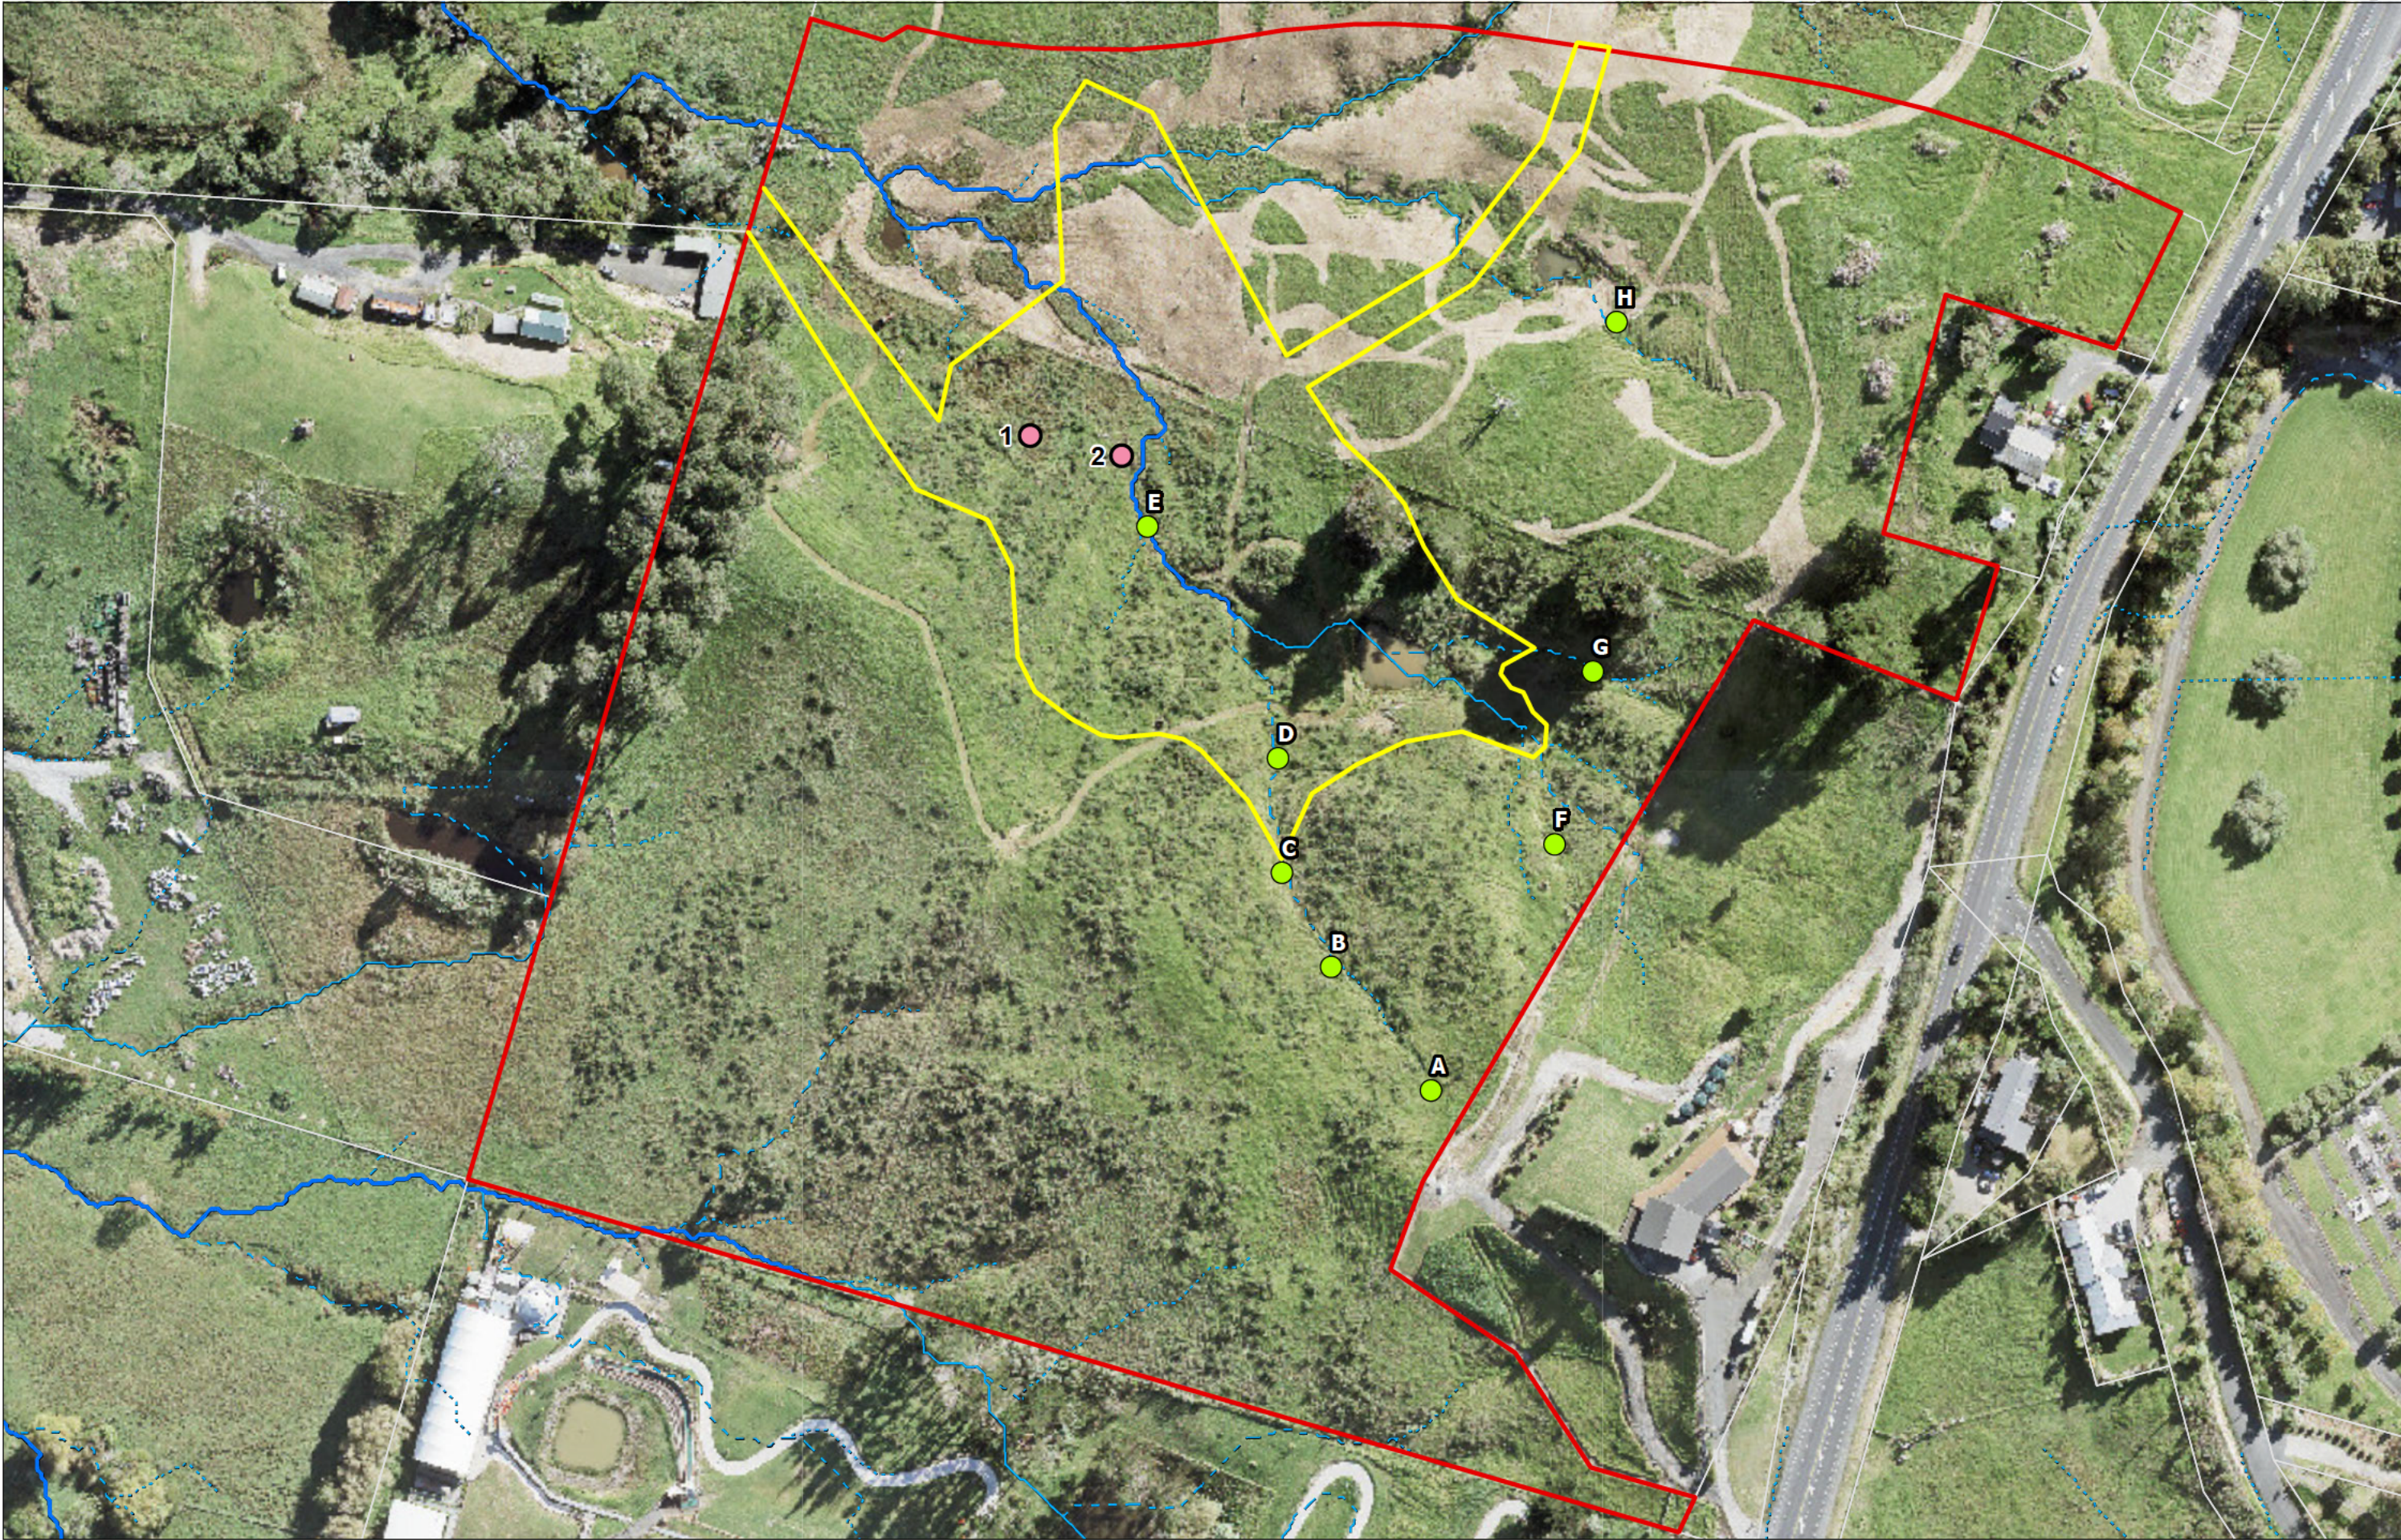
The property is located at 1 Silverwater Drive, Silverdale (Lot 7 DP 545151), Auckland. The total property area is 10.29 ha but our assessment is specific to the 1.34 ha (13,400 m<sup>2</sup>) within the property where earthworks are proposed, as well as the haul roads and access points associated with these works (Figure 1).

The overall property is sloping from east to west with undulating terrain. The property has historically been grazed by livestock but livestock appear to have been absent for several years as the property has a dense cover of kikuyu and gorse.

Two small, discrete areas with prospective wetland characteristics in the north-western corner of the proposed site for earthworks were distinguished by visual observation (Figure 1; henceforth referred to as Features 1 and 2). At each of these sites vegetation composition was assessed in a single 2 m × 2 m quadrat (Figures 4 and 5; Table 2) and the presence of hydric soils (i.e. soils which have been wet for sufficient time so that they develop under anoxic conditions; Fraser et al. 2018) was also assessed.

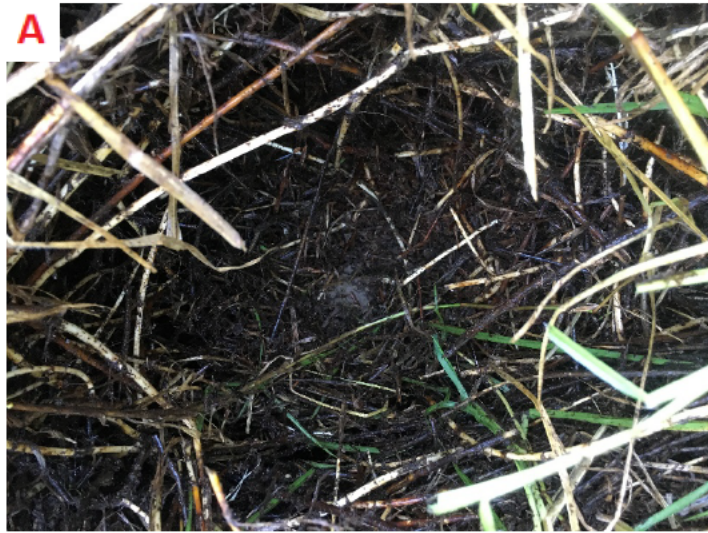
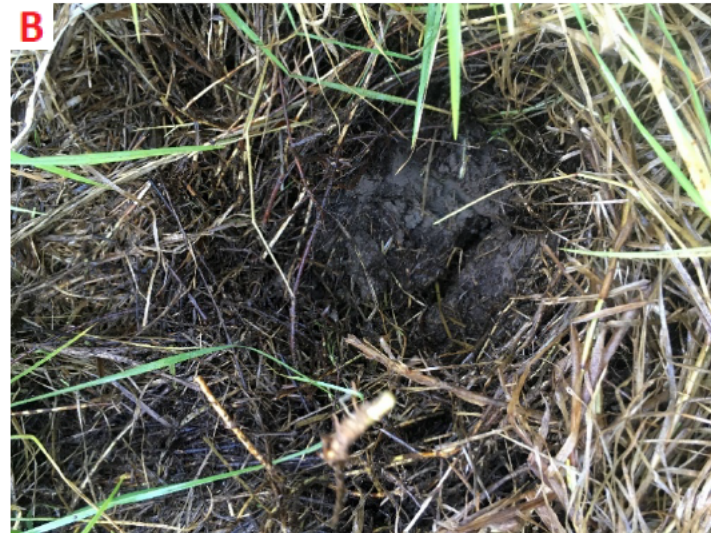
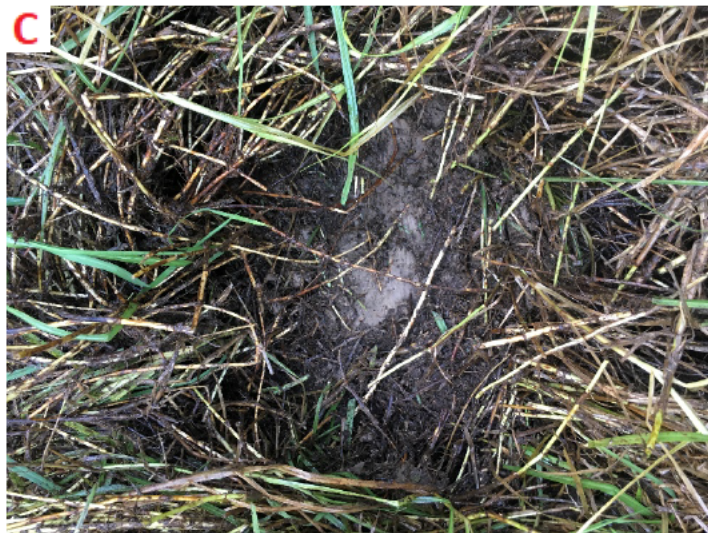
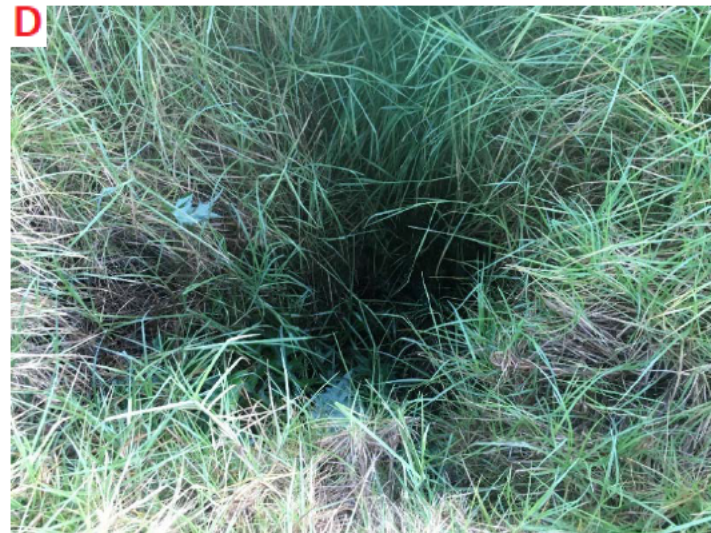
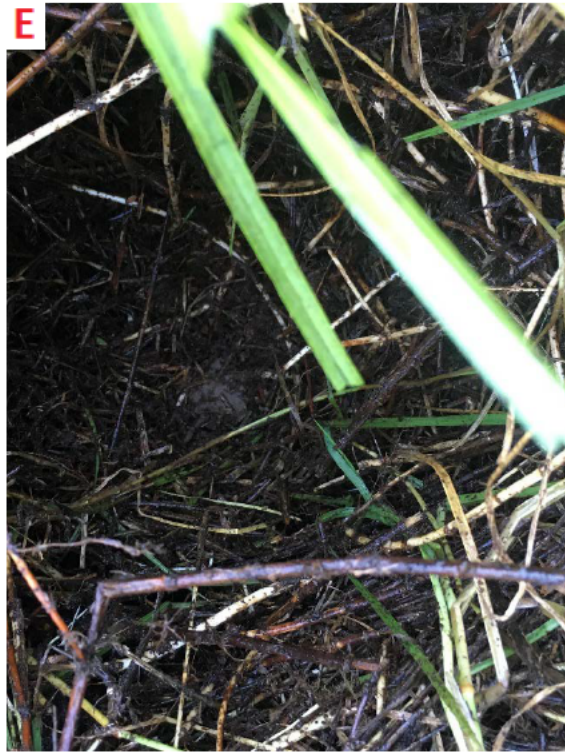
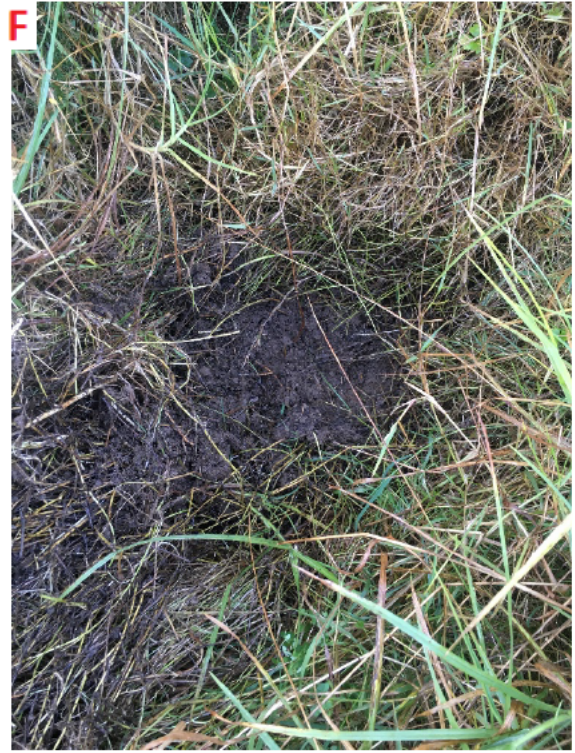
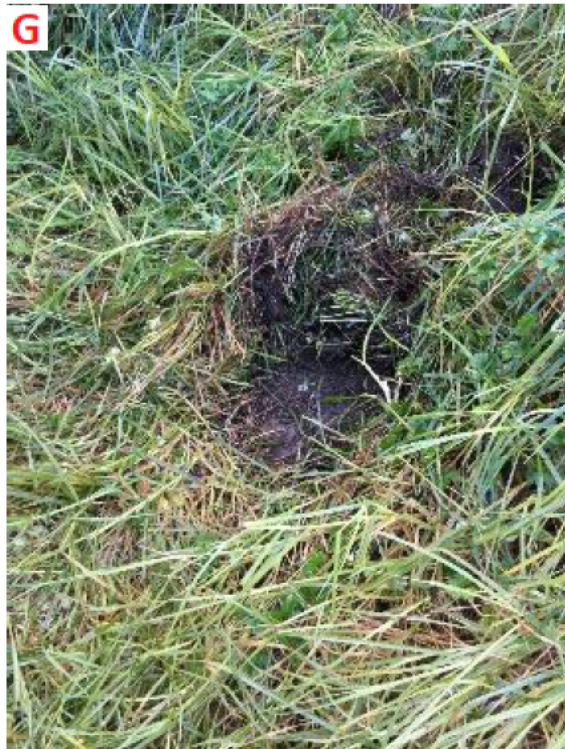
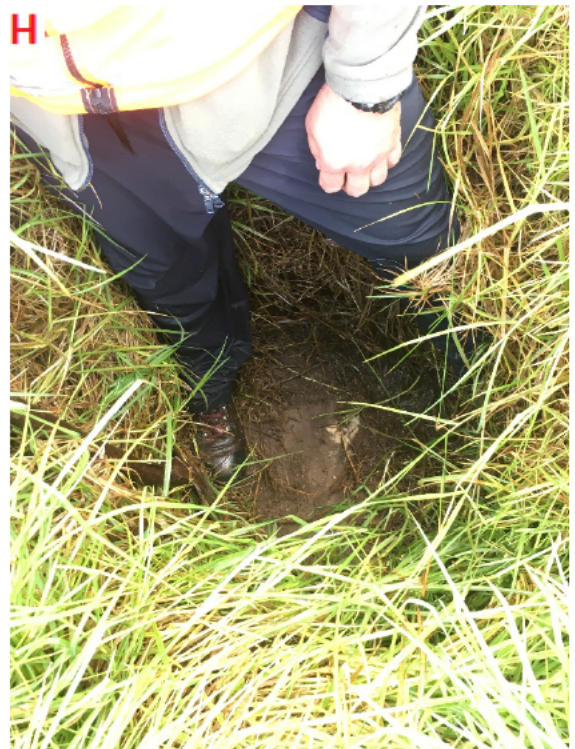
**Figures 2a-h:** Photos from watercourse investigations at 1 Silverwater Drive, Silverdale in July 2021

There are several small flow paths that run from the eastern boundary of the property and join a watercourse that extends from the centre of the proposed earthworks area to the northern boundary of the property (Figure 1). All of the watercourses and flow paths within the area proposed for earthworks and immediately adjacent and above this area in the catchment were investigated to classify them according to the AUP(OP) criteria for permanent intermittent rivers and streams and ephemeral streams (Auckland Unitary Plan Practice and Guidance note 2021; Table 1).

Along the length of each watercourse representative sites were investigated using a shovel to cut away kikuyu to reveal the stream bed to classify the watercourse. The watercourses and flow paths comprised well-defined to deeply incised channels overgrown with kikuyu and gorse the entire cross-sectional width, and no water was found in any of these channels (Figures 2a - h). In several locations there were deep holes (>2 m deep) within the channel of the watercourse/flow path and these also had no water in them (Figure 2d). The watercourses within the site were classified as ephemeral due to the stream bed being above the water table at all times, and they appear to only receive surface flows.

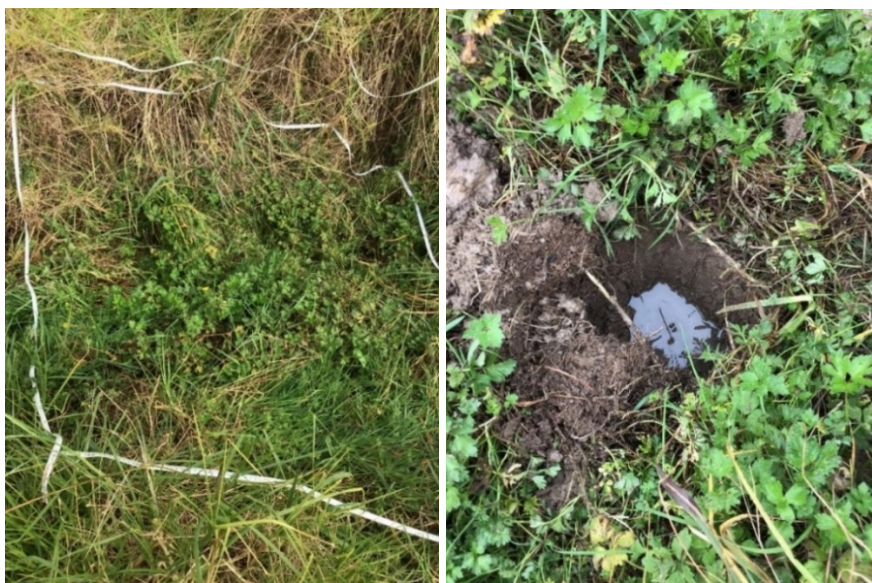
Feature 1 appears to be a part of an adjacent ephemeral stream channel (Figures 1 and 4). The feature itself is within a channel with banks, though vegetation covers the bed. Vegetation met the 'dominance test' (i.e., more than half the dominant species were OBL, FACW or FAC wetland plants, Table 2), and while soil investigations found no hydric soils present, water was present close to the soil surface within the channel. In addition, patches of standing water were found near the northern boundary of the subject site, amongst deep kikuyu and gorse scrub, though the overgrowth of vegetation obscured the extent of wet area.

A quadrat survey was undertaken within Feature 1 to calculate the 'prevalence index' of wetland vegetation in accordance with NPS-FM protocols. The plot scored as wet-tolerant vegetation, though the score was marginal (2.95 where the threshold is less than 3). The feature meets the criteria of a wetland under the NPS-FM protocols. During the second site visit (9 August 2021), the feature was assessed by BML ecologists and the Auckland Council representative and there was consensus that this feature forms part of an adjacent ephemeral stream channel and is not a wetland.

**Figure 4 (a & b).** Feature 1 vegetation and soil (high groundwater table).

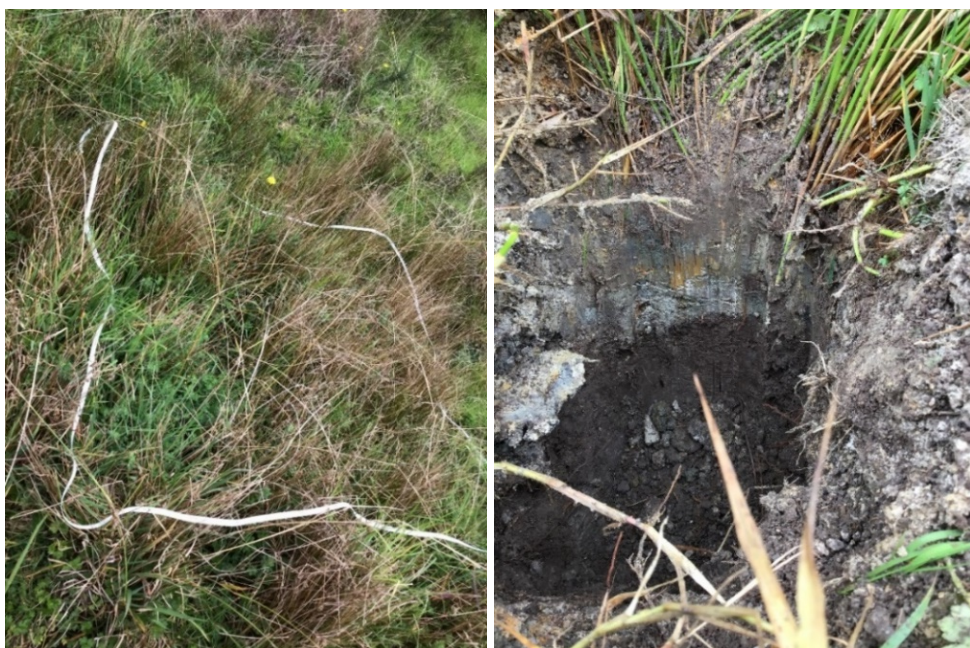
Feature 2 was located in the vicinity of an artificial pond mapped in Biosearches (2016). This site was completely dry but contained a small (5 – 10 m<sup>2</sup>) patch of rushes and other wet tolerant vegetation (Figure 5). It was evident that 'normal circumstances' were not present within and adjacent to Feature 2 as there was evidence of recent soil disturbance and modification through soil movement. Despite soil disturbance we did still proceed with the delineation protocol, and the feature met the 'dominance test', though while a c.10 – 15 cm layer of hydric soil was found in the soil profile, organic topsoil was found beneath it, indicating that this feature is likely to be the result of soil disturbance. It is likely the surface (hydric) soil deposit contained a seedbank from a previous wet site and the soil has been deposited in this location as there was obvious soil disturbance.

A quadrat survey was undertaken within Feature 2 to calculate the 'prevalence index' of wetland vegetation in accordance with NPS-FM protocols. The plot scored as wet-tolerant vegetation (Table 2) and meets the criteria of a wetland under the NPS-FM protocols. However, the feature appears to be the result of soil disturbance and so a further site visit was made to the site to clarify this. During the second site visit (9 August 2021), the feature was assessed by BML ecologists and the Auckland Council representative and there was consensus that this feature is not a wetland and is the result of soil having been deposited in this location and that the surface (hydric) soil deposit contained a seedbank from a previous wet site.

**Figure 5 (a & b).** Feature 2 vegetation and soil (hydric soil overlying organic soil)
