Report Title	Geotechnical Investigation - 597 E	ast Maddisons Roa	ad, Rolleston	
Project No.	12903.000.005	Doc ID	97	
Client	Hughes Developments Ltd	Client Contact	Kelvin Back	<
Distribution (PDF)	Kelvin Back			
Date	Revision Details/Status	WP	Author	Reviewer
03/09/2020	Issued to Client	ВК	JRW	DEB

1 Introduction

ENGEO Ltd was requested by Hughes Developments Ltd to undertake a geotechnical investigation of the property at 597 East Maddisons Road, Rolleston, Christchurch, as outlined in our variation proposal (ref: P2020.001.804_01).

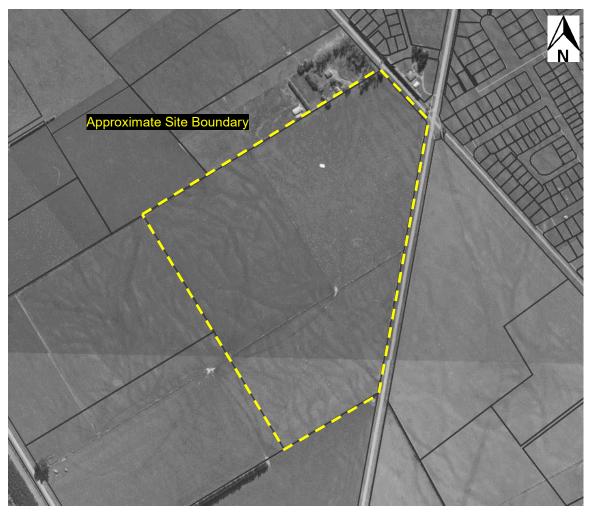
Figure 2: Historical Aerial Photo - 1970 - 1974

The site comprises relatively flat ground, with gentle undulations and depressions in some areas. As evident on aerial imagery (Canterbury Maps, 2019) and observed during our site walkover conducted on 25 August 2020, undulating and depressed ground can be attributed to paleo-channels, which traverse the site in a general northwest to southeast direction (Figure 2). Based on observations, sandy silt deposits with variable thickness are expected to have in-filled the paleo-channels where they have not remained as channel features. Inferred paleo-channels have been mapped to give an indication of areas with potential channel in-fill (Appendix 1).

Image sourced from Canterbury Maps. Not to scale.

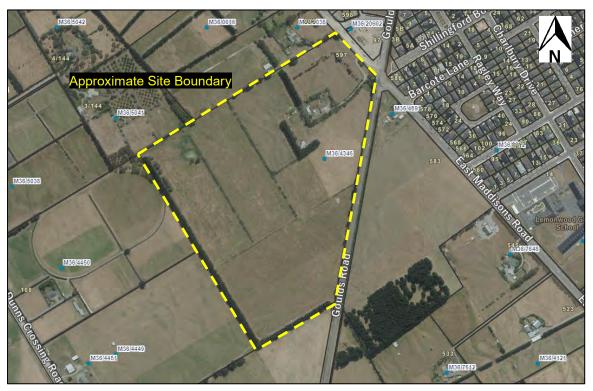
Figure 3: Nearby ECan Borehole Locations

ECan Borehole	Total Depth (m)	Water Level Below Ground Level (m)	Generalised Borelog as Logged by Driller
M36/4346	28.5	9.71	Gravel with silt and sand to 28.5 m depth. A layer of silt recorded from 6 to 8 m depth.
M36/4891	26.7	9.81	Gravel to 26.7 m depth.
M36/5041	34	9.73	Gravel with silt and sand to 34 m depth.
M36/4449	24.2	9.27	Gravel to 24.2 m depth.
M36/7512	29	9.32	Sandy gravel to 21.3 m depth.

Aerial photograph sourced from Canterbury Maps. Not to scale.

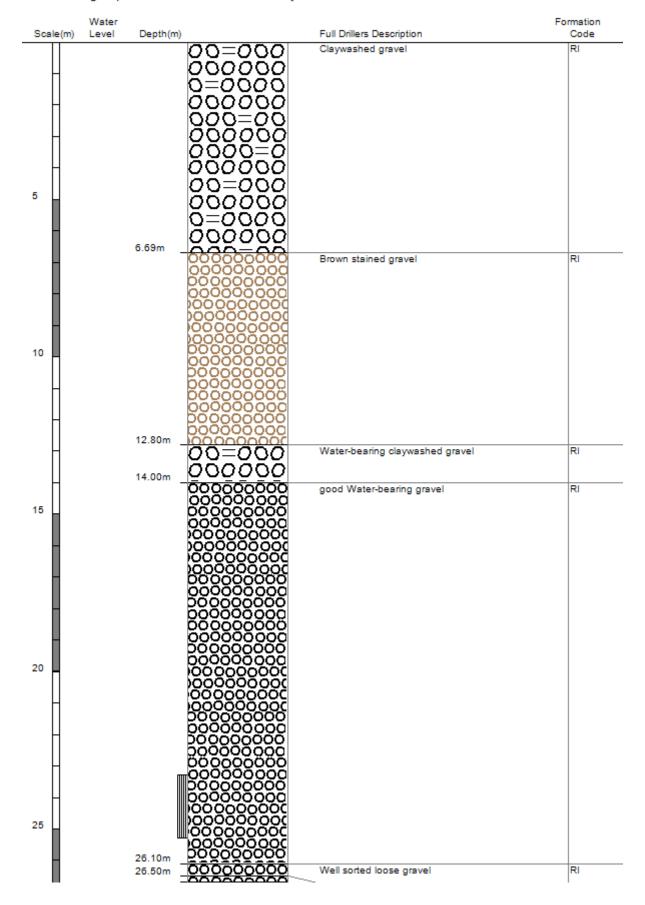
Bore or Well No	M36/5041		
Well Name	DUNNS CROSSING ROAD		
Owner KAJENS TRADING DEVELOPMENT LTD

Borelog Depth: 26.7 m Drill Date: 05-May-1995

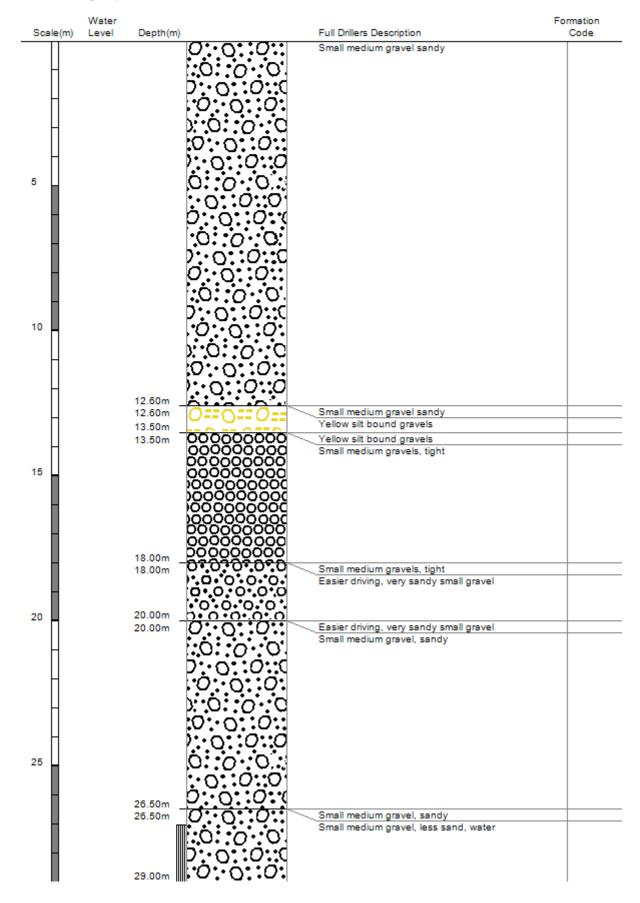
Borelog Depth: 29.0 m Drill Date: 01-Dec-2003
