## Geotechnical Investigation

108 Dunns Crossing Road

Rolleston

08.11.2019

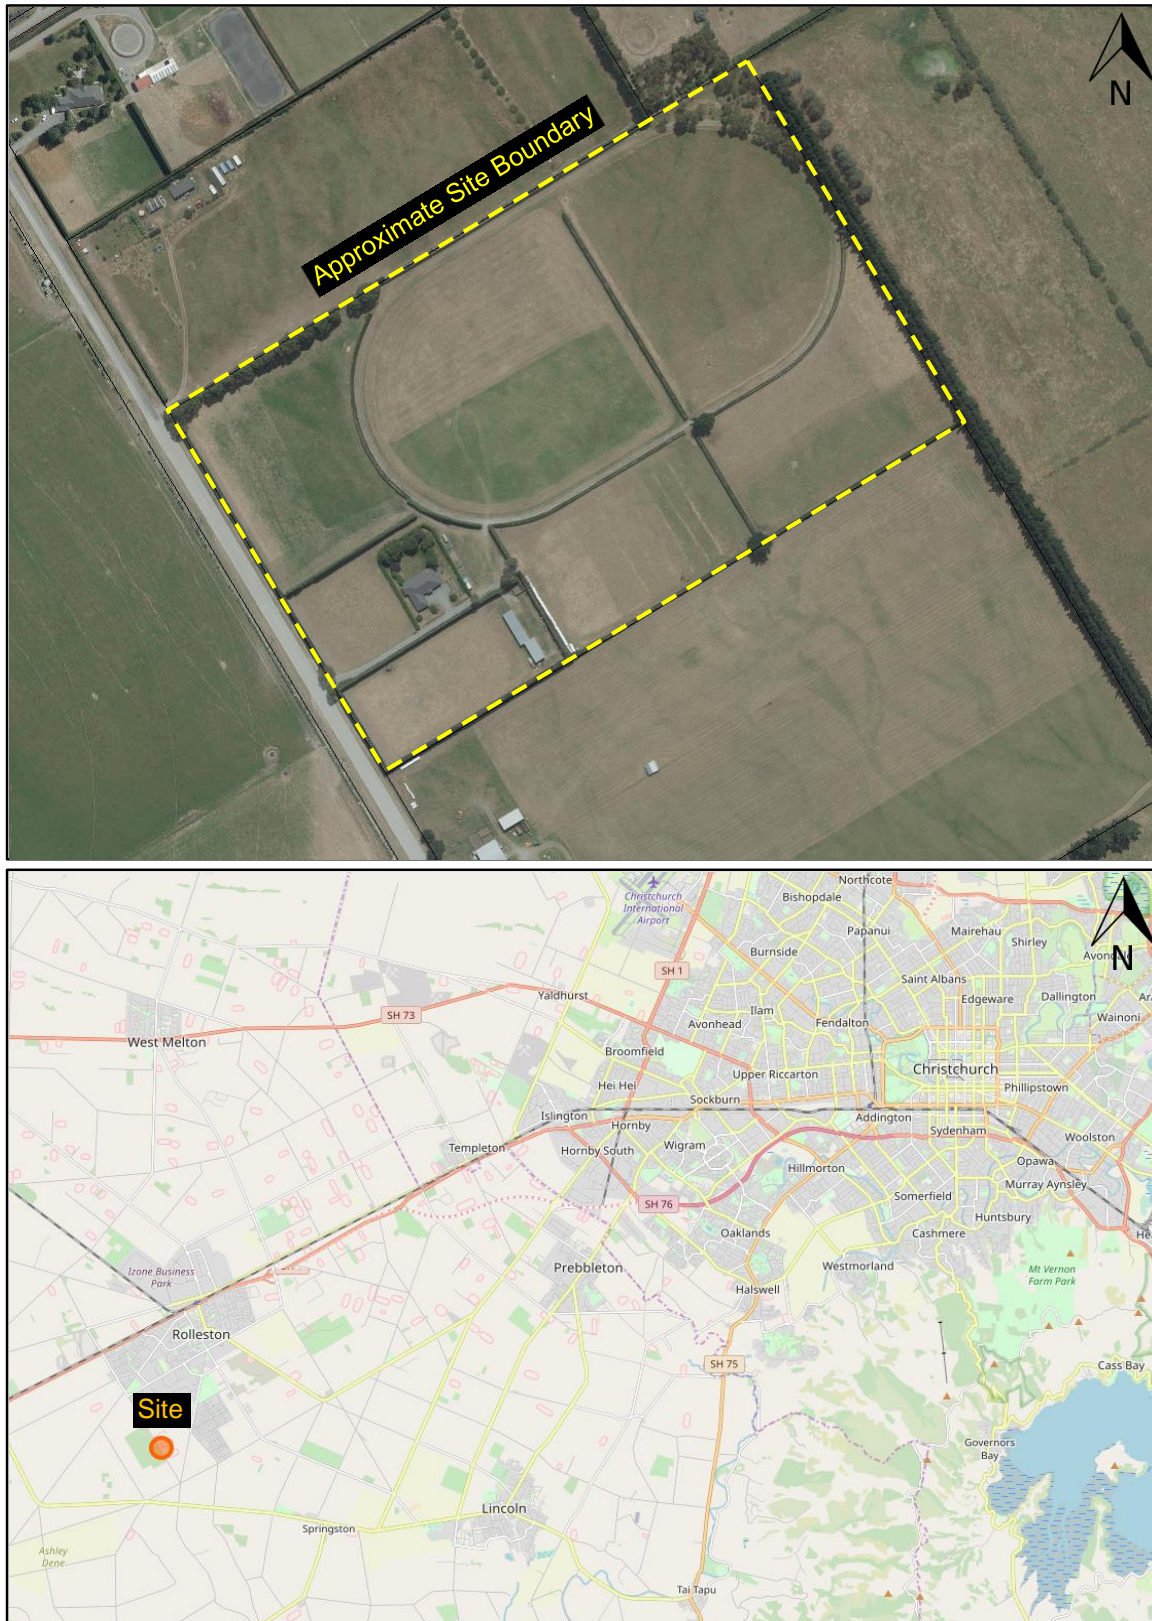
Figure 1: Site Location Plan

It is located approximately 3 km southwest of Rolleston town centre. The site is bound to the southwest by Dunns Crossing Road, and all other sides by rural properties (Figure 1).

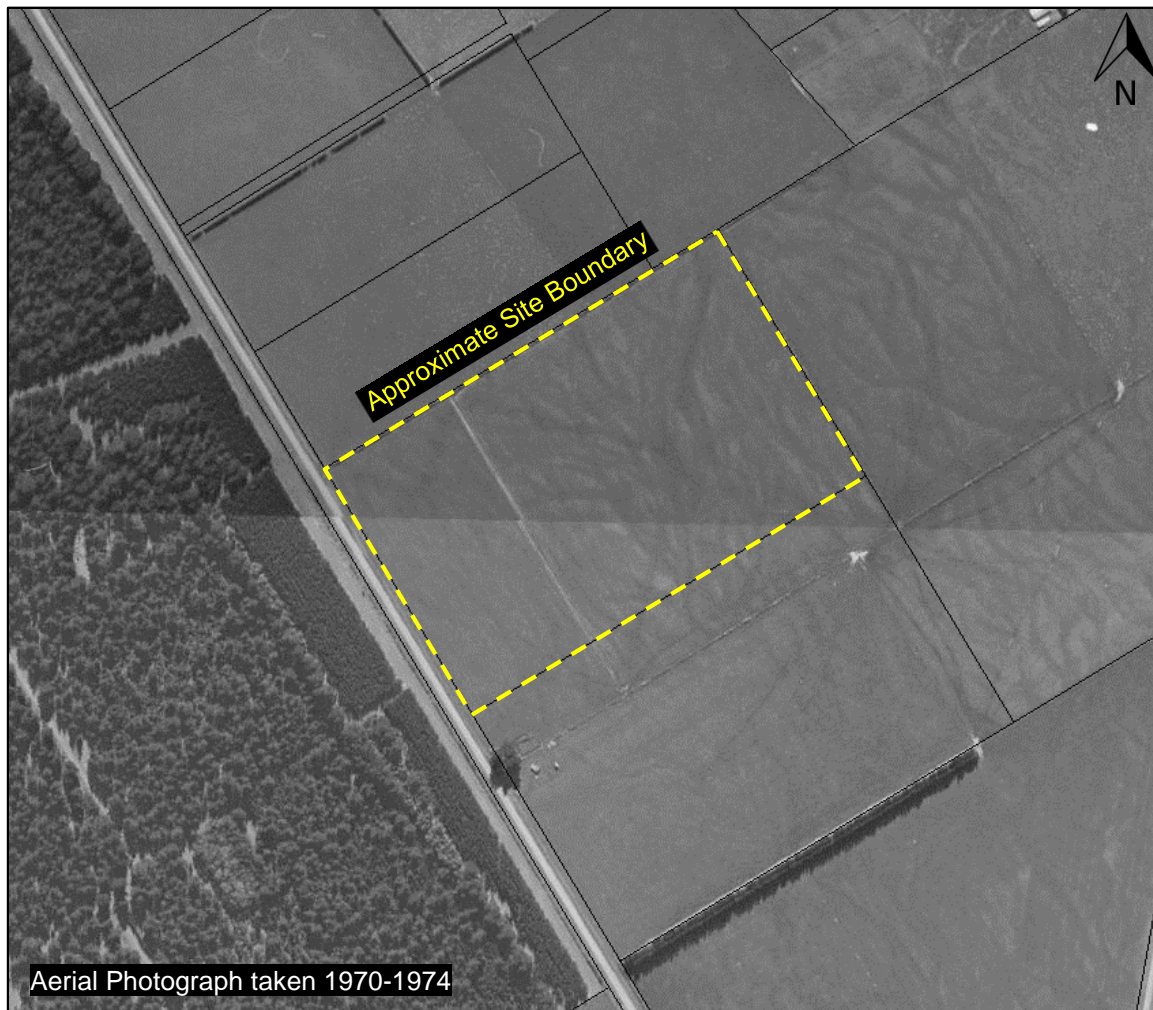
**Figure 2: Historical Aerial Imagery – 1990 to 1994**

The site comprises relatively flat ground, with gentle undulations and depressions in some areas. As evident on aerial imagery (Canterbury Maps, 2019) and observed during our site walkover conducted on 4 November 2019, undulating and depressed ground can be attributed to paleo-channels, which traverse the site in a general northwest to southeast trend (Figure 2). Based on observations, silty sand deposits with variable thickness (up to 0.8 m) are expected to have in-filled the paleo-channels where they have not remained as channel features. Inferred paleo-channels have been mapped to give an indication of areas with potential channel in-fill (Appendix 1).

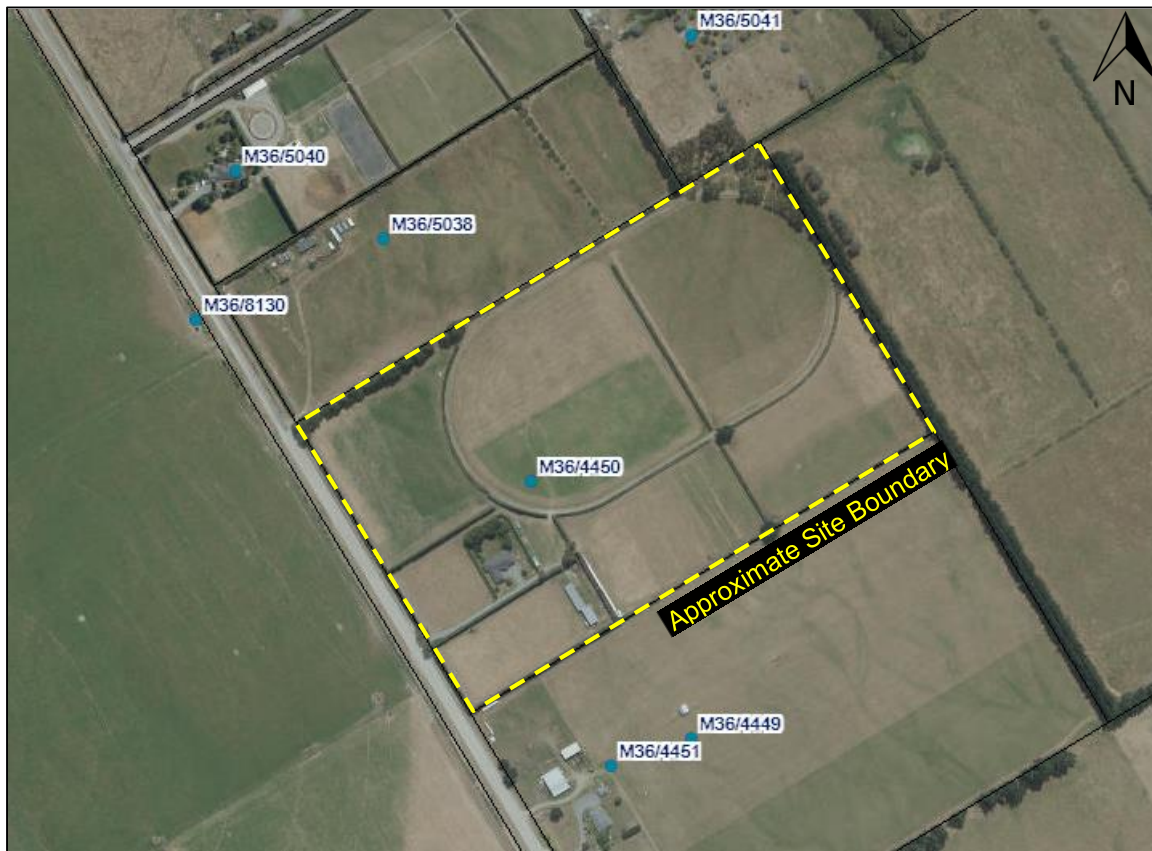
**Figure 3: Nearby ECan Borehole Locations**

A review of four deep ECan borehole logs was conducted. The first (M36/4450), is located on-site, and appears to be a water well servicing the properties irrigation. The other boreholes are located to the north (M36/5038), north east (M36/5041) and south (M36/4449) of the site. A borehole is located west of Dunns Crossing Road (M36/8130) but has no borehole data for the first 54 m of the soil profile on Canterbury Maps (Figure 3)

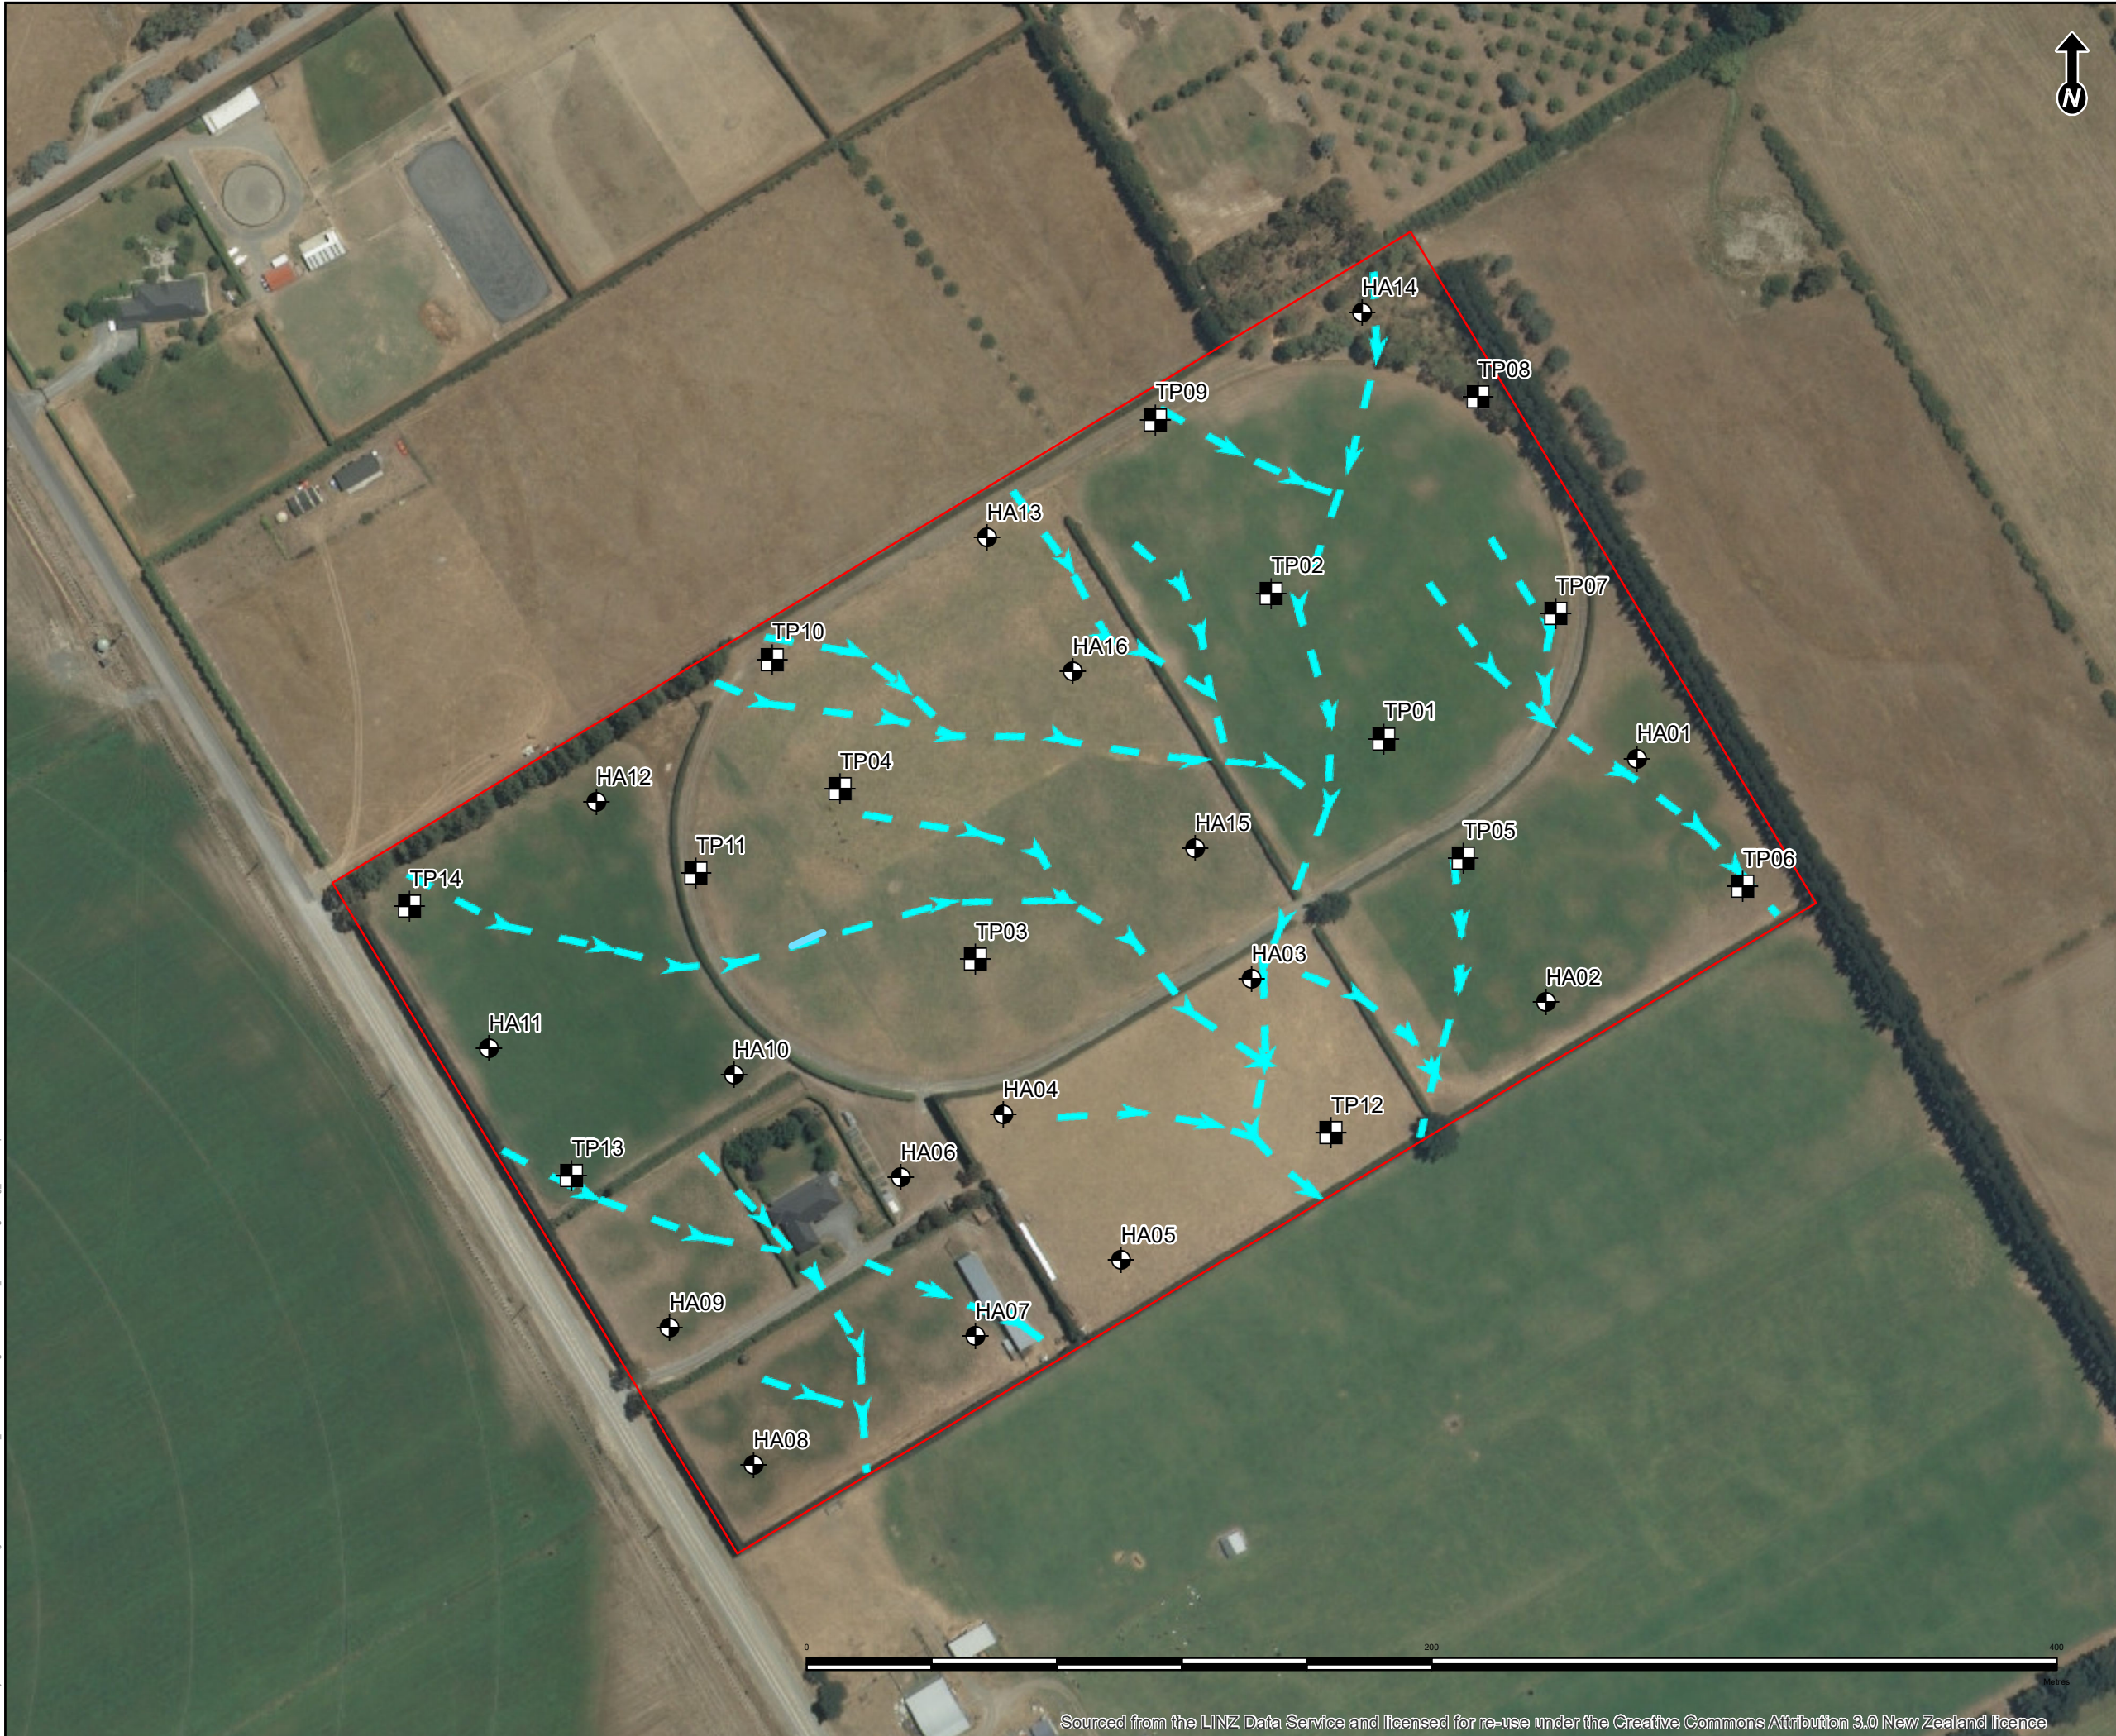
### Site Plan and Inferred Paleo Channels

- Legend**
- Hand auger locations
  - Test pit locations
  - Flow Path
  - Site boundary
