Geotechnical Investigation

3/144 Dunns Crossing Road

Rolleston

12903.001.000_91

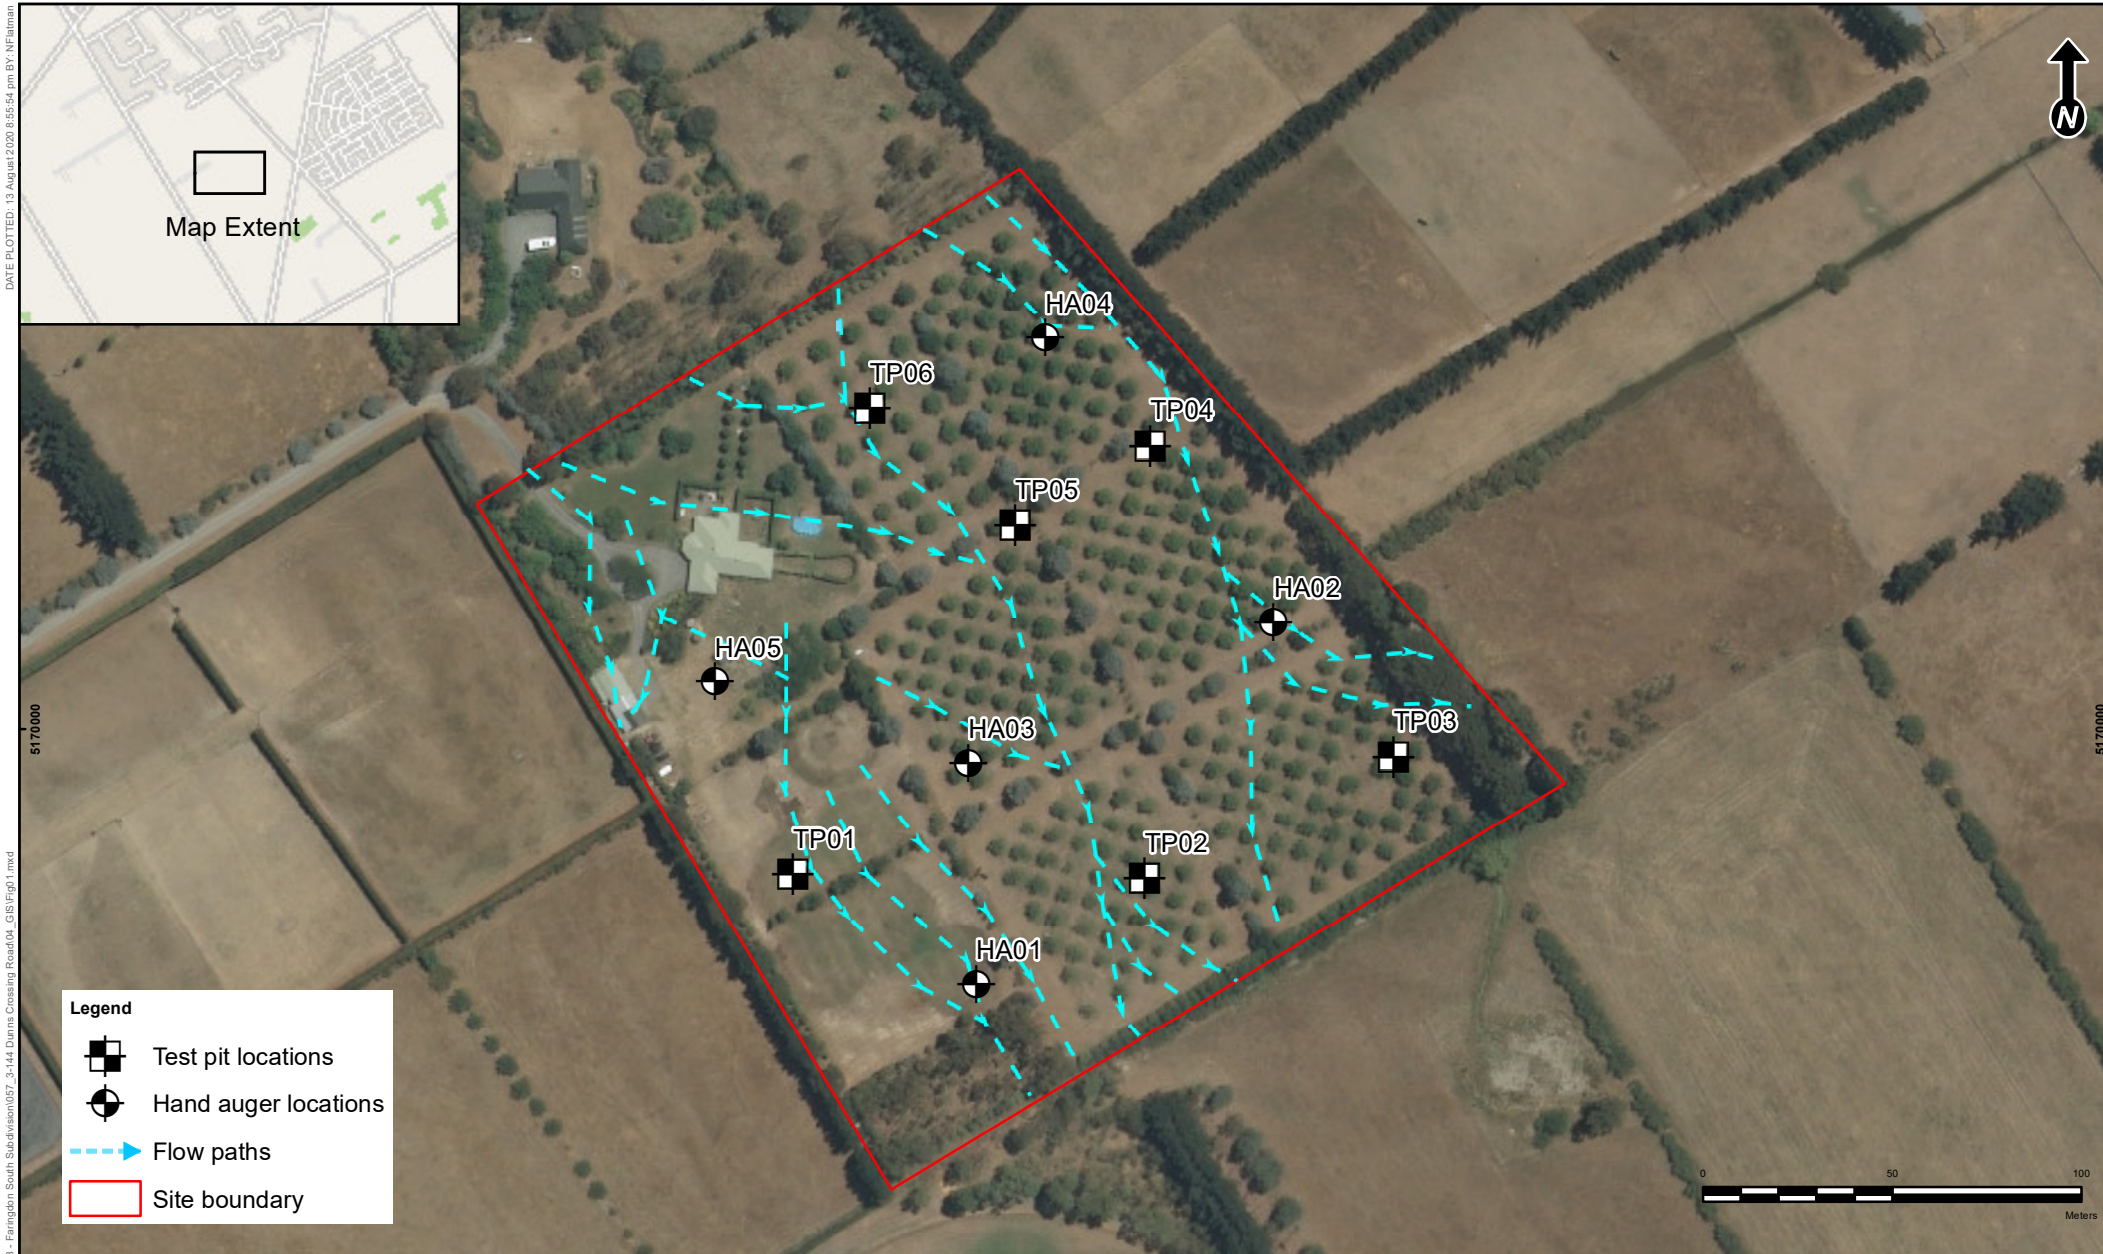
Geotechnical Site Plan

Site Plan and Inferred Paleo Channels

- Test pit locations
- Hand auger locations
- Flow paths
- Site boundary

The site comprises relatively flat ground, with gentle undulations and depressions in some areas. As evident on aerial imagery (Canterbury Maps, 2019) and observed during our site walkover conducted on 5 August 2020, undulating and depressed ground can be attributed to paleo-channels, which traverse the site in a general northwest to southeast direction (Figure 2). Based on observations, sandy silt deposits with variable thickness are expected to have in-filled the paleo-channels where they have not remained as channel features. Inferred paleo-channels have been mapped to give an indication of areas with potential channel in-fill (Appendix 1).

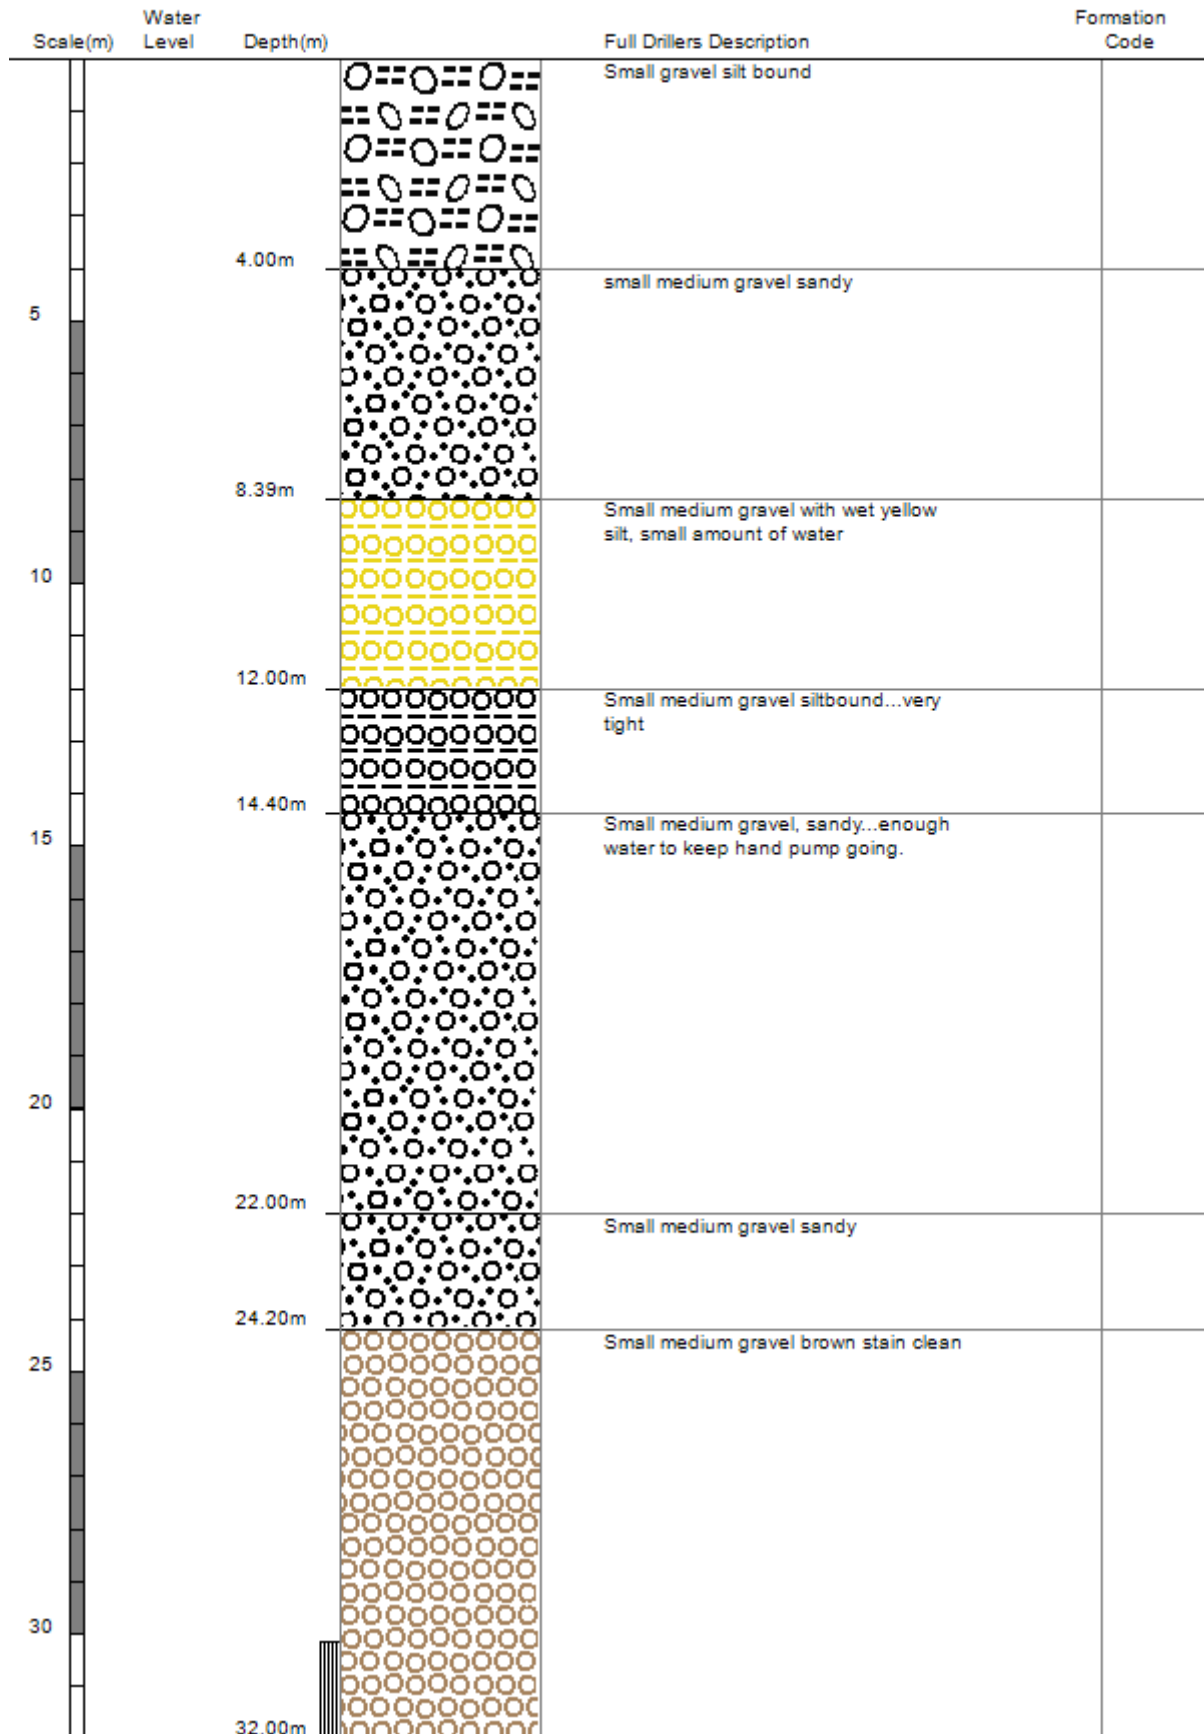
Drill Method: Cable Tool

Borelog Depth: 32.0 m Drill Date: 01-Nov-1996
