## Combined Preliminary and Detailed Site Investigation

108 Dunns Crossing Road  
Springston  
Canterbury

08.11.2019  
12903.000.000\_69

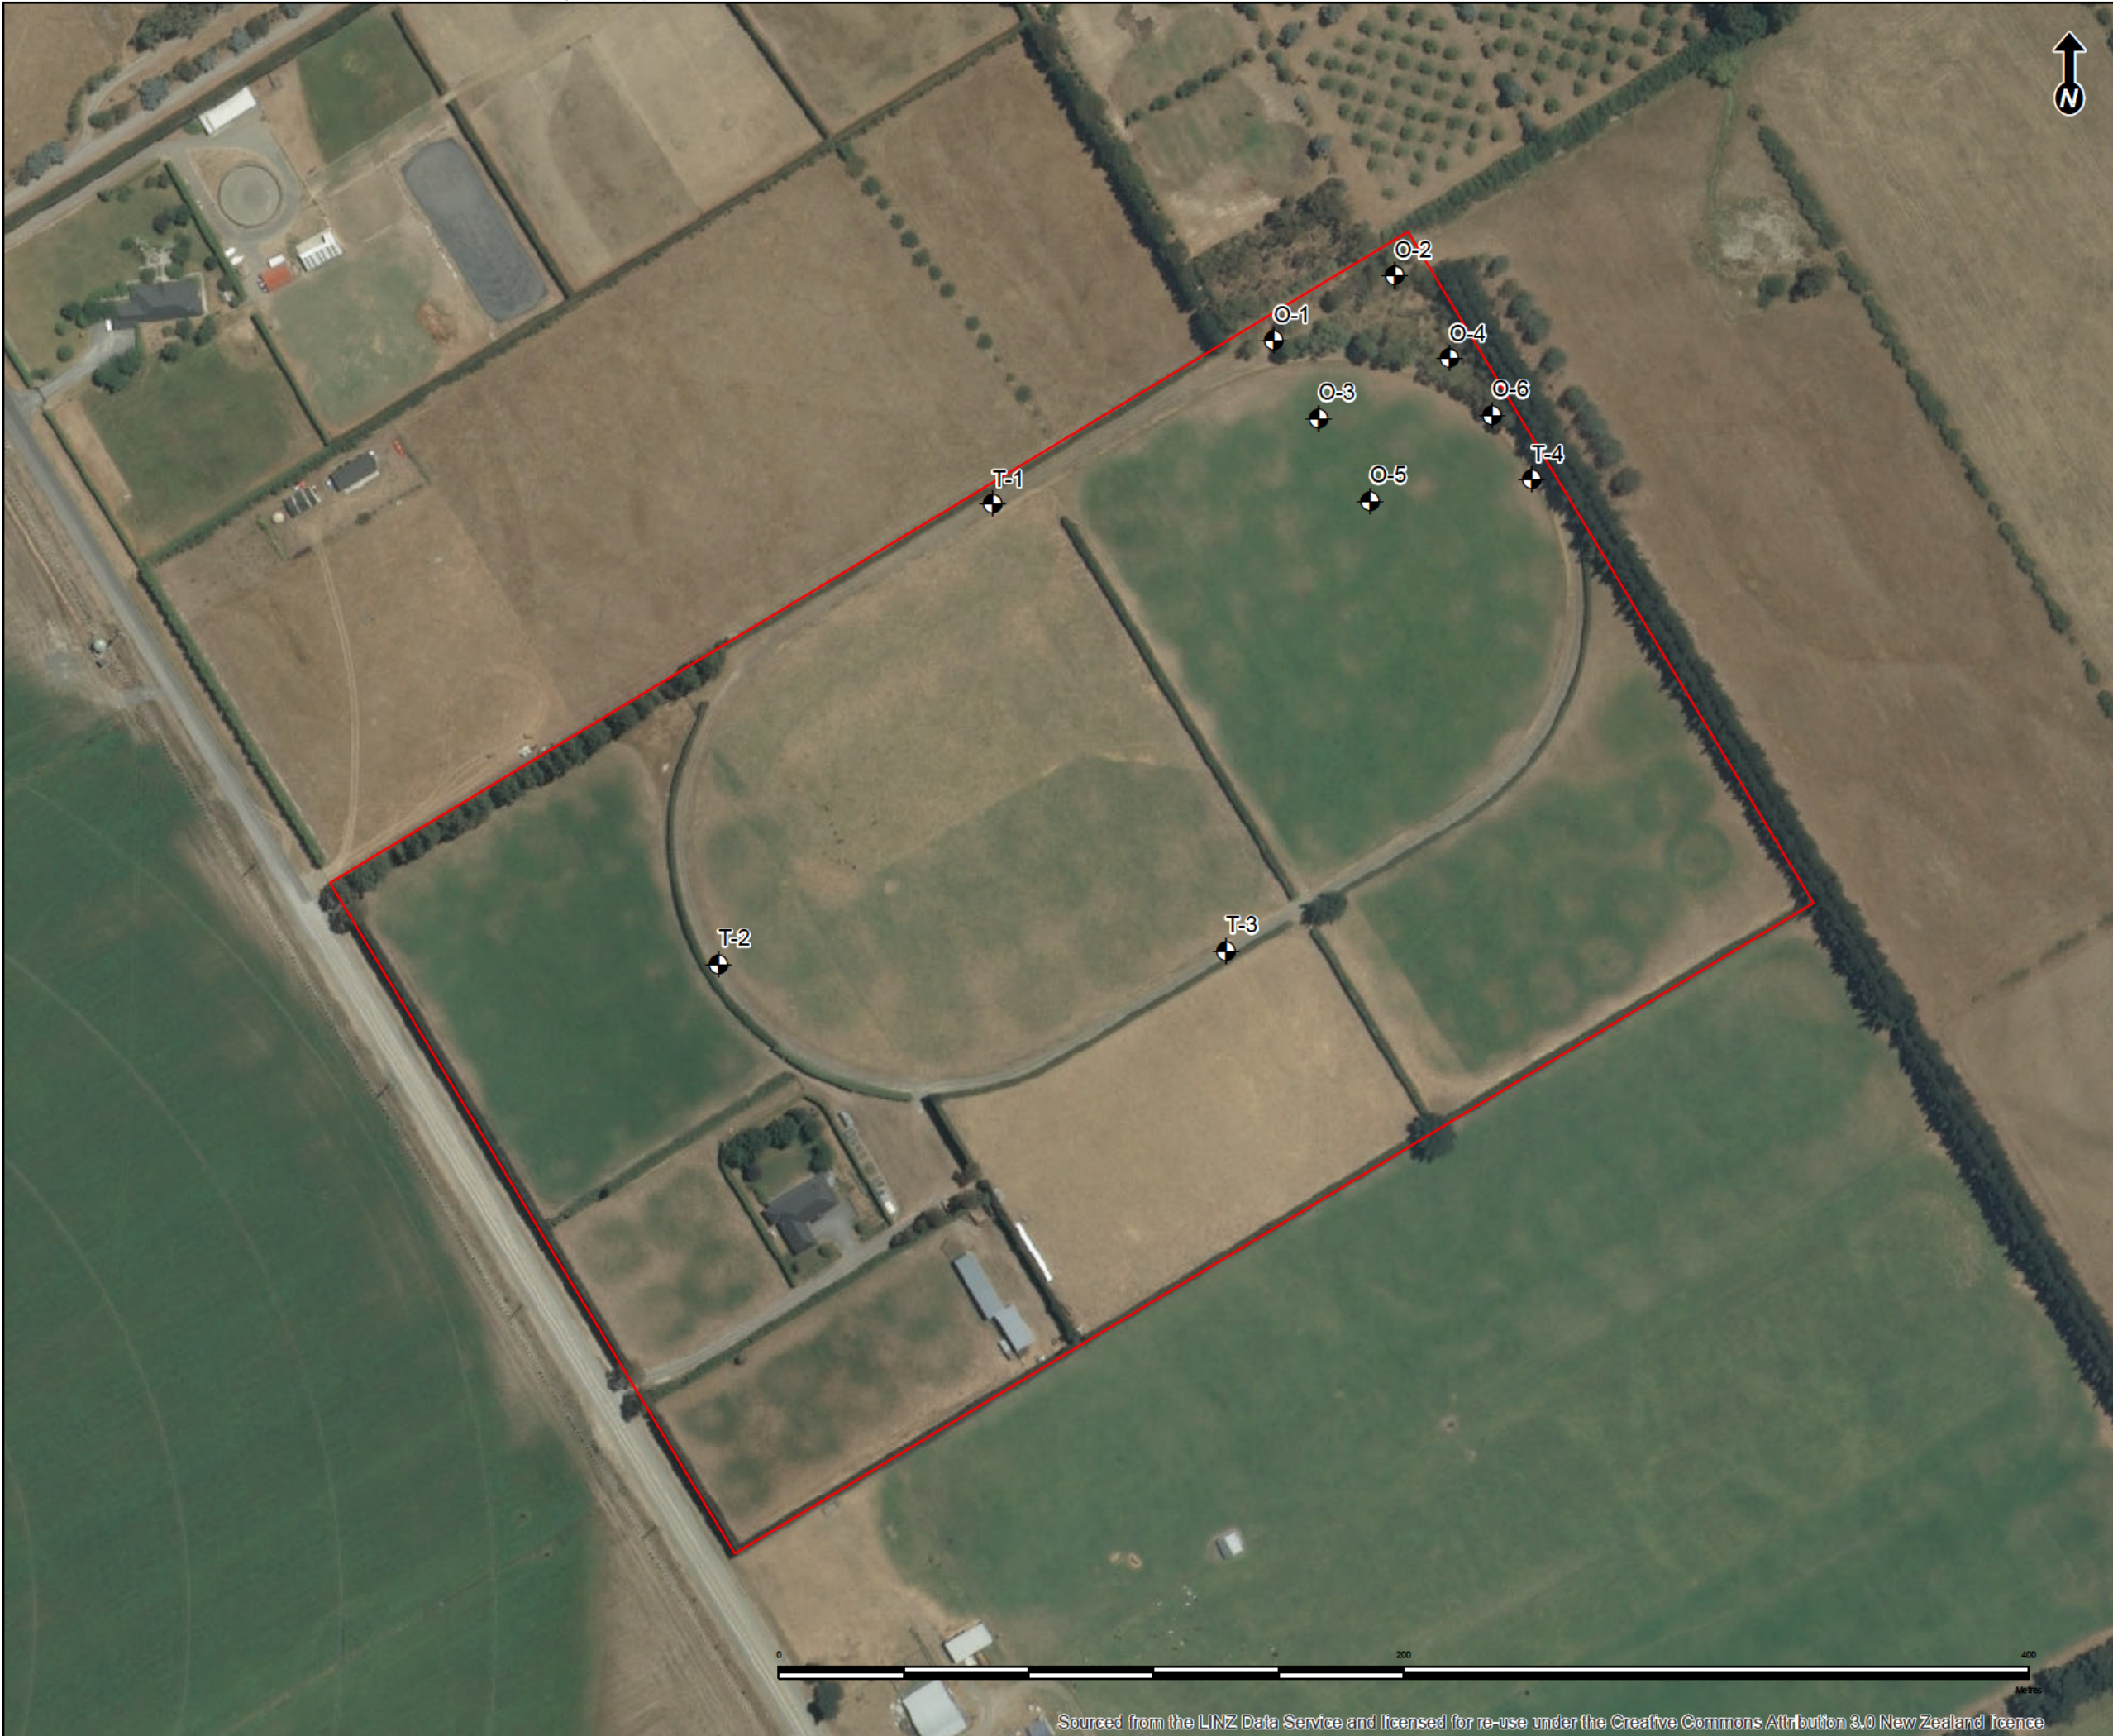
- Legend**
- Site boundary
  - Sample locations

The site location and investigation areas are shown in Figure 1. ENGEO understands that the site is to be redeveloped into a residential subdivision. The environmental assessment was performed as part of an investigation into the potential contaminants at the site and the suitability of the site for residential land use.

The total site area is 101,150 m<sup>2</sup> and has the legal description of LOT 2 DP 61278. We understand that the property at 108 Dunns Crossing Road is to be subdivided into residential lots. The site location is displayed in Figure 1.

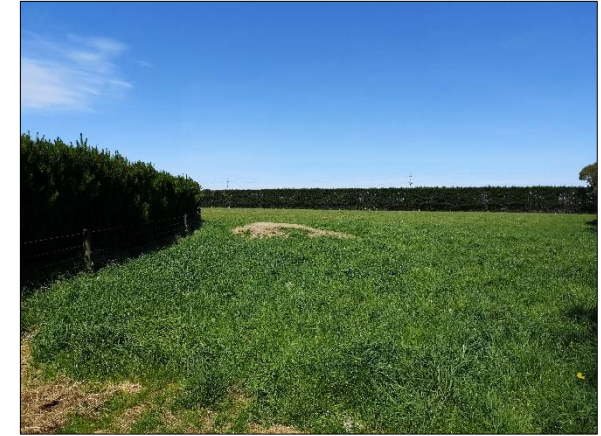
Photo 9: Southern Gravel Stockpile (old oval track material)

| Site Conditions | Comments |
|---|---|
| Additional observations | <p>Small stockpile of gravel was observed to the west of the horse track.</p> <p>Small piles of greenwaste were observed in the north-west corner of the site below the gum trees.</p> <p>One 10L drum and one 100L drum were observed near the sheds. These drums were empty and no soil staining was visible on the ground.</p> |

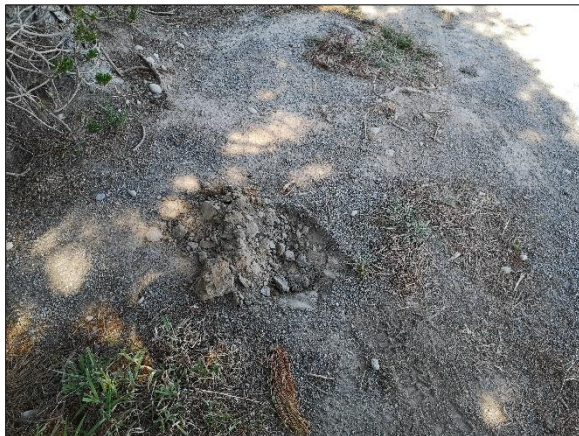
Photo 10: Typical strata of horse track material

During the site walkover the horse track was sampled for impacted imported fill material. It was noted that the imported fill consisted of gravel and shells. The laboratory analysis of four samples from around the trotting track area were submitted for analysis for heavy metals and PAHs. Six samples were also collected from the north-western corner of the site for heavy metals and OCPs due to the neighbouring site being a historic orchard. All ten samples returned concentrations below the site specific regional background criteria and the applicable NES human health criteria.

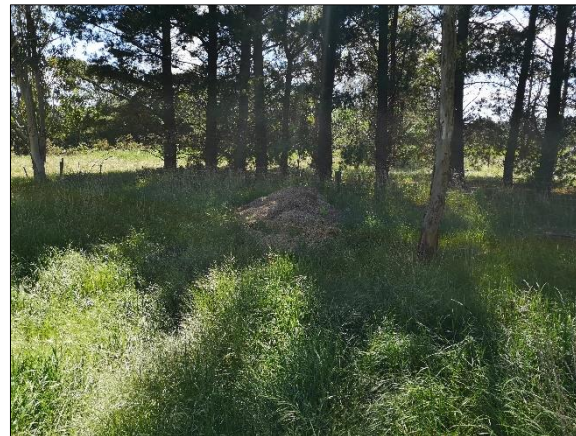
Photo 11: Green waste pile in gum trees northwest corner of the site

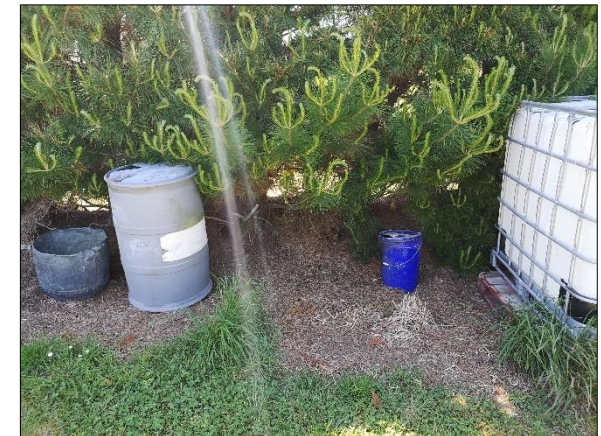
Photo 12: Empty storage containers near sheds
