## Detailed Environmental Site Investigation

3/144 Dunns Crossing

Rolleston

12903.003.000\_92

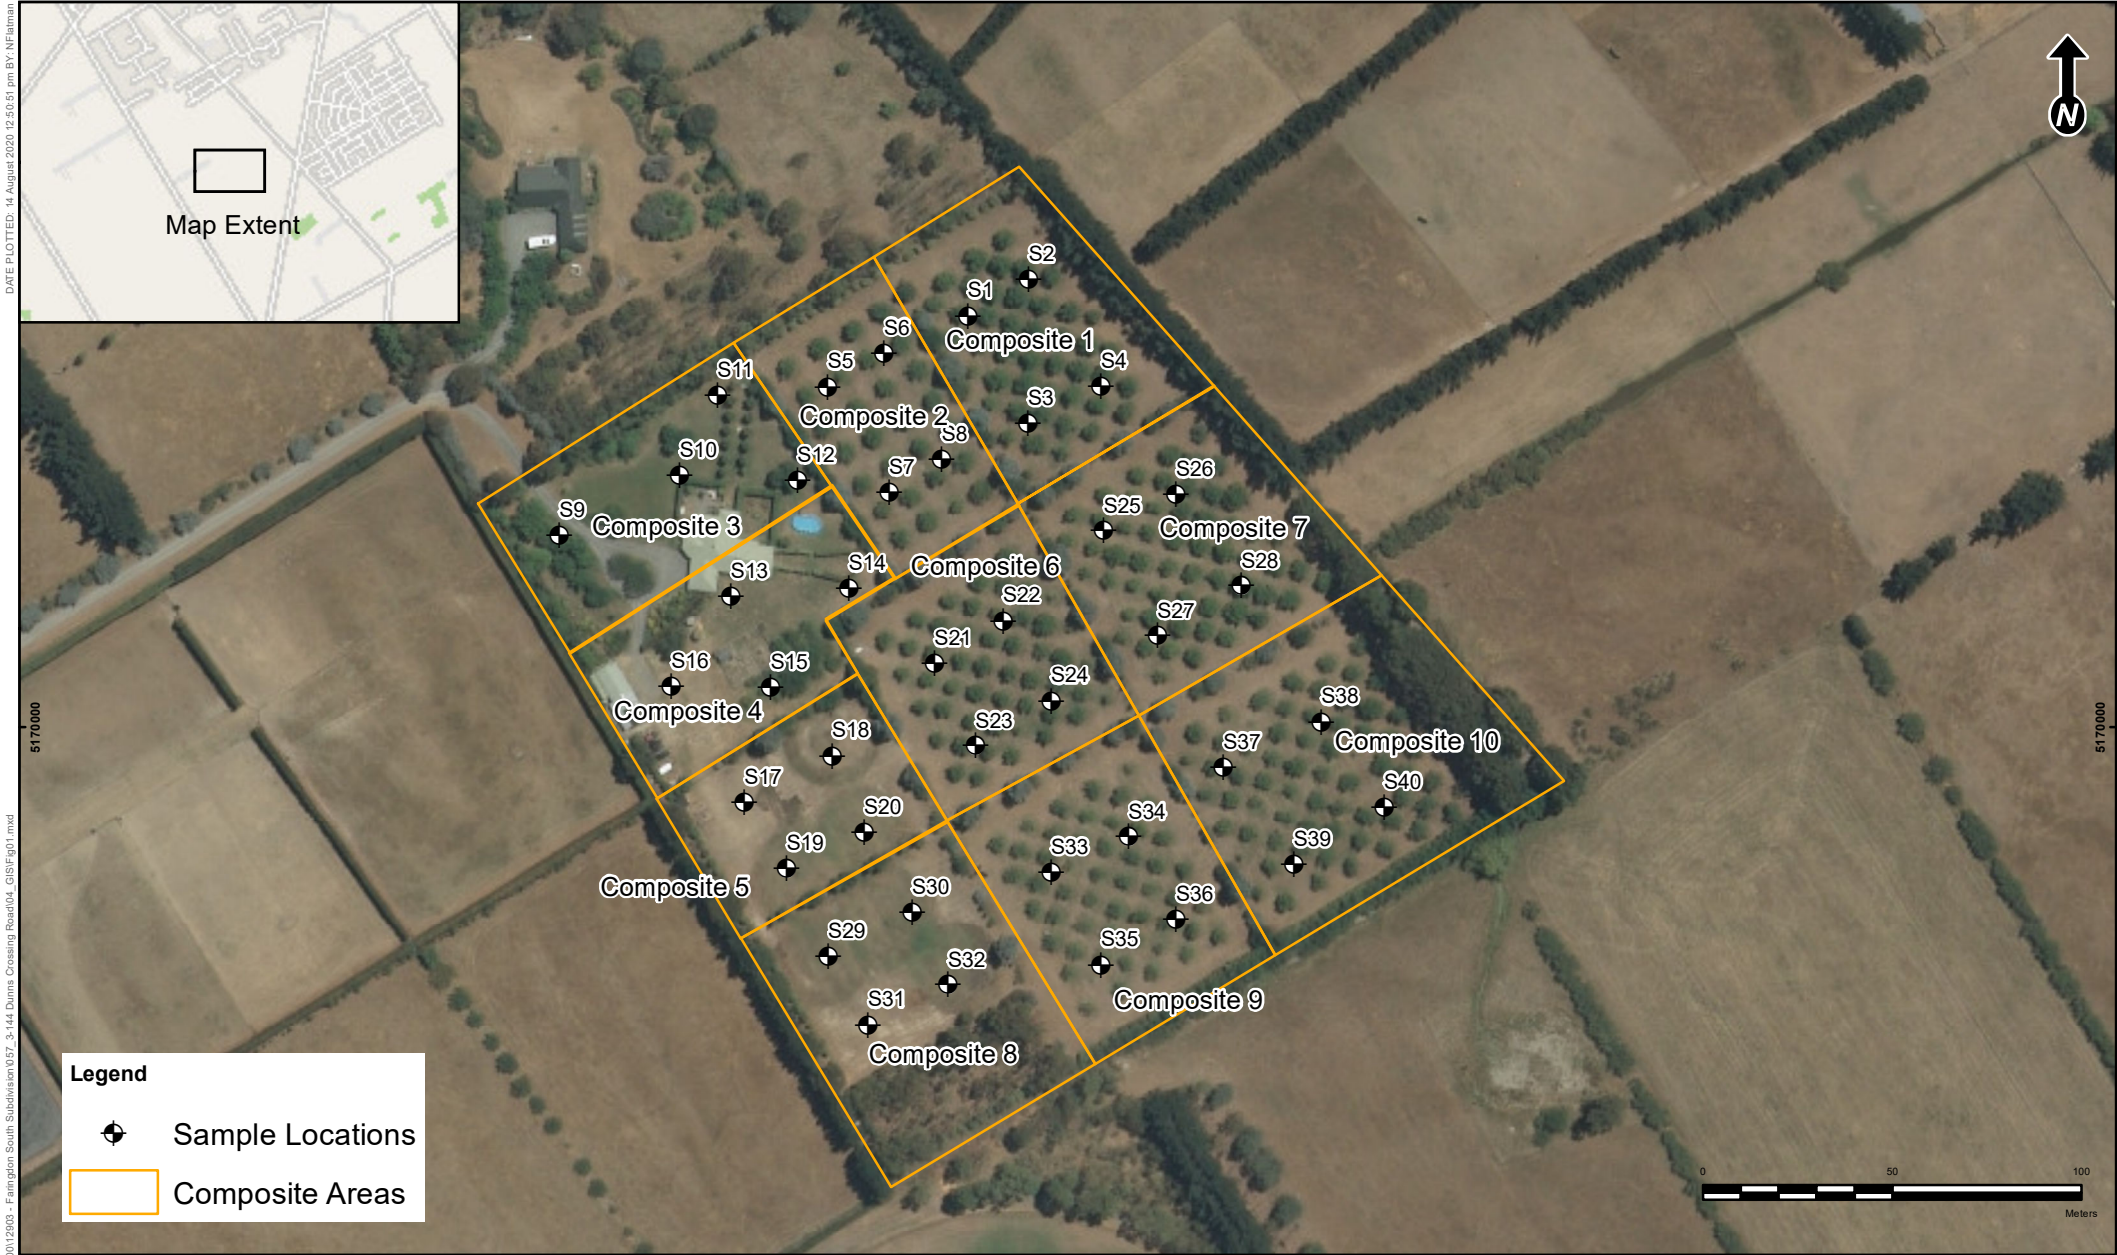
- Collection for 40 discrete soil samples from 0.0-0.3 m depth from across the site. The samples were grouped into 10 separate areas defined by areas of trees. The soil samples were composited in the laboratory into ten, four-point composite soil samples.

One composite sample (Composite 5), made up of four subsamples, returned concentrations of arsenic above the adjusted NES residential 10% land use criteria. The arsenic concentration reported by the laboratory is 6 mg/kg with the adjusted criteria at 5 mg/kg. The same composite sample also reported concentrations of cadmium and lead above the site specific background levels. Although the arsenic exceedances is considered marginal, it is recommended that analysis of the four subsamples comprising Composite 5 is completed to determine the risk to human health and determine potential remediation and disposal options (if required).

Due to the presence of arsenic concentrations above the adopted human health criterion in an isolated area of the site, additional analysis is recommended to determine whether remediation of soils is required for the site to be suitable for the proposed redevelopment.

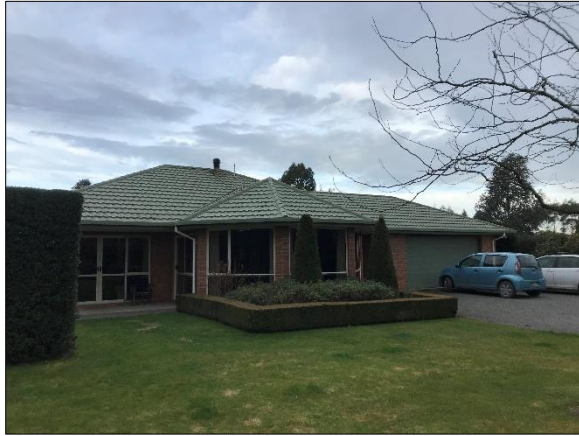
Photo 1: Dwelling

The property file information did not pertain to any asbestos containing materials being used in the construction of the buildings. Because of the age of the buildings (constructed pre-2000) a full asbestos demolition survey is required; this is to ensure that any asbestos materials are identified prior to demolition works so that they can be removed in a safe manner.

If the buildings on-site are to be refurbished or demolished, the presence of asbestos in these buildings should be identified by undertaking full asbestos demolition surveys. If identified on the outside of the buildings in a deteriorated state, the soils surrounding the buildings should also be tested.

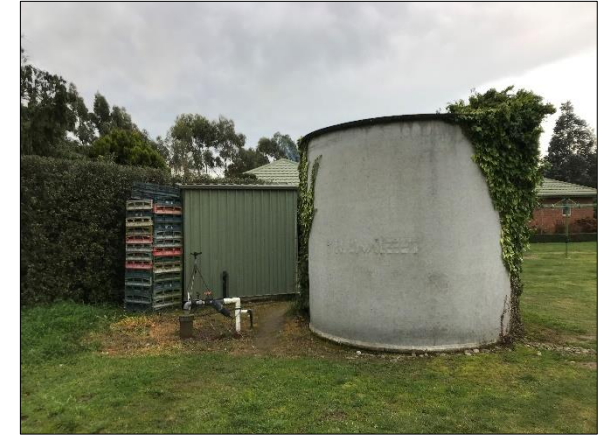
Photo 3: Water tank, well and pumpshed

| Site Conditions | Comments |
|---|---|
| <b>Additional observations</b> | <p>A well, pump shed and water tank were observed to the south of the dwelling.</p> <p>A previous chicken coup area which was constructed from timber fence poles and metal wire was observed to the south of the dwelling. A glasshouse (domestic scale) was observed near the chicken coup along with several plastic bread trays which were used for drying the walnuts.</p> <p>A few empty 100 L plastic drums were observed on the site which were being used for horse jumps. It was confirmed with the site owners that they were brought onto site as empty containers.</p> <p>A wrecked car was observed near the barn along the south-western boundary line. No staining was observed in surface soils below the car.</p> |

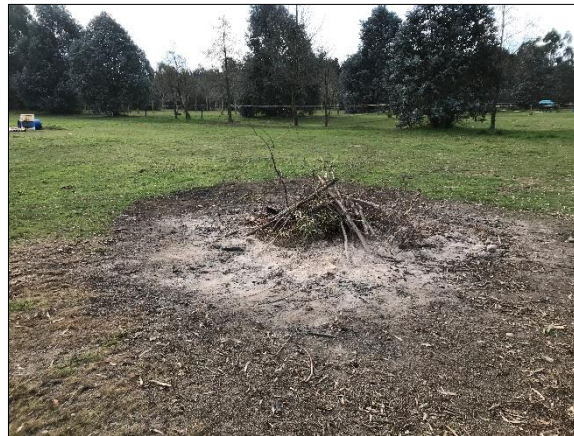
Photo 5: 5. Burnpile 1

| Site Conditions | Comments |
|---|---|
| <b>Visible signs of contamination</b> | <p>Four areas of orchard were observed in the north-eastern section of the site. The walnut trees were planted in rows with eucalyptus trees planted between each area.</p> <p>Three burn piles were observed in the cleared paddocks on the site. The material appeared to be free from any building materials or domestic rubbish. The site owner indicated that the burn piles were used for burning green waste only with no domestic rubbish or treated timber being burnt.</p> <p>The horse corral which was observed in the aerial photograph review was no longer present on site however obvious markings were in the ground from the previous corral ring.</p> |

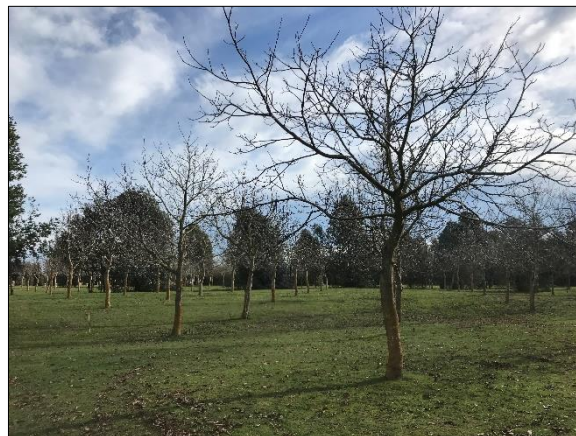
Photo 8: Orchard area

| Potential Source of Contamination | Contaminants of Concern | Possible Extent of Contamination | HAIL Activity as defined by the NES |
|---|---|---|---|
| Orchard – walnut trees | Heavy metals<br>Organochlorine pesticides (OCPs) | The entire site | A10. Persistent pesticide bulk storage or use including sport turfs, market gardens, orchards, glass houses or spray sheds |

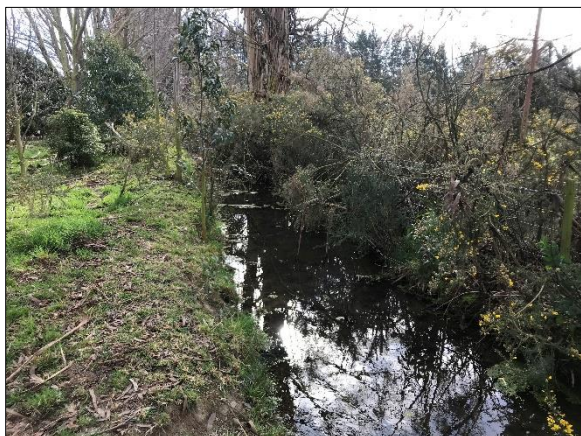
Photo 10: Stream along north-eastern boundary line

| Site Conditions | Comments |
|---|---|
| <b>Surface water appearance</b> | No visual indication of potential contamination such as suspended sediment or sheen was observed in the stream running along the north-eastern boundary. The stream was flowing during the visit. |
