## Detailed Environmental Site Investigation

92 Dunns Crossing Road

Rolleston

16.12.2019

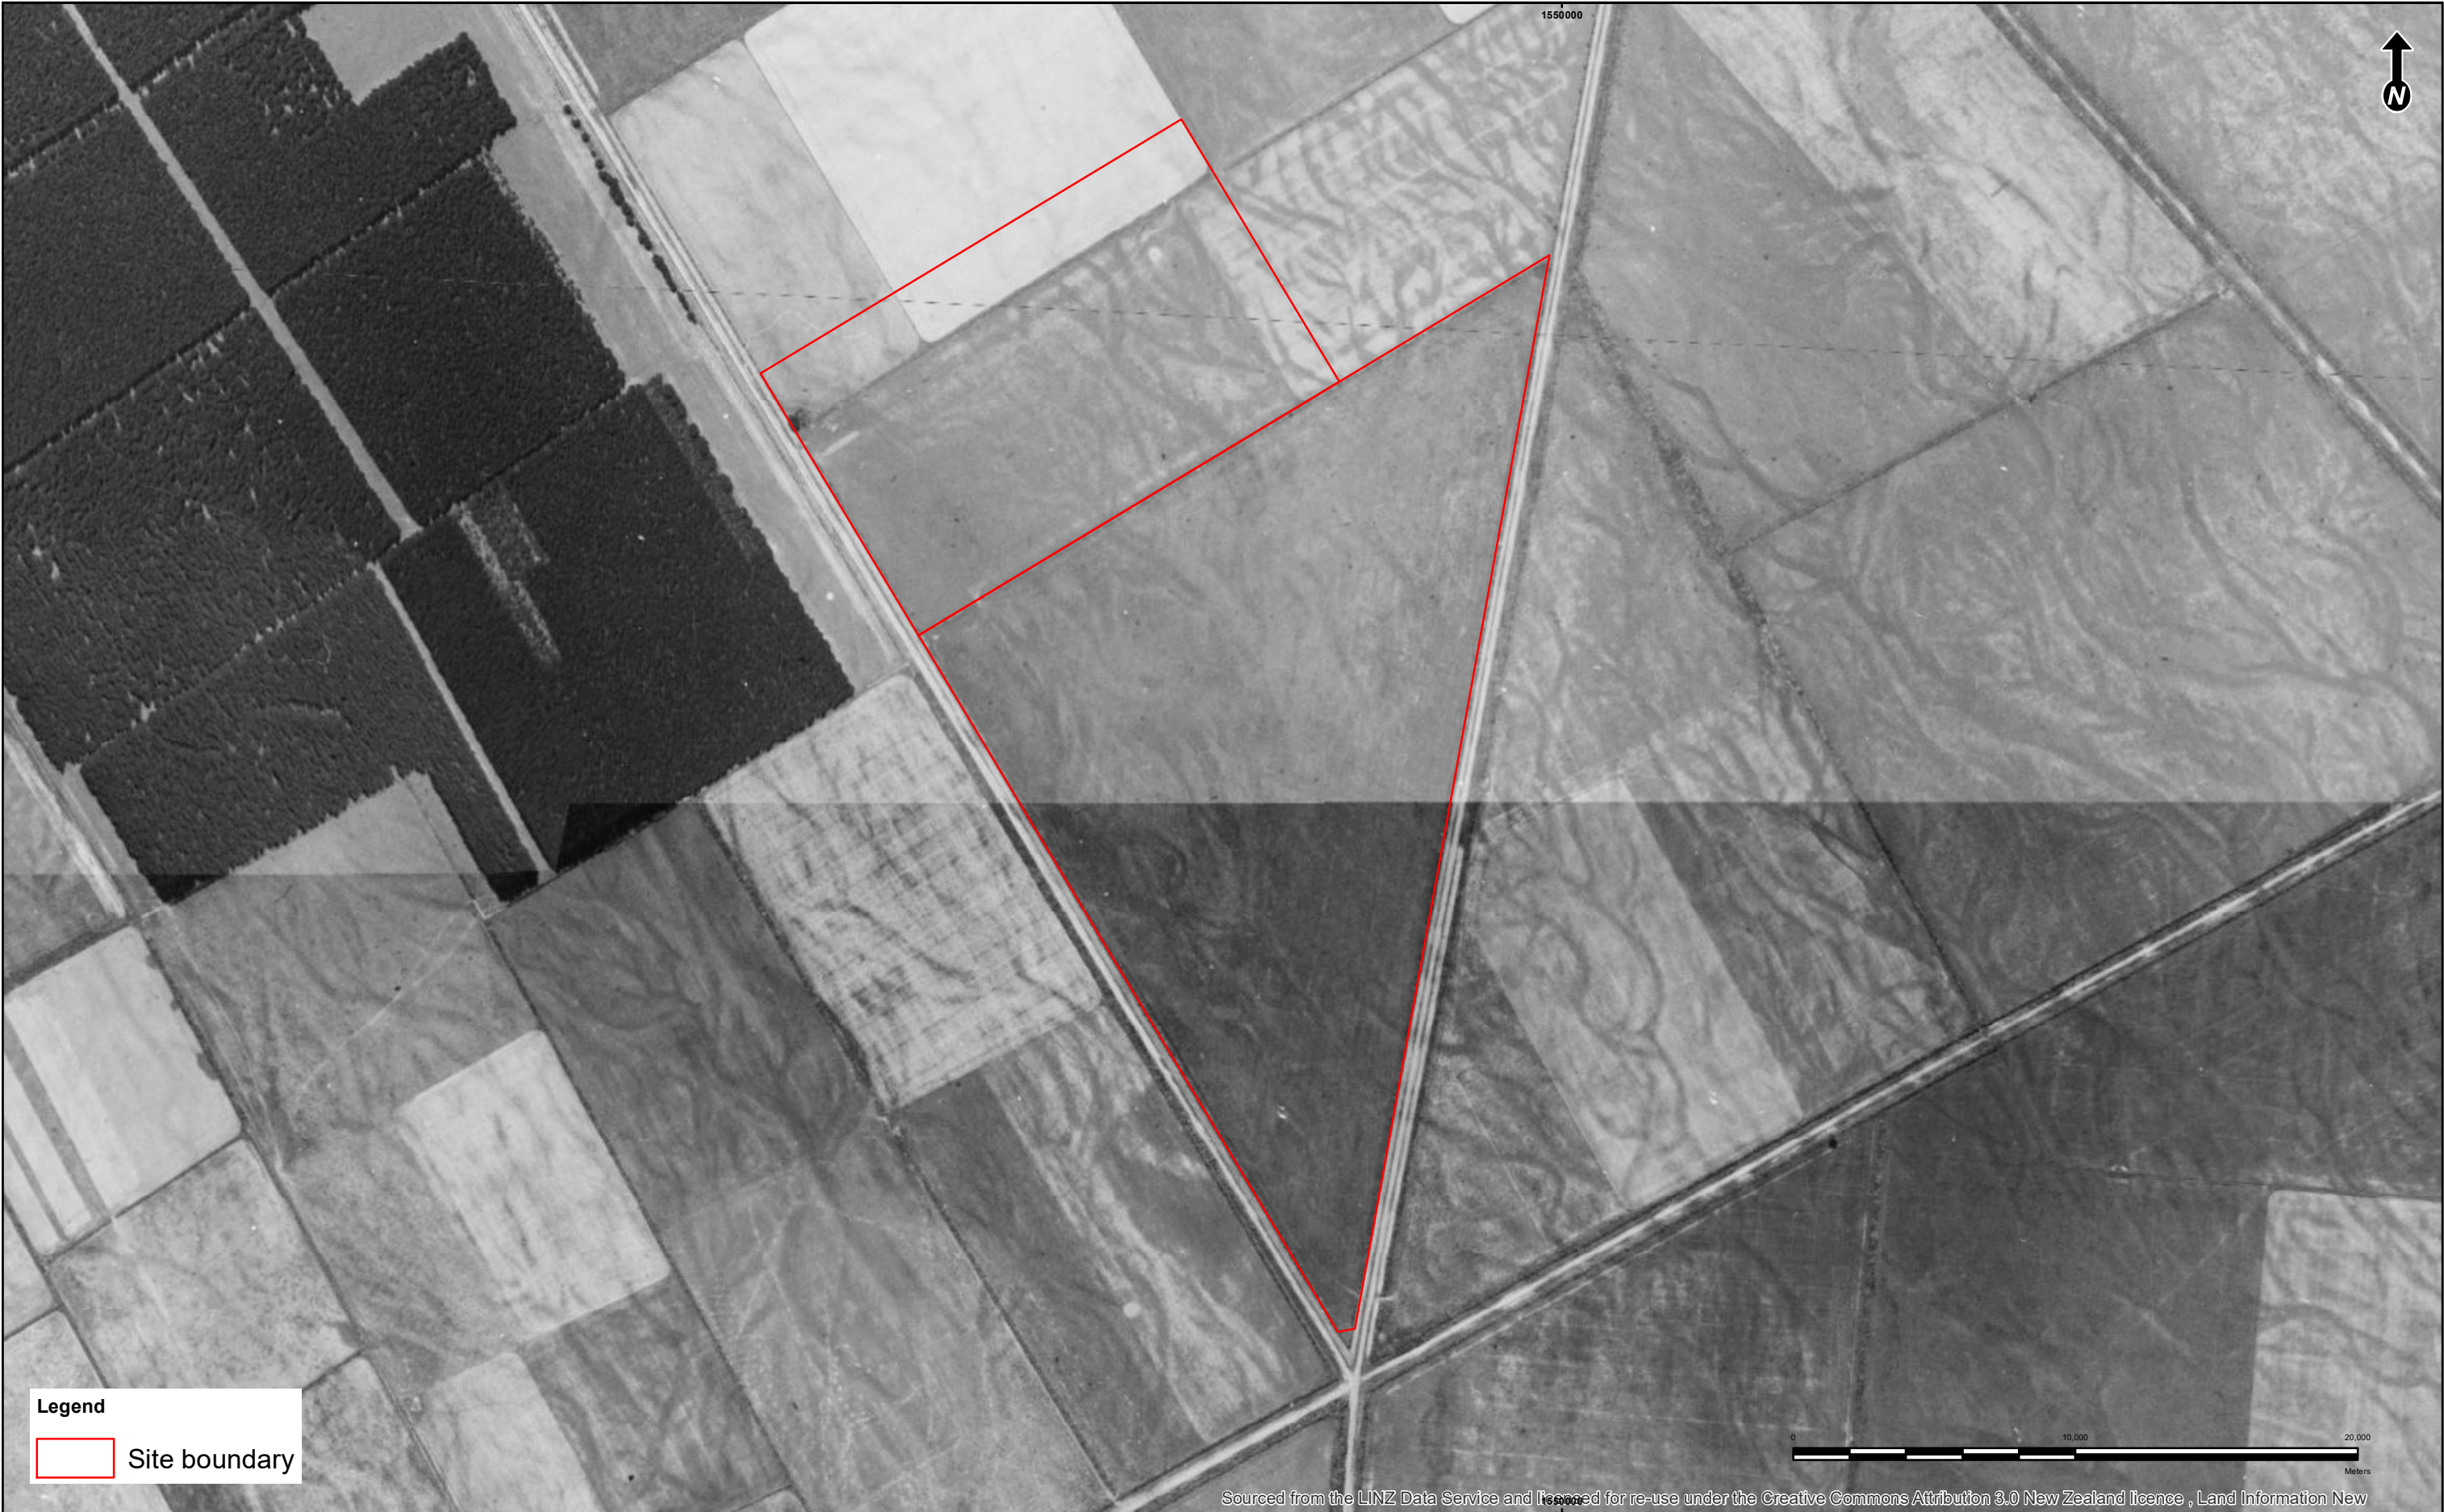
| Date | Figure | Source | Description |
|---|---|---|---|
| 1940-1944 | 1a | Canterbury Maps | <p>The sites are undeveloped and appear to be grassed and presumably used for grazing. A small shed is observed in the western corner of 92 Dunns Crossing Road. Alluvial flow paths are visible across the sites running northwest to southeast.</p> <p>The surrounding areas are also undeveloped to the north, east and south. The land to the west across Dunns Crossing Road is a part of a large forestry block.</p> |

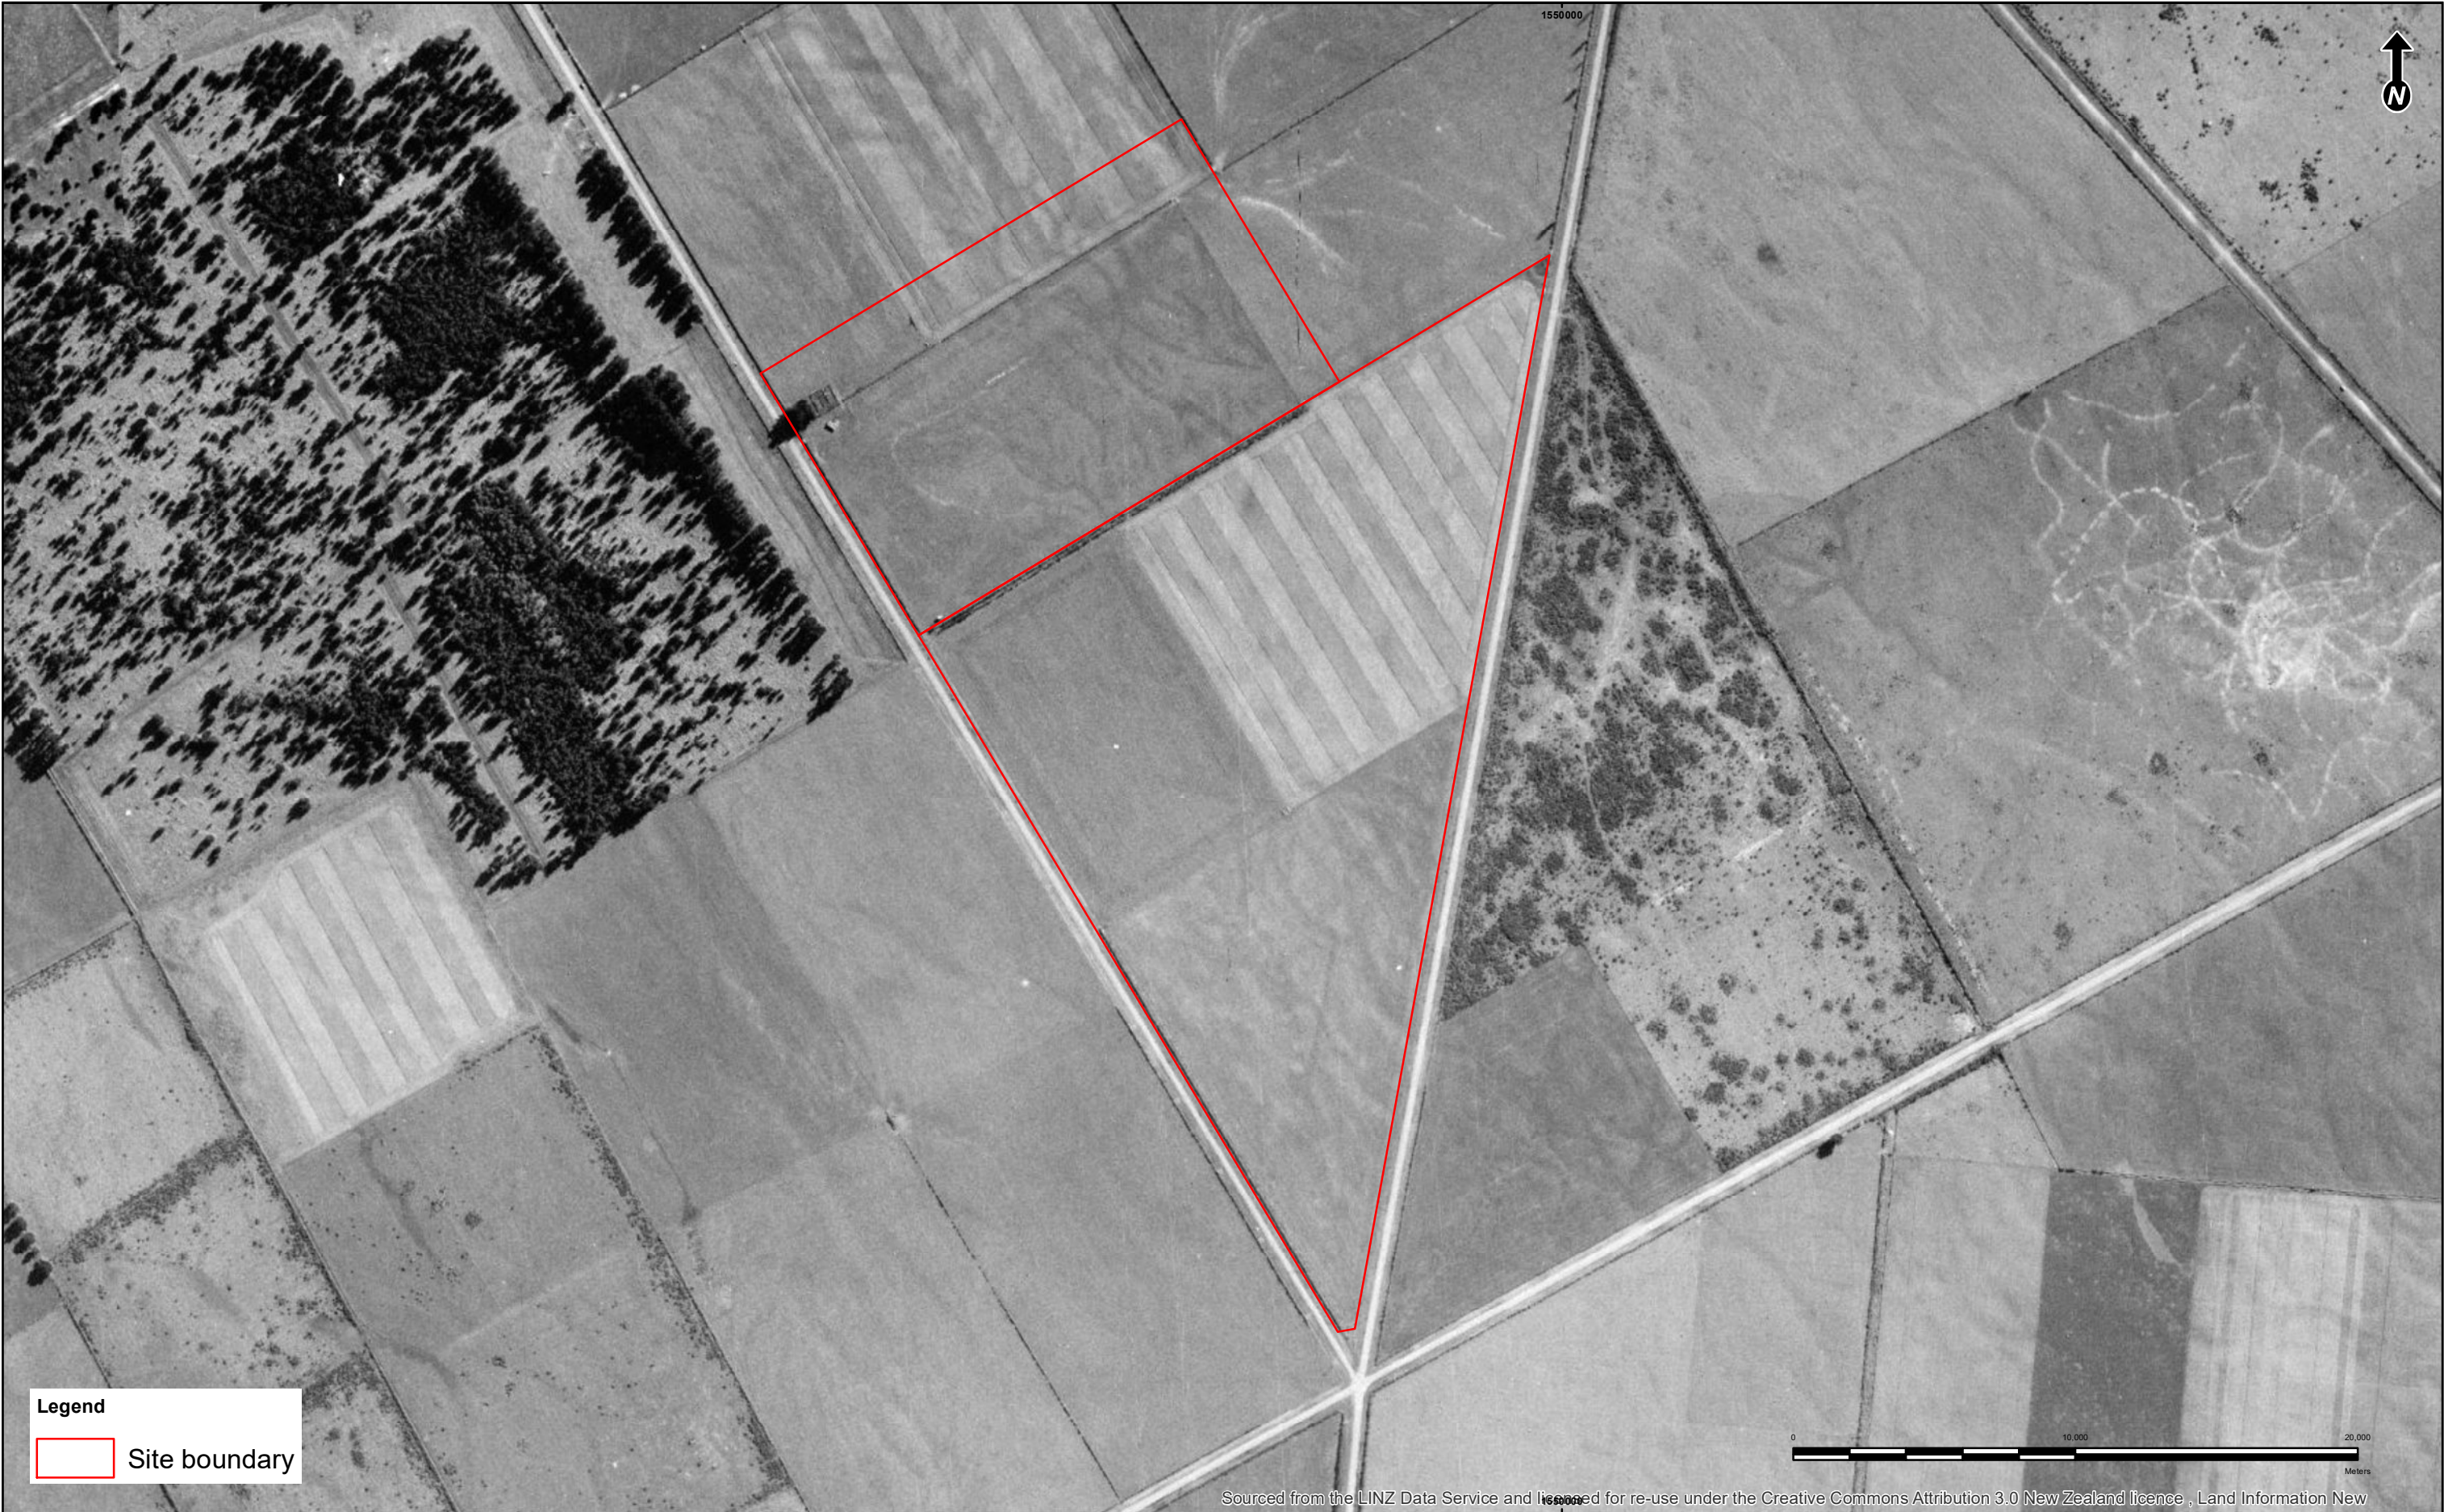
| Date | Figure | Source | Description |
|---|---|---|---|
| 1960-1964 | 1b | Canterbury Maps | <p>A pen or sheep dip is observed just north of the shed in the western corner of 92 Dunns Crossing Road. There is a visible fence line around the shed, which can be seen to feed into the paddock with the pen / sheep dip in it. A large area of the Gould Road site has been planted with crops. A line of vegetation is visible between the Gould Road site and 92 Dunns Crossing Road.</p> <p>The surrounding area remains mainly unchanged. The forestry block across Dunns Crossing Road appears to have been thinned or felled.</p> |

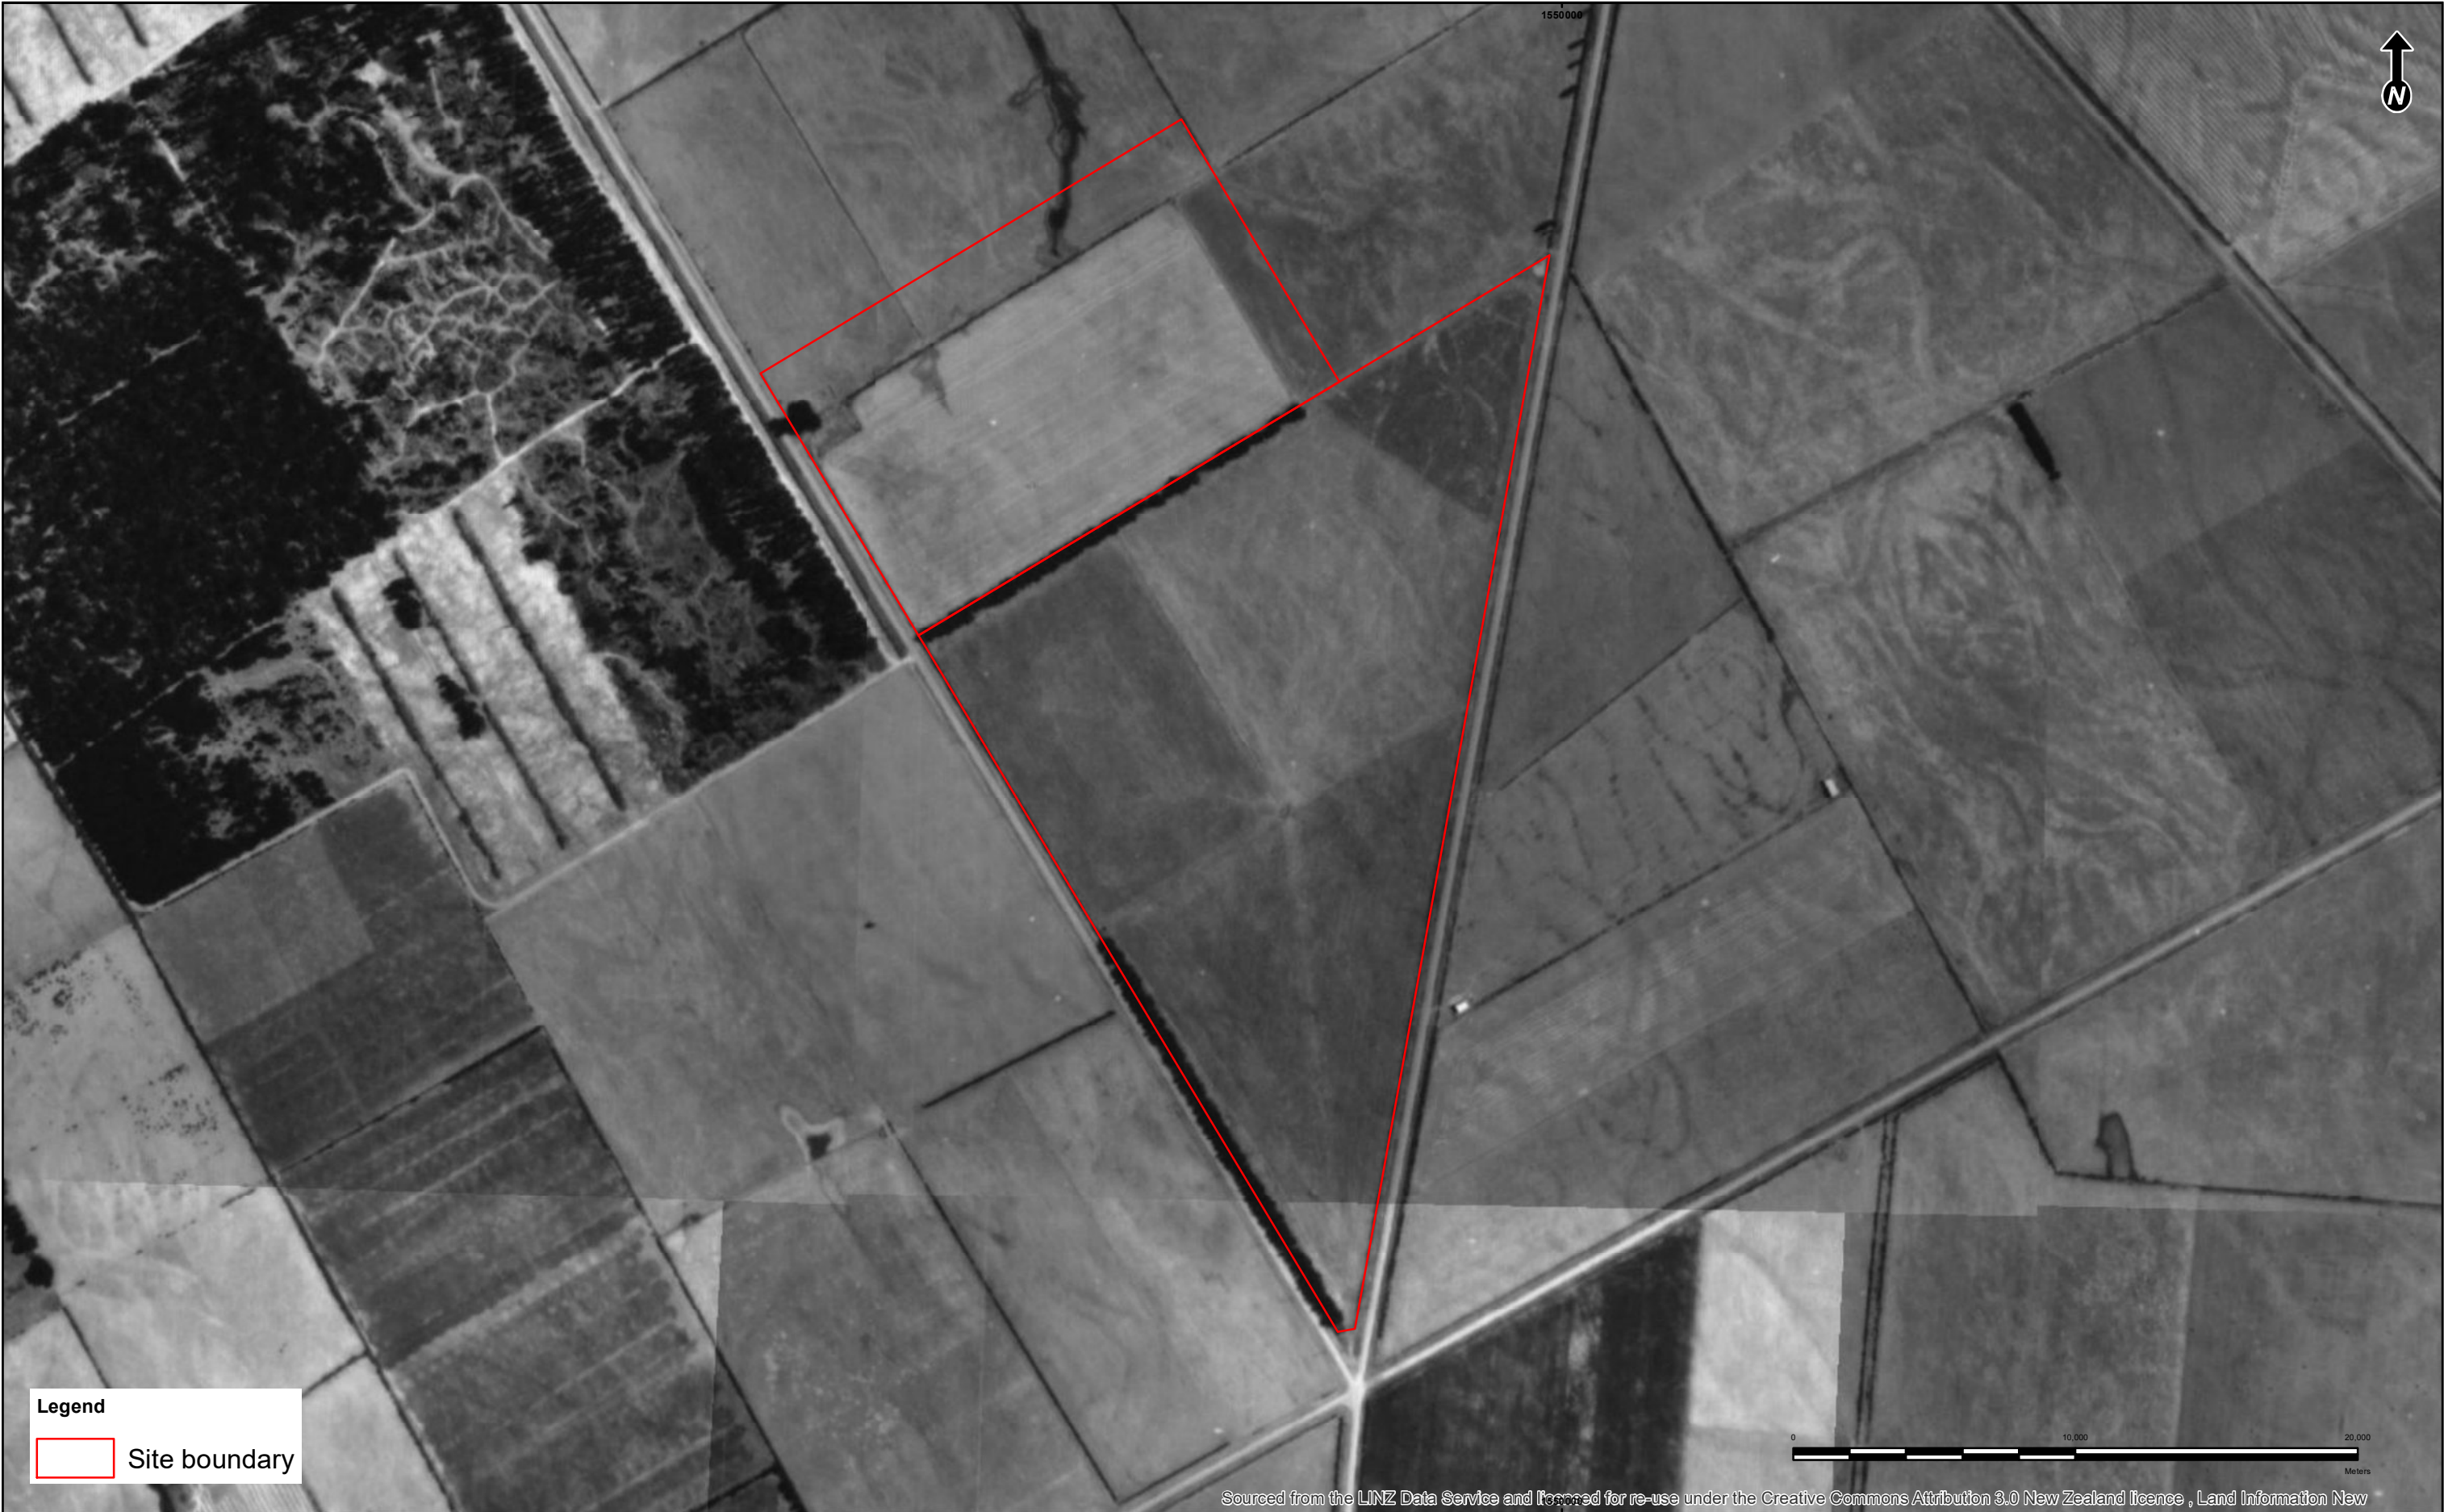
| | <b>Christchurch Office</b><br>124 Montreal Street<br>Sydenham, Christchurch 8023<br>Tel: 03 328 9012<br>www.engeo.co.nz | Title:<br><b>Historical Aerial Photograph - 1980-1984</b> | Aerial: LINZ and Eagle Technology, CC-BY-3.0-NZ.<br>Map image: LINZ NZTopo Series, CC-BY-3.0-NZ. | | Client: <b>Hughes Developments Ltd</b> | | Figure No: |

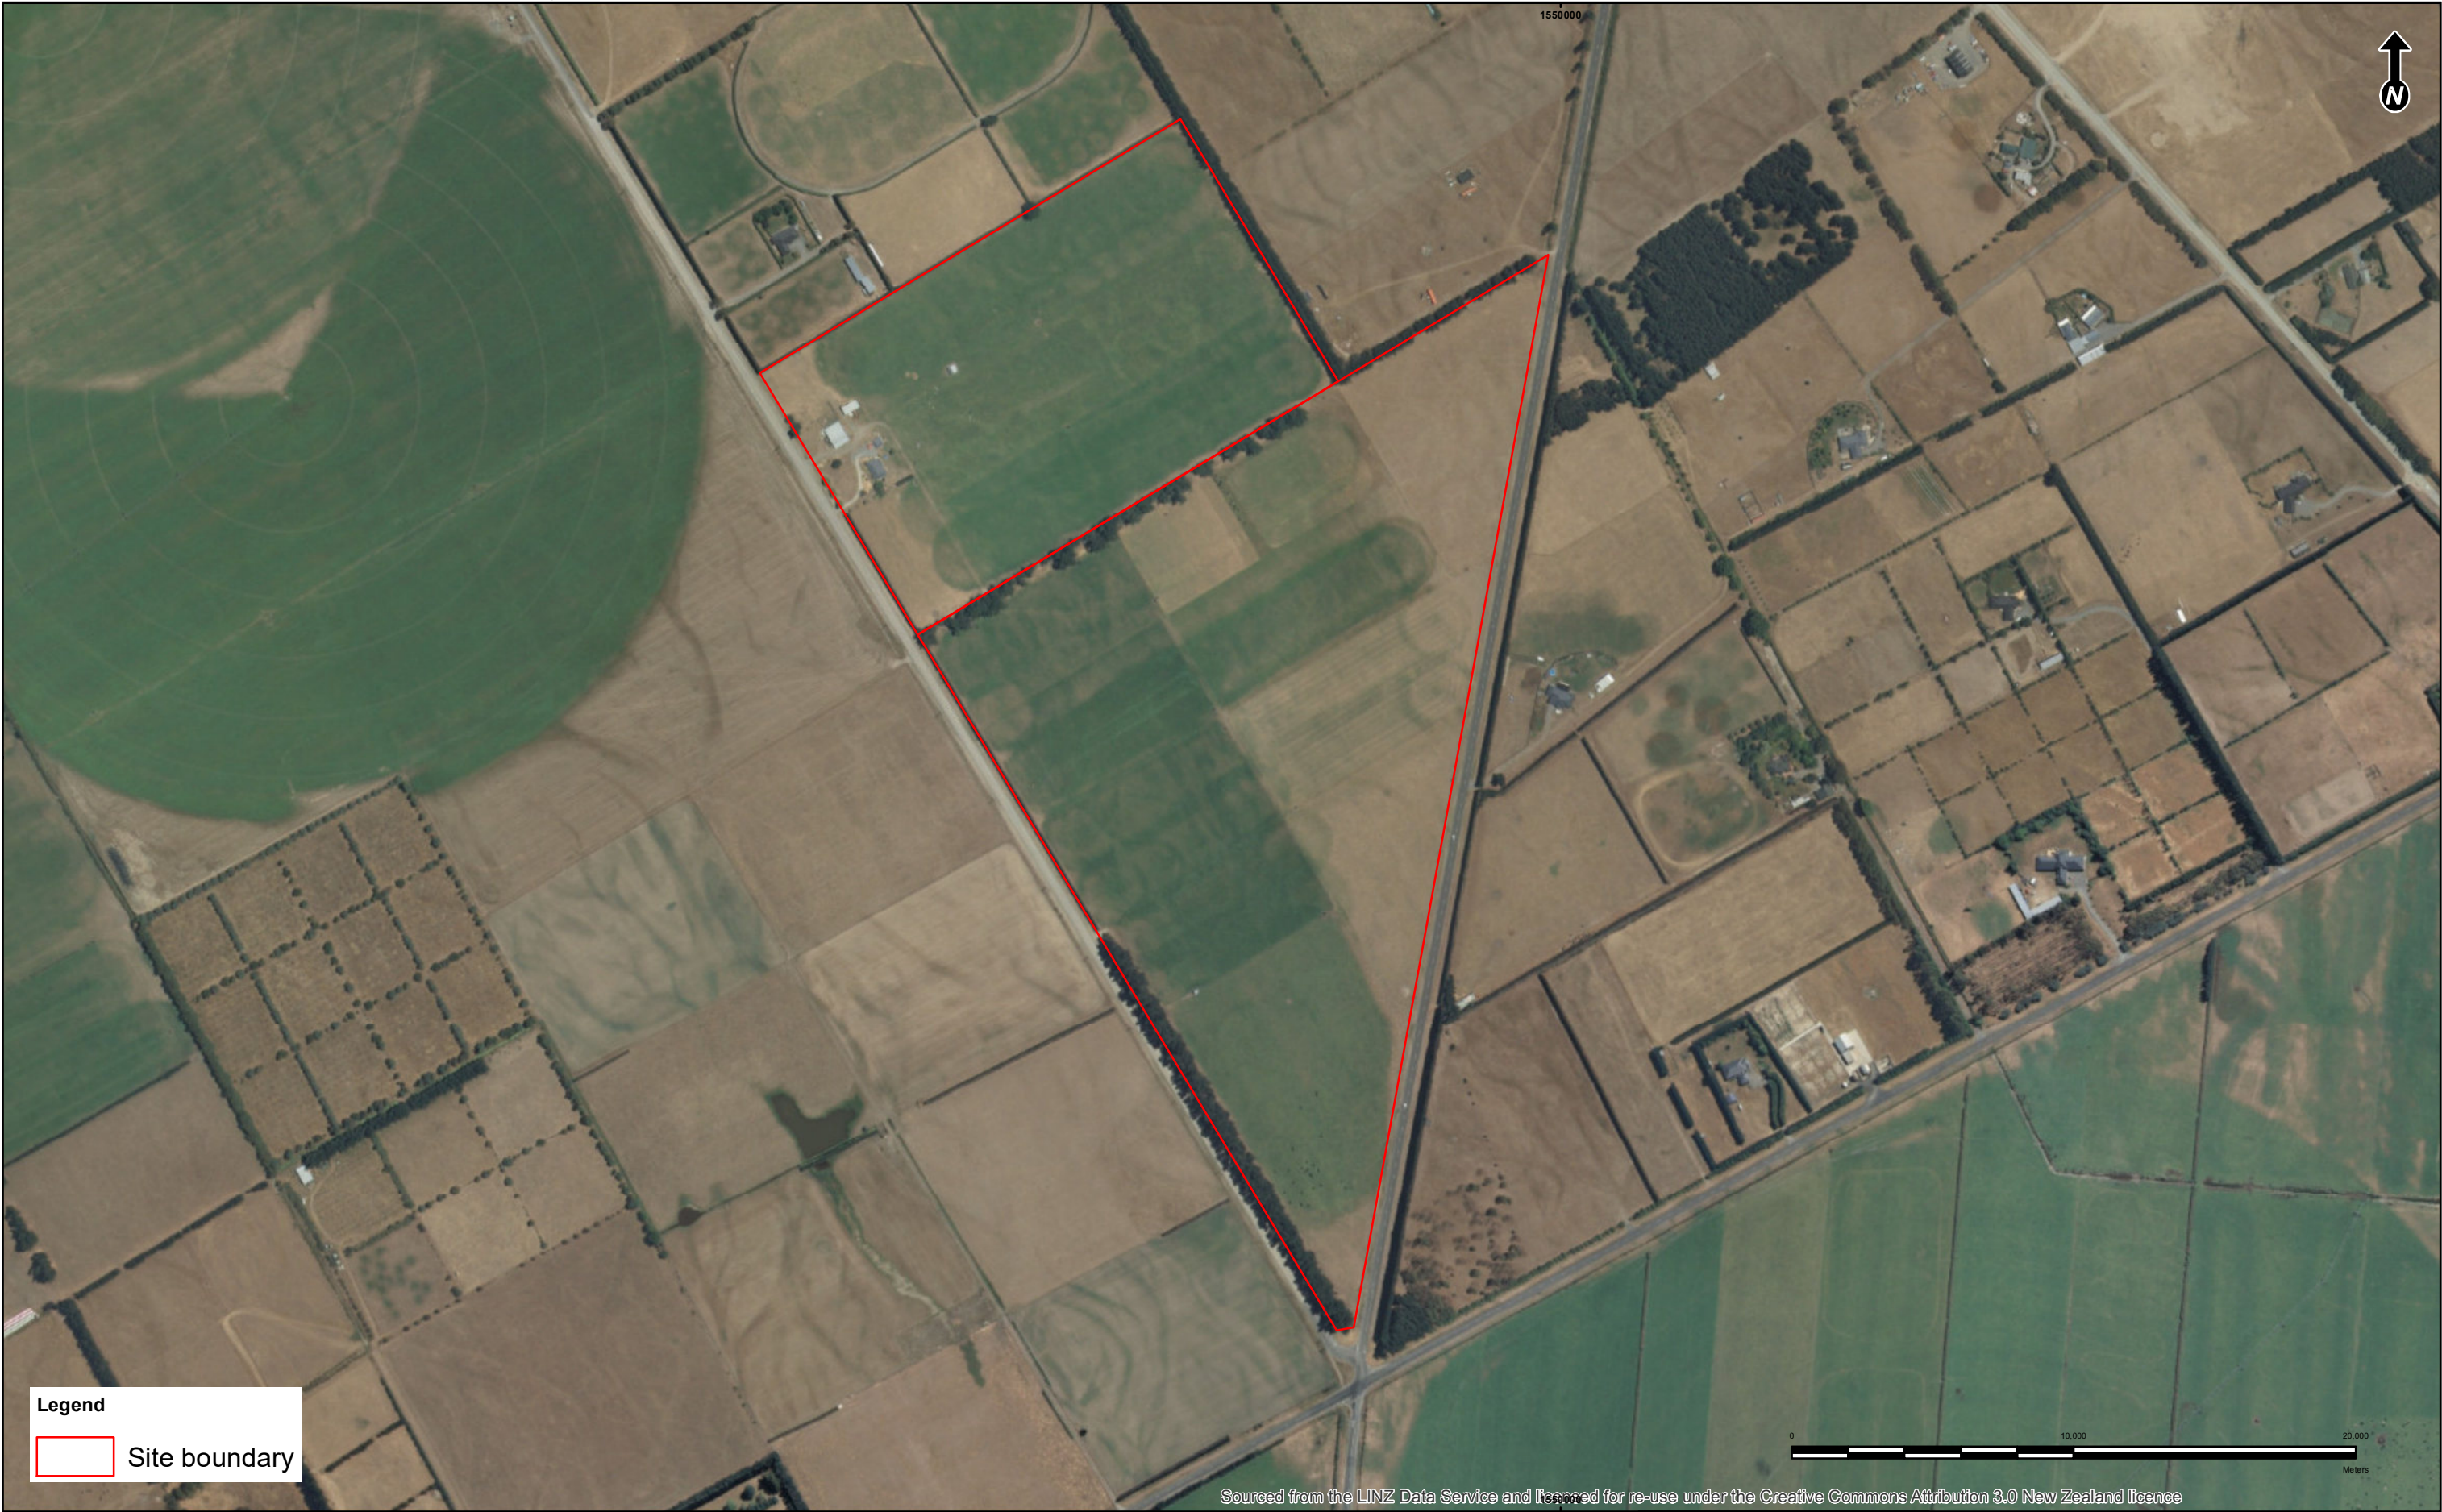
| Date | Figure | Source | Description |
|---|---|---|---|
| 2010-2015 | 1g | Canterbury Maps | <p>Another shed has been constructed to the east of the newly constructed shed observed in the 2000-2004 photograph. A small glasshouse is observed near a vegetable garage to the east of the dwelling.</p> <p>The surrounding areas from the sites remain mainly unchanged.</p> |

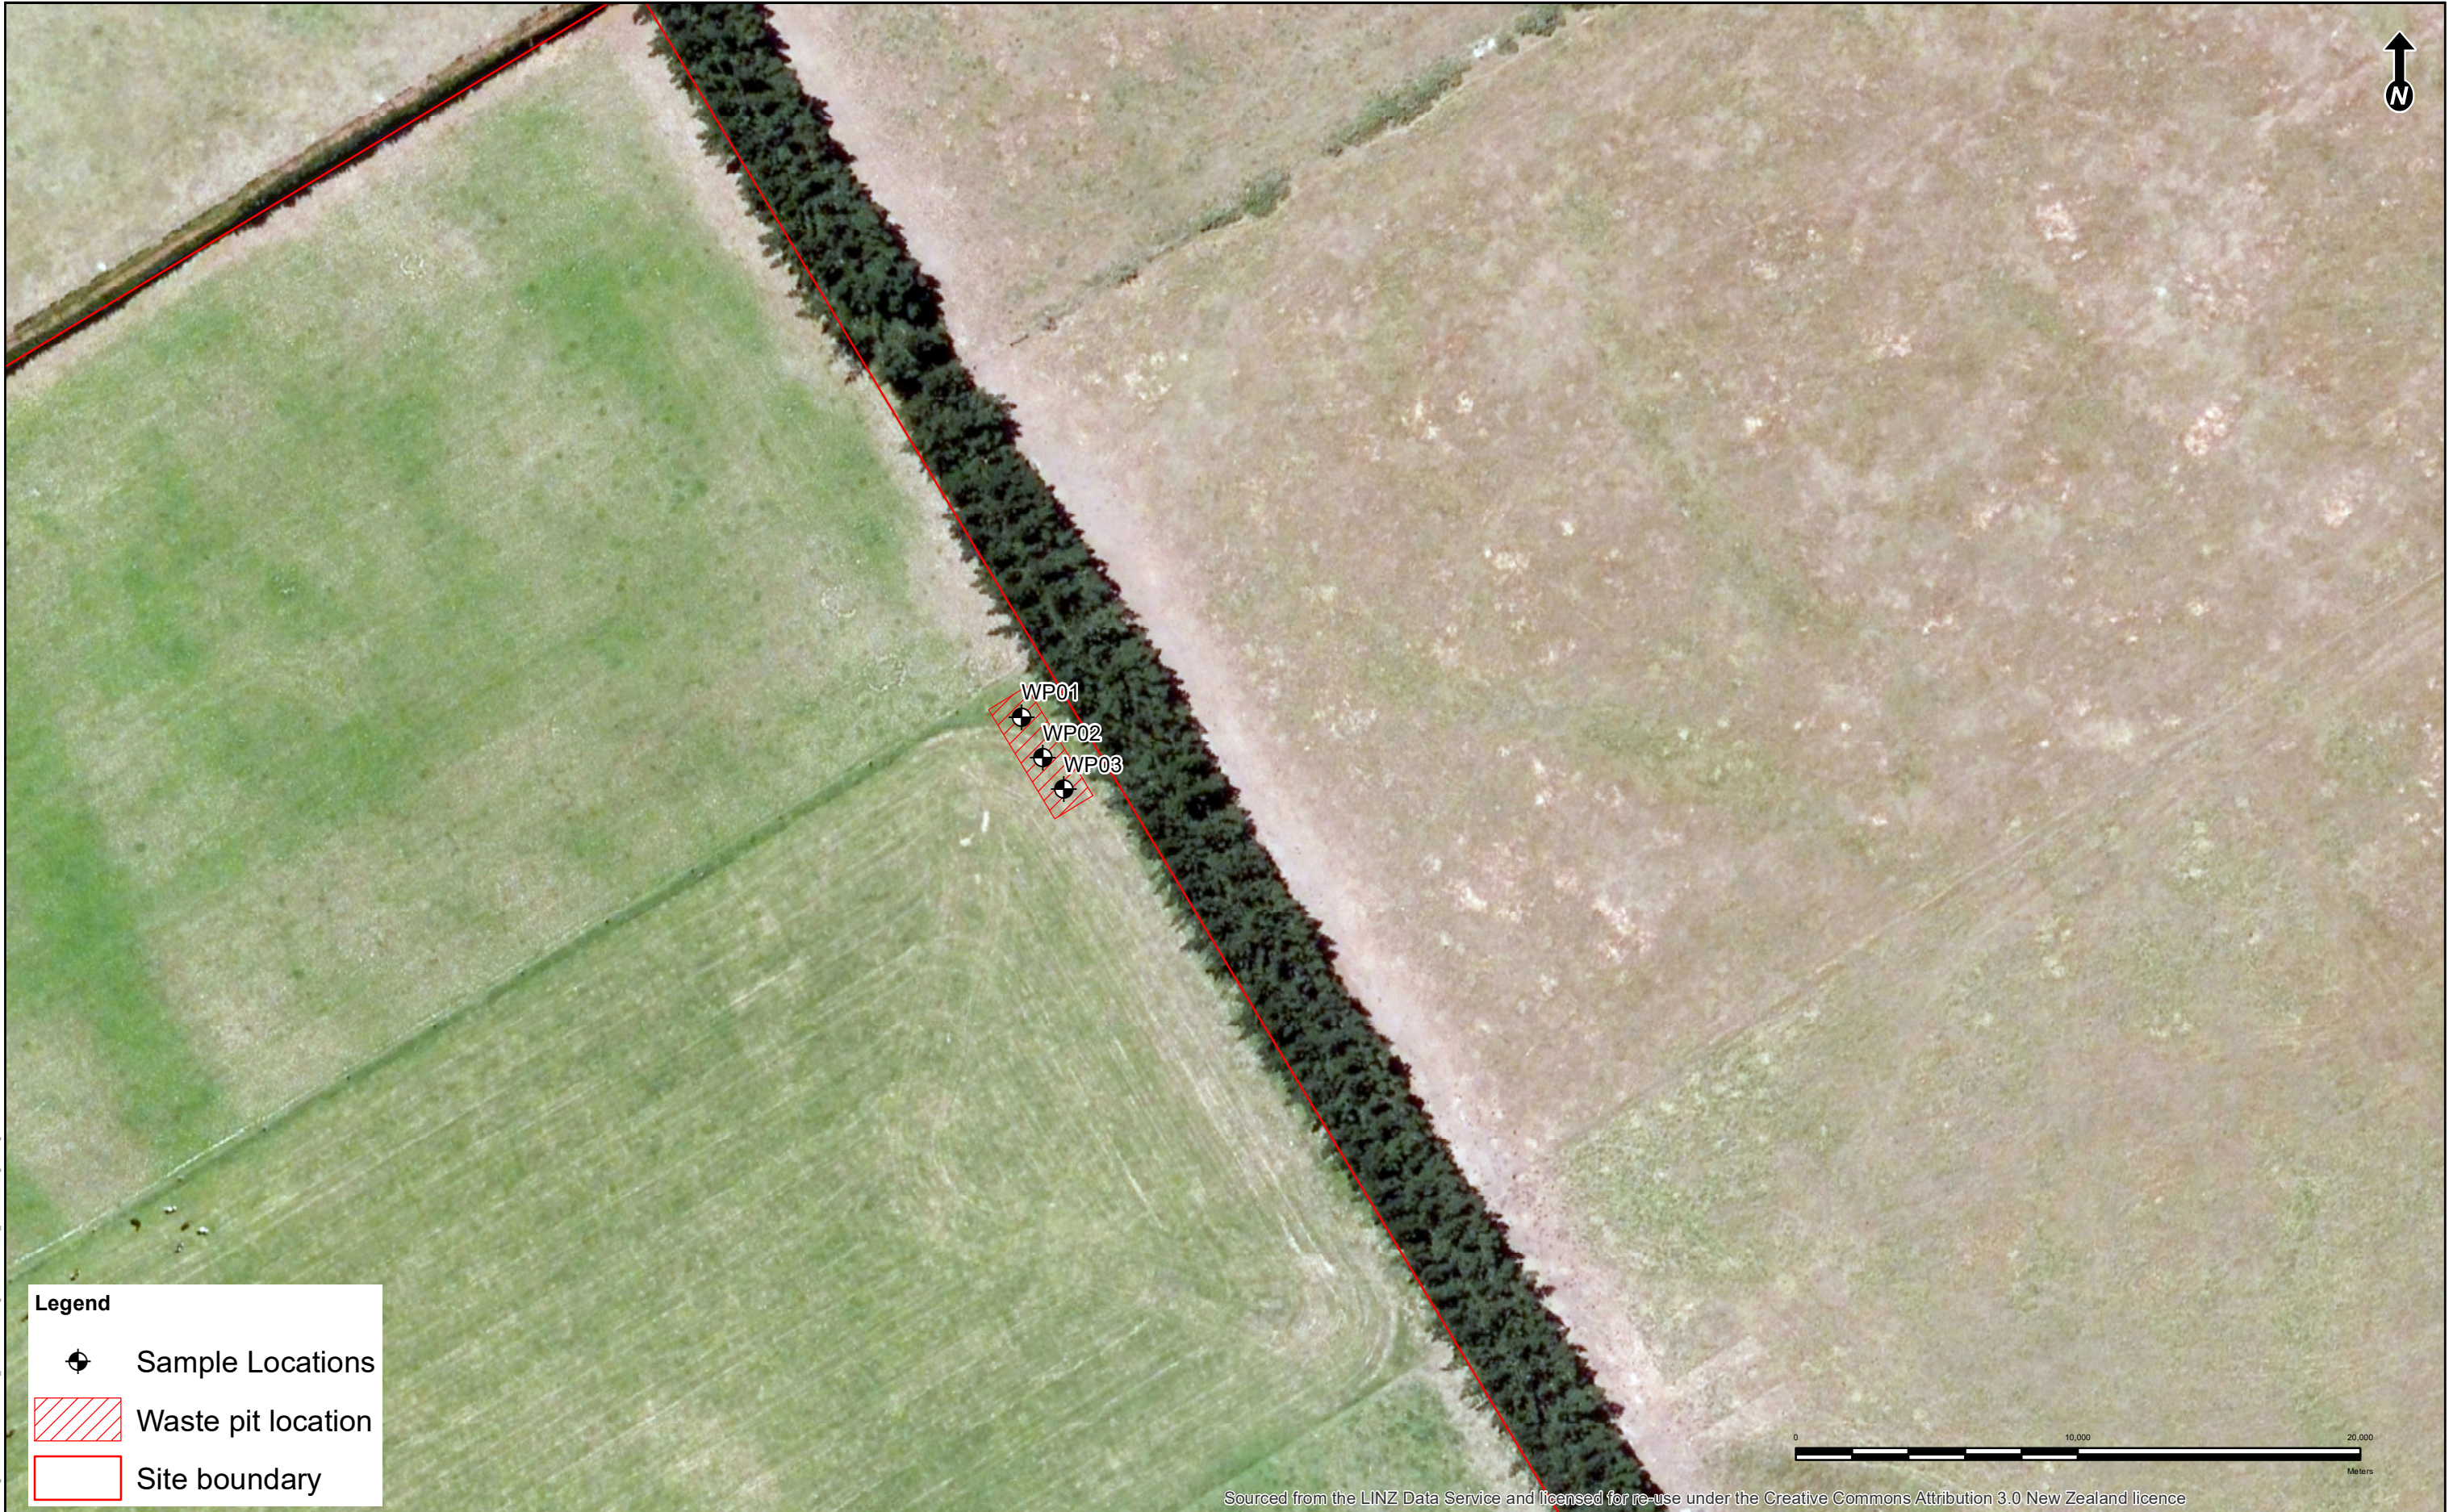
| Figure 2: | Sampling Location Plan |

Eight samples were collected from around the former sheep dip area and storage shed from the surface soils (0.0-0.2 m below ground level). One sample (HA08) returned concentrations of lead above the NES residential land use criteria. Several other samples analysed from the sheep dip area returned concentrations of heavy metals above the site-specific regional background criteria. DDT was detected in HA05 and HA06 but was still below the NES human health residential criteria. Additional samples (HA09-HA16) have been collected from around HA08 to assess the extent of the lead impact; all of these samples were below the NES human health criteria for residential land use. These locations are included on Figure 2.

- Sample Locations
- Waste pit location
- Site boundary

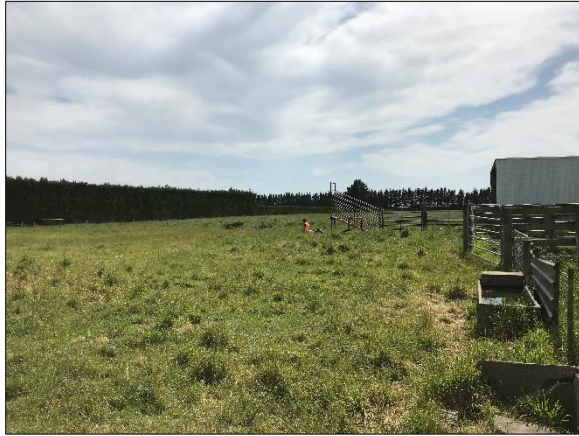
Photo 1: Area of former sheep dip

The Canterbury Regional Council's Listed Land Use Register identified HAIL activity A8. *Livestock dip or spray race operations* as being on the sites. The sheep dip area was identified during a Selwyn District Council historical aerial photograph review. The property file for the sites was viewed at Selwyn District Council, and contained no information related to potentially hazardous activities having occurred at the sites.

Based on the current results, remediation of the soils in the areas of the burn drum, former sheep dip, waste pit and AGST should be undertaken. Works should be detailed in a Remedial Action Plan (RAP) which will also include the procedures for the handling, management and disposal of contaminated soils. Following remediation, a validation report will be required to indicate the sites are suitable for their intended end use.

Soils from the burn drum, sheep dip and AGST areas should be removed and properly disposed of prior to the redevelopment of the sites and remaining soils validated. The removal of these areas would be considered a permitted activity under Regulation 8(3) of Resource Management (National Environmental Standard for Assessing and Managing Contaminants in Soil to Protect Human Health) Regulation 2011 due to the small volume to be removed.

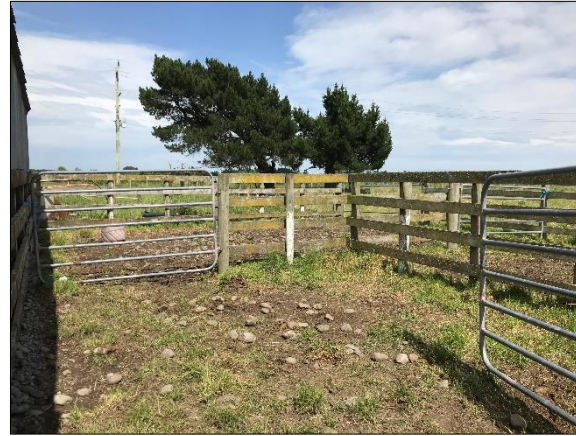
Photo 2: Stock loading - holding pen

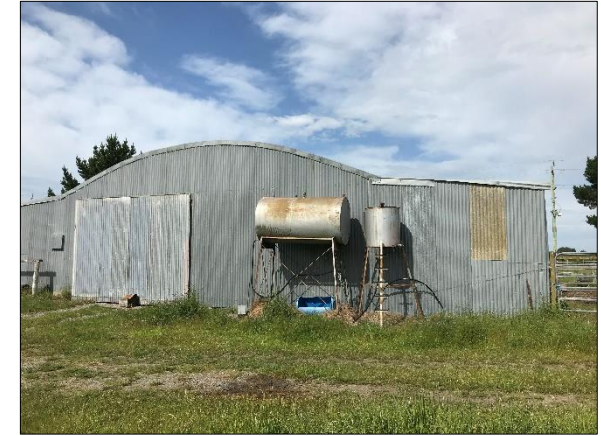
Photo 3: 1000 L above ground storage tank near large barn

| Site Conditions | Comments |
|---|---|
| <b>Additional observations</b> | <p>A 1000 L above ground storage tank was observed to the north of the large barn near the dwelling.</p> <p>A 100 L metal drum was observed to the south of the dwelling. The drum contained cardboard waste and there was visible ashy material spilling from the bottom of the drum.</p> <p>A large (10 m long, 3 m wide and 1.5 m deep) waste pit was observed along the eastern boundary line at 92 Dunns Crossing Road. Please refer to Section 7.1 for additional information for the waste pit.</p> <p>A large radio tower was observed in the eastern corner of the Goulds Road property.</p> |

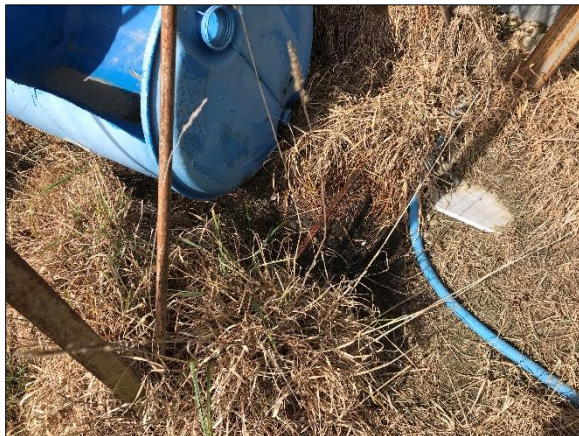
Photo 4: Staining below above ground storage tank

| Site Conditions | Comments |
|---|---|
| Visible signs of contamination | A small area of soil staining was present below a 1000 L above ground storage tank (diesel). |

Ash and charcoal material was observed in the sample collected from the burn drum. The soil collected from beneath the AST was visually stained a black colour and smelt of diesel.

One soil sample (SS01) was collected from stained material below the AST. The total petroleum hydrocarbon results for C10-C14 were reported above the NES human health criteria for residential land use in silty sand soil types. The sample SS01 also reported elevated heavy metal concentrations against the regional background levels.

The soils from the waste pit are suitable for disposal at Kate Valley Landfill as asbestos contaminated waste. The soils from the above ground storage tank and burn drum should be checked with Kate Valley to assess whether they will accept these soils. Additional TCLP analysis may be required to be undertaken.

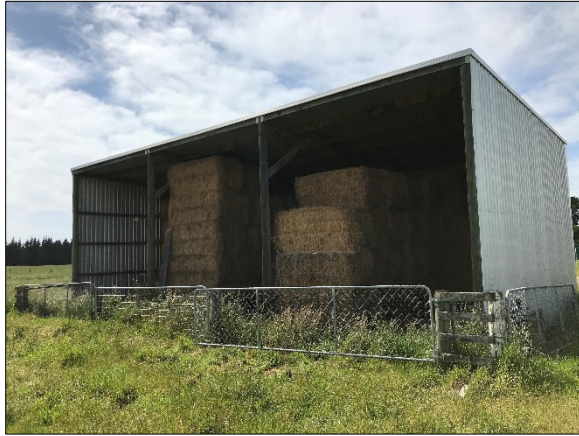
Photo 7: Barn towards the north of the sheep dip area

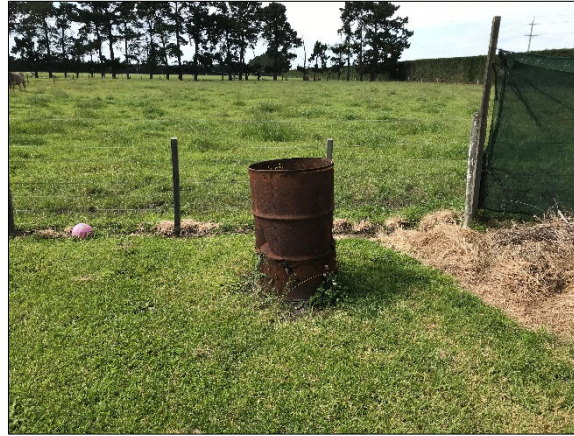
Photo 8: Drum with burnt material to the east of the dwelling

One sample (SS02) was collected from the burn pile to the east of the house. The analysis reports that arsenic, cadmium and chromium are above the NES human health residential criteria and arsenic is also above the NES commercial / industrial outdoor worker human health criteria. All heavy metals were reported as being above the site-specific background criteria.

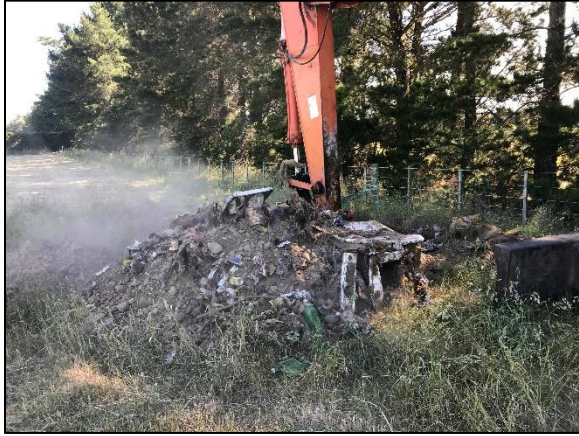
Photo 13: Waste pit along eastern boundary at 92 Dunns Crossing Road

The current owner of the sites was interviewed as a part of the investigation. Mr Robertson stated that when he purchased the property a waste pit was visible along the eastern boundary line of 92 Dunns Crossing Road. He also stated that the only storage tank was the above ground storage tank (AGST) near the large barn at 92 Dunns Crossing Road. During the site walkover, a small burn drum was observed to the south of the dwelling which had ashy material spilling from the drum onto the underlying soils.

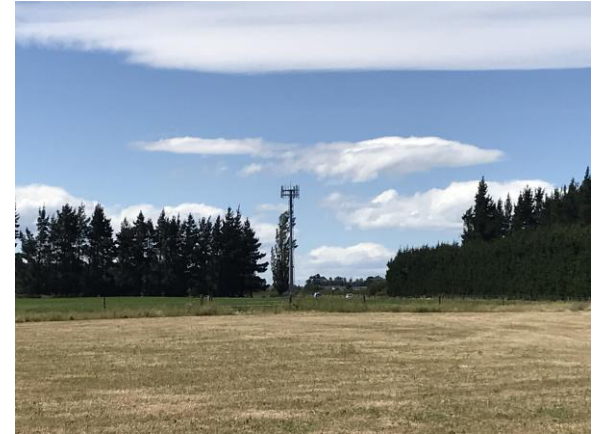
Photo 18: Radio tower in eastern paddock at Goulds Road Site
