Ref: 65157

Subject: 470-476 Great South Road and 2 & 8 Gatland Road, Papakura - Freshwater Constraints

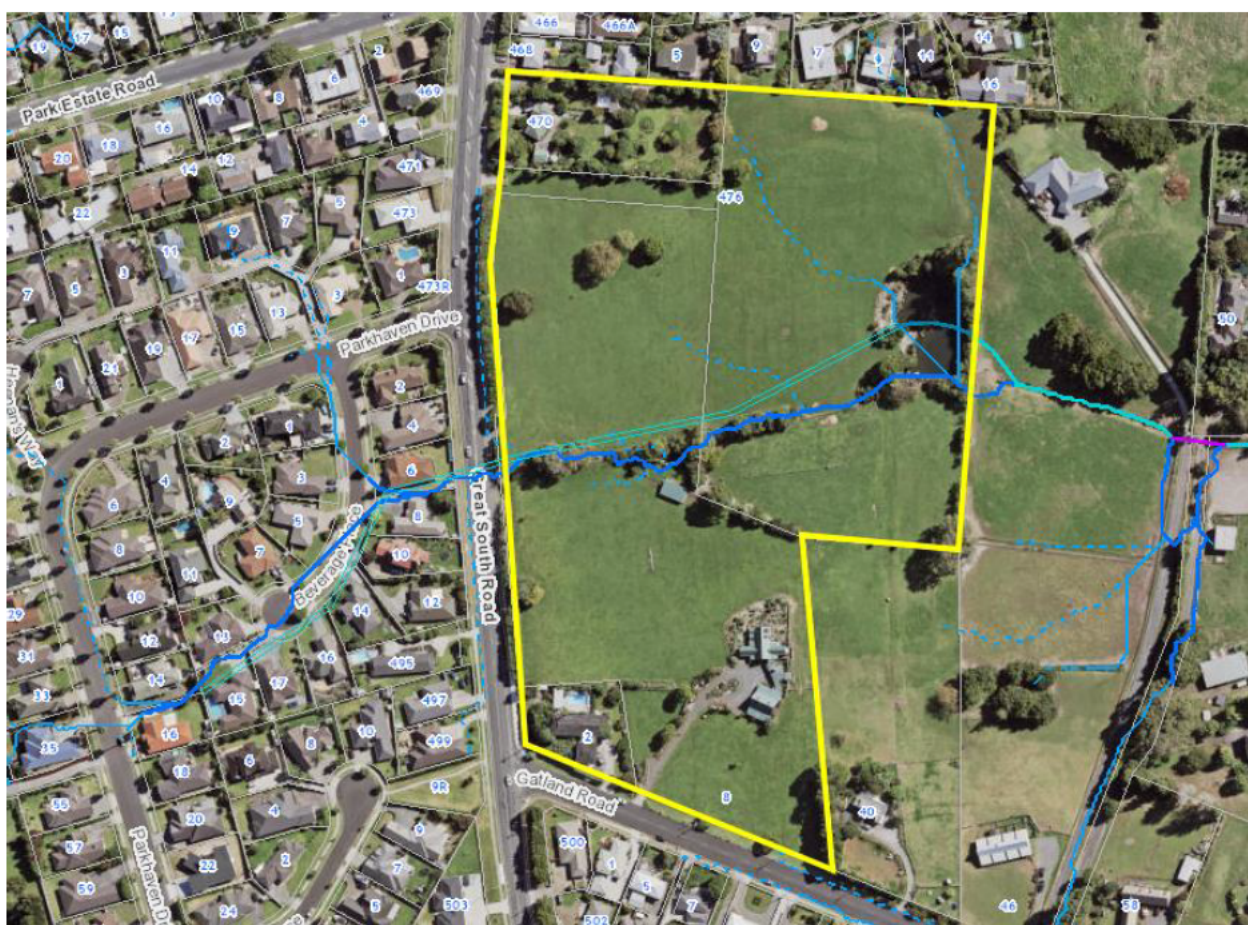
Figure 1. 470-476 Great South Road and 2 & 8 Gatland Road, Papakura – Auckland Council GeoMaps with Streams and Overland Flow Paths Overlay.

No streams or natural wetlands were present on site. The main flow path through the site has been piped and is clearly marked as piped in the Auckland Council GeoMaps overlays (Figure 1 and Figure 3).

The adjacent properties were assessed by desk-top analysis and boundary assessments. No natural wetlands were observed. The northern and western boundaries are fully urbanised with roading and housing (Figure 1). The upper eastern boundary is a lifestyle block with grassed lawn and the lower eastern boundary and south boundaries are pasture used for thoroughbred horses (a land use that is not associated with wetlands or boggy ground). (Photo 8).

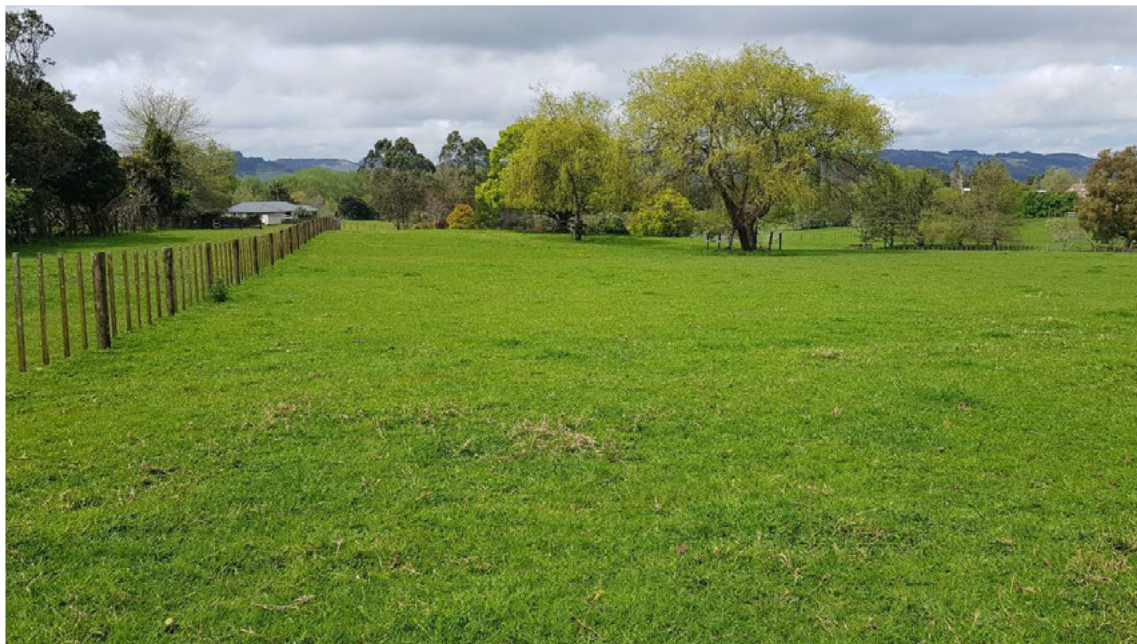
Photo 1. General aspect of north-western part of site from elevated point, view east towards the pond (trees in background).

The site is a pastoral site and is actively farmed (Photo 1 and Photo 2) which has been the dominant land use from before 1959, as illustrated on the Auckland Council GeoMaps historical aerial photography. The site does not have a current ecosystem classification, and the potential ecosystem of the site is designated WF7 Puriri Forest Ecosystem, although that is not what is currently present.

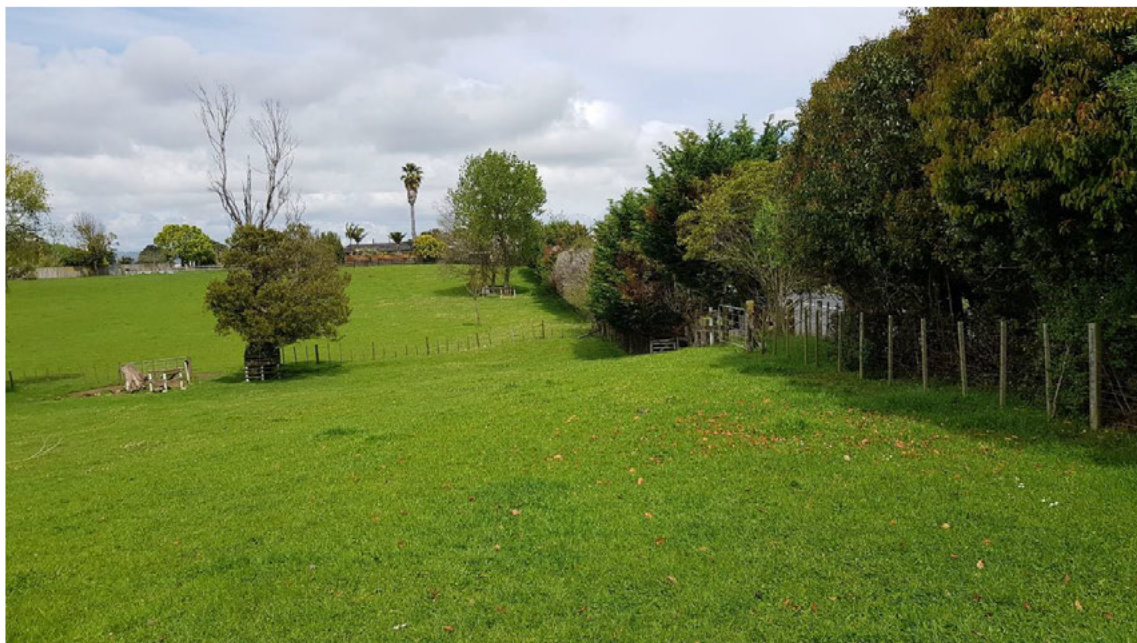
Photo 2. General aspect of the western part of the site, view towards top of the central gully along Great South Road boundary fence.

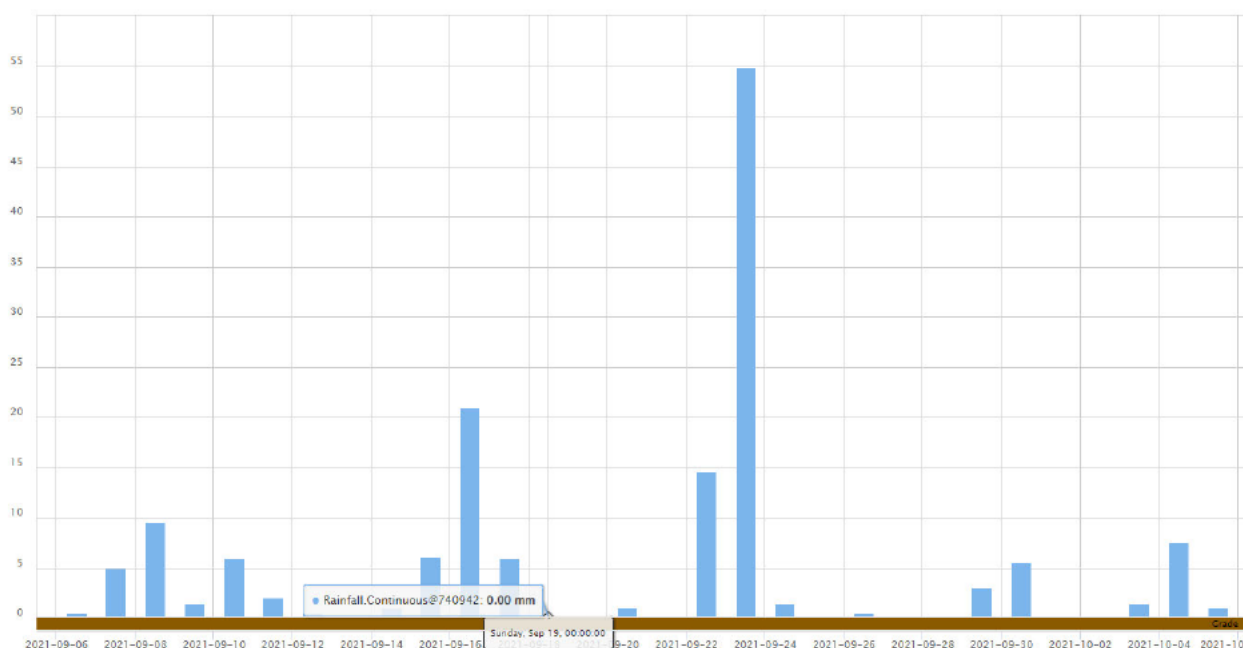
Two significant rainfall events (>15mm) occurred within the month prior to the site assessment with 89mm in the preceding fortnight and 10mm rain within the previous two days (Figure 2).

Figure 2. Rainfall data (mm) 6 September to 6 October 2021 at Longford Park. Data Source: Auckland Council Environmental Data Portal.

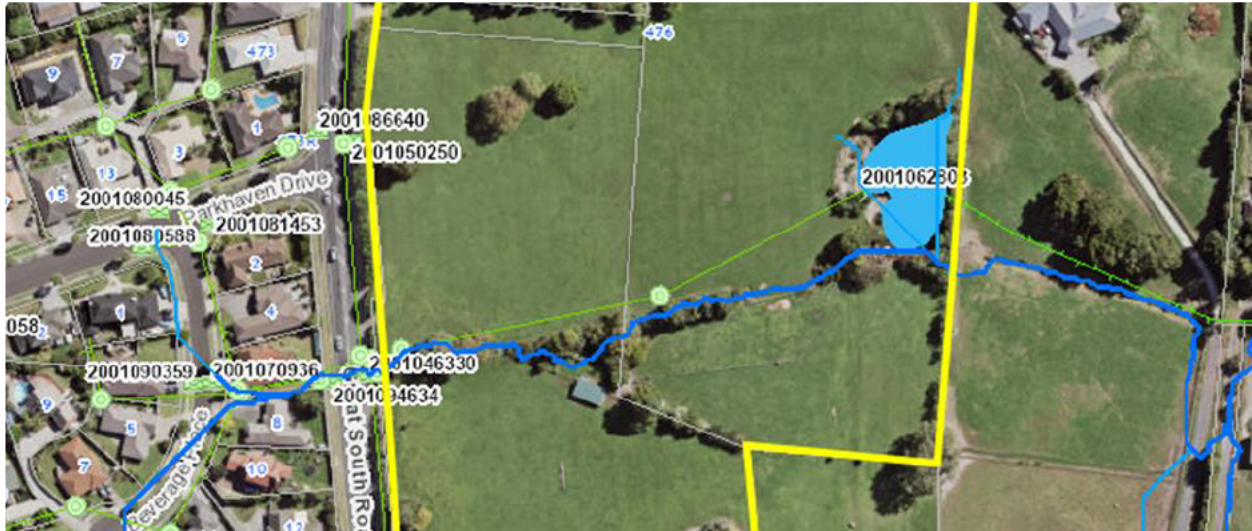
Figure 3. Auckland Council GeoMaps Underground Services Stormwater overlay illustrating the piped network to the stormwater pond (green).

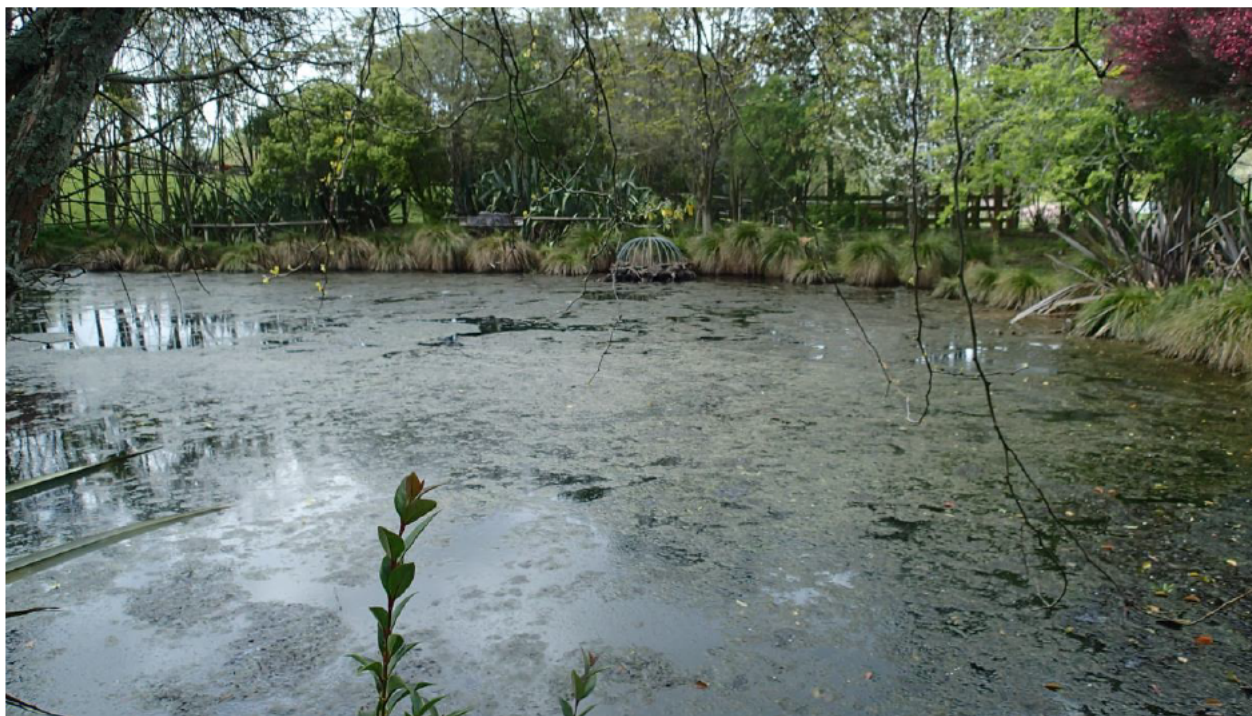
The only freshwater ecosystem present on site was the large stormwater treatment pond (Figure 3, Photo 3, Photo 4) near the eastern boundary of the site.

Photo 3. Stormwater treatment pond and scuffy dome outlet from pond.

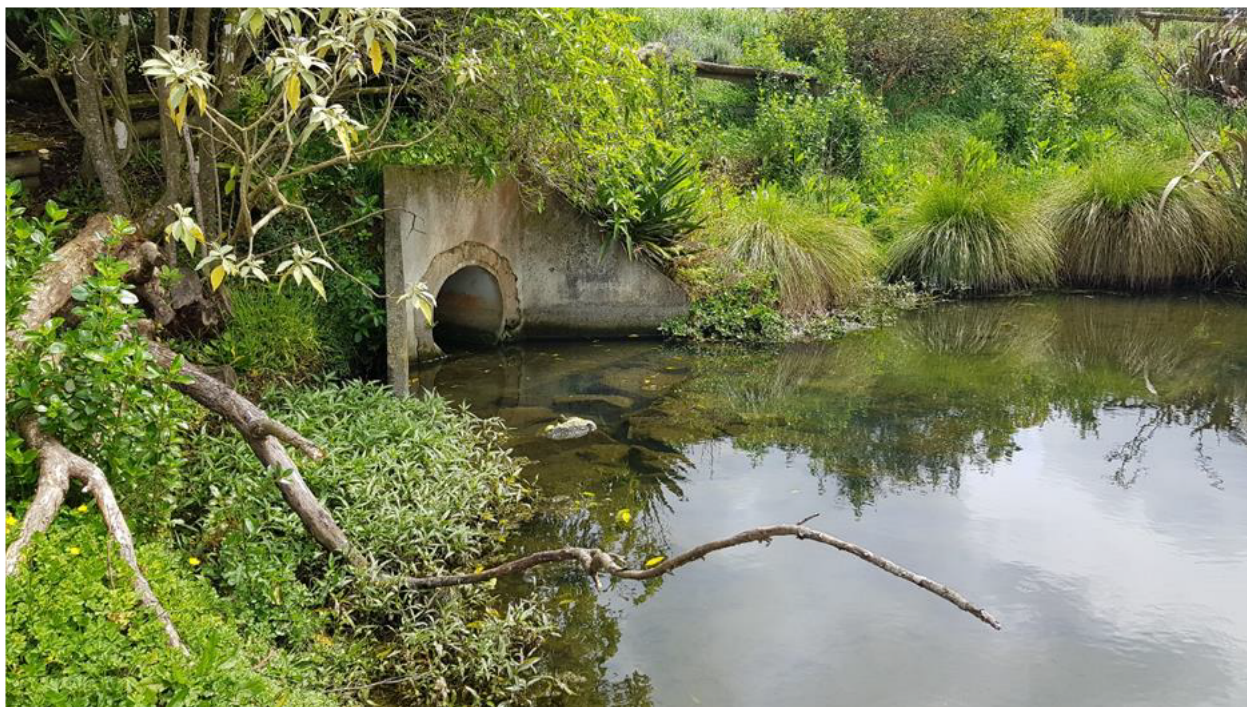
Photo 4. Culvert outlet to stormwater treatment pond

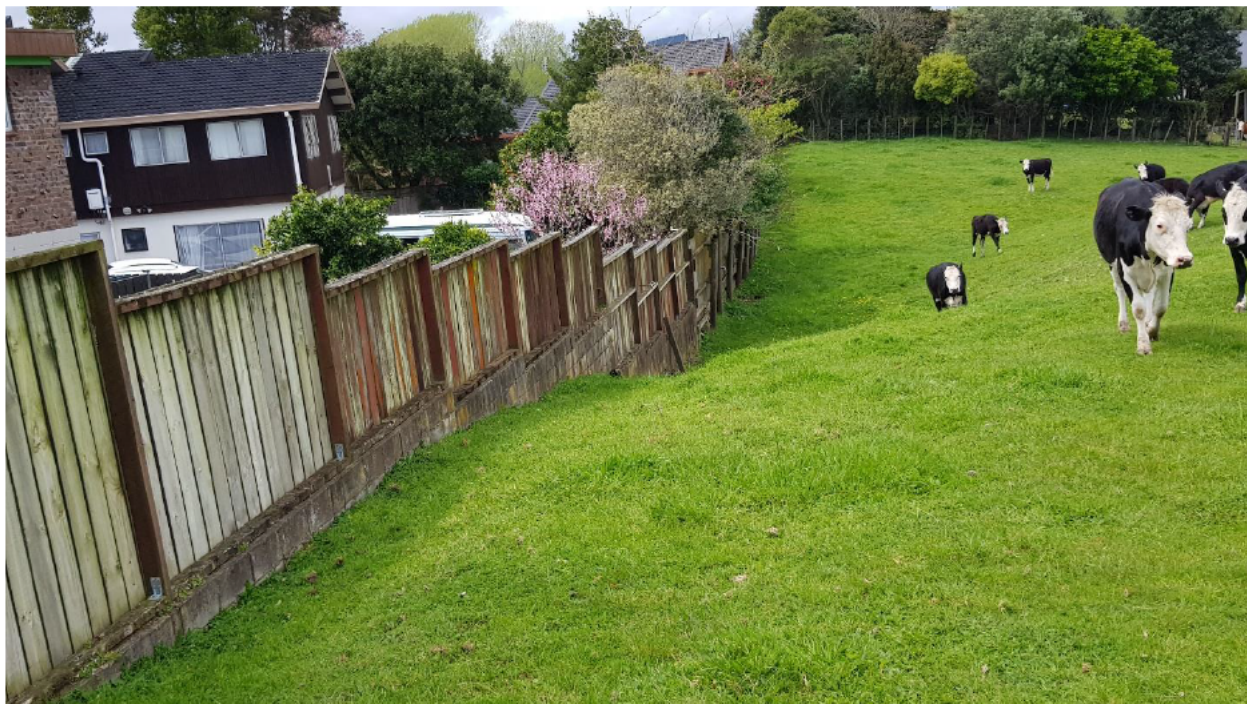
The predicted flowpaths from the Auckland Council GeoMaps overlay were ground truthed. None of the predicated flow paths met the criteria for streams and no wetlands were present. (Photo 5 to Photo 7).

Photo 5. Predicted flow path from northern boundary – no stream.

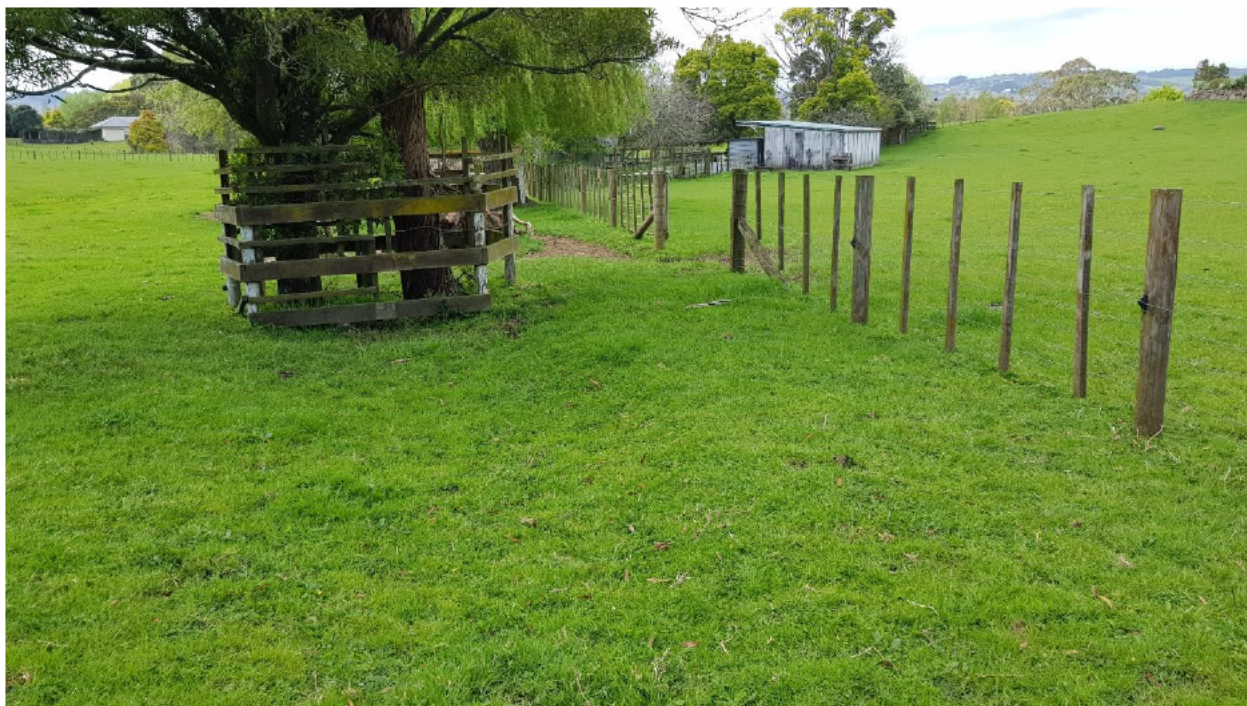
Photo 6. Upper site with view along lowest gradient with no flow path present (view east towards the pond)

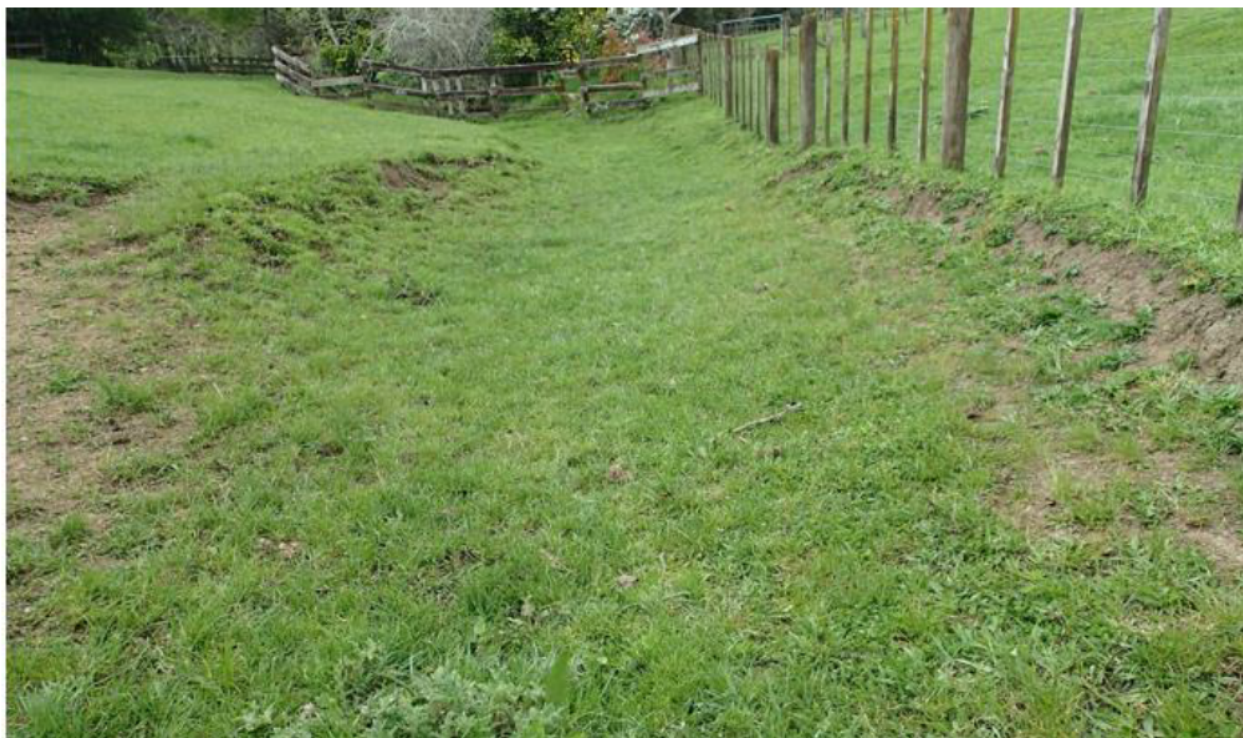
Photo 7. Central part of the site with no flow path present at the low point (flow path piped). View towards pond with pond trees in background.

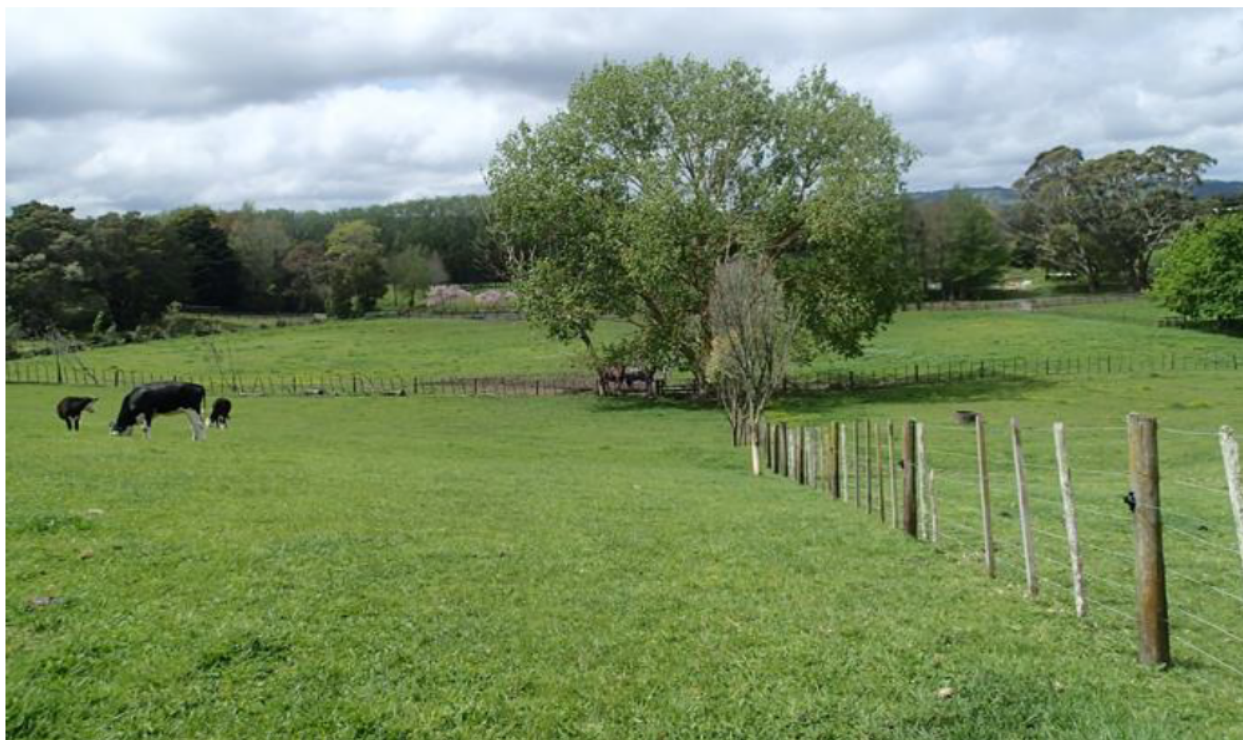
Photo 8. Southern boundary properties (note horses under central trees)
