Opunake Solar Farm

For Harmony Energy Storage Limited

Draft Ecological Effects Assessment Report

February 2023

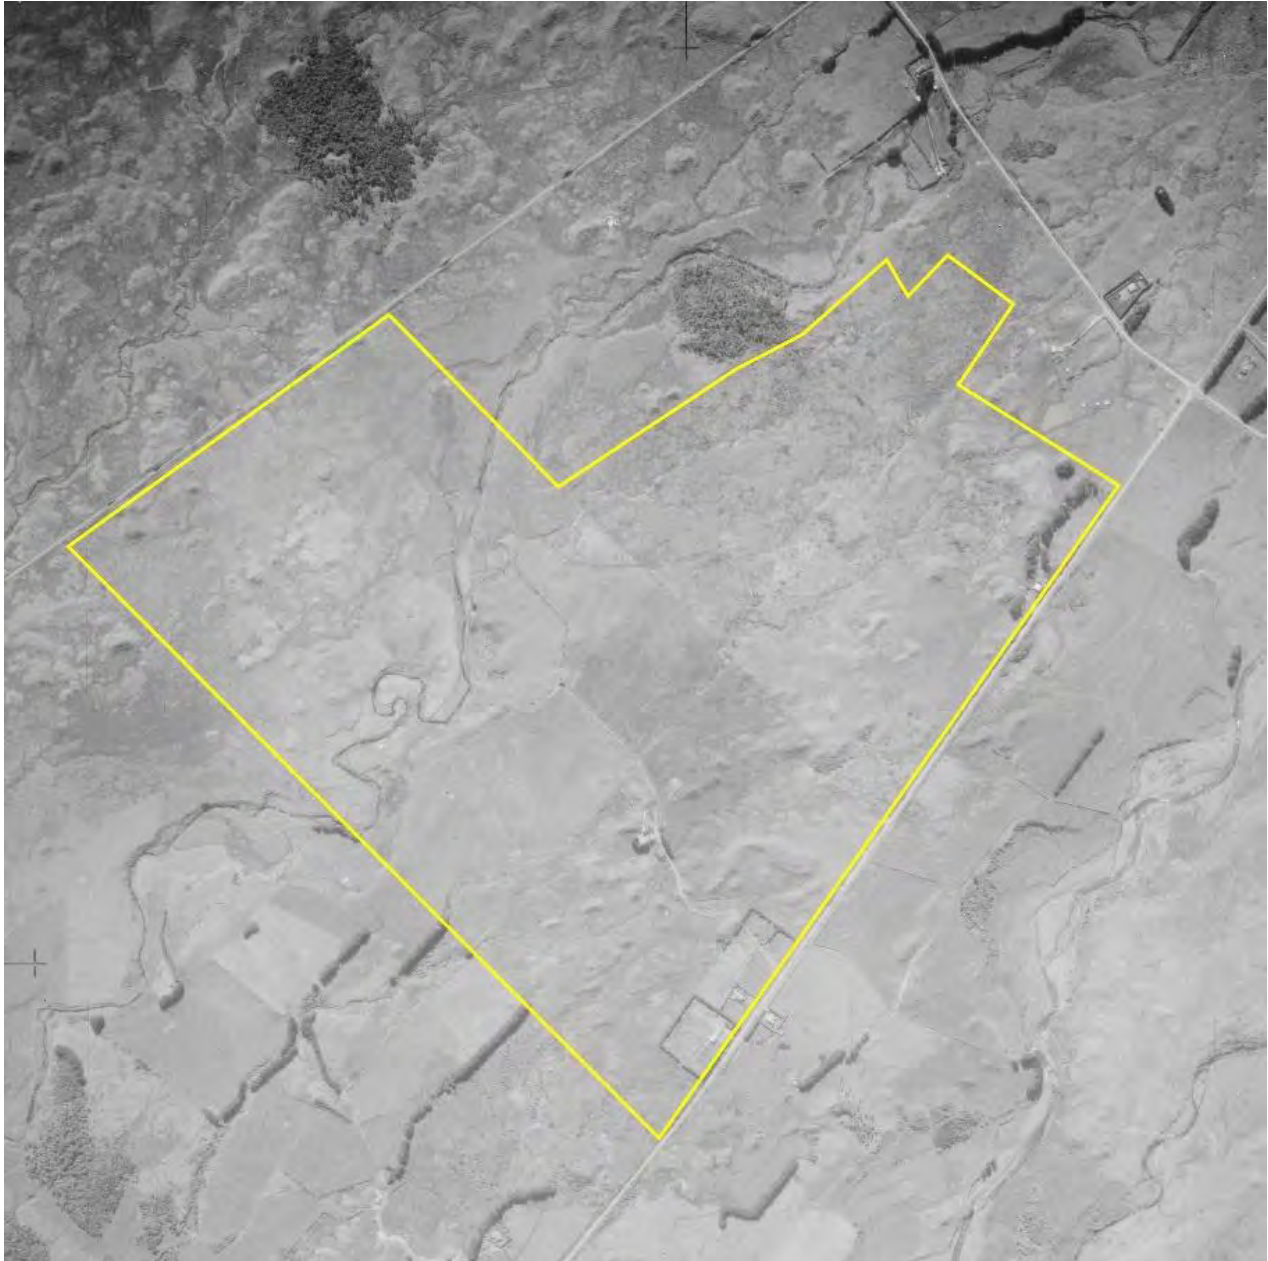
Figure 2: Historical Imagery of the proposed solar farm site 03/09/1954 (Retrolens, 2022). Approximate site boundary is shown in yellow.

Based on aerial imagery, it appears that the site has been primarily under pasture since at least 1954 (Figure 2). The site is within generally low gradient relief, sloping in a south westerly direction towards the coast.

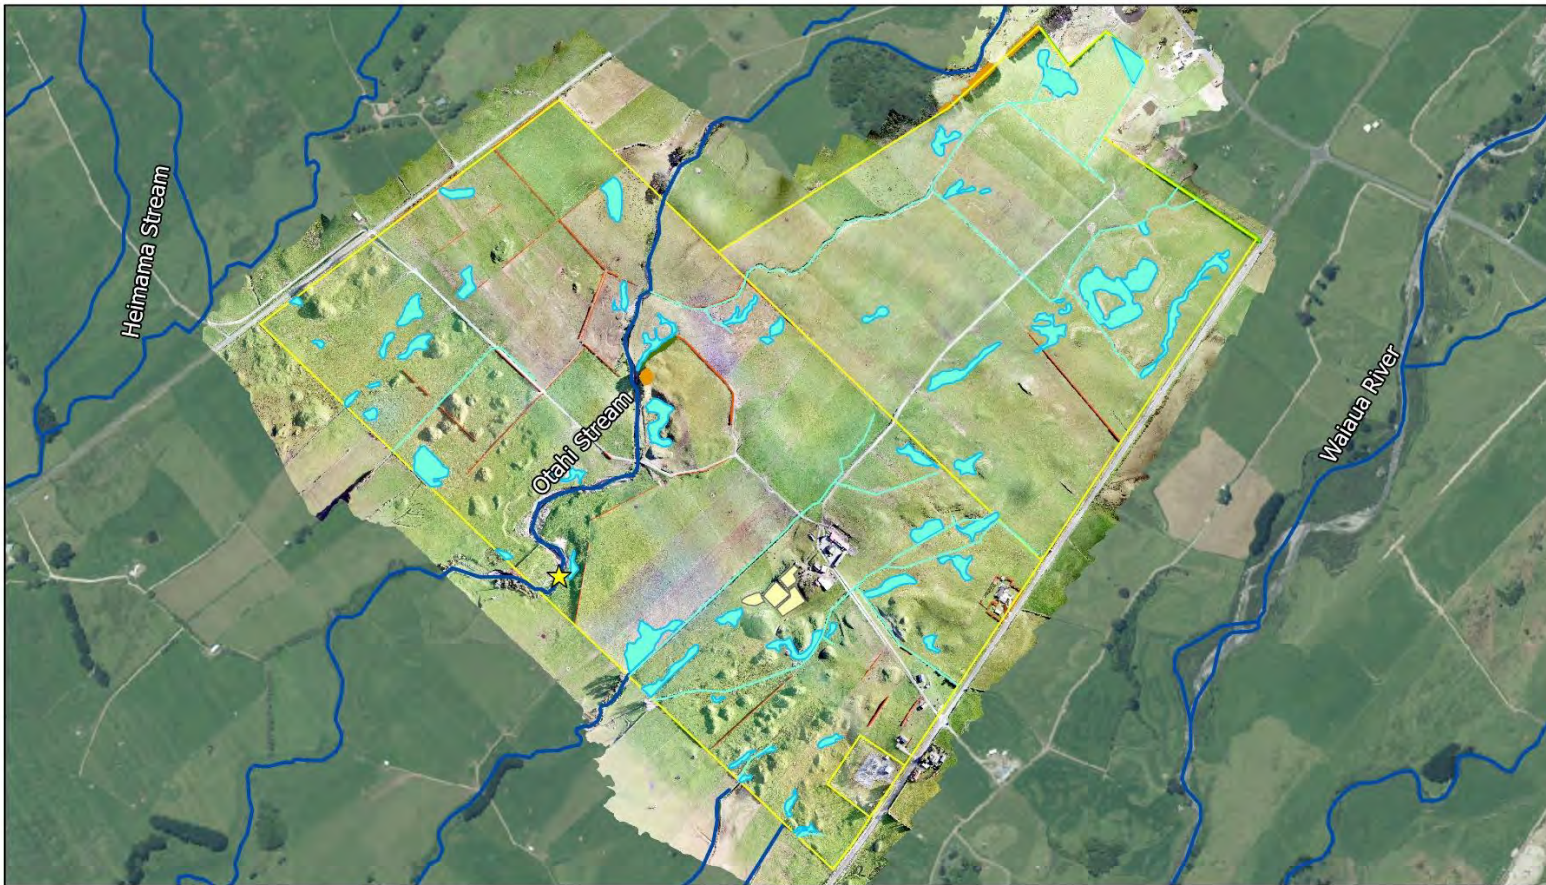
Figure 5: Vegetation cover within the proposed solar farm site. Note that, aside from infrastructure, unshaded areas constitute fields of exotic pasture.

A map showing the terrestrial and wetland vegetation is shown in Figure 5, below, whilst representative site photographs are included in Figure 4. Note that an additional map showing the labels of each wetland, stream and drain is included in Appendix B

A map visually presenting the location of wetland habitat is provided in Figure 5, above, representative photographs are included as Figure 6, whilst the characteristics of each wetland is provided in Table 2.

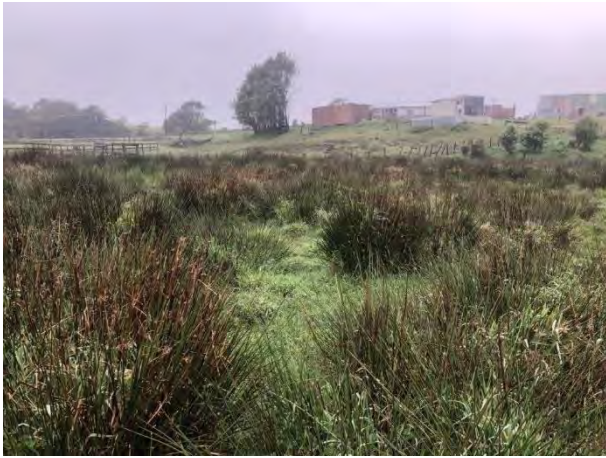
Photo E: View from west to east looking across representative rushland wetland habitat associated with wetland W55.

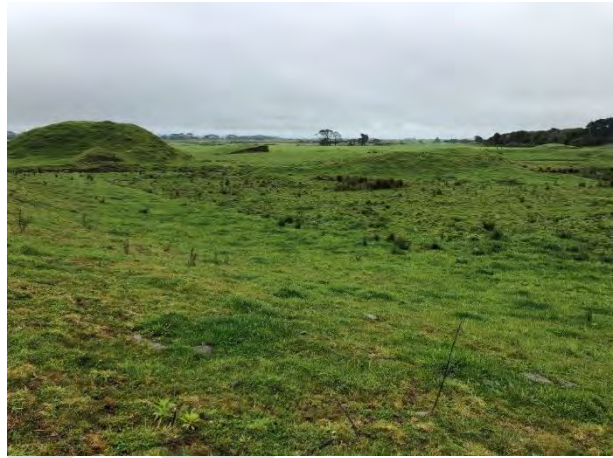
Photo F: View from east to west looking across marshy hygrophilous grassland habitat within wetland W49.

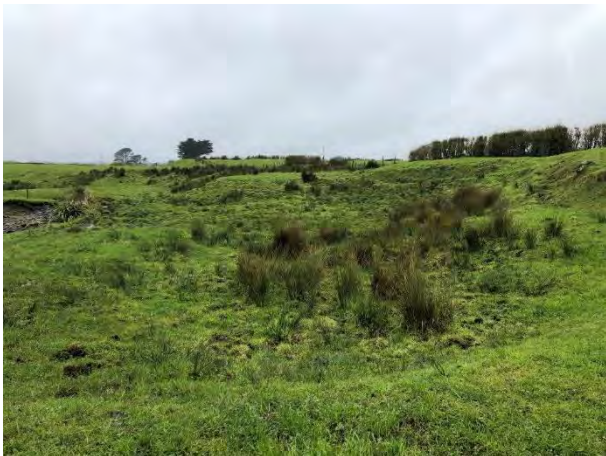
Photo G: View from south to north of wetland W17 showing mixed rushland-hygrophilous grassland habitat on the floodplain of the Otahi Stream.

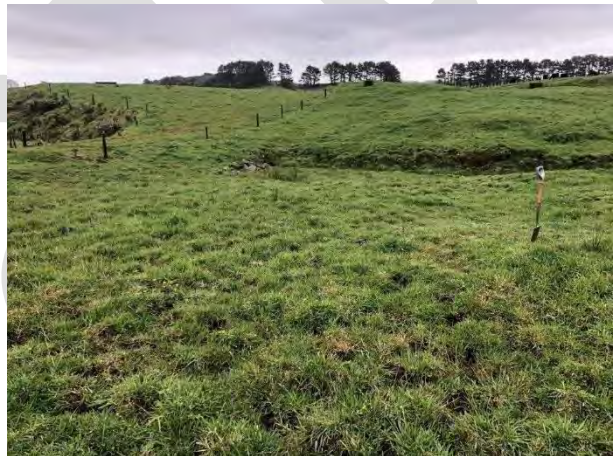
Photo H: Hygrophilous grassland habitat associated with seepage within wetland W51.

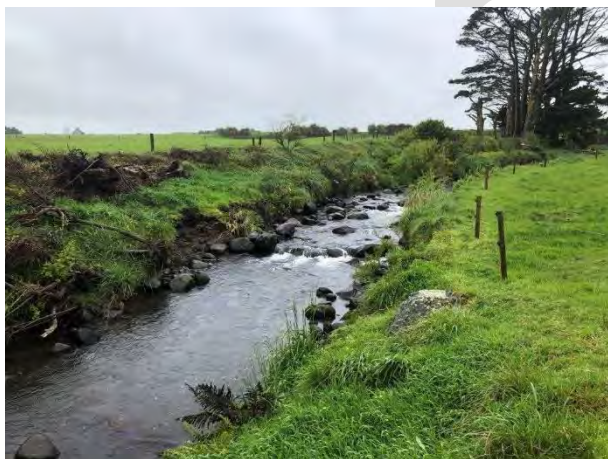
Photo I: View from south to north looking upstream from the left-hand bank of the Otahi Stream at the northern extent of the site, showing common pasture grasses within the riparian zone.

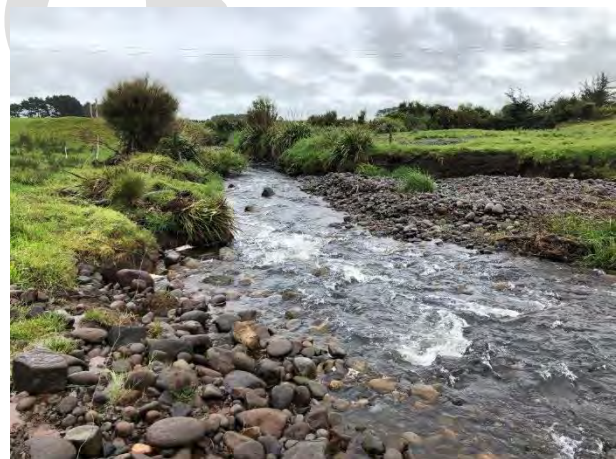
Photo J: View of cobble habitat and riffle biotopes within the Otahi Stream. Note the bank erosion on the right-hand bank.

The perennial Otahi Stream, which bisects the site, comprised primarily boulder / cobble-alluvial substrate within a 5-10m wide, 2m deep active channel. The diversity of rocky substrate within the river was high however limited alluvial and vegetative habitat was noted within the overall stream extent. Riffles and runs were the dominant biotopes onsite with moderate, clear flows observed on the day of assessment. The Otahi Stream is crossed by a single bridge structure, which does not appear to hinder local fish/macroinvertebrate migration.

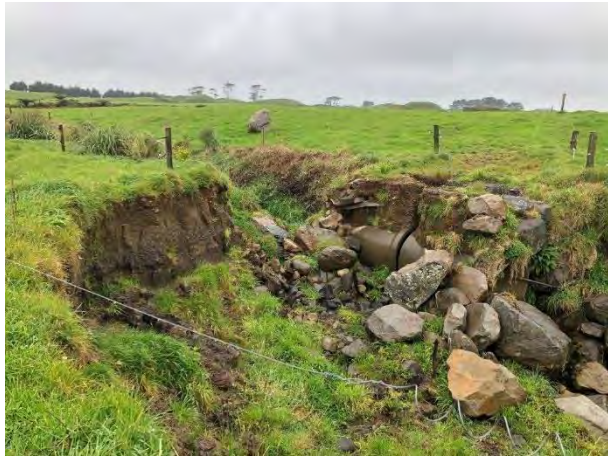
Photo K: Erosion around a culvert crossing within stream S5.

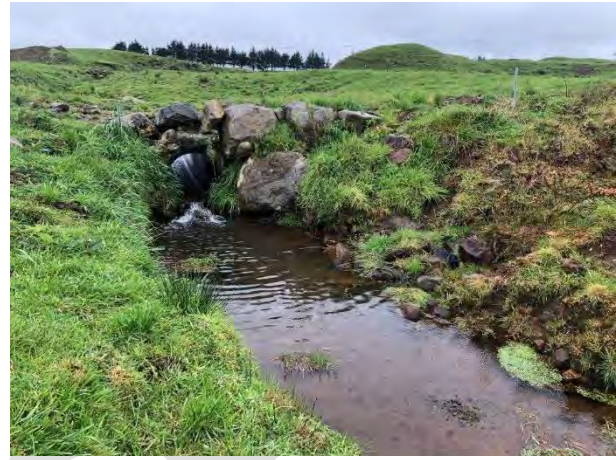
Photo L: A perched culvert within stream S4 likely resulting from channelisation of flows, these conditions can be problematic for fish passage

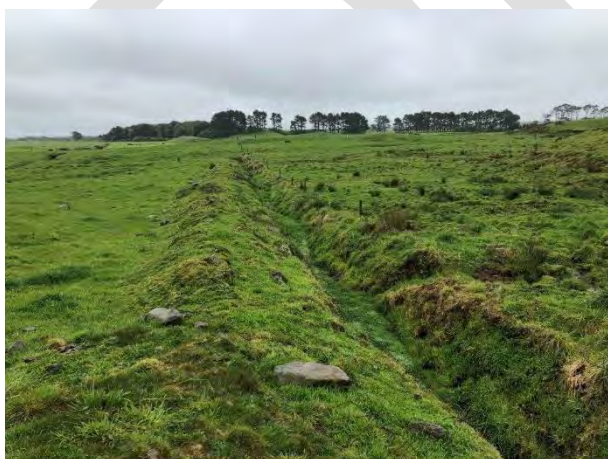
Photo M: View from south east to north west near the top of drain 3b. Excavated material was still present adjacent to this drain.

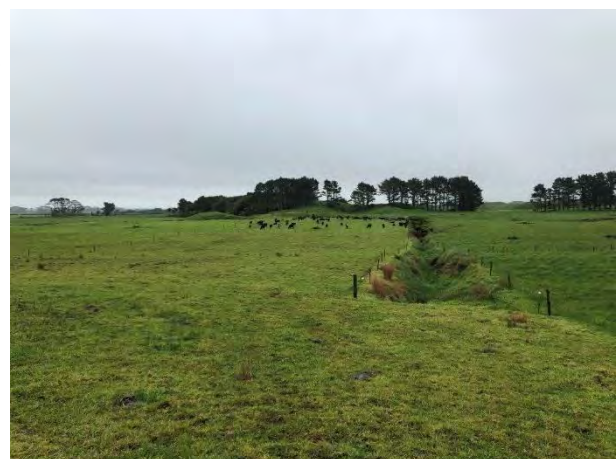
Photo N: View from south east to north west near the top of drain D4b. Note the good vegetative cover, which characterised most drains onsite.

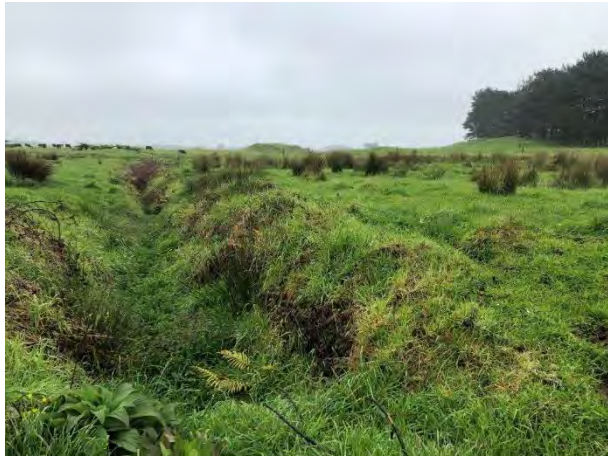
Photo O: View from north east to south west from the top of drain 4c.

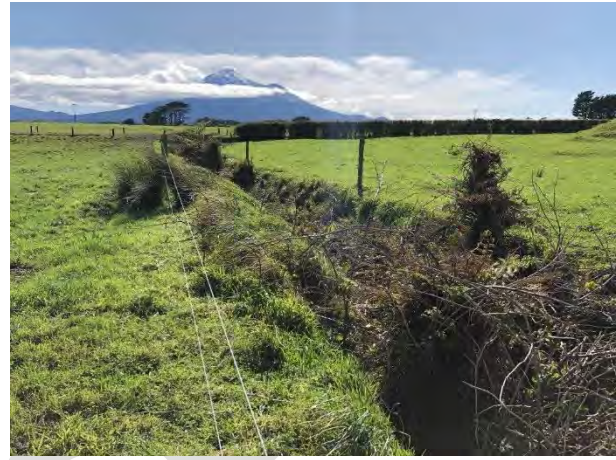
Photo P: View from south west to north east looking upslope from the right-hand bank of drain D6. This drain exhibited comparatively higher levels of weed encroachment (mostly blackberry) although recent control via spraying was evident.

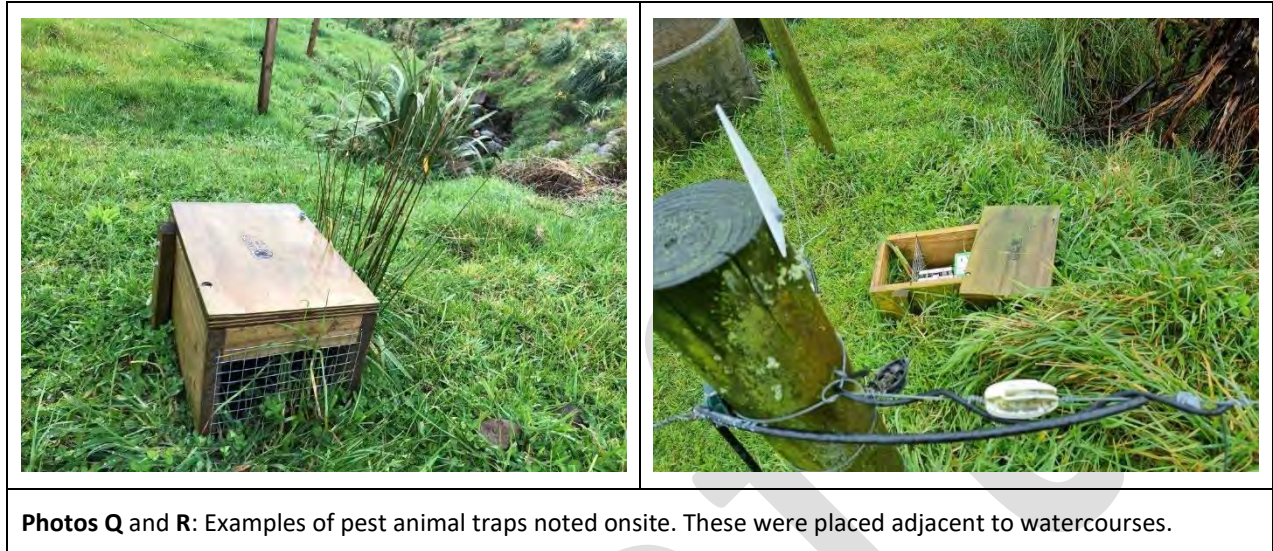
Figure 9: Pest traps observed on the property.

No pest animals or evidence of pest animals, such as scat or tracks, were observed during the site visit. It is likely that pest animals such as rats, possums, mustelids, hedgehogs, and feral cats are present within the general area as pest traps were noted within the site boundary (Figure 9).

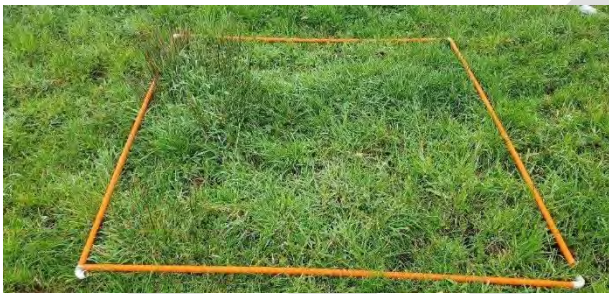
Photo S: Example of plot placement within the property boundary.

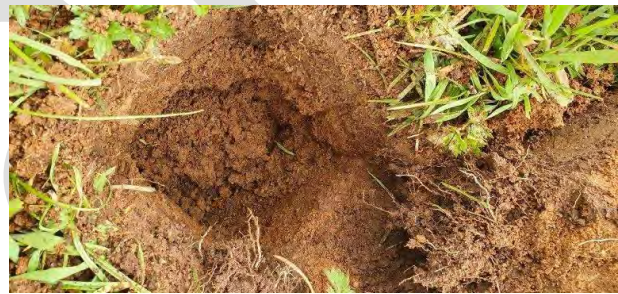
Photo T: Excavated soil sample to check wetland hydrology, which was non-wetland in this case.
