**Karaka North Village – Ecological
Assessment
June 2020**

Document title:	Karaka North Village – Ecological Assessment
Prepared for:	Karaka North Village Ltd
Version:	Version 2
Date:	4 June 2020
Document name:	63179 Karaka North Village Ecology - June 2020

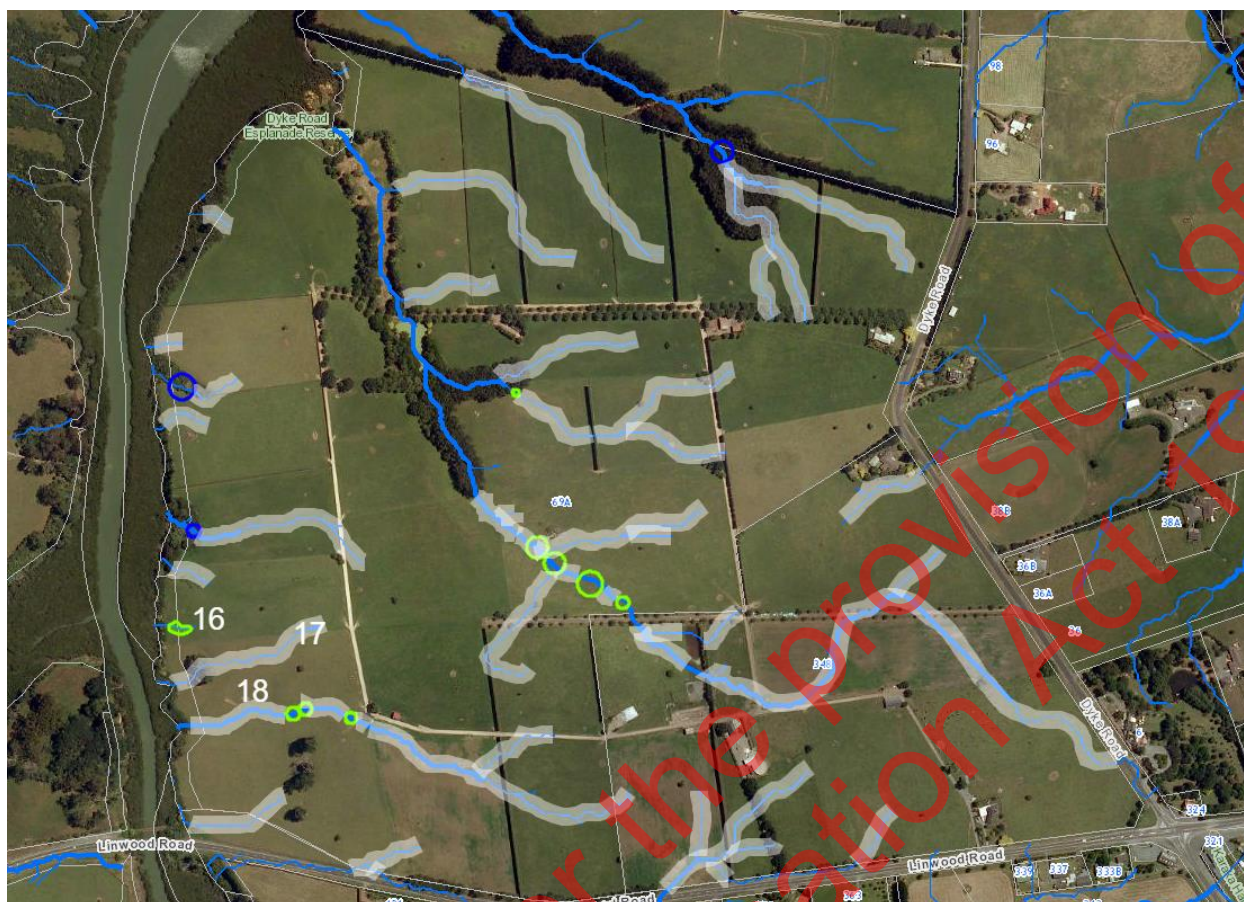
Figure 4. Ground-truthed Classifications of AUP Overland Flow Paths Overlay.

Aquatic habitats (blue); overland flow paths i.e. not a stream (white), wetlands or areas with small patches of hydrophytic vegetation (green).

With the exception of the central Mainstem watercourse, below the treeline, which formed a permanent stream, five areas on the property provided indeterminate habitats (Figure 5 to Figure 9), and the lower reaches of three tributaries formed intermittent streams, tributaries 8, 12 and 14 (Figure 8 and Figure 9).

- Several small boggy patches below this site in the central flow path, with 10% or less cover of water pepper (green circles in Figure 4 and Figure 5);

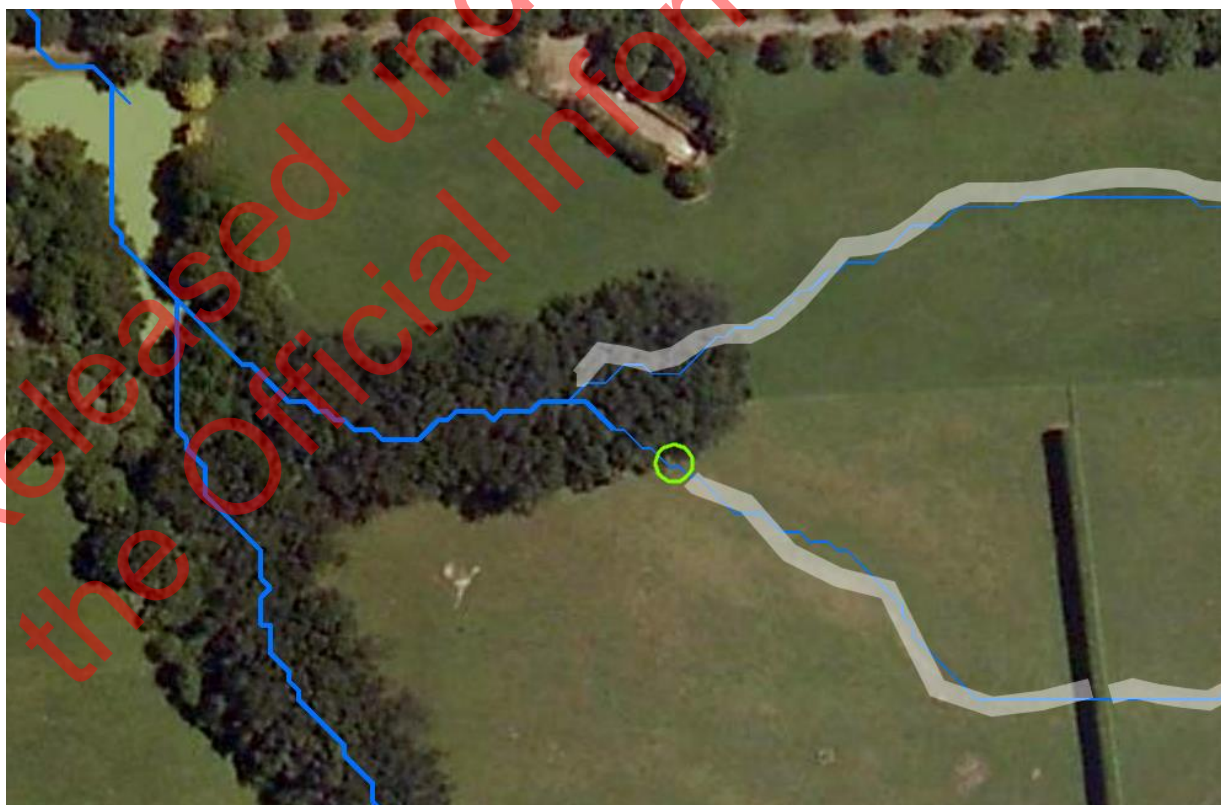
Figure 6. Tributary 4, left branch, indeterminate start of intermittent stream.

- Tributary 4, true left branch just before treeline with some channelization (Figure 6);
- Tributary 16 near the boundary fence which formed a boggy area, but with only 10 – 50% vegetation indicative of a wetland (Figure 4, Figure 7);

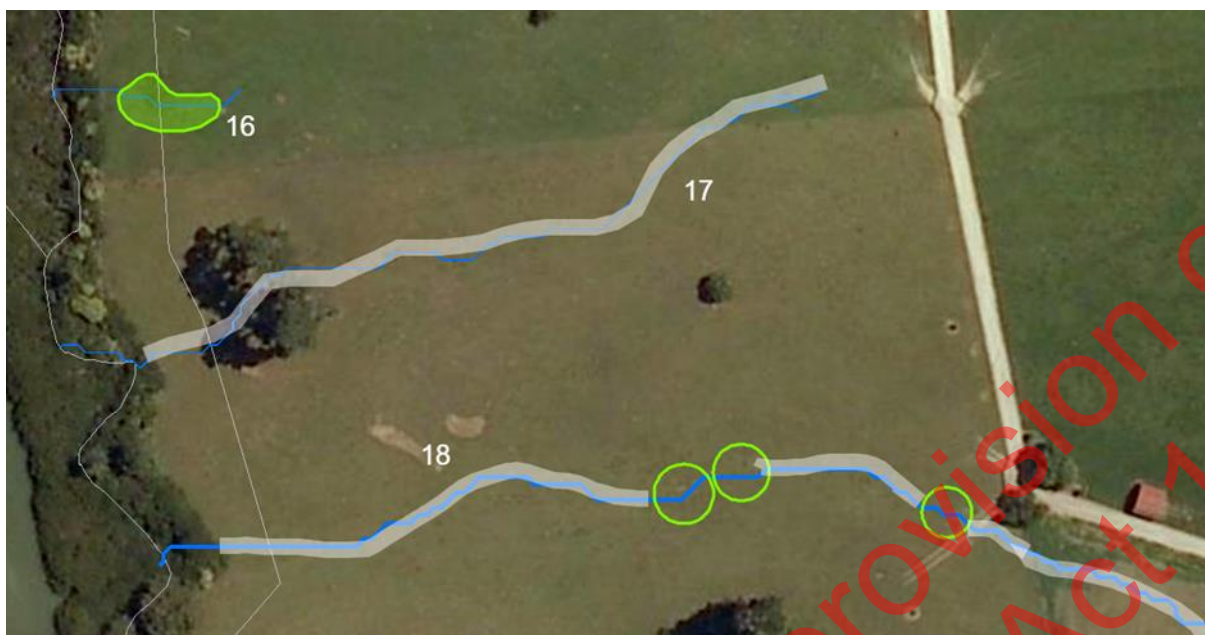
Figure 7. Tributary 16 – potential intermittent wetland and Tributary 18 identifying areas of marginal aquatic habitat.

- Lower third of Tributary 18, two small boggy areas with a low presence of vegetation indicative of a wetland and a short area of channelisation. The upper patch was induced by vehicle ruts in the access track to the south-western paddock where it crossed the flow path, and the second patch was located on a hillock approximately 115m up the catchment from the estuary. Immediately below

the hillock was a 4m channelised area before the area reverted to a grassy overland flow path (Figure 7).

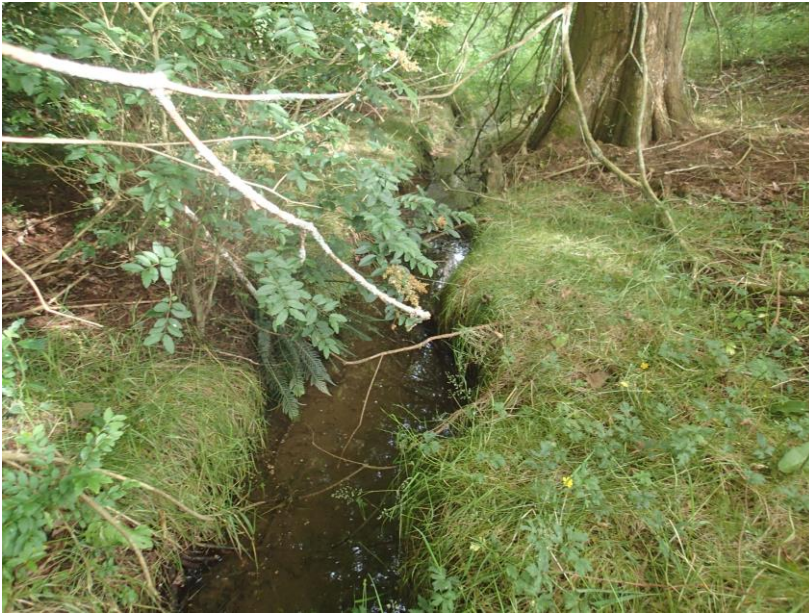
Photo 1. Upper section of central watercourse within the fenced bush area.

The central watercourse formed defined channels at or within the bush areas fenced off upstream of the pond. The main stream originated in a defined pool (1-2m wide by 4m long) with starwort (*Callitriche stagnalis*) 4m upstream from the bush fenceline. Within the bush it formed a narrow incised channel, with high shading (Photo 1). The riparian vegetation comprised poplar (*Populus* species), privet, rank grasses, Yorkshire fog (*Holcus lanatus*) and redwoods (*Sequoia sempervirens*). A second, mainly dry intermittent stream flow path was present with the eastern tongue of bush. The streams flowed north and north-west to a large pond in the centre of the site (refer cover photo).

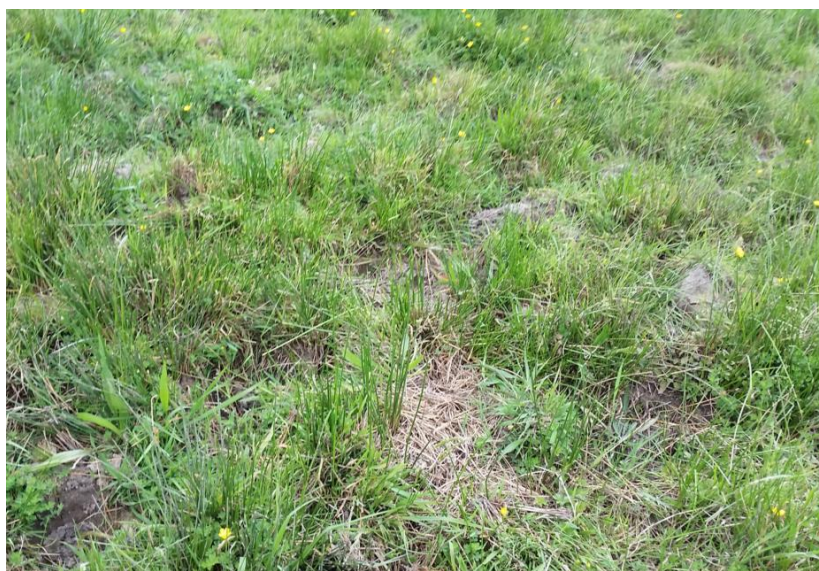
Photo 2. Boggy ground near fenceline – located mainly within the Esplanade reserve.

At Tributary 16 near the boundary fence a boggy area was present grading from 10% to 50% hydrophytic vegetation i.e. vegetation indicative of a wetland. The area was dominated by pasture grasses with 10 – 50% exotic soft rush, *Juncus effusus*, Yorkshire fog and buttercup (*Ranunculus* species). The potential of the site if stock are prevented access is indeterminate, as the boggy ground appears to have formed from a damaged overland flow path. The potential of the area as a wetland if stock are removed and the coastal vegetation zone planted is very poor, as it is highly likely to revert to an overland flow path. The area lies mostly within the 20m yard of the CMA.

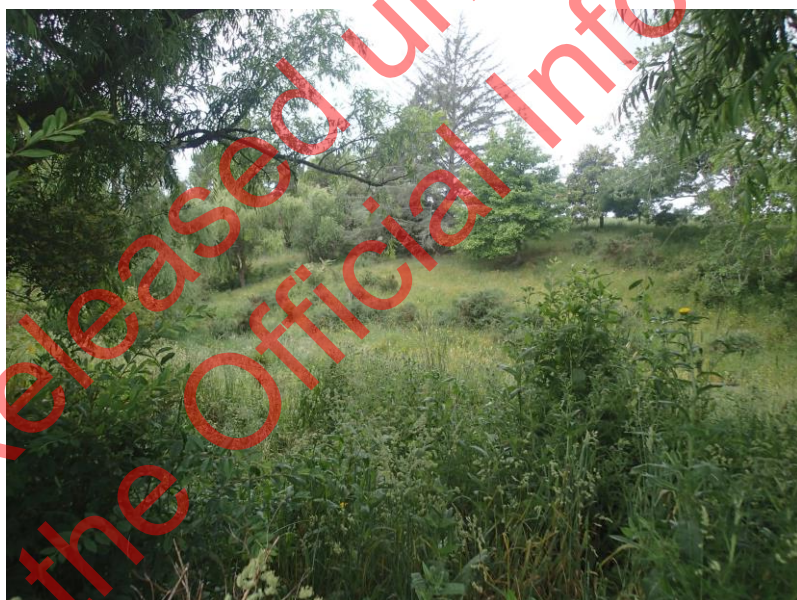
Photo 8. View through riparian zone of lower Mainstem (stream path running left to right in the centre of the photo)

Downstream of the pond the riparian area was fenced, with the vegetation dominated by rank grasses with gorse and patches of larger trees, (crack willow *Salix fragilis*, oak) on the outer extents of the riparian area (Photo 8).

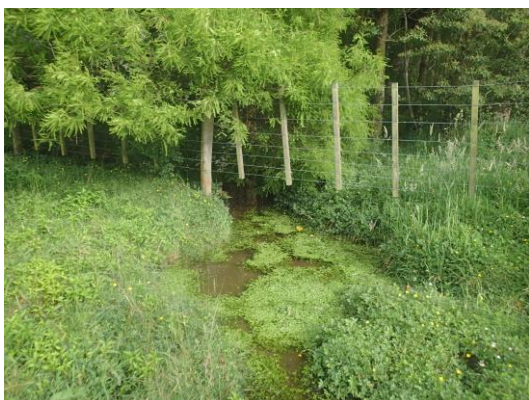
Start of Mainstem Stream- a pool with aquatic habitat 4m from the fence line

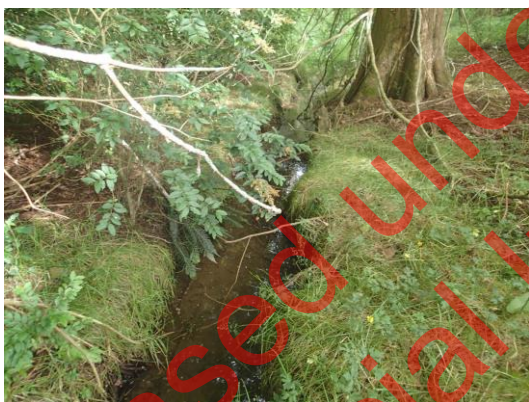
Mainstem stream within treeline – permanent stream

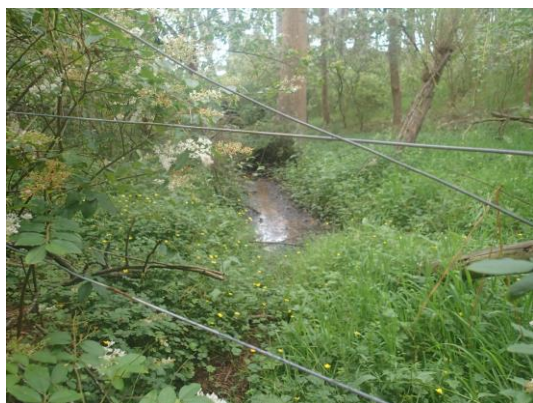
Tributary 8 – start of intermittent stream just before property boundary fence

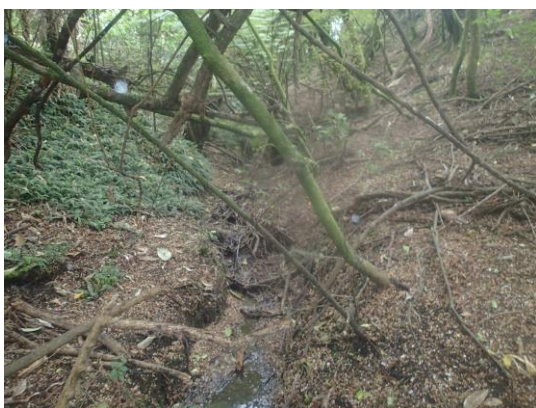
Tributary 12 – intermittent stream within bush area

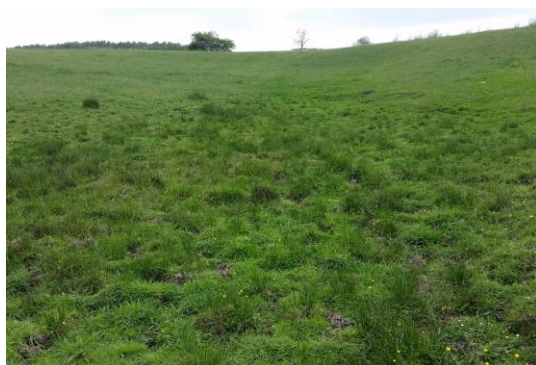
Tributary 16. Area with low presence of *Juncus effusus* and buttercup

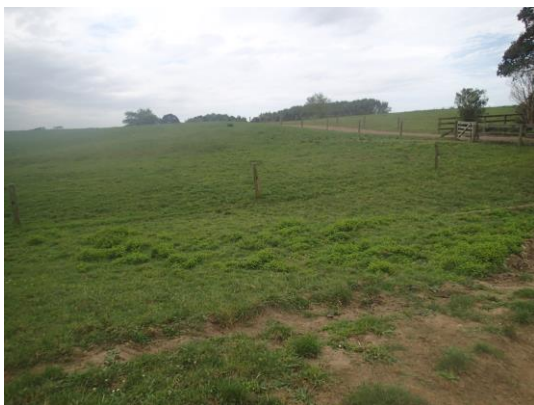
Tributary 18 - water pepper in flow path near access crossing

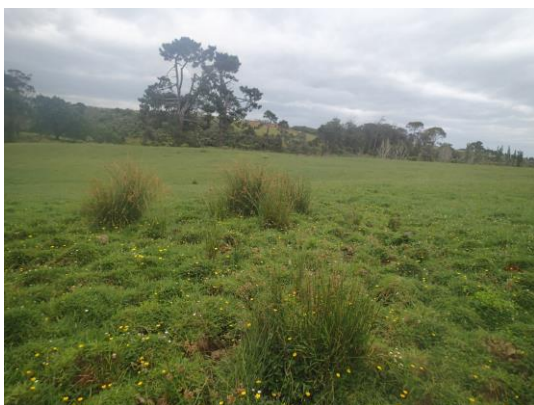
Tributary 18 – patch of rushes and pugged ground
