Kopu Marine Precinct Ecology Report
Prepared For
Urban Solutions Ltd.

February 2019

Document Name	AA4539 Kopu_Ecology_V1.1	
Version History:	V0.1	18/02/2019
	V1.0	04/04/2019
	V1.1	30/04/2019

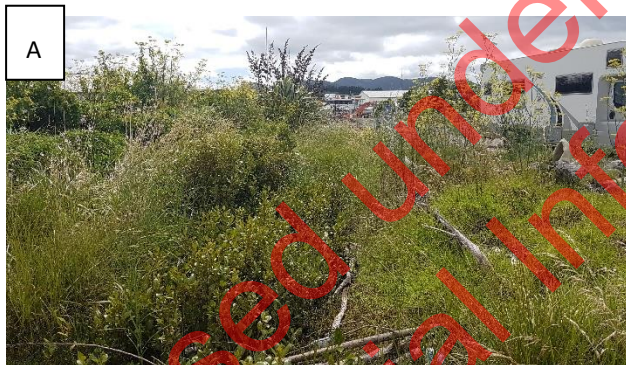
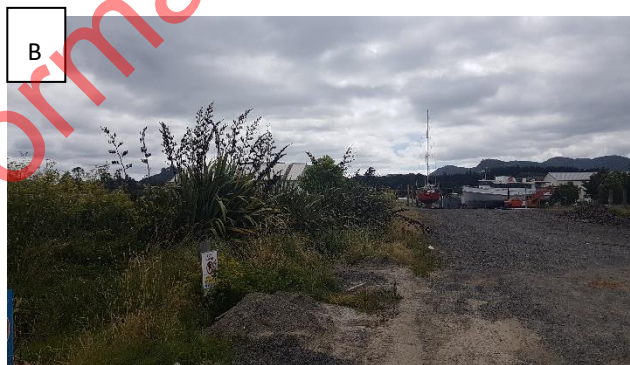
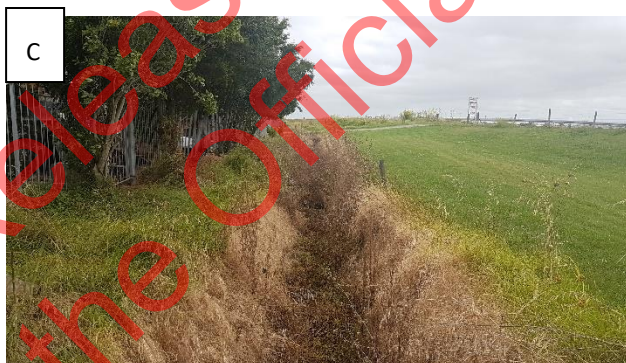
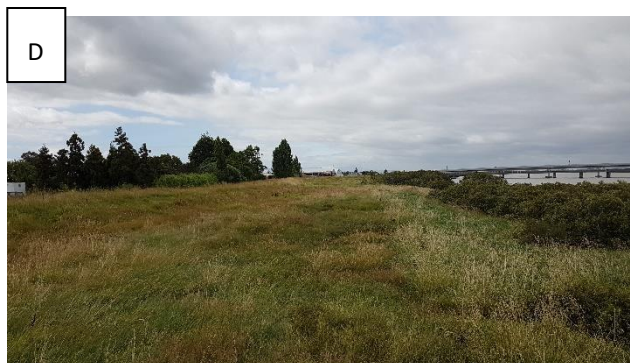
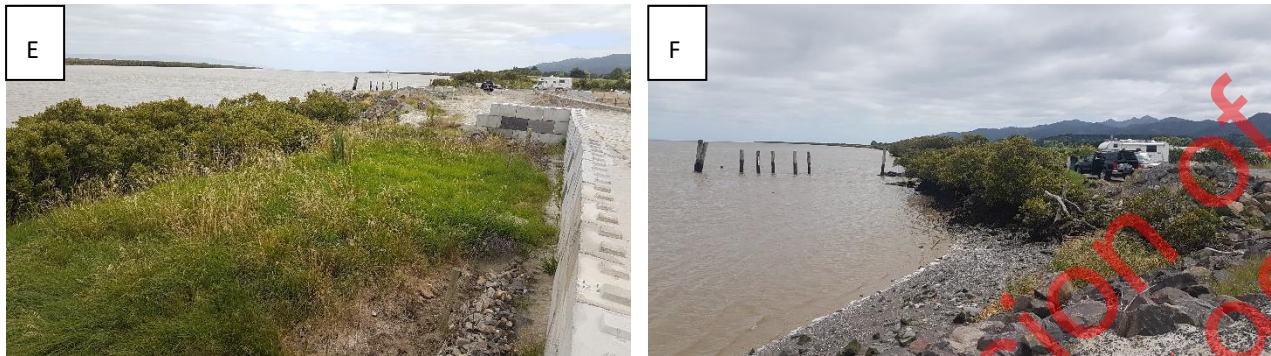
- A small man-made tidally influenced watercourse (40 m in length) at the northern end of the carpark (Figure 1A, 1B). This had mangrove seedlings in the lower 15 m, then rushes and weed species. A row of mature flax (*Phormium tenax*) lined the upper true right side.

- Mown grass to the east, on either side of the bike trail (Figure 1C).
- Ungrazed, weed infested paddocks to the south (Figure 1D).
- Mangrove habitat and transitional wetland to the west of the stockpile area (Figure 1E). A 10 m wide stand of mangroves, between 1.5 to 3 m high, transitions into a small brackish wetland containing sea rush, marsh clubrush, flax, divided sedge and pastoral weeds. The brackish wetland was approximately 10 m wide and contained a high density of crab holes. Mangrove seedlings were growing along the lower edge of the riprap wall on either side of the barge wharf. There was a stand of small mangrove trees between the barge wharf and boat ramp (Figure 1F).

Figure 1: Habitats around the periphery of the existing facilities. A) downstream end of watercourse, B) Upstream end of watercourse, C) Mown grass surrounding the entrance, D) Ungrazed, weed infested pasture to the south, E) Mangrove stand and transitional wetland beside stockpile area, F) Mangrove stand between boat ramp and barge wharf.

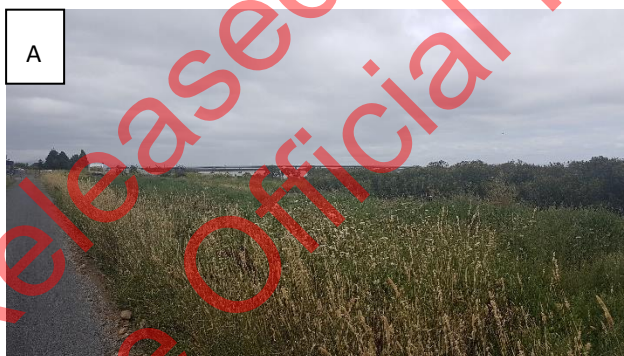
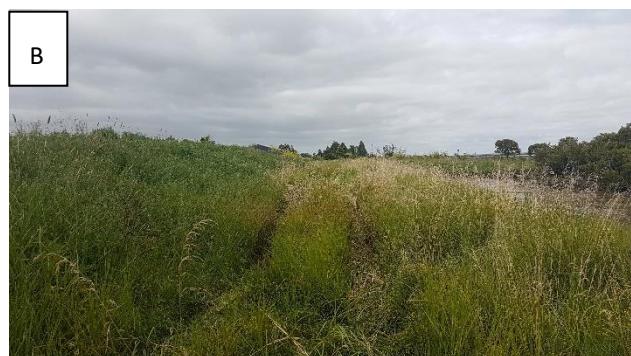
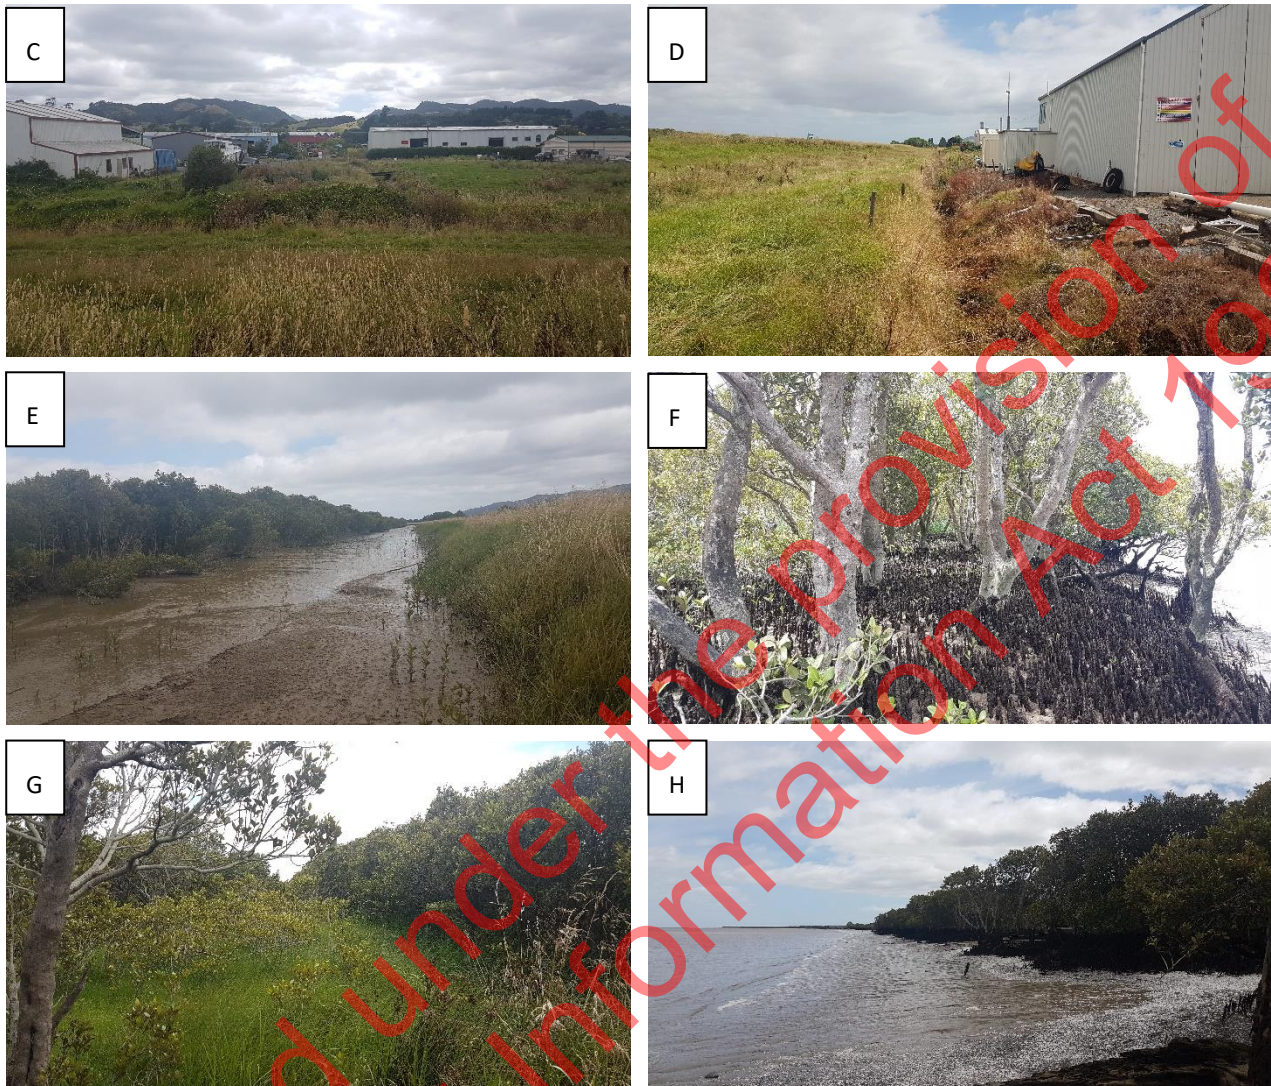
The proposed carpark and paved hardstand area will partially sit upon the shoreward (western) slope of the stop banks. At the time of survey, the stop bank appeared to be a former stock grazing area, as evidenced by the fencelines along its length. Stock was present on the eastern slopes of the stop bank. There was no evidence of grazing on the shoreward slopes where vegetation was characterised by rank pasture and pastoral weeds (Figure 2A). No significant native vegetation was noted. The lower slopes, adjacent to the borrow area, were mainly water tolerant weeds, including saltwater paspalum and glyceria (*Glyceria maxima*) (Figure 2B).

King Street, the proposed secondary access road, is an existing paper road and is located between 21 and 25 Queen Street. The strip of land has weedy overgrowth similar to that on the stop bank (Figure 2C).

A stormwater drain lies along the shoreward edge of the commercial buildings (Figure 2D) and runs north from the Kopu Bridge to the Te Kupata Stream. A smaller drain joins this along the edge of 21 Queen Street.

An intertidal area, spanned approximately 15 m from the edge of the stop bank to a stand of mature mangroves (Figure 2E). On talking with the local digger operator (who was collecting soil samples for the 4Sight land and water quality report), this intertidal area was created as a borrow are, allowing convenient excavation of marine sediment to top up the stop bank when required. The inlet for this borrow area is adjacent to the boat ramp and the borrow area extends alongshore as far as the Te Kupata Stream. This area was characterised by a deep layer of fine sediment, with a shallow (<2 cm) oxic layer. Given the modified nature and historical use and purpose of this area, no biological cores were collected here.

The Waihou River intertidal area seaward of the mangrove stand, was characterised by a narrow band of firm, coarse sediment and shell hash, then a deep layer of finer sediment towards the low tide channel (Figure 2H). An algal film was noted on finer sediment.

Figure 2: Habitats within proposed redevelopment area. A) Ungrazed paddocks on upper stop bank, B) Lower stop bank, C) Looking straight down King Street paper road, D) Drainage canal along edge of industrial buildings, E) Burrow pit area, F) Seaward mangrove stand, G) Wetland between mangrove stands, H) Foreshore area with consolidated shellhash changing to fine sediment.
