Solar Farm Site Assessment - Marton

Civil Report – Proposed Solar Farm at 1618 Wellington Road, Marton

Prepared for Energy Farms Ltd

Prepared by Beca Limited 10 February 2023

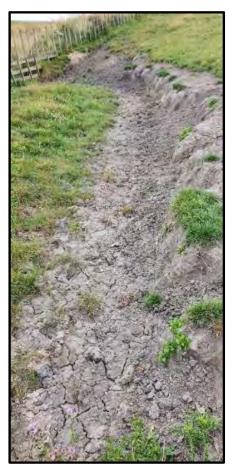
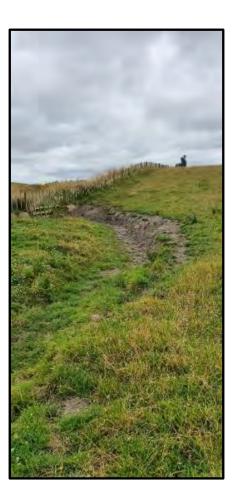
Figure 5 – Watercourse 1 – Refer Figure 15 for watercoarse location

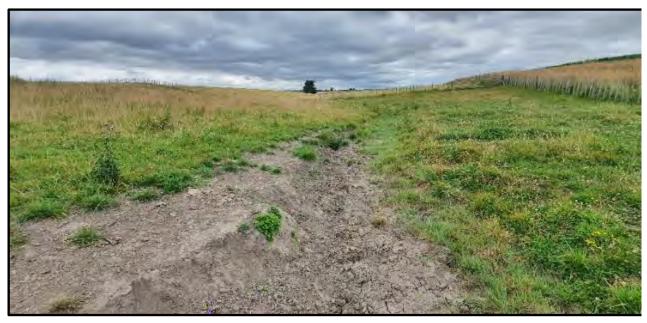
Figure 6 – Watercourse 2 – Refer Figure 15 for watercoarse location

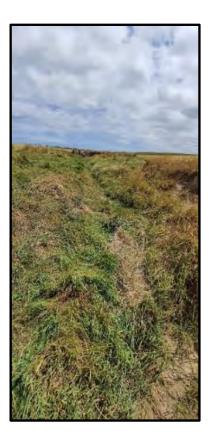
Figure 7 – Watercourse 3 – Refer Figure 15 for watercoarse location

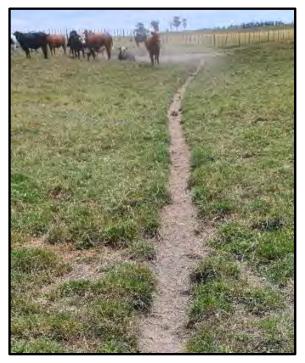
Figure 8 – Watercourse 4 – Refer Figure 15 for watercoarse location

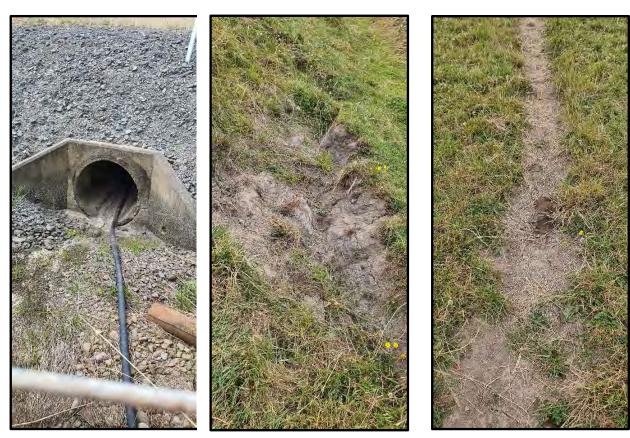
Figure 9 – Watercourse 5 – Refer Figure 15 for watercoarse location

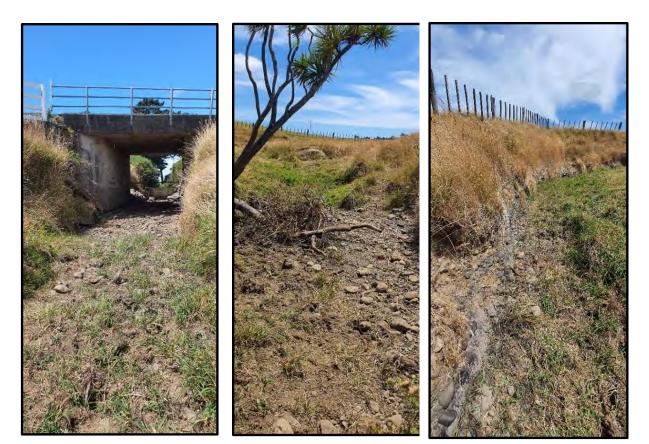
Figure 10 – Watercourse 6 – Refer Figure 15 for watercoarse location

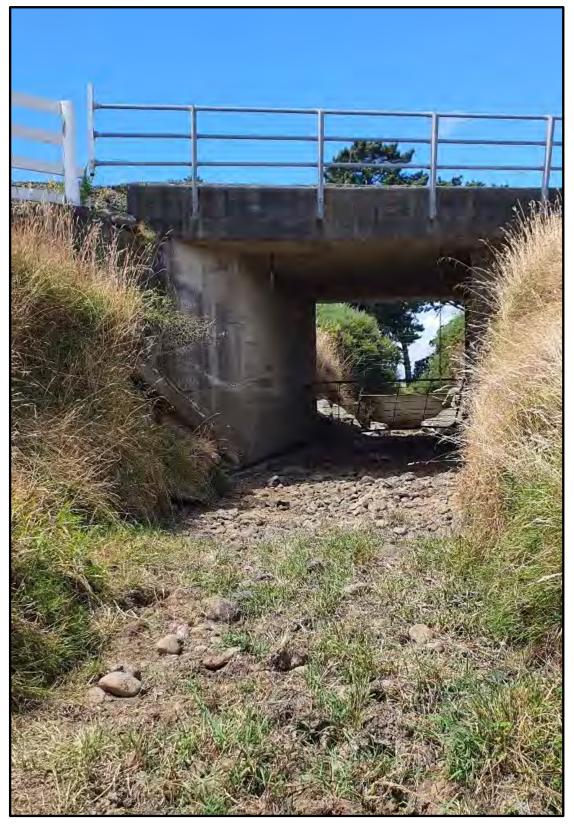
Figure 12: Site photograph showing the presence of cobbles in the near surface soils.

During a recent ecological site walkover, (Beca, 2022), photographs taken along and adjacent to watercourse channels indicate the near surface soils may contain gravel and cobbles (50-200mm), with some boulders (>200mm), as shown in Figure 12 below. Steeper slopes on the banks of watercourses also show some evidence of small-scale instability as presented in Figure 13 and Figure 14.

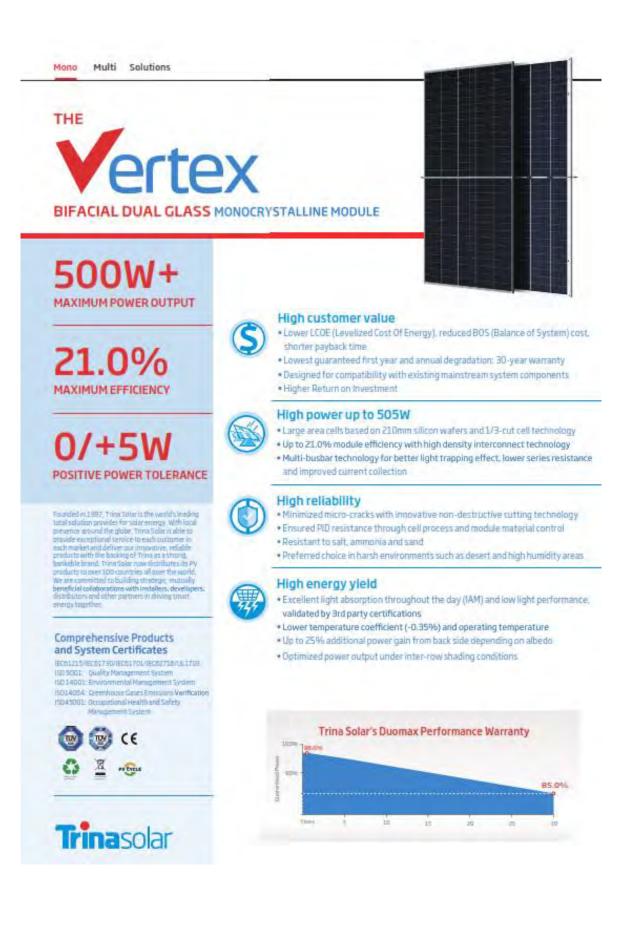
DIMENSIONS OF PV MODULE(mm)

NMOT (Normal Munchile Operating Temperature)	41°C(±3K)	Operational Temperature	-40 to+85*	
Temperature Coefficient of Pres	-0.35%/K	Maximum SystemVoltage	1900VDC()	
Temperature Coefficient of Vac - 0.25%/K		Max Series Fuse Rating	20A	
Temperature Coefficient of Is	0.04%/K			
(Do reliconnect Place in Combiner Box with two or	morestrings in paralle	iconnectioni		
WARRANTY		PACKACING CONFIGURATION		
12 year Product Workmanship Warran	ty	Modules per box:	30 pieces	
30 year Power Wattanty		Modules per 40' container: 600 pieces		
299 first year degradation				
D 45% annual degradation				
(Please refer to product warranty for details)

The solar panel layout is based on Trinasolar Vertex 500Wt, Bifacial Duel Glass, Monocry, panels (as per the data sheet in Appendix A), arranged in 2P (portrait). The dimensions of each panel are 2.187m high x 1.102m wide. A 20mm gap has been allowed for between each 2P sets of panels. To be clear, a panel has been allowed for every 1.102m + 10mm (1/2 the gap) along the tracker rail in a north-south direction. The panels face due east-west. Each panel is assumed to have a 50 Volt open circuit voltage.
