15 December 2022

Re: 31 Ngongotahā Road, Rotorua – Preliminary Ecology Assessment

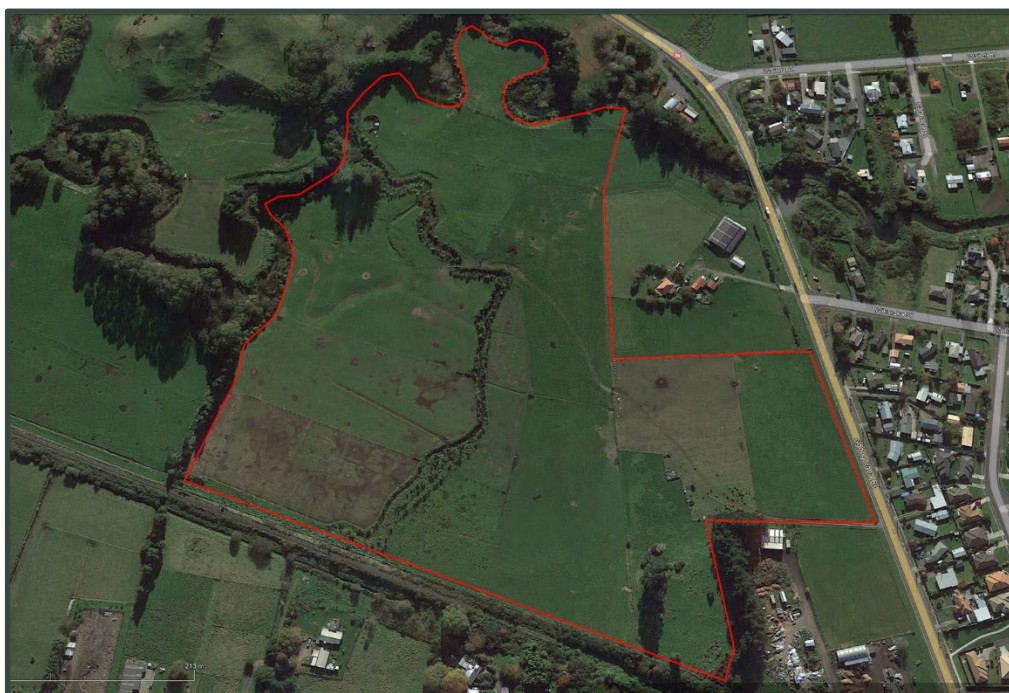
Overall, the property is dominated by improved pasture (Figure 1) and at the time of my site visit was being actively managed for animal grazing (Figure 2).

Figure 1: The property location (red polygon) illustrating coverage of pasture vegetation.

This assessment relates to the whole property as shown in Figure 1. I understand 'Stage 1' of the development for which the Fast Track application is being sought is limited to the south-eastern portion of the site. This area of the site is relatively simple from an ecological perspective, as it comprises of two paddocks of improved pasture and a paddock of rank grass.

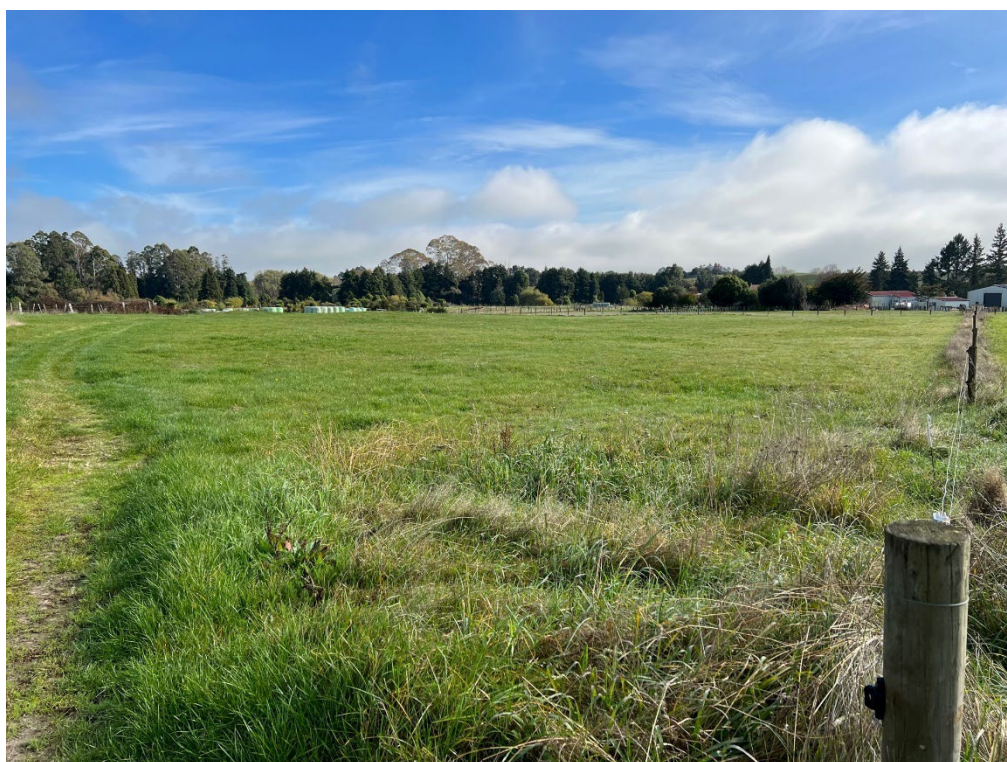
Figure 2: A view of the dominant vegetation. Photo take from site entrance on Ngongotahā Road looking in a north-westerly direction.
