## Appendix B: Investigation Data

# EXCAVATION LOG

## 6. Conclusion and recommendation

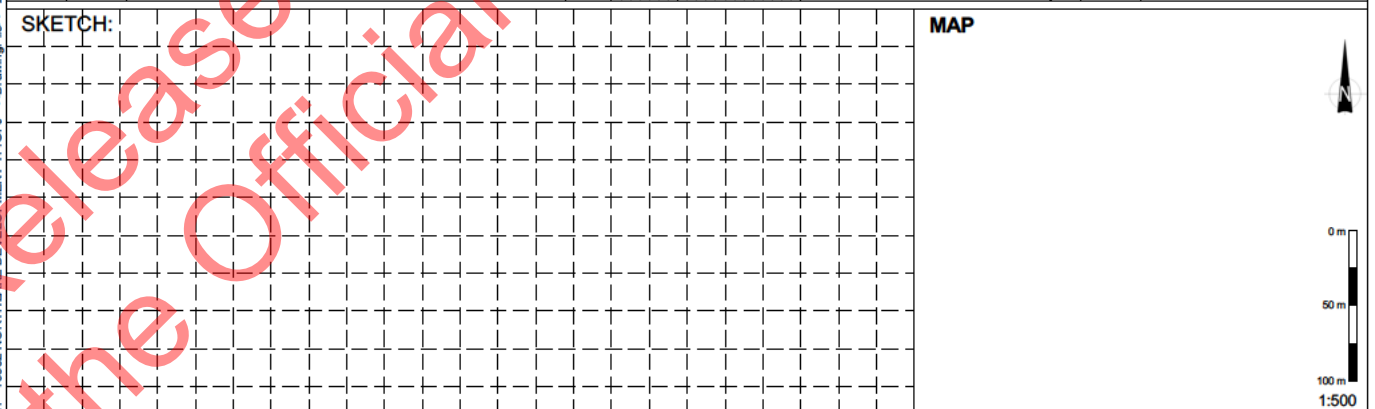
<b>SKETCH:</b>	<b>MAP</b>

Elevation (m LINZ)	Depth (m)	Geological Description (refer to separate Geotechnical and Geological Information sheet for further information)	Legend	Weathering	Field Strength Soil   Rock	Defect Description (type, orientation, spacing, roughness, persistence aperture, infilling etc)	Groundwater	Samples	Tests
+328.30									
+328.15	0.15	SILT with some sand and minor rootlets <1mm; brown. Dry, non-plastic; sand, fine. (TOPSOIL)							
+327.97	0.33	SILT with some sand and trace gravel; light yellowish brown. Dry; slightly plastic (when wet); hard; sand, fine; gravel, fine; subrounded to subangular; schist and quartz. (LOESS/LOESS-COLLUVIUM)							
	1	Silty fine to coarse GRAVEL with some sand; light brown. Gravel, subrounded to subangular, schist and quartz; sand, fine to medium. (GLACIAL OUTWASH)

1.10m - 1.80m Grades to cobbly GRAVEL with some sand; grey. Sand, medium to coarse.							
+326.50	1.80								
	2	SILT with some gravel and sand; greyish brown. Moist; slightly plastic; dilatant; sand, fine to medium; gravel, fine to coarse, sub rounded to subangular, schist and quartz. (GLACIAL TILL)							
	3								
+325.20	3.10								
		EOH @ 3.10 m

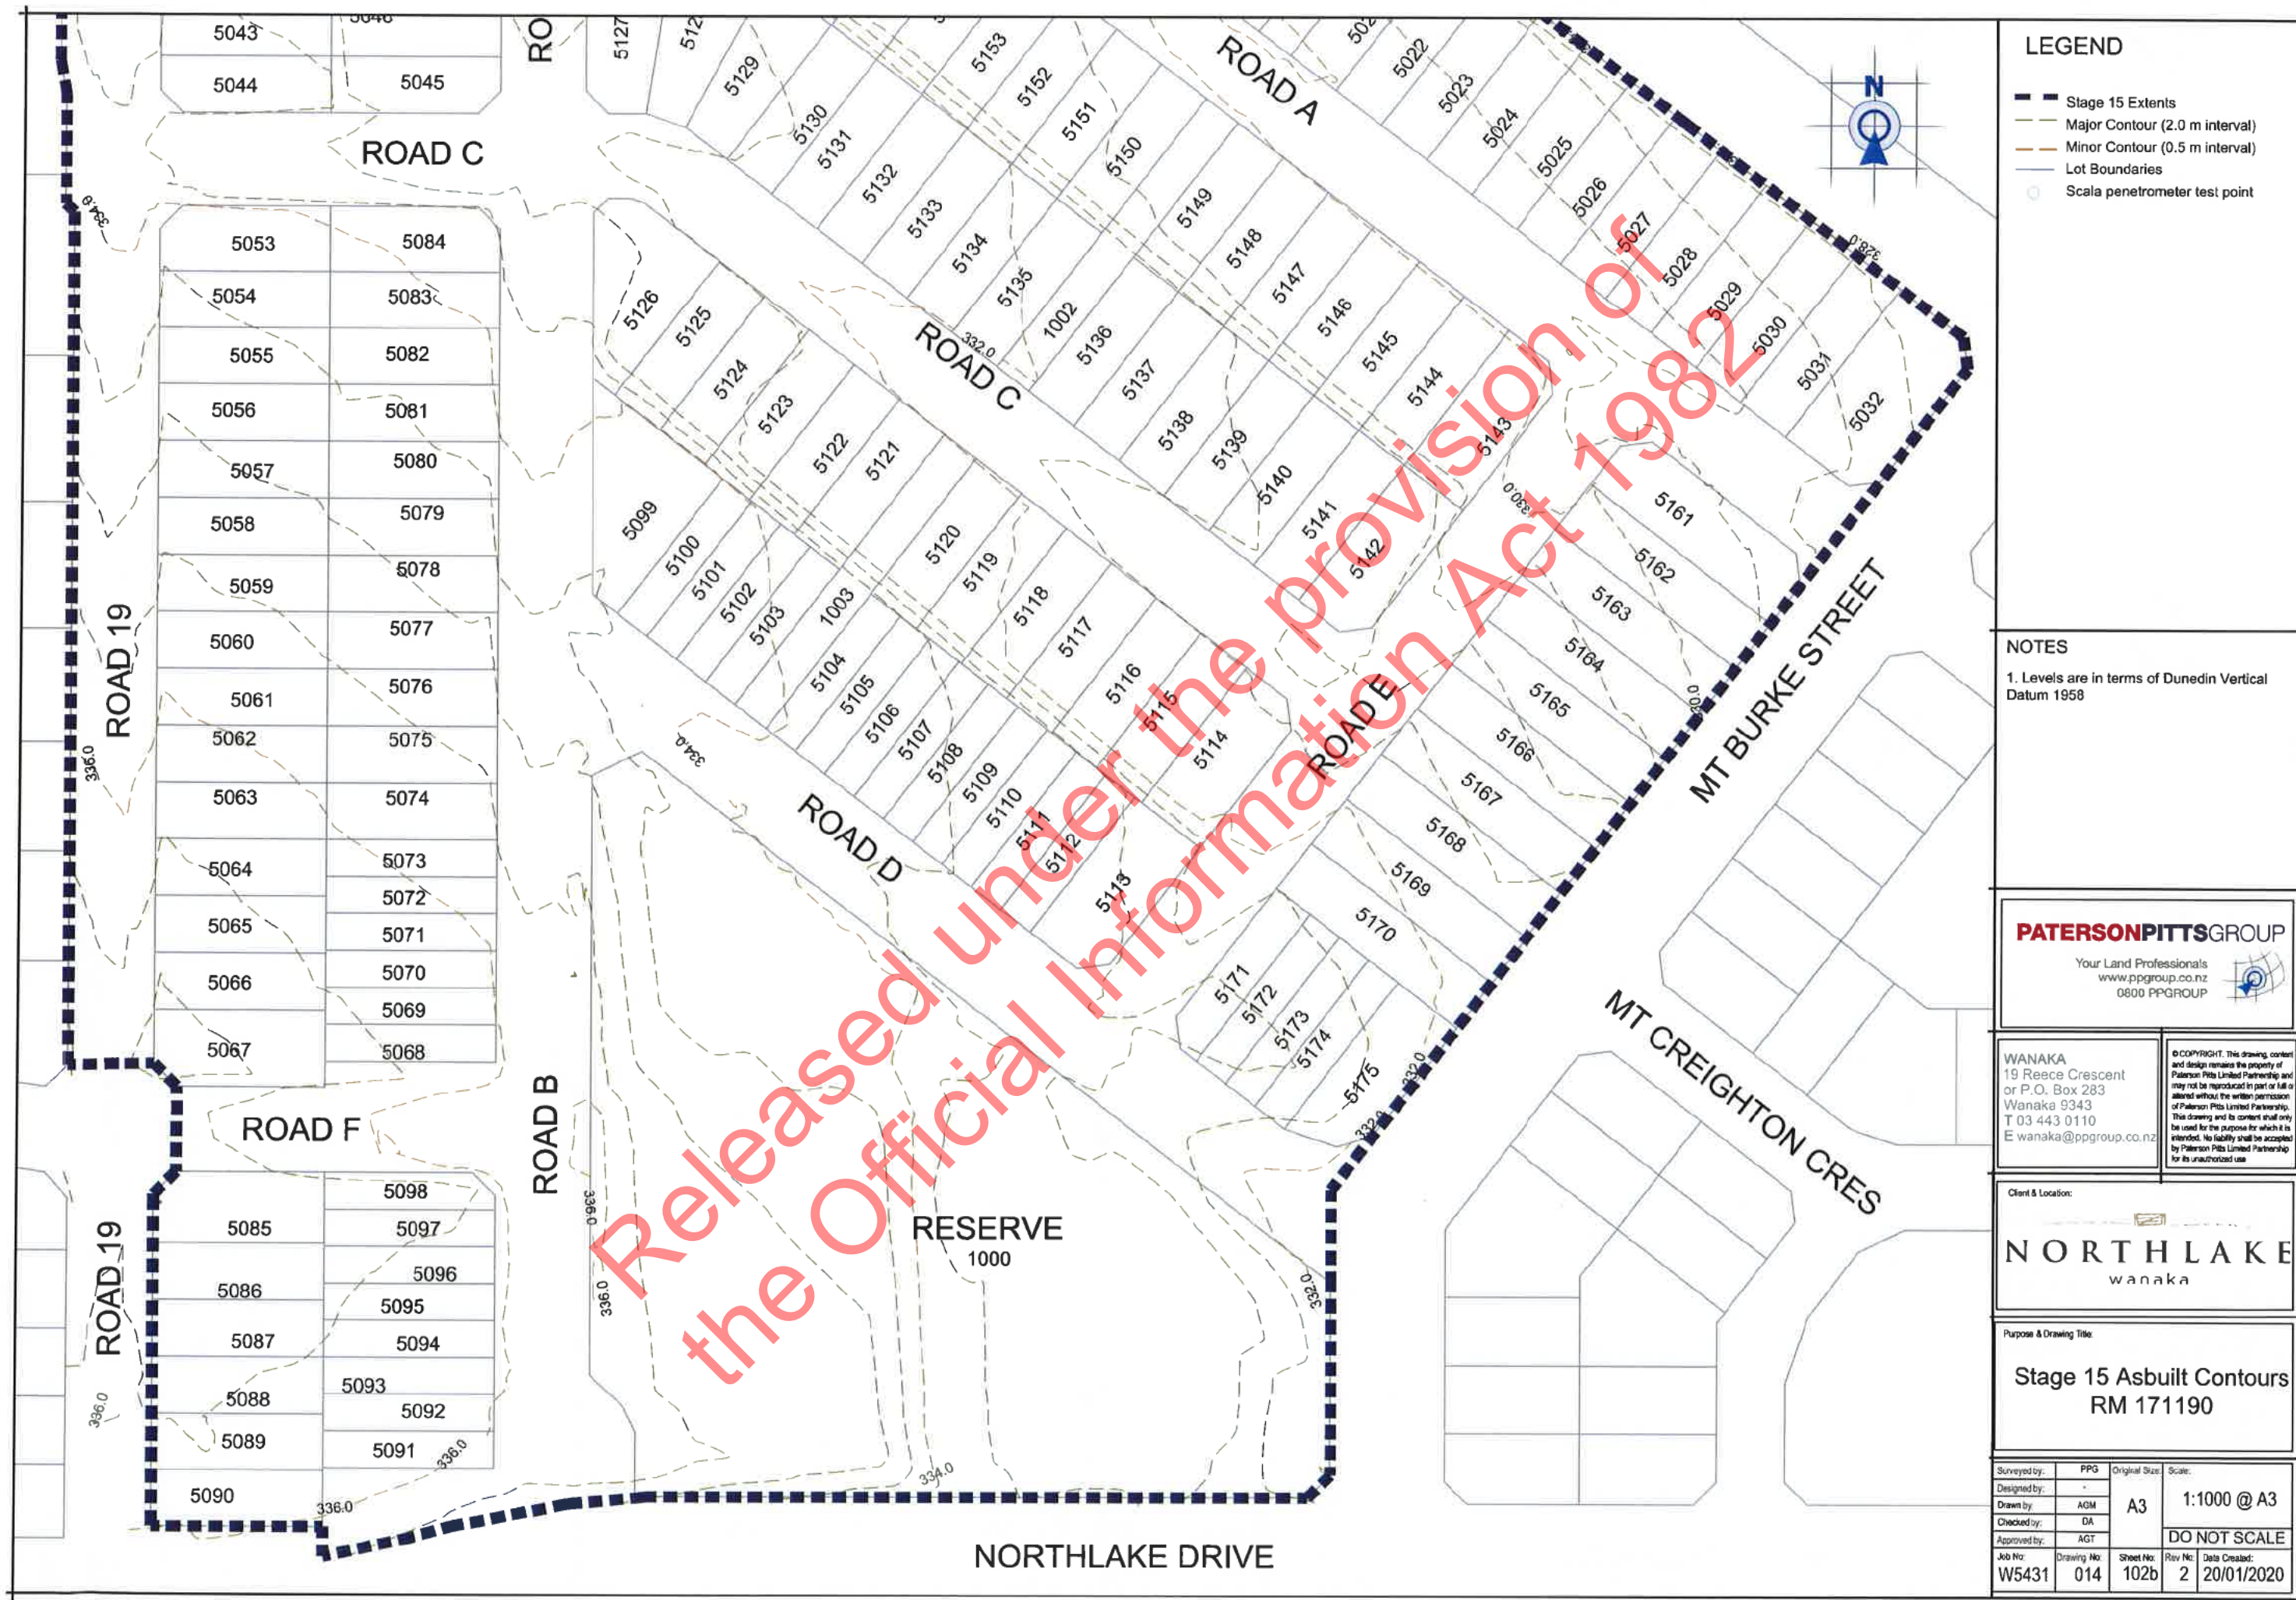
**Stage 15 Asbuilt Contours**  
**RM 171190**

- LEGEND**
- Stage 15 Extents
  - Major Contour (2.0 m interval)
  - Minor Contour (0.5 m interval)
  - Lot Boundaries
  - Scala penetrometer test point

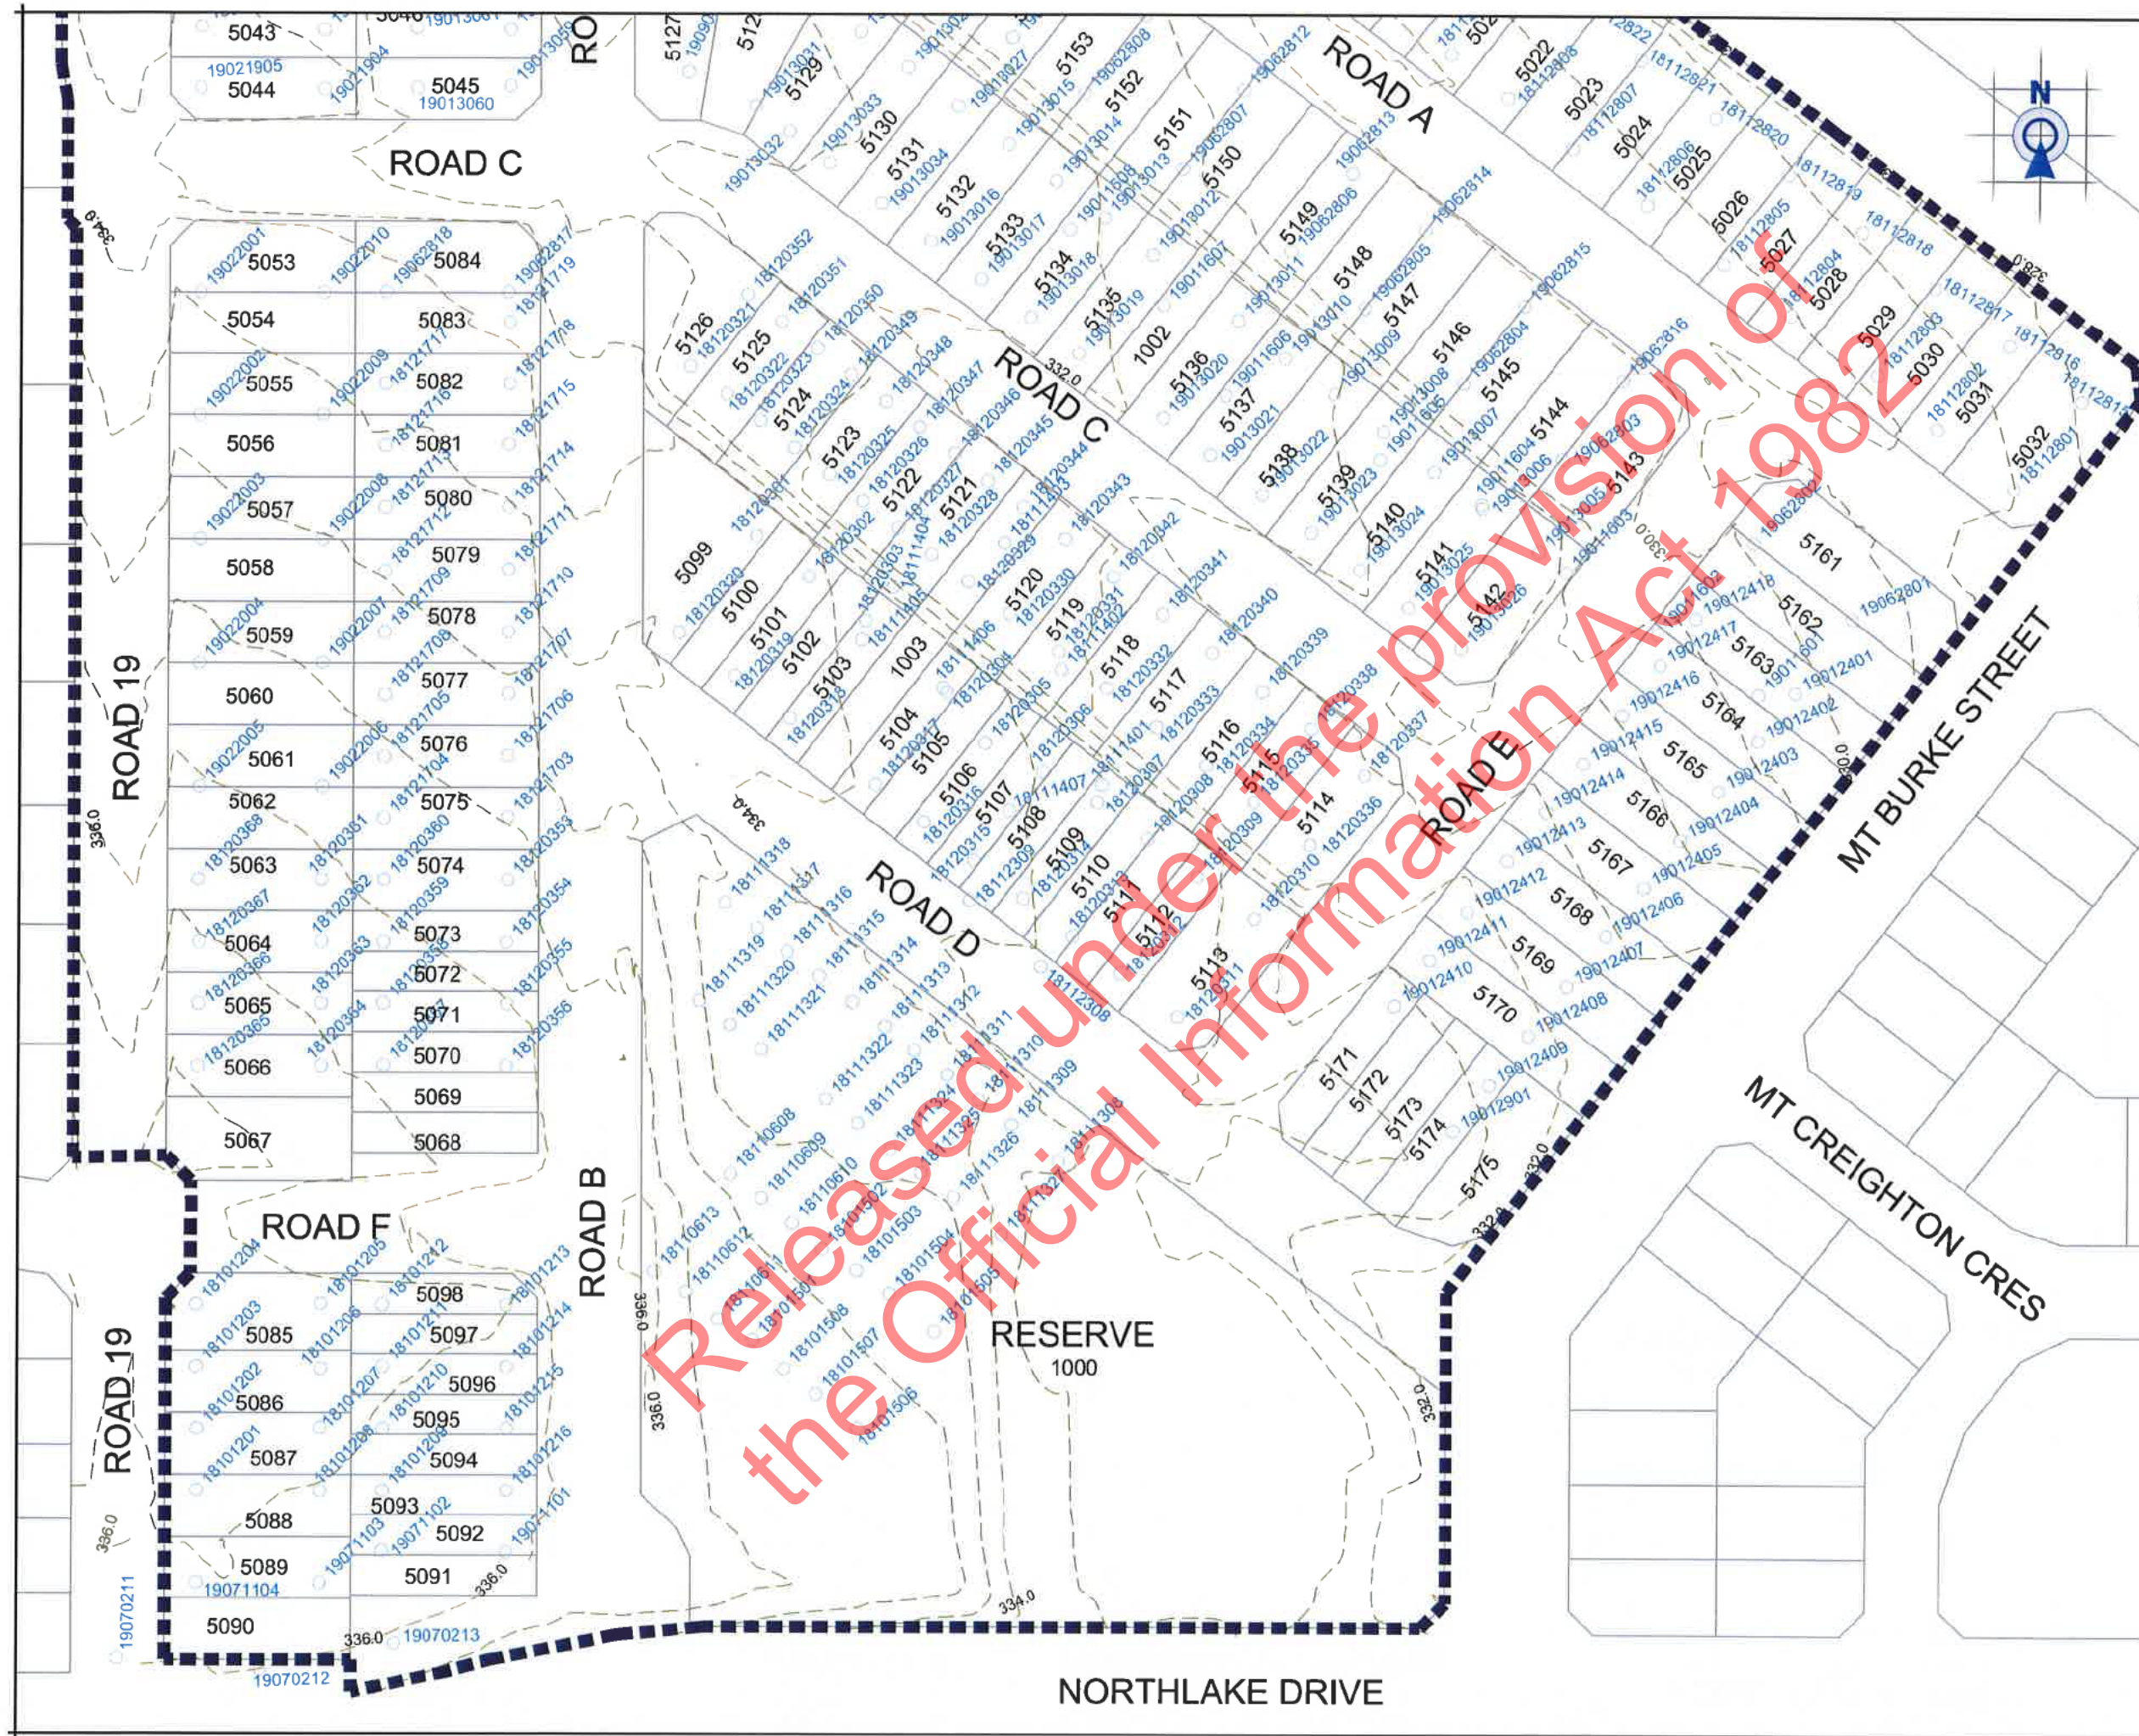
From the as built contour plan it can be observed stage 15

- (b) The completed works take into account land slope and foundation stability considerations, subject to the appended foundation recommendations and earthworks restrictions, (which should be read in conjunction with the appended final site contour plan).
