DETAILED SITE INVESTIGATION (DSI)

55 BROOKVALE ROAD, HAVELOCK NORTH, HASTINGS

REFERENCE NUMBER: REP-H0155/DSI/JUN21

PREPARED FOR: ODERINGS NURSERIES CHCH LTD

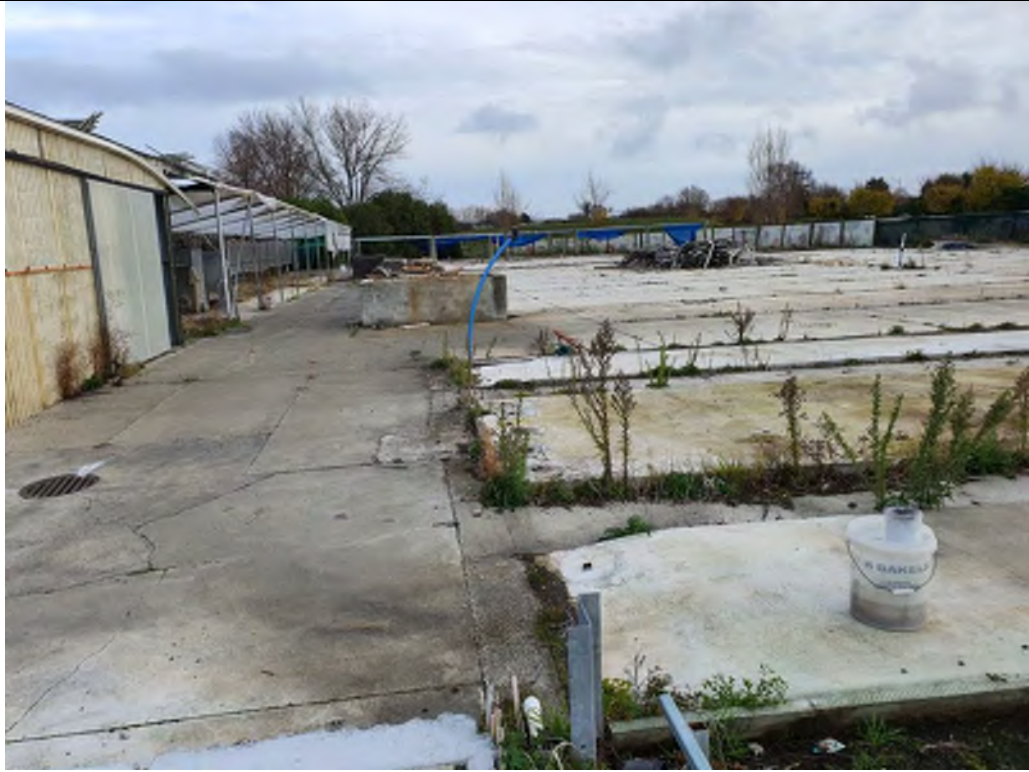
The rear portion of the site has been altered since the most recent aerial image with the bulk of glass and shade houses now removed from the site, leaving only the concrete foundations. One glasshouse remains on the southern edge of cluster closest to the garden centre itself while shade house structures are present in the north western corner. Some residual stacks of timber and metal were present on site from the demolition activities, however no evidence of any asbestos containing materials was directly observed. Small piles of refuse were noted on the north eastern edge of the glasshouse adjacent to the gravel accessway.

PLATE 1: REAR OF SITE WITH RESIDUAL CONCRETE AND MINOR SHADE HOUSE REMNANTS.

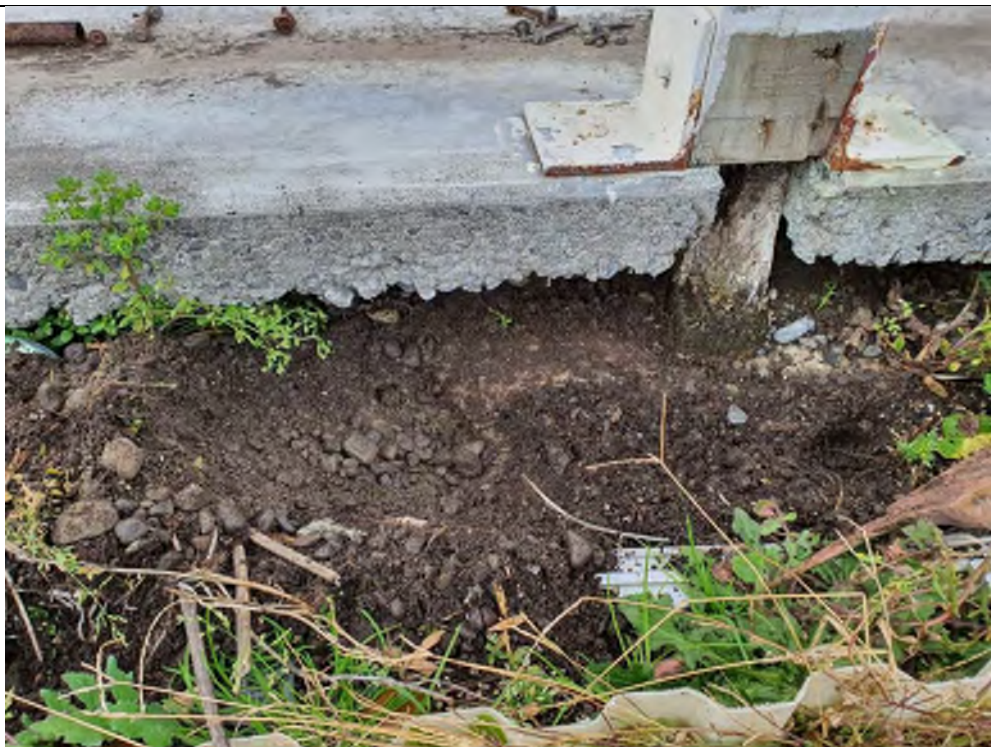
As asbestos containing materials were noted in the property file as being utilised for foundation construction, GSL endeavoured to excavate test pits adjacent to the concrete slab to determine if any residual products could be identified. No evidence of any buried asbestos containing materials were noted, however it appeared that a slab had been repoured across the top of the oldest glasshouse. Excavation on this side wall identified degrading timber foundation poles, but nothing

PLATE 2: EDGE OF OLDEST GLASSHOUSE SHOWING FOUNDATIONS WITHIN TEST PIT.

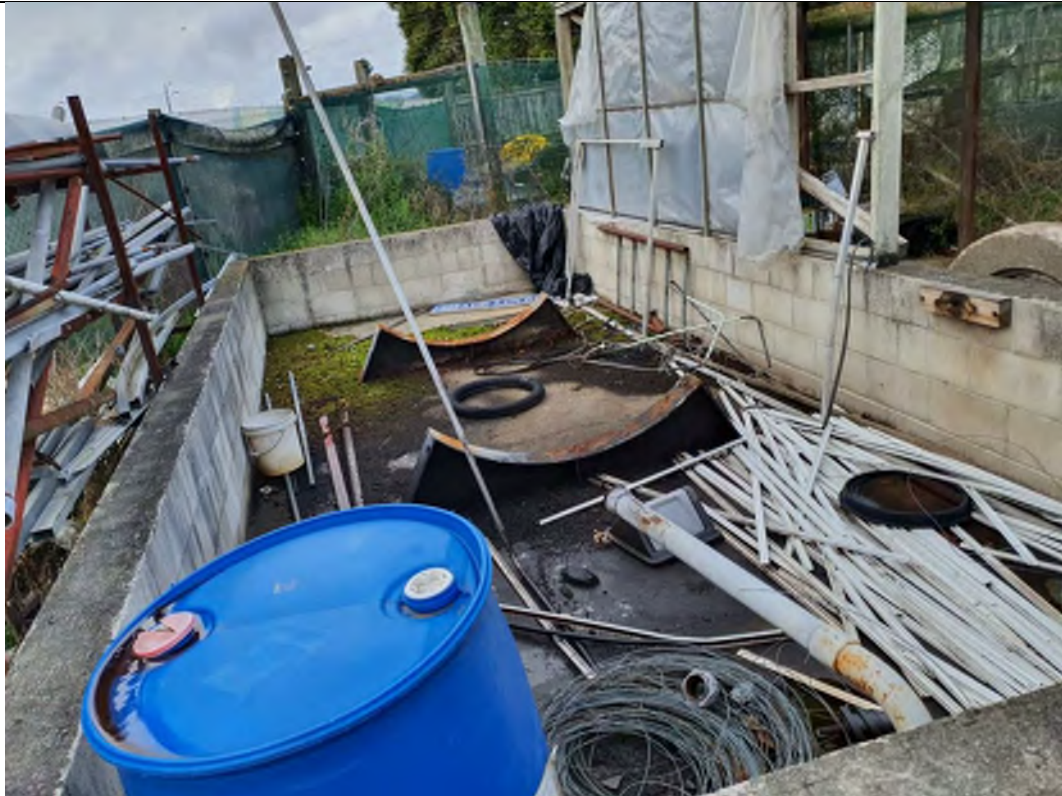
A diesel tank had been present on site to provide fuel source for the boiler room and distribution amongst the glasshouses. Inspection of the area confirmed that the bund remained in place with no distinct evidence of degradation or damage. The area concrete within the bunded footprint was heavily stained and some residual diesel odour was noted. Access to the area of the diesel tank was via a gravel track along the north eastern edge of the site and it was clear that any refuelling activities would have had to have occurred from this location.

PLATE 3: FORMER DIESEL TANK BUND WITH STAINING EVIDENT IN FOREGROUND.

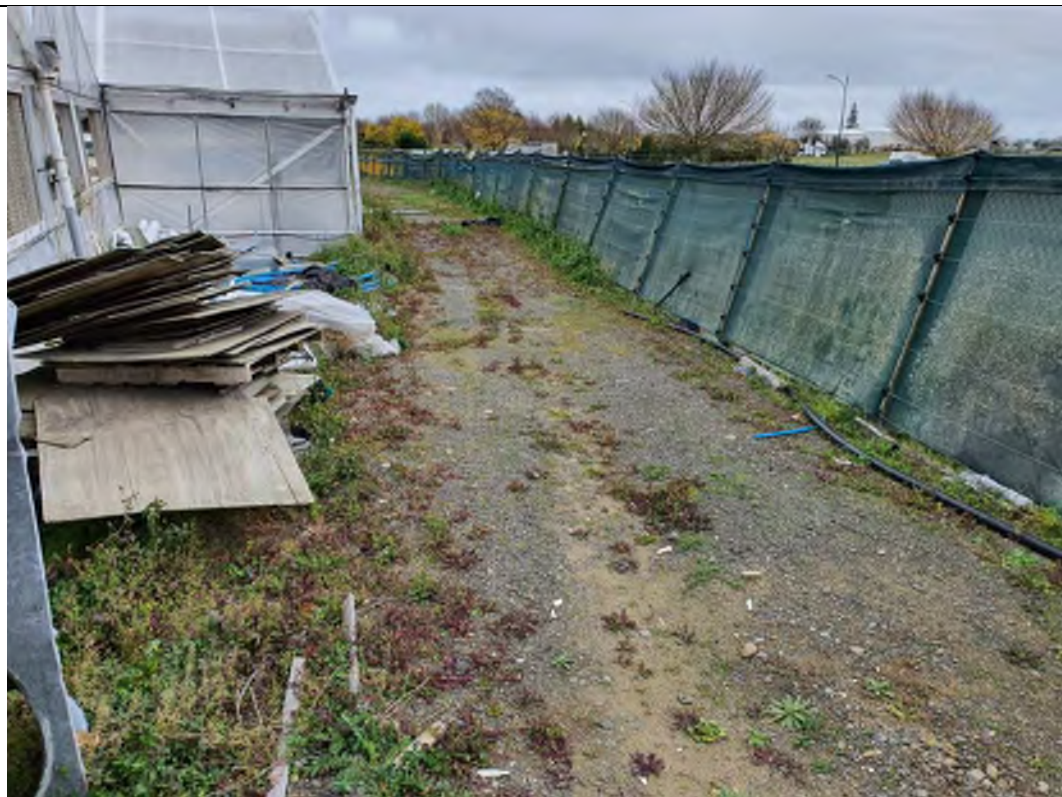
PLATE 4: AREA OF STORAGE BEHIND RESIDUAL GLASSHOUSE.

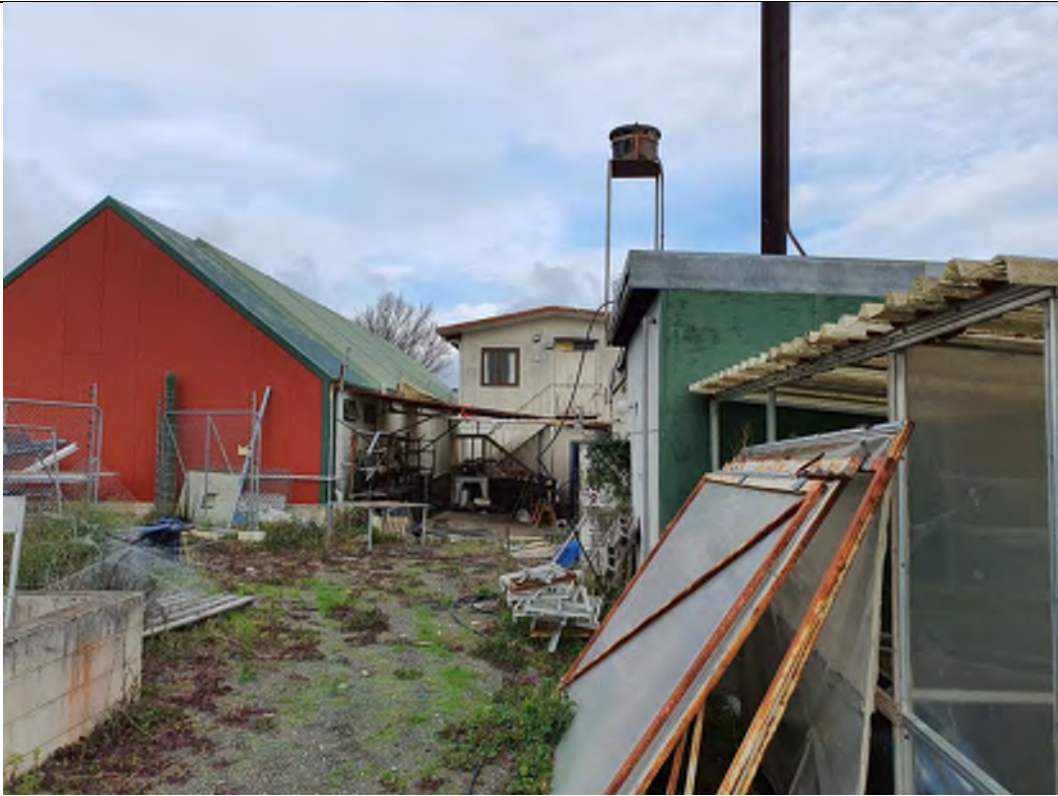
Inspection of the boiler house and residual building infrastructure, understood to be the former Plant Propagation Laboratories lab identified residual flat fibre cement sheeting still present on these buildings. Visual observations did not note any distinct evidence of damage or degradation of these building materials considered to present a risk of soil contamination.

PLATE 5: REAR OF BOILER HOUSE SHOWN RIGHT OF FRAME WITH FORMER LABORATORY CENTRE AND OPERATIONAL GARDEN CENTRE LEFT.

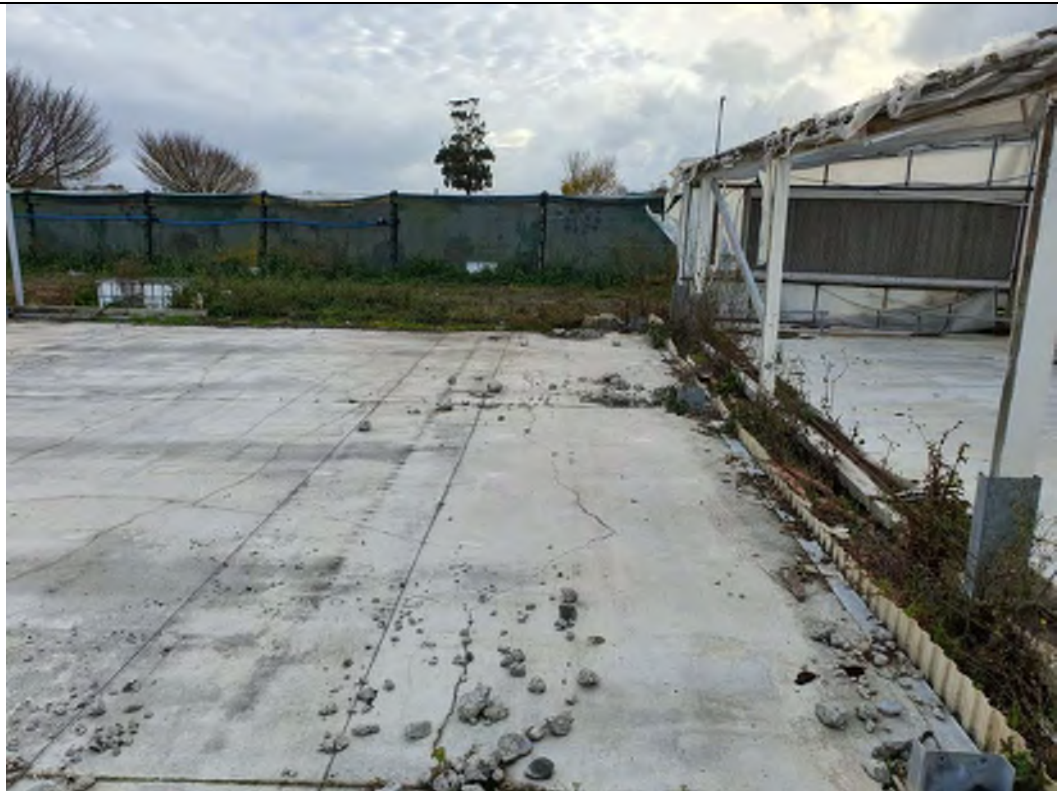
PLATE 6: RESIDUAL CONCRETE FOUNDATIONS WITH FIBREGLASS PRESENT ON EDGES.
