Preliminary Freshwater Ecology
Assessment

PRELIMINARY ECOLOGICAL SURVEYS OF THE PROPOSED MIMIHAU WIND FARM SITE, SOUTHLAND

Contract Report No. 6656

February 2023

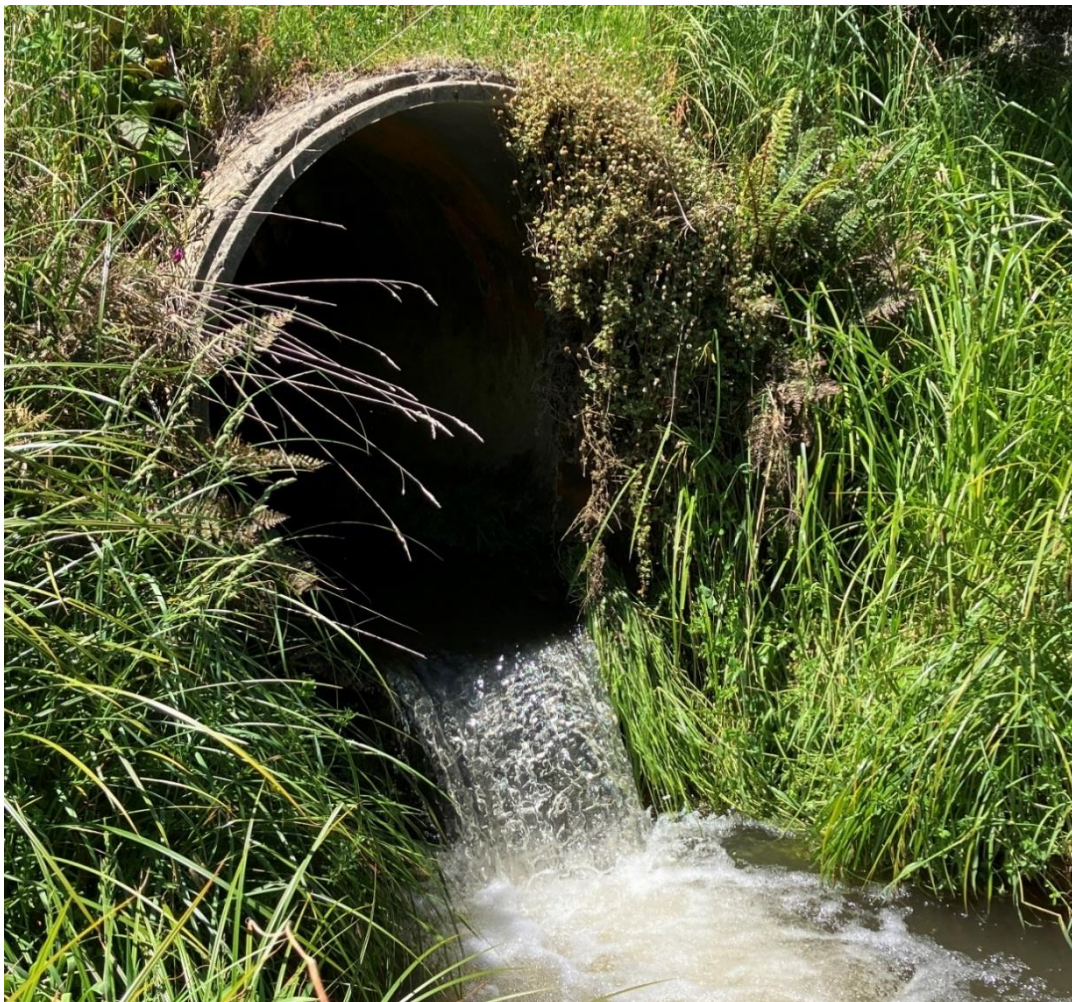
Plate 1: Downstream end of the perched culvert identified at Site 2.

Site 2 had a significantly perched culvert (Plate 1); this culvert has a drop of approximately 0.35 metres and is undercut by approximately 0.15 metres. Indigenous fish cannot jump over obstacles as trout can; they can climb past obstacles, but not upside-down. The concrete culvert is narrower than the stream, increasing the velocity within the culvert, this creates a velocity barrier.

The two structures causing fish passage issues require remediation, which will increase the potential habitat available to fish within the surrounding waterways. Remediation at Site 4 will be simple, as it only requires clearance of debris from the upstream side of the triple-barreled culvert, although this will need care as the debris may be providing refuge for a number of species. Remediation at Site 2 will be more involved. The significant fall height and undercutting means a simple remediation such as installation of spat rope will be insufficient. A fish ramp or similar structure is recommended for the downstream end, with works to improve the upstream alignment. However, if this road is to be upgraded for windfarm access purposes, a complete replacement of the structure would give the best outcomes for restoring fish passage.

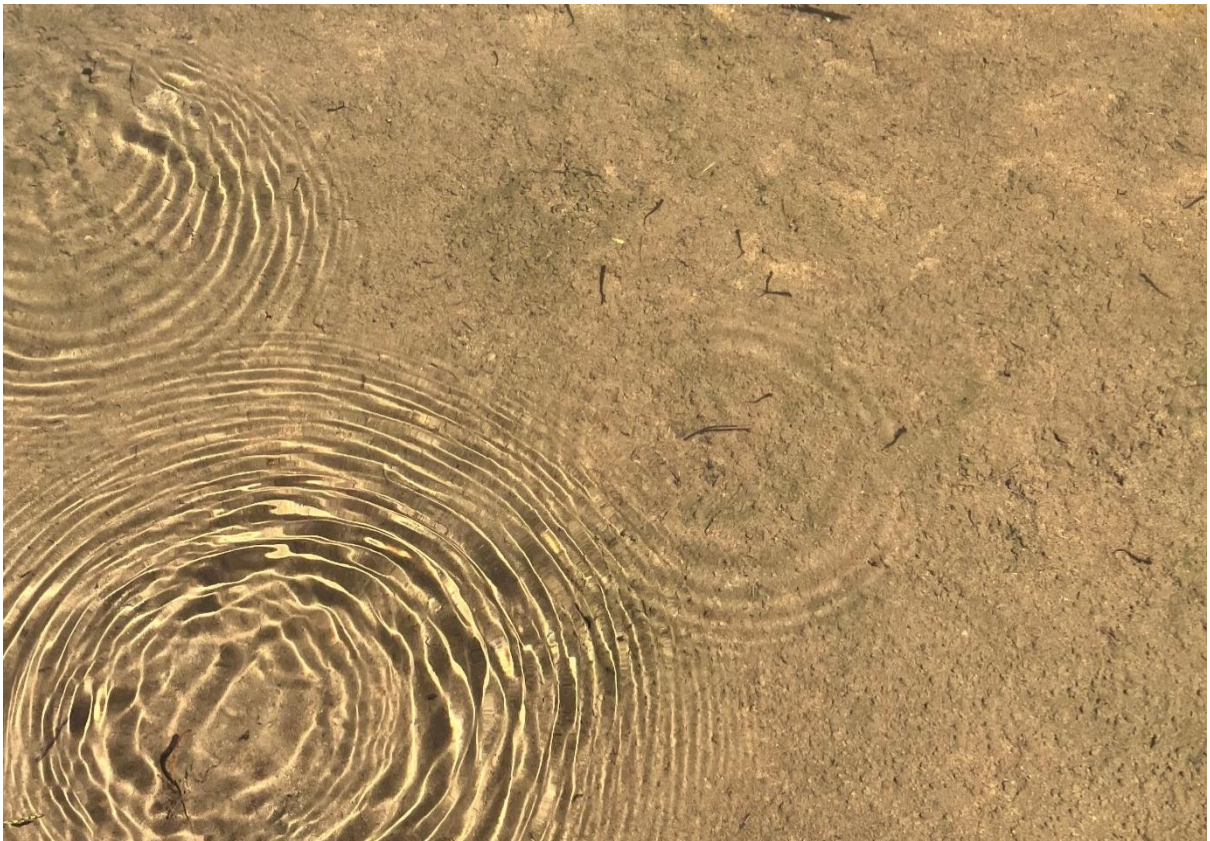
Plate 2: Juvenile galaxiids observed at Site 1, shadows of the fish are more visible than the fish themselves

Of the 56 galaxiids caught, 53 were between 45 and 80 millimetres, and the remaining three were significantly larger at 10.5, 10.5 and 13.5 centimetres (Figure 2). Additionally, groups of small galaxiids were observed at sites 1 and 4, these fish were likely post-larvae juveniles and were small enough to evade capture in either trap or net (Plate 2). The presence of these juvenile fish is a positive indicator of population health and successful recruitment.

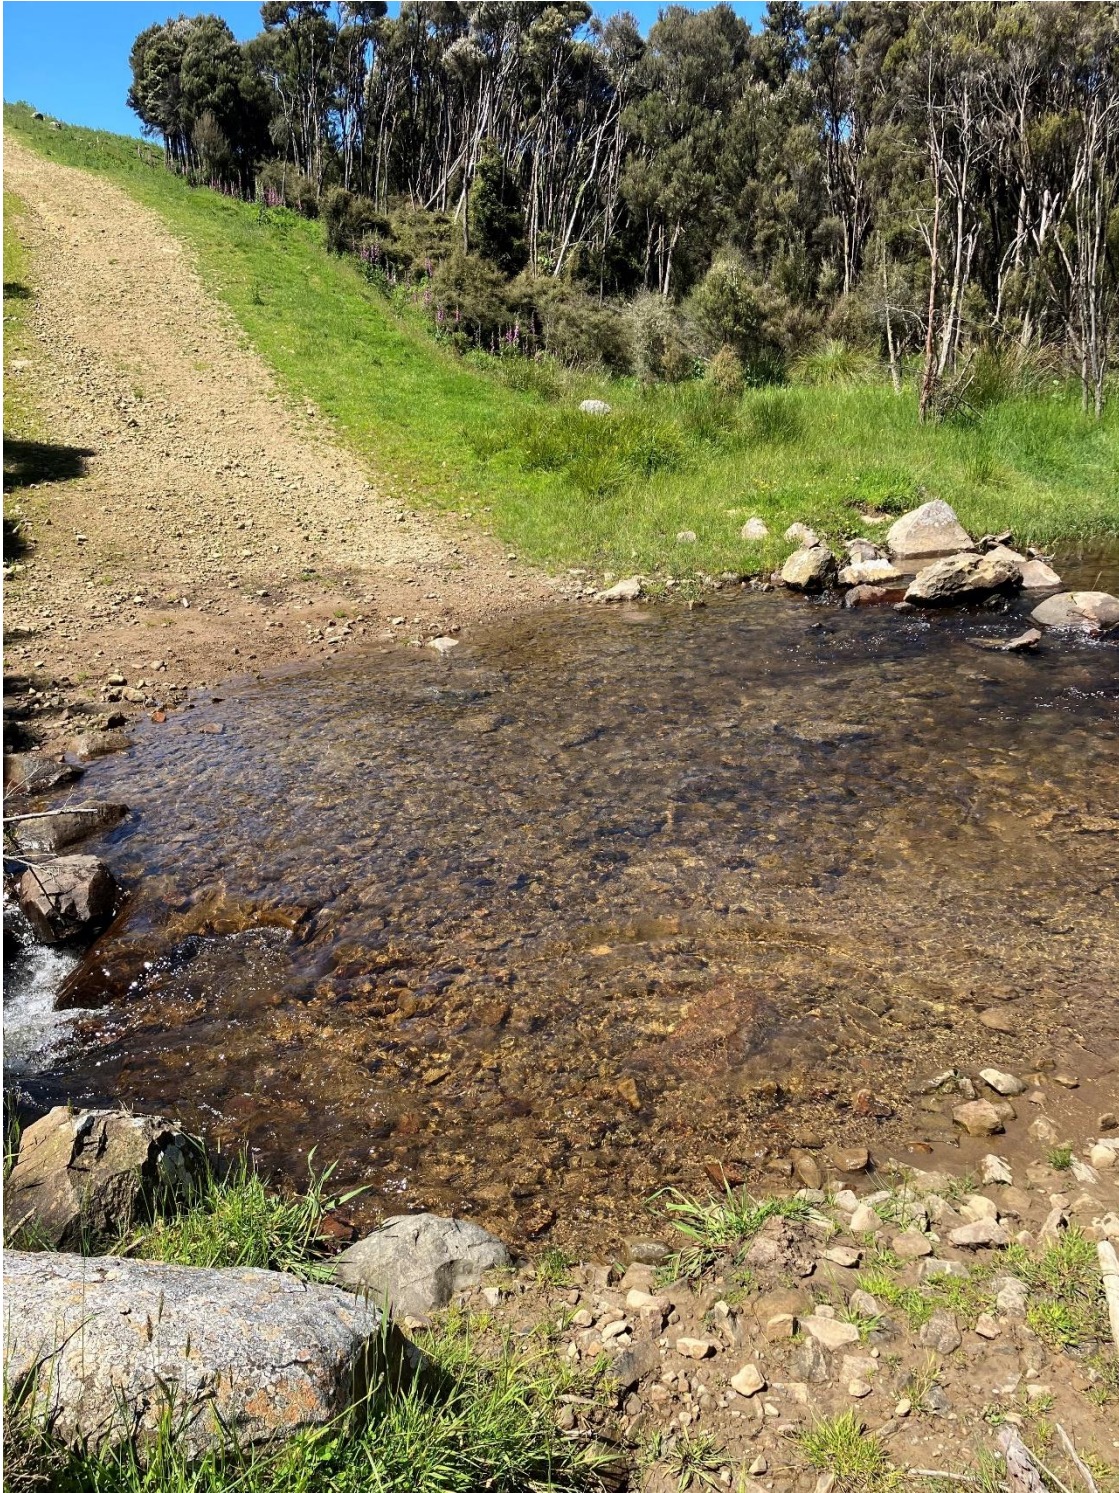
- At site 1, there is a ford present (Plate A2.1). It is comprised of large gravel and cobbles and posed no fish passage concerns for smaller species at the time of site visit. There is the potential for issues for larger fish species, or for all fish species during periods of low flow.
- Site 3 is an excellent example of a fish-friendly structure; it is a large, single-barreled culvert with corrugations (Plate A2.4). There were some large rocks within the culvert itself, but these posed no issues for fish passage and may have a positive effect by providing fish cover within the culvert.
- Site 6 has many points along the stream bed where angled bedrock is exposed creating steep flows which may provide barriers to fish with poor swimming or climbing abilities.
- Sites 5 and 7 are both crossed by bridges which pose no fish passage concerns.

Plate A2.1: Ford crossing at Site 1, large gravel size and sufficient water depth ensures that fish passage is unlikely to be an issue during normal flows.

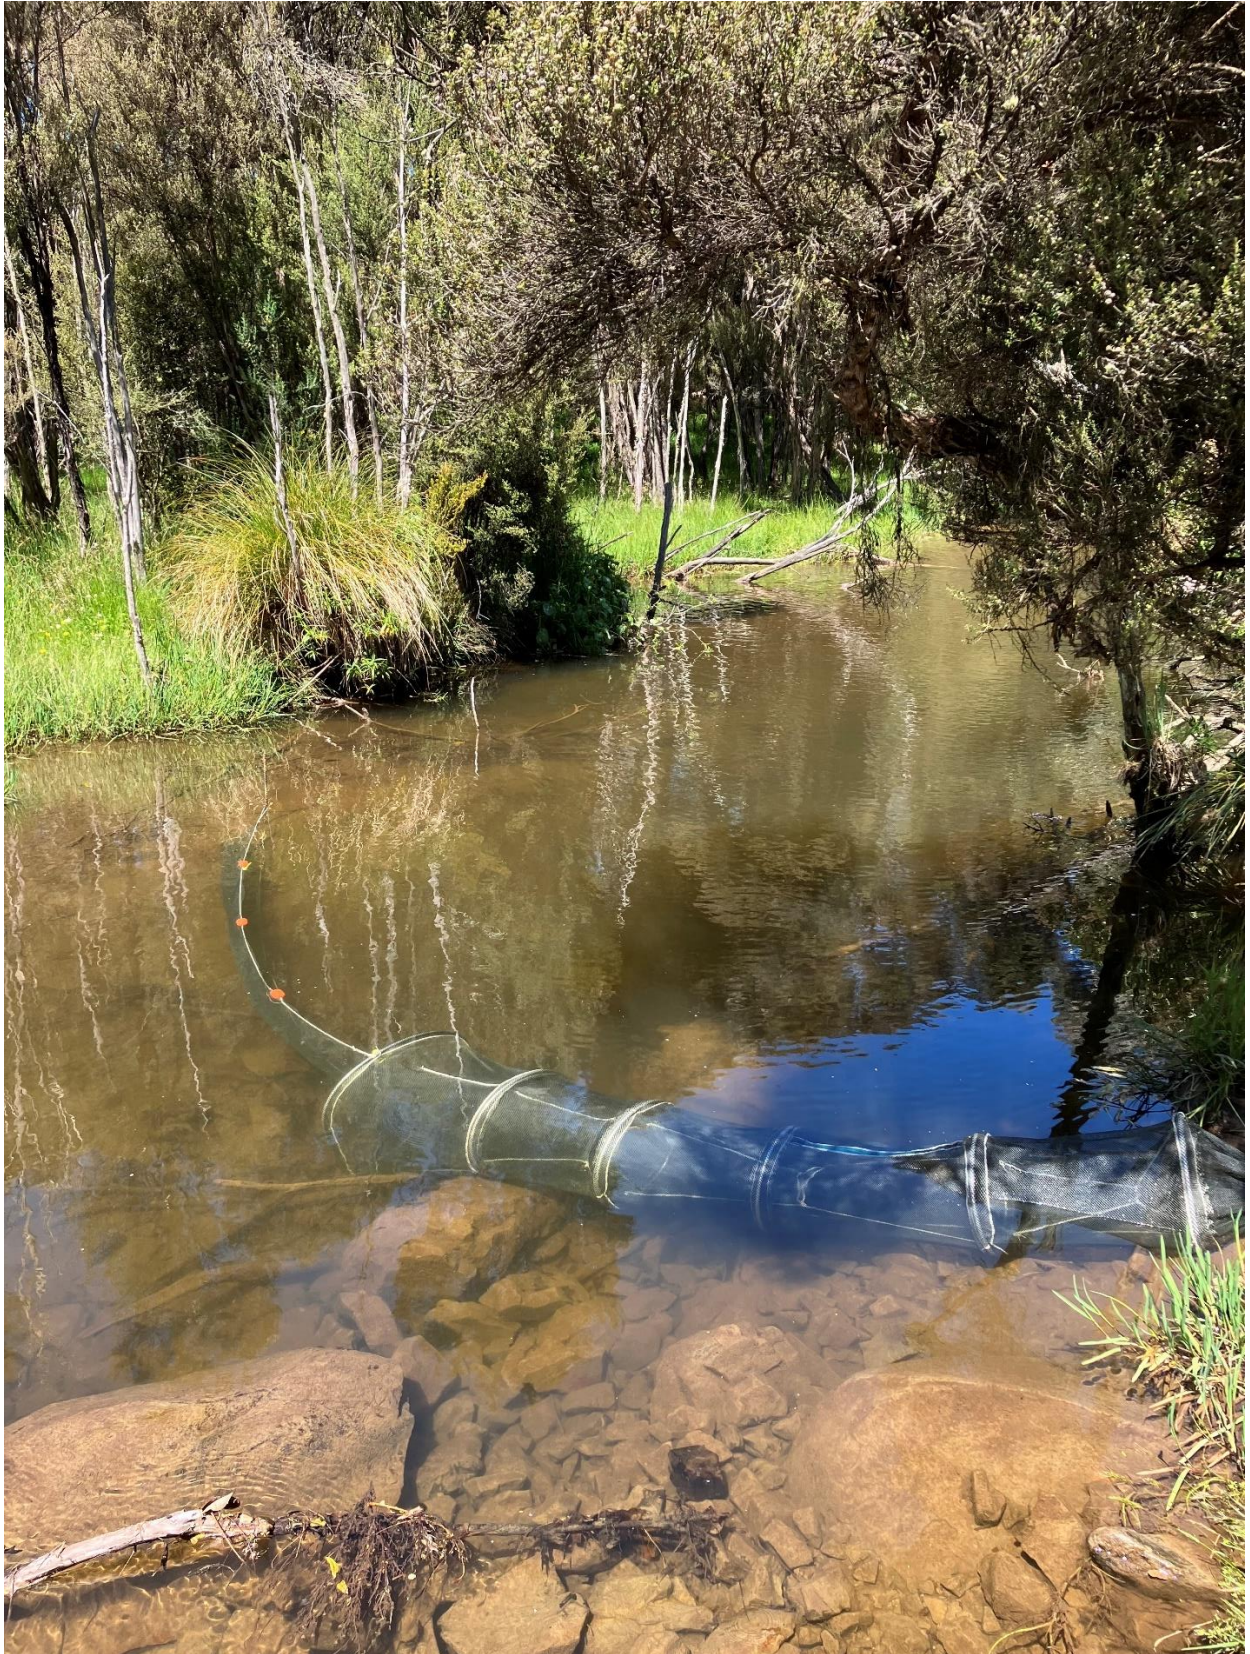
Plate A2.2: Fyke net set upstream of the ford at Site 1.

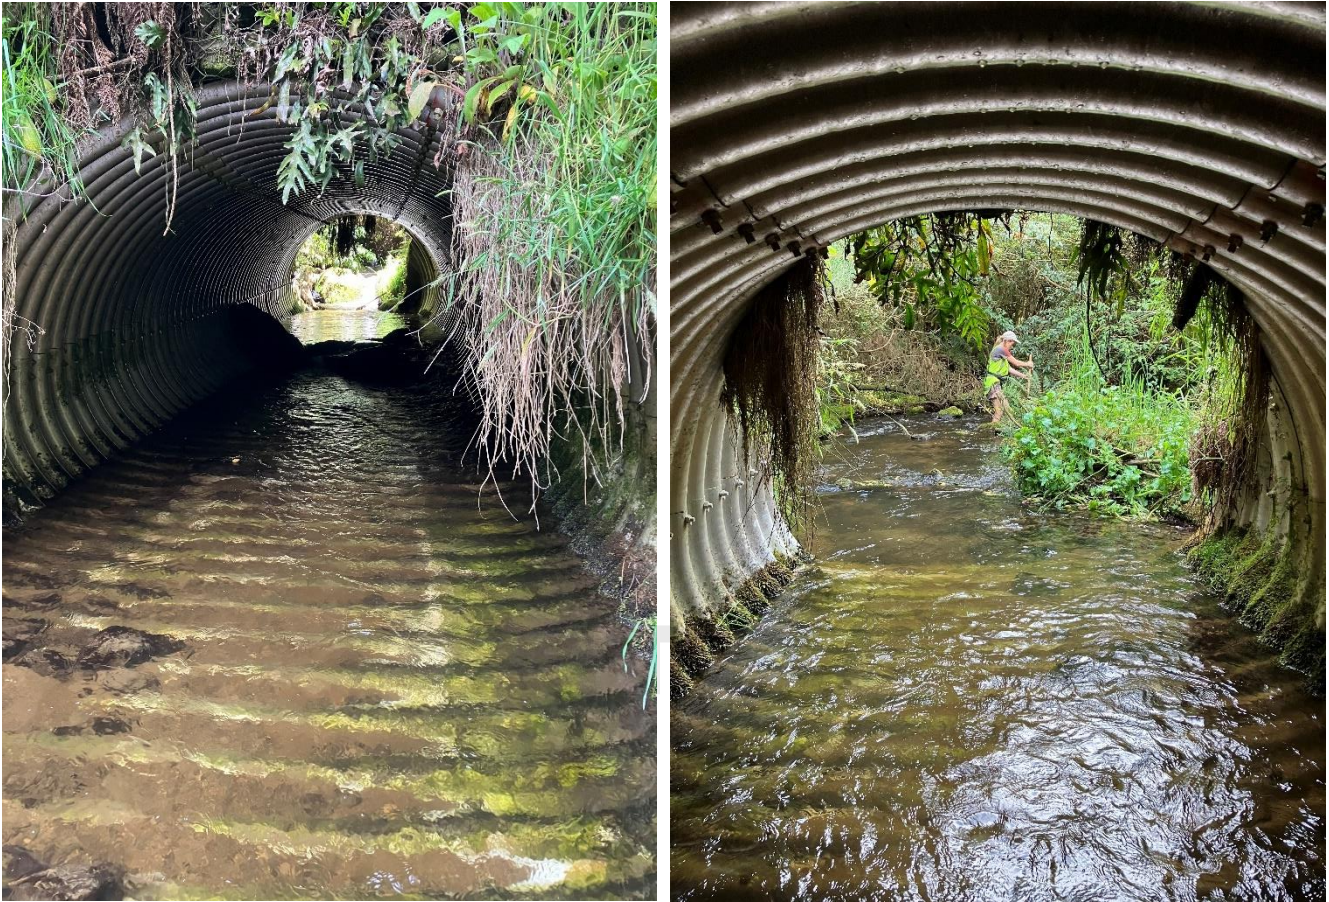
Plate A2.4: The culvert at Site 3 is an example of a fish-friendly structure. Views looking upstream (left) and downstream (right) from within the culvert. Width of the culvert is approximately that of the stream, and is in line with the stream both in and out. The water is a similar depth and velocity within the culvert as it is in the stream, and a small amount of bed material has collected within the culvert.

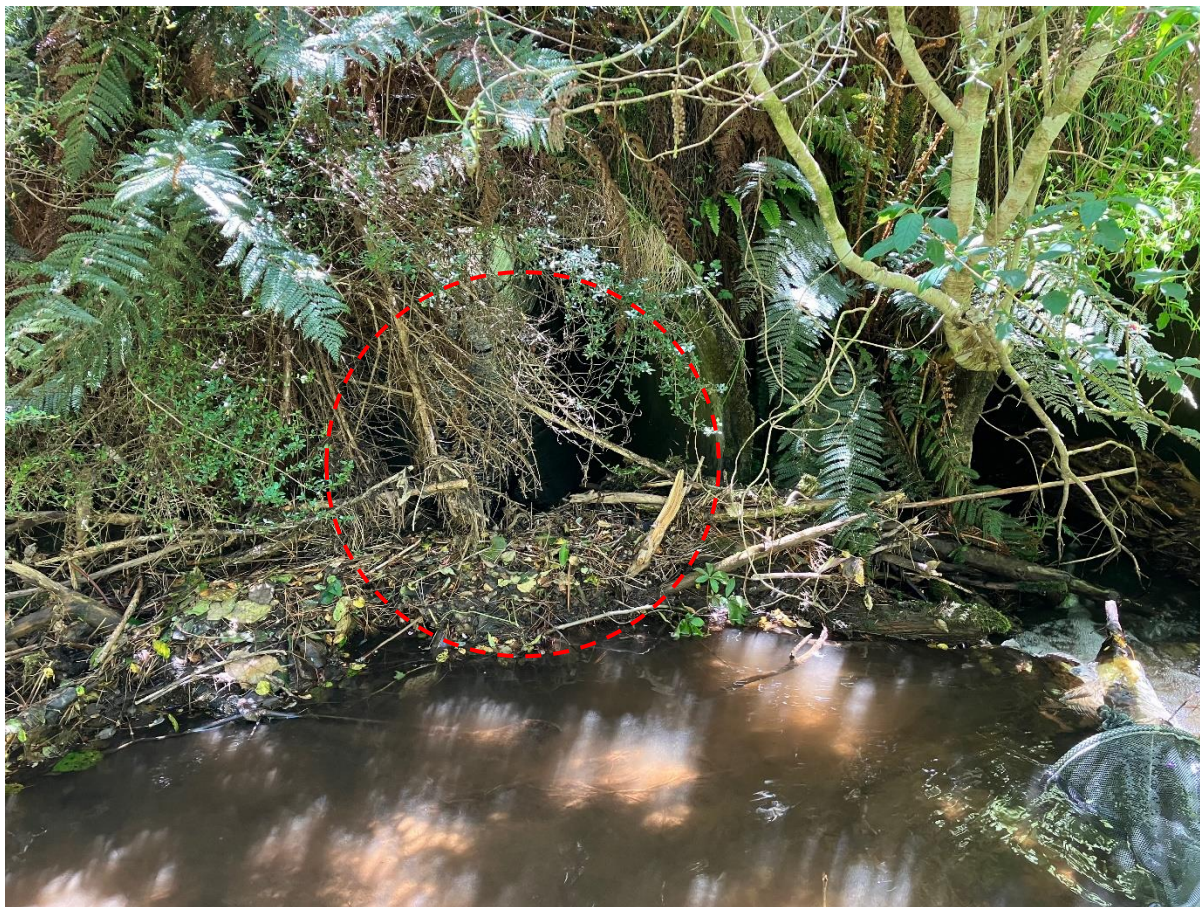
Site 4 has a slight barrier through a buildup of debris against the upstream end of the triple-barreled culvert partially blocking of two of the barrels and a small fall (approximately 0.15 metres) has formed around debris near the third barrel.

Plate A2.5: Debris build-up at the upstream end of the triple barrelled culvert at Site 4, this will restrict fish passage and has caused a small fall to develop, directing majority of the stream flow down the right most barrel. Dashed outline indicates the approximate location of the central culvert barrel.

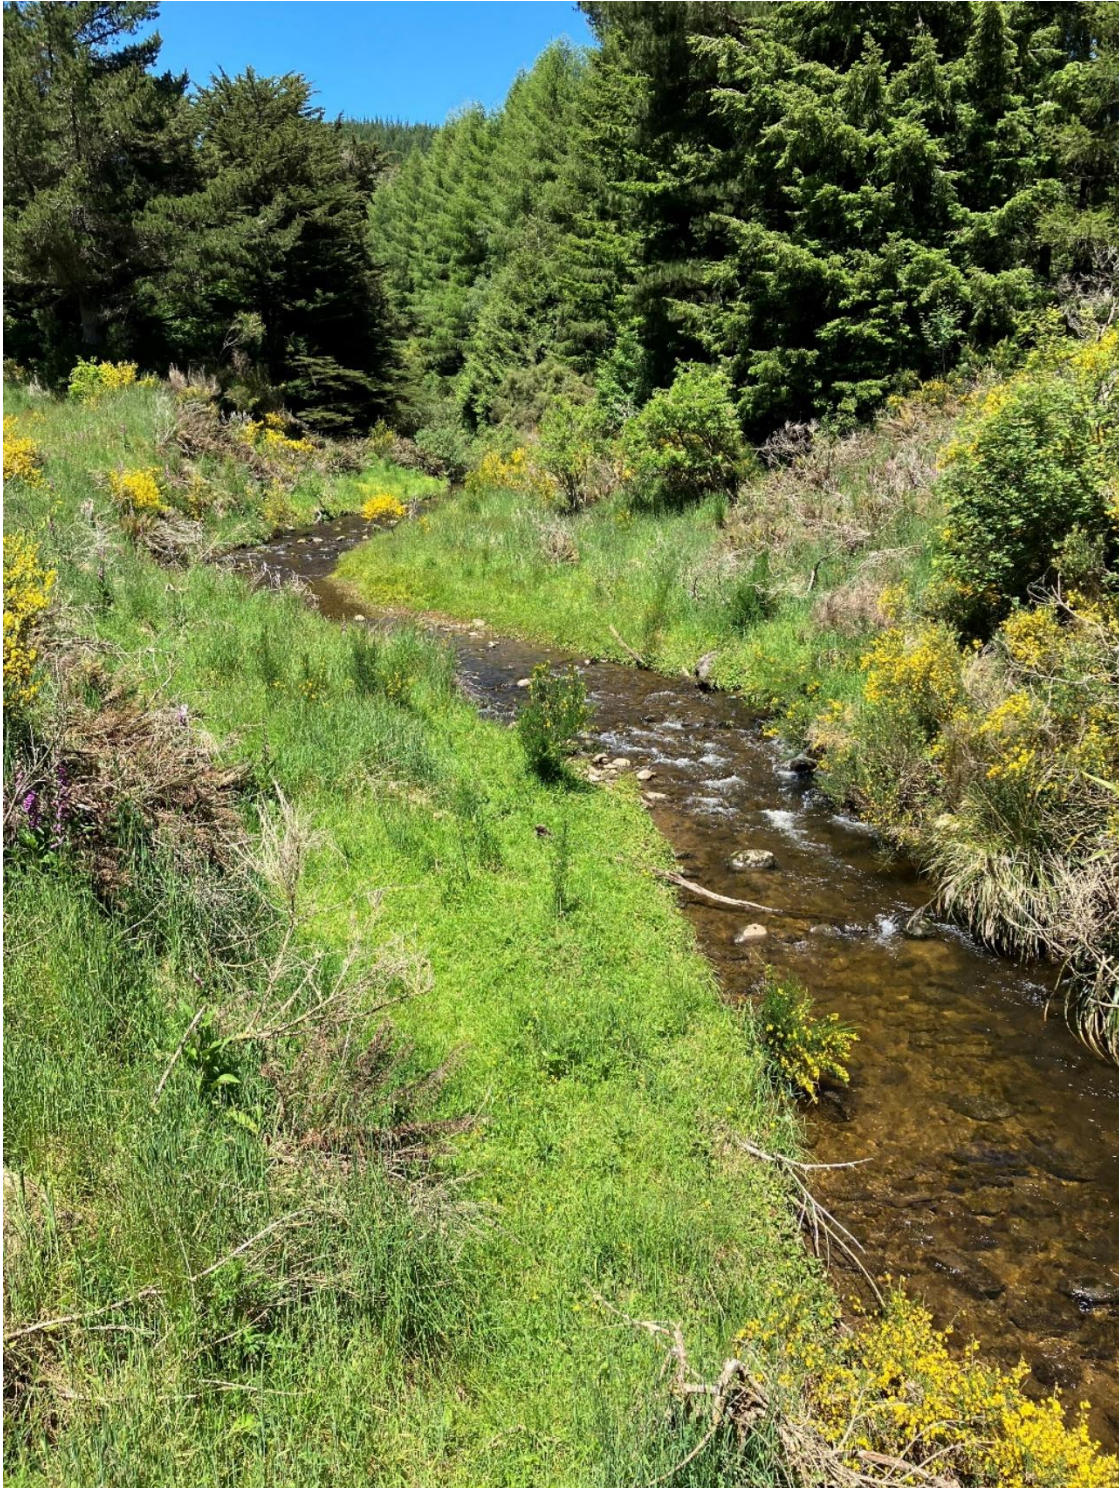
Plate A2.6: Site 5, this site had a well-defined riffle-run hydrological structure.

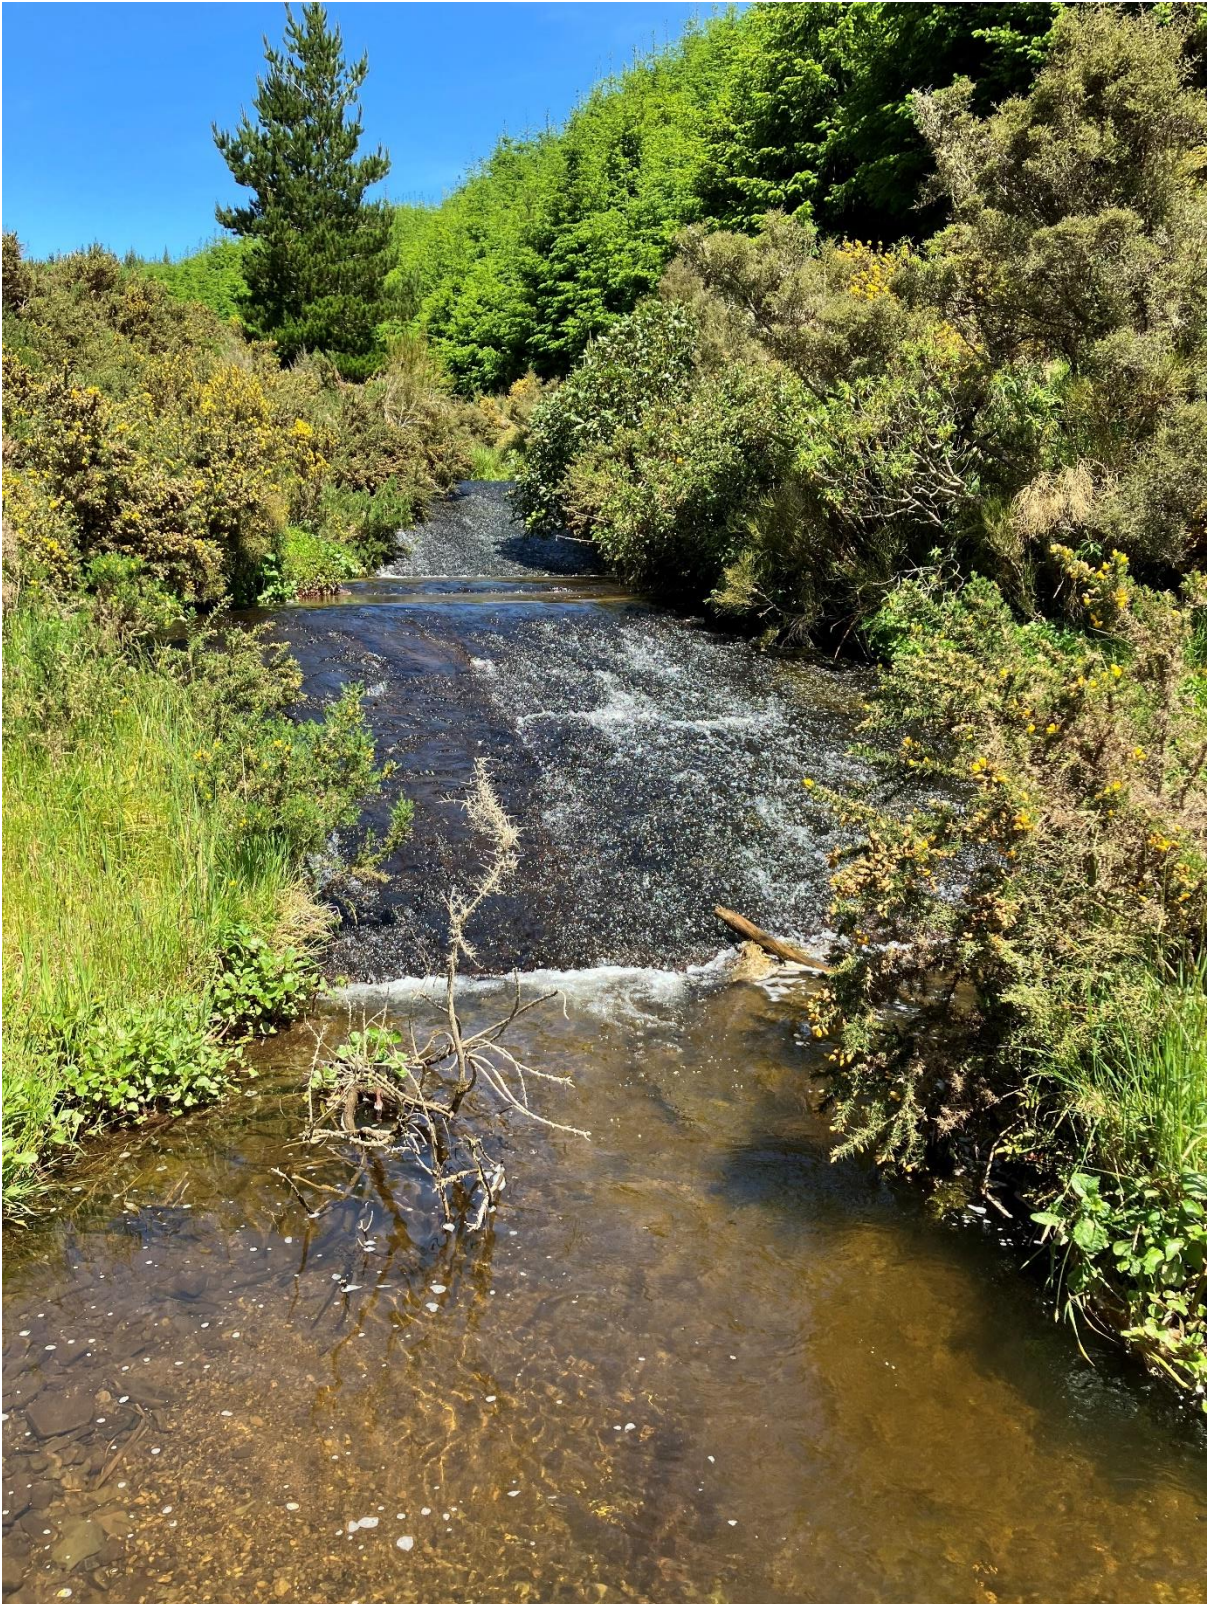
Plate A2.7: Stream bed formation at Site 6, where elevated bedrock forms sloped runs with deeper areas of pools between.

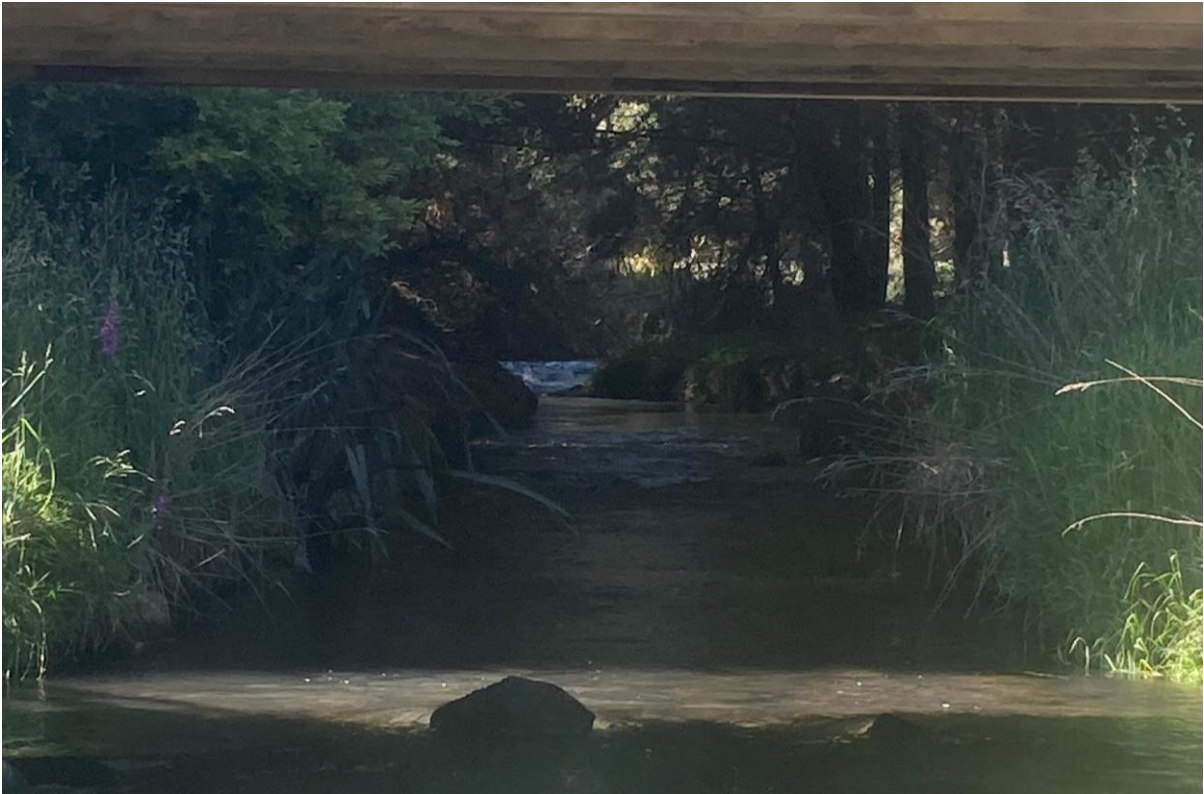
Plate A2.8 Natural fall upstream of the bridge crossing at Site 7

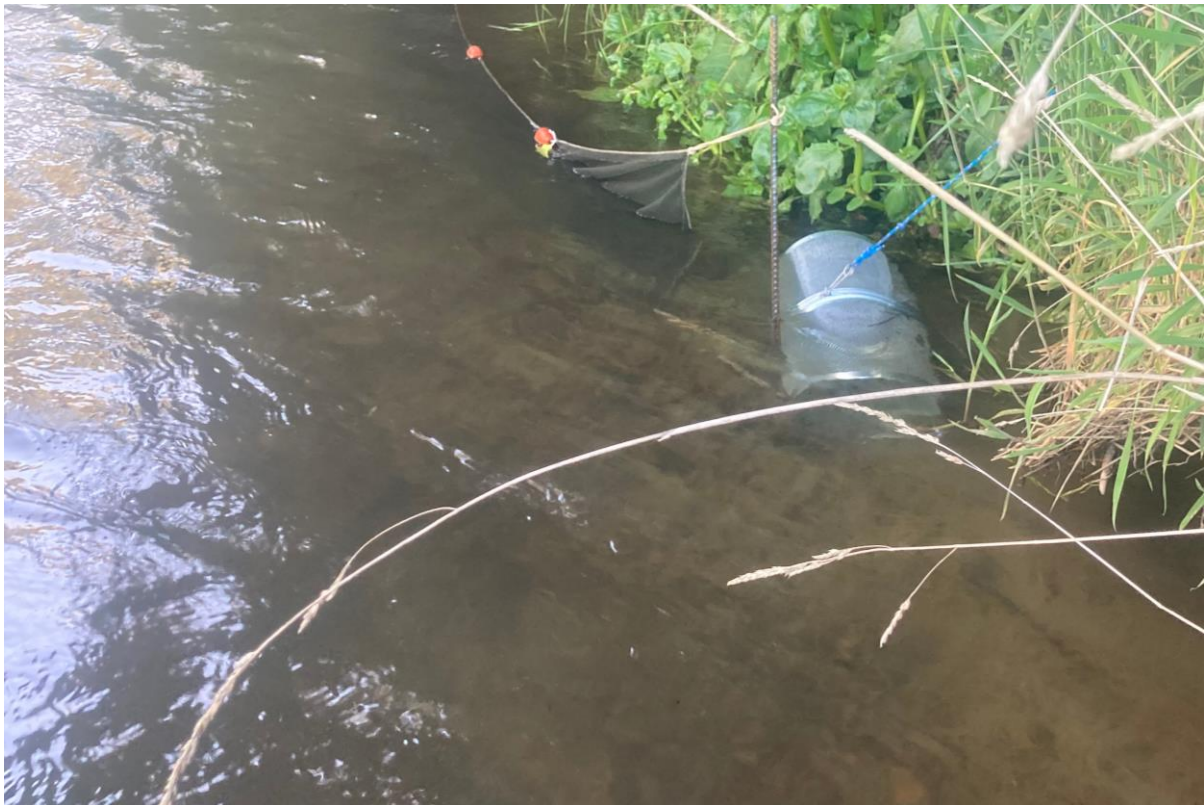
Plate A2.9 Gee minnow and fyke nets set at Site 7.

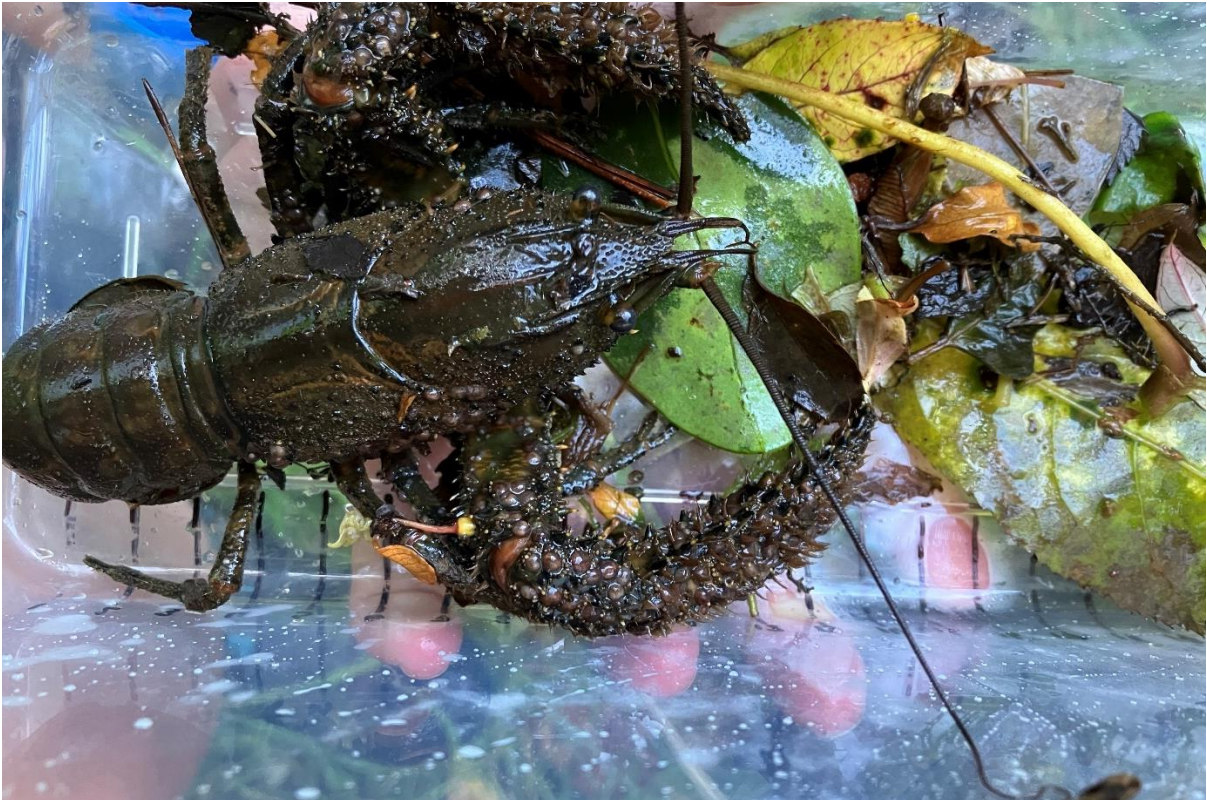
Plate A2.10: Large kōura caught at Site 3, note the soft, commensal flatworms living on the front claws. These do not negatively affect the kōura, but eat tiny crumbs of food it creates.

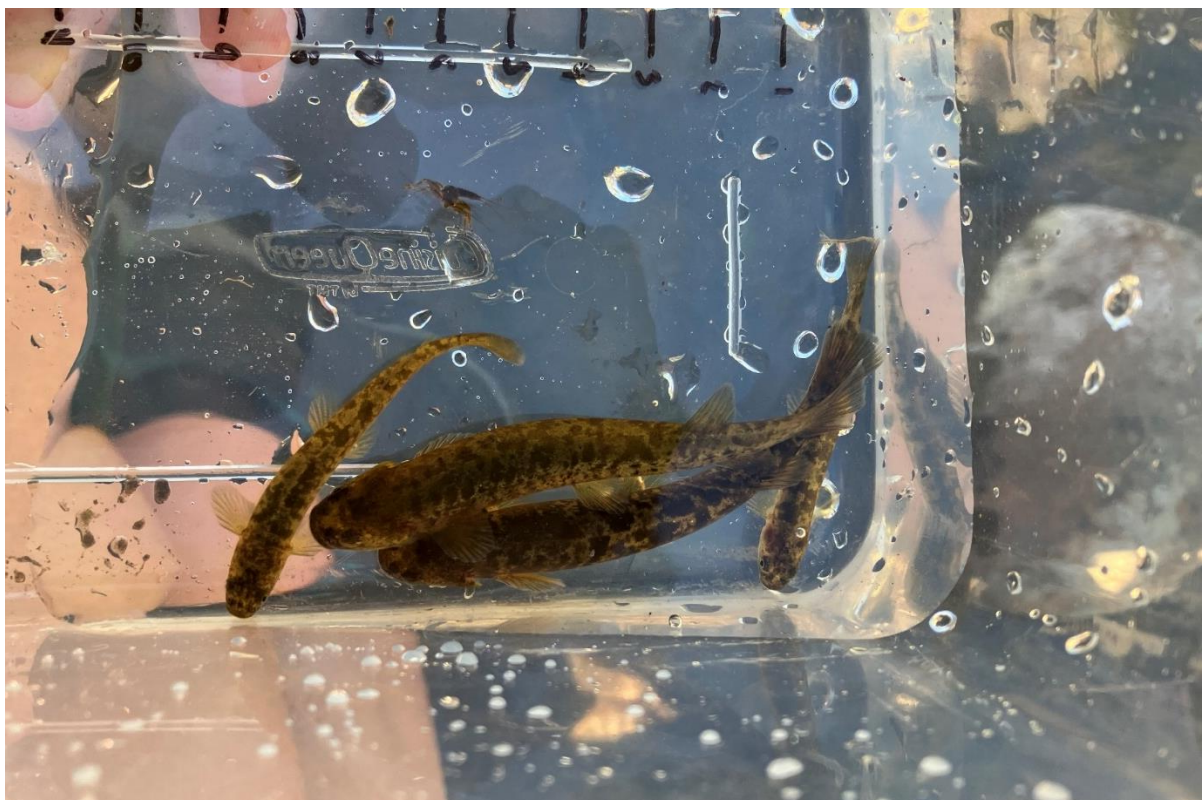
Plate A2.11: Several galaxiids captured at Site 5.

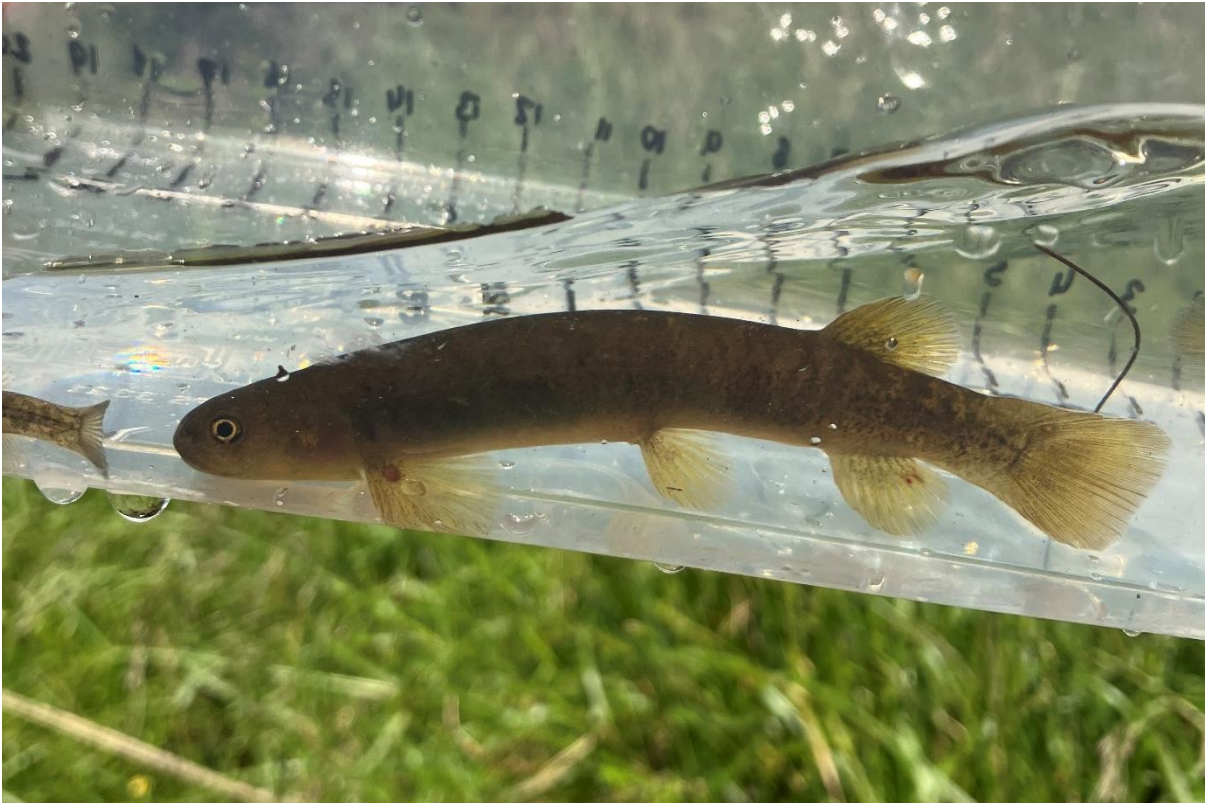
Plate A2.12: Side view of a galaxiid captured at Site 6, showing the large eye, small mouth and rounded head shape typical of a Gollum galaxiid.

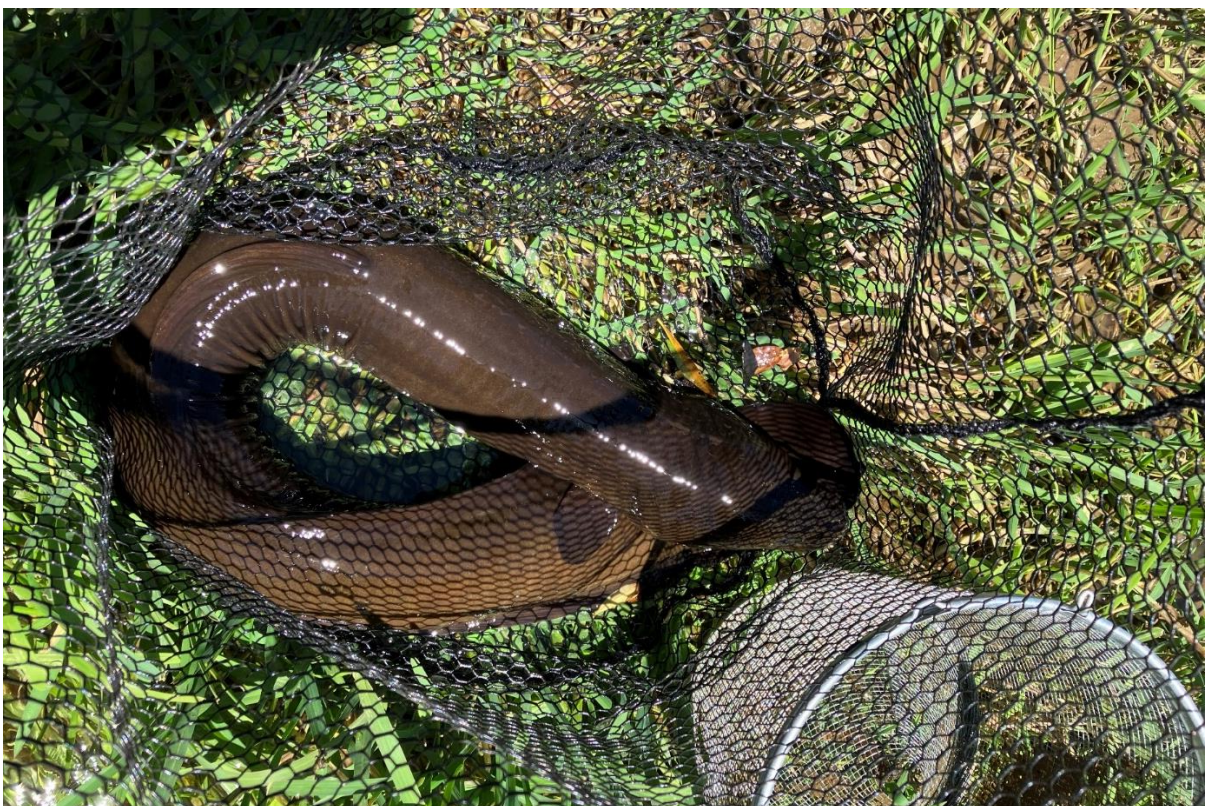
Plate A2.13: Longfin eel captured at Site 7, weighing 3.2 kg and with a length of 92 cm. A longfin eel this size is most likely a female.
