Project Number 18670.000.001

Geotechnical Investigation

76-80 Great South Road, Newmarket,
Auckland

Submitted to:
Dilworth Trust Board
2 Erin Street
Epsom
Auckland 1051

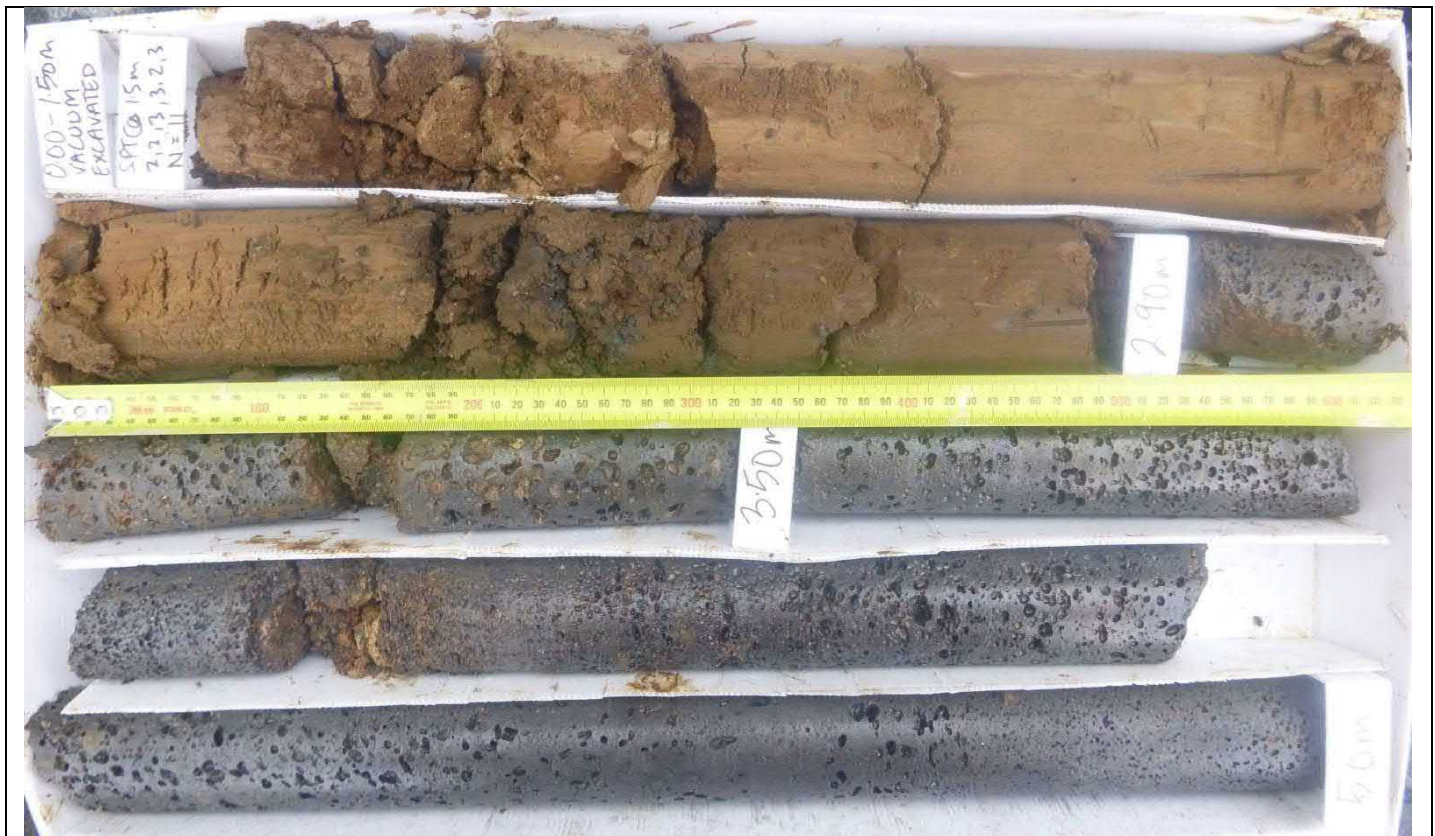
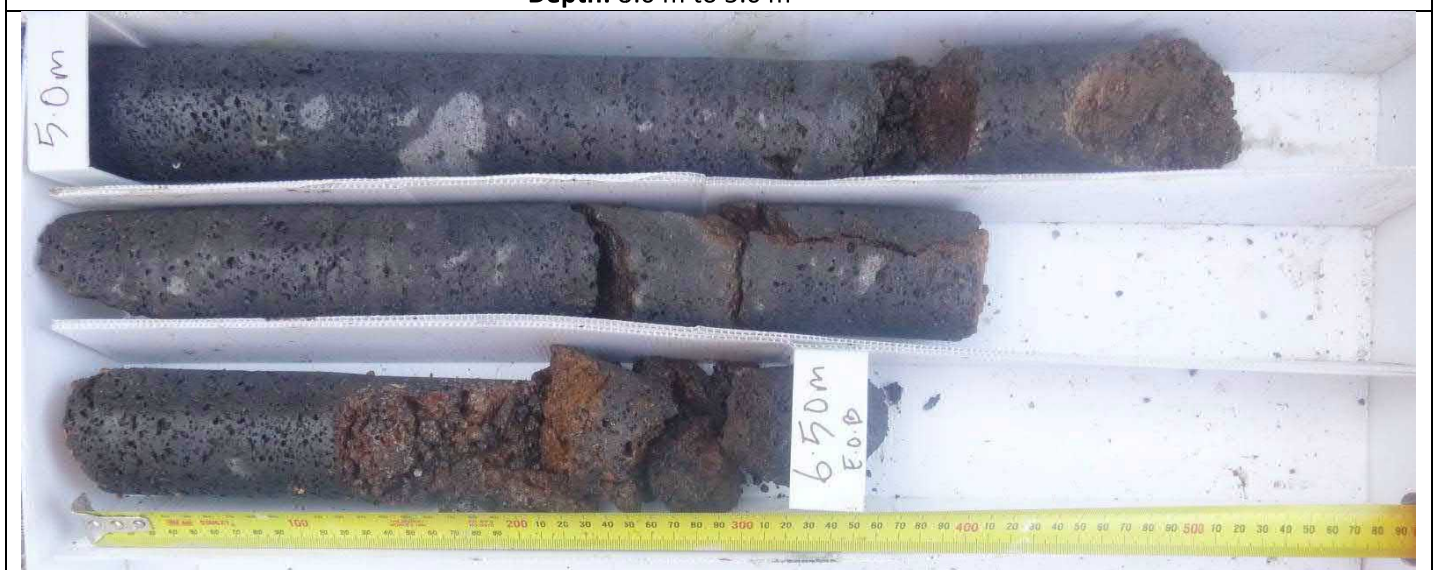
80 Great South Road	Borehole Number:	MH01		
		Compiled:	PP	Date:	02/06/2015
Title:	MH01 CORE BOX PHOTOGRAPHS

Depth: 0.0 m to 5.0 m

Depth: 5.0 m to 6.5 m

Based on the available investigation data, the top of basalt is modelled to occur to within 2 m to 5 m of the existing ground surface. Recovered core from MH01 to MH03 show the contact between the basalt and the overlying volcanic soils is relatively clean with intact rock at the contact. As such, we consider stub piles founding on the top of basalt or piles embedded within the basalt rock to be suitable for the proposed development.

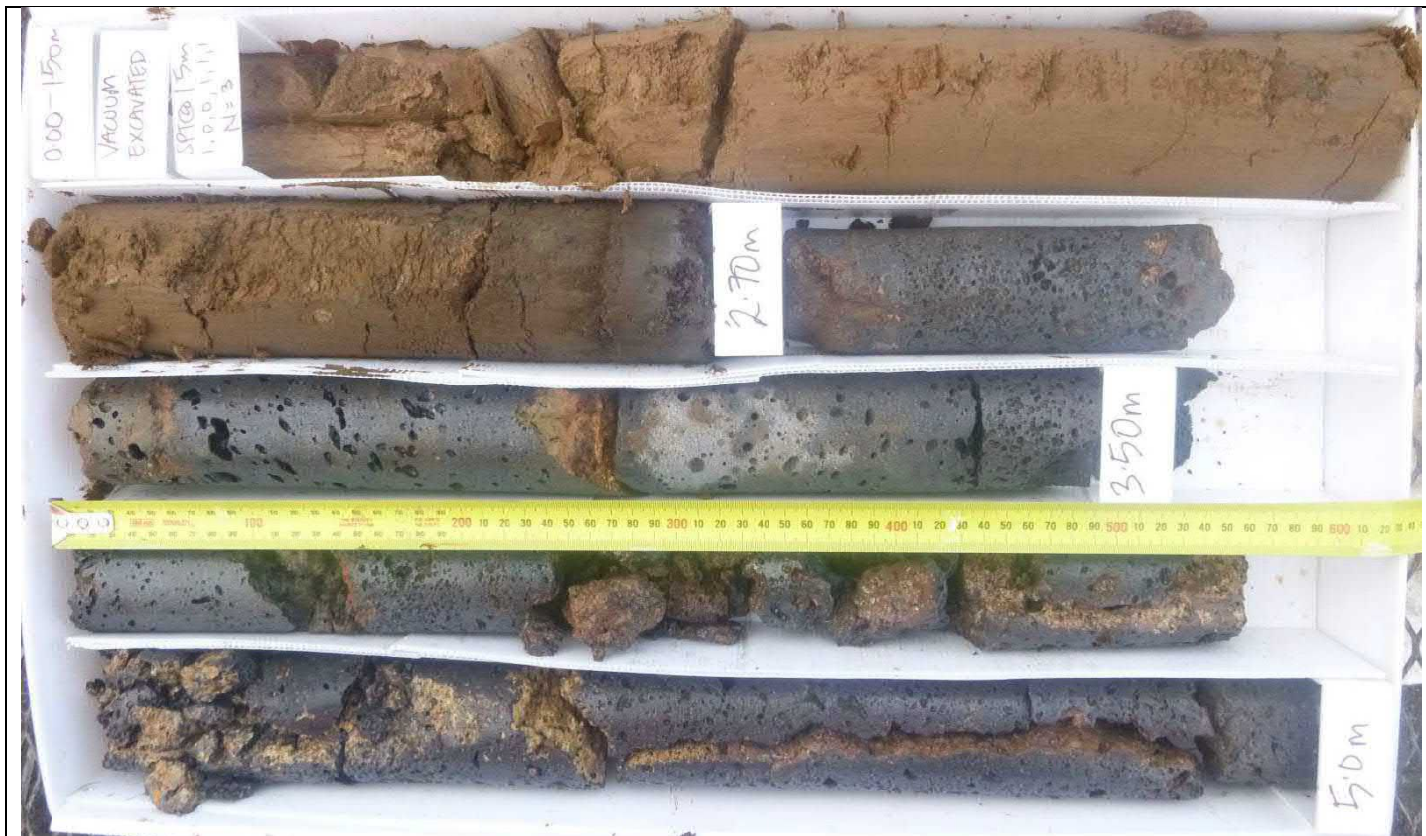
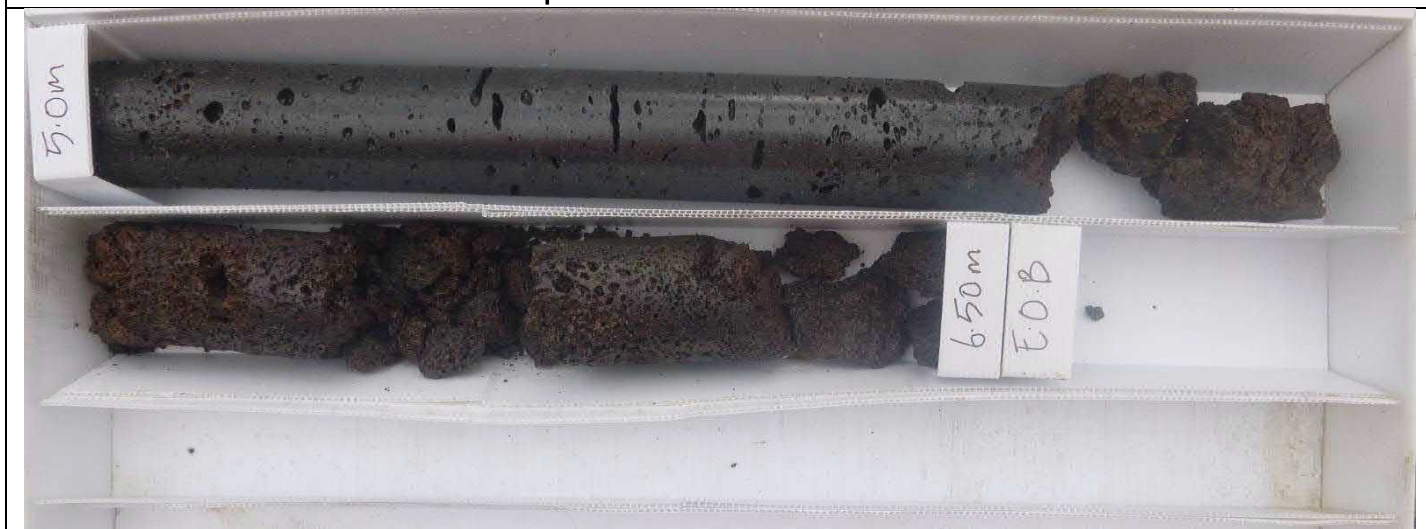
80 Great South Road	Borehole Number:	MH02		
		Compiled:	PP	Date:	02/06/2015
Title:	MH02 CORE BOX PHOTOGRAPHS

Depth: 0.0 m to 5.0 m

Depth: 5.0 m to 6.5 m

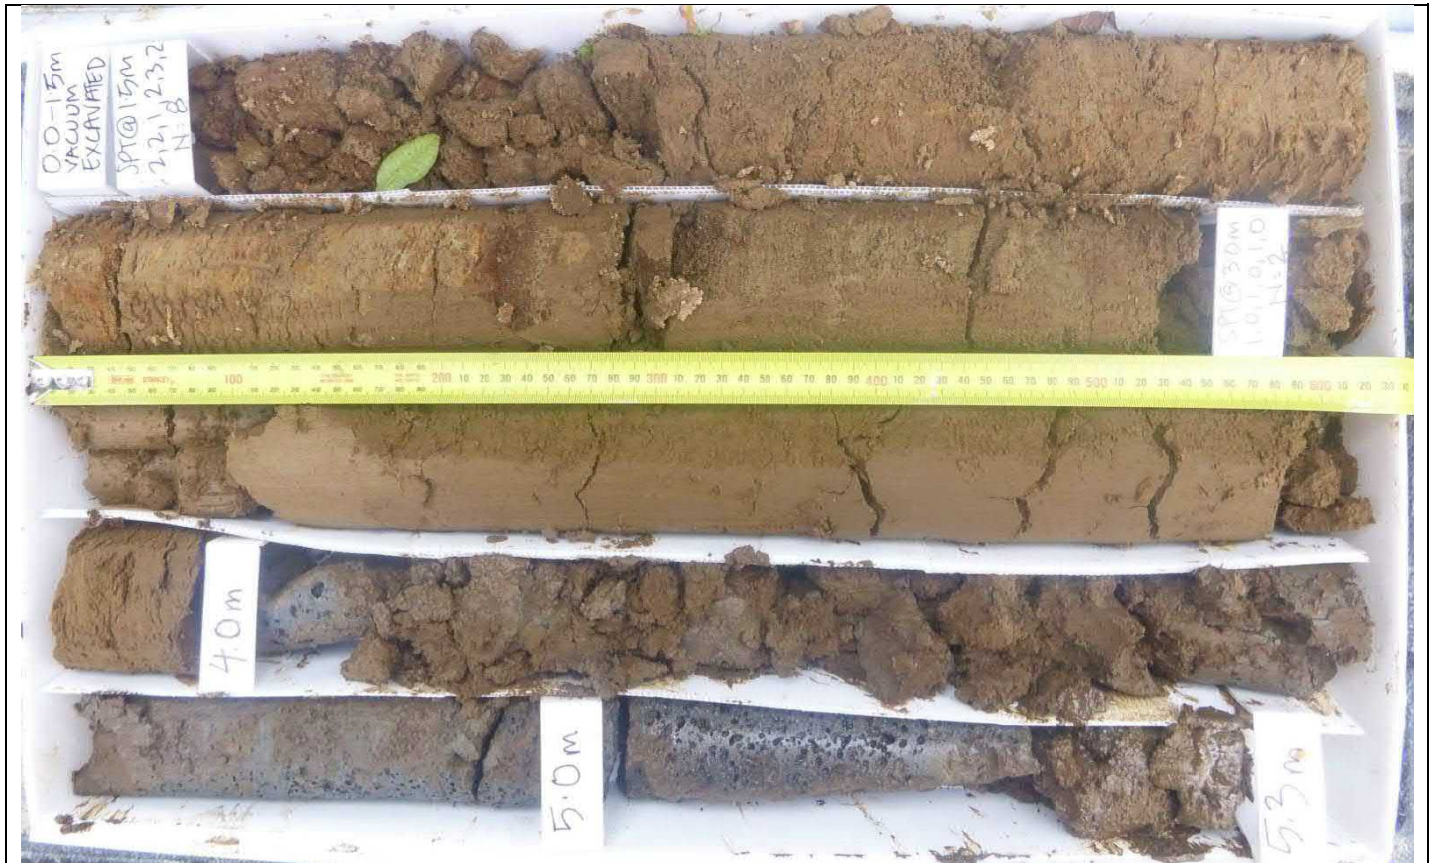
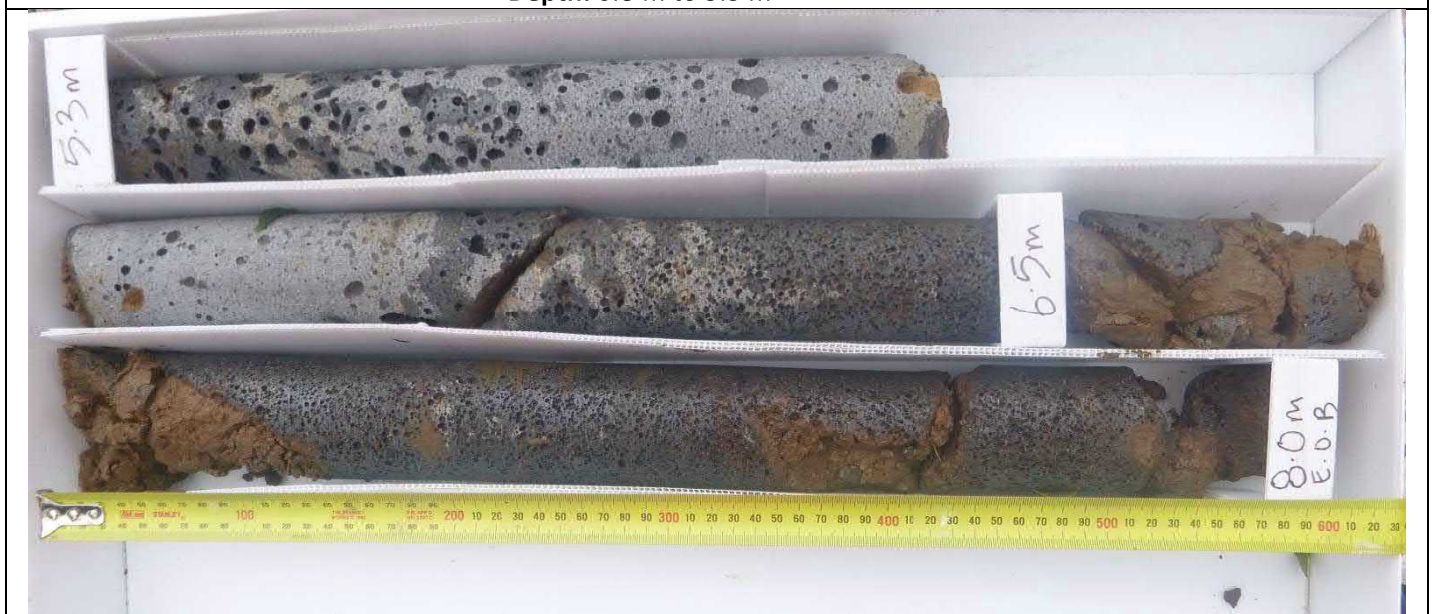
80 Great South Road	Borehole Number:	MH03		
		Compiled:	PP	Date:	02/06/2015
Title:	MH03 CORE BOX PHOTOGRAPHS

Depth: 0.0 m to 5.3 m

Depth: 5.3 m to 8.0 m

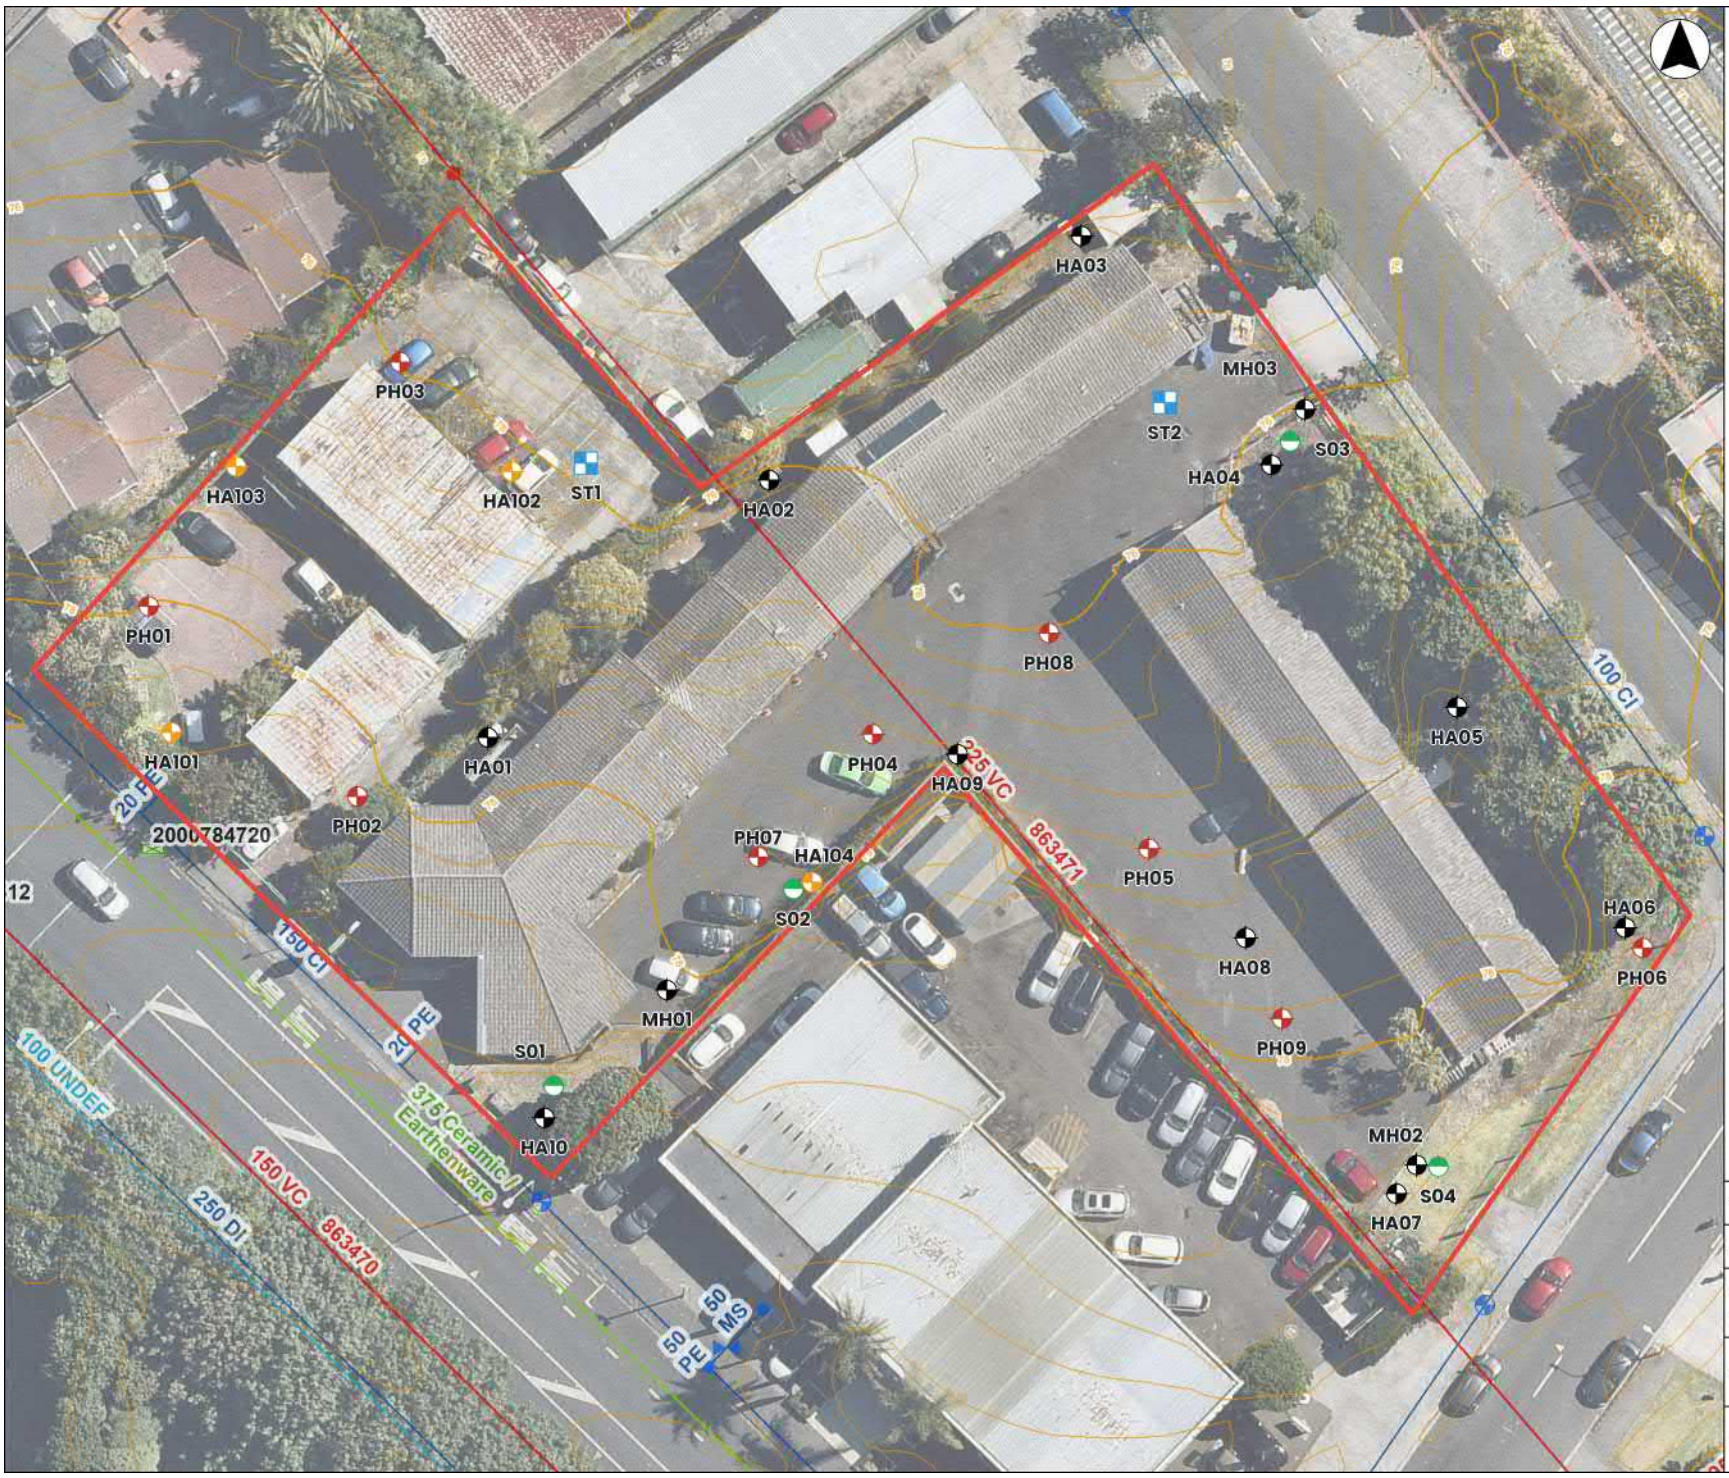
APPENDIX 4:
Investigation Location Plan

- Legend**
- ENGEO 2022 Soakage Tests
 - ⊕ ENGEO 2022 Percussion Boreholes
 - ⊕ ENGEO 2022 Hand Auger Boreholes
 - ⊕ ENGEO 2022 Scala Penetrometer Tests
 - ⊕ Coffey 2015 Investigations
 - Site Boundary
 - Contours
 - Contours 050m

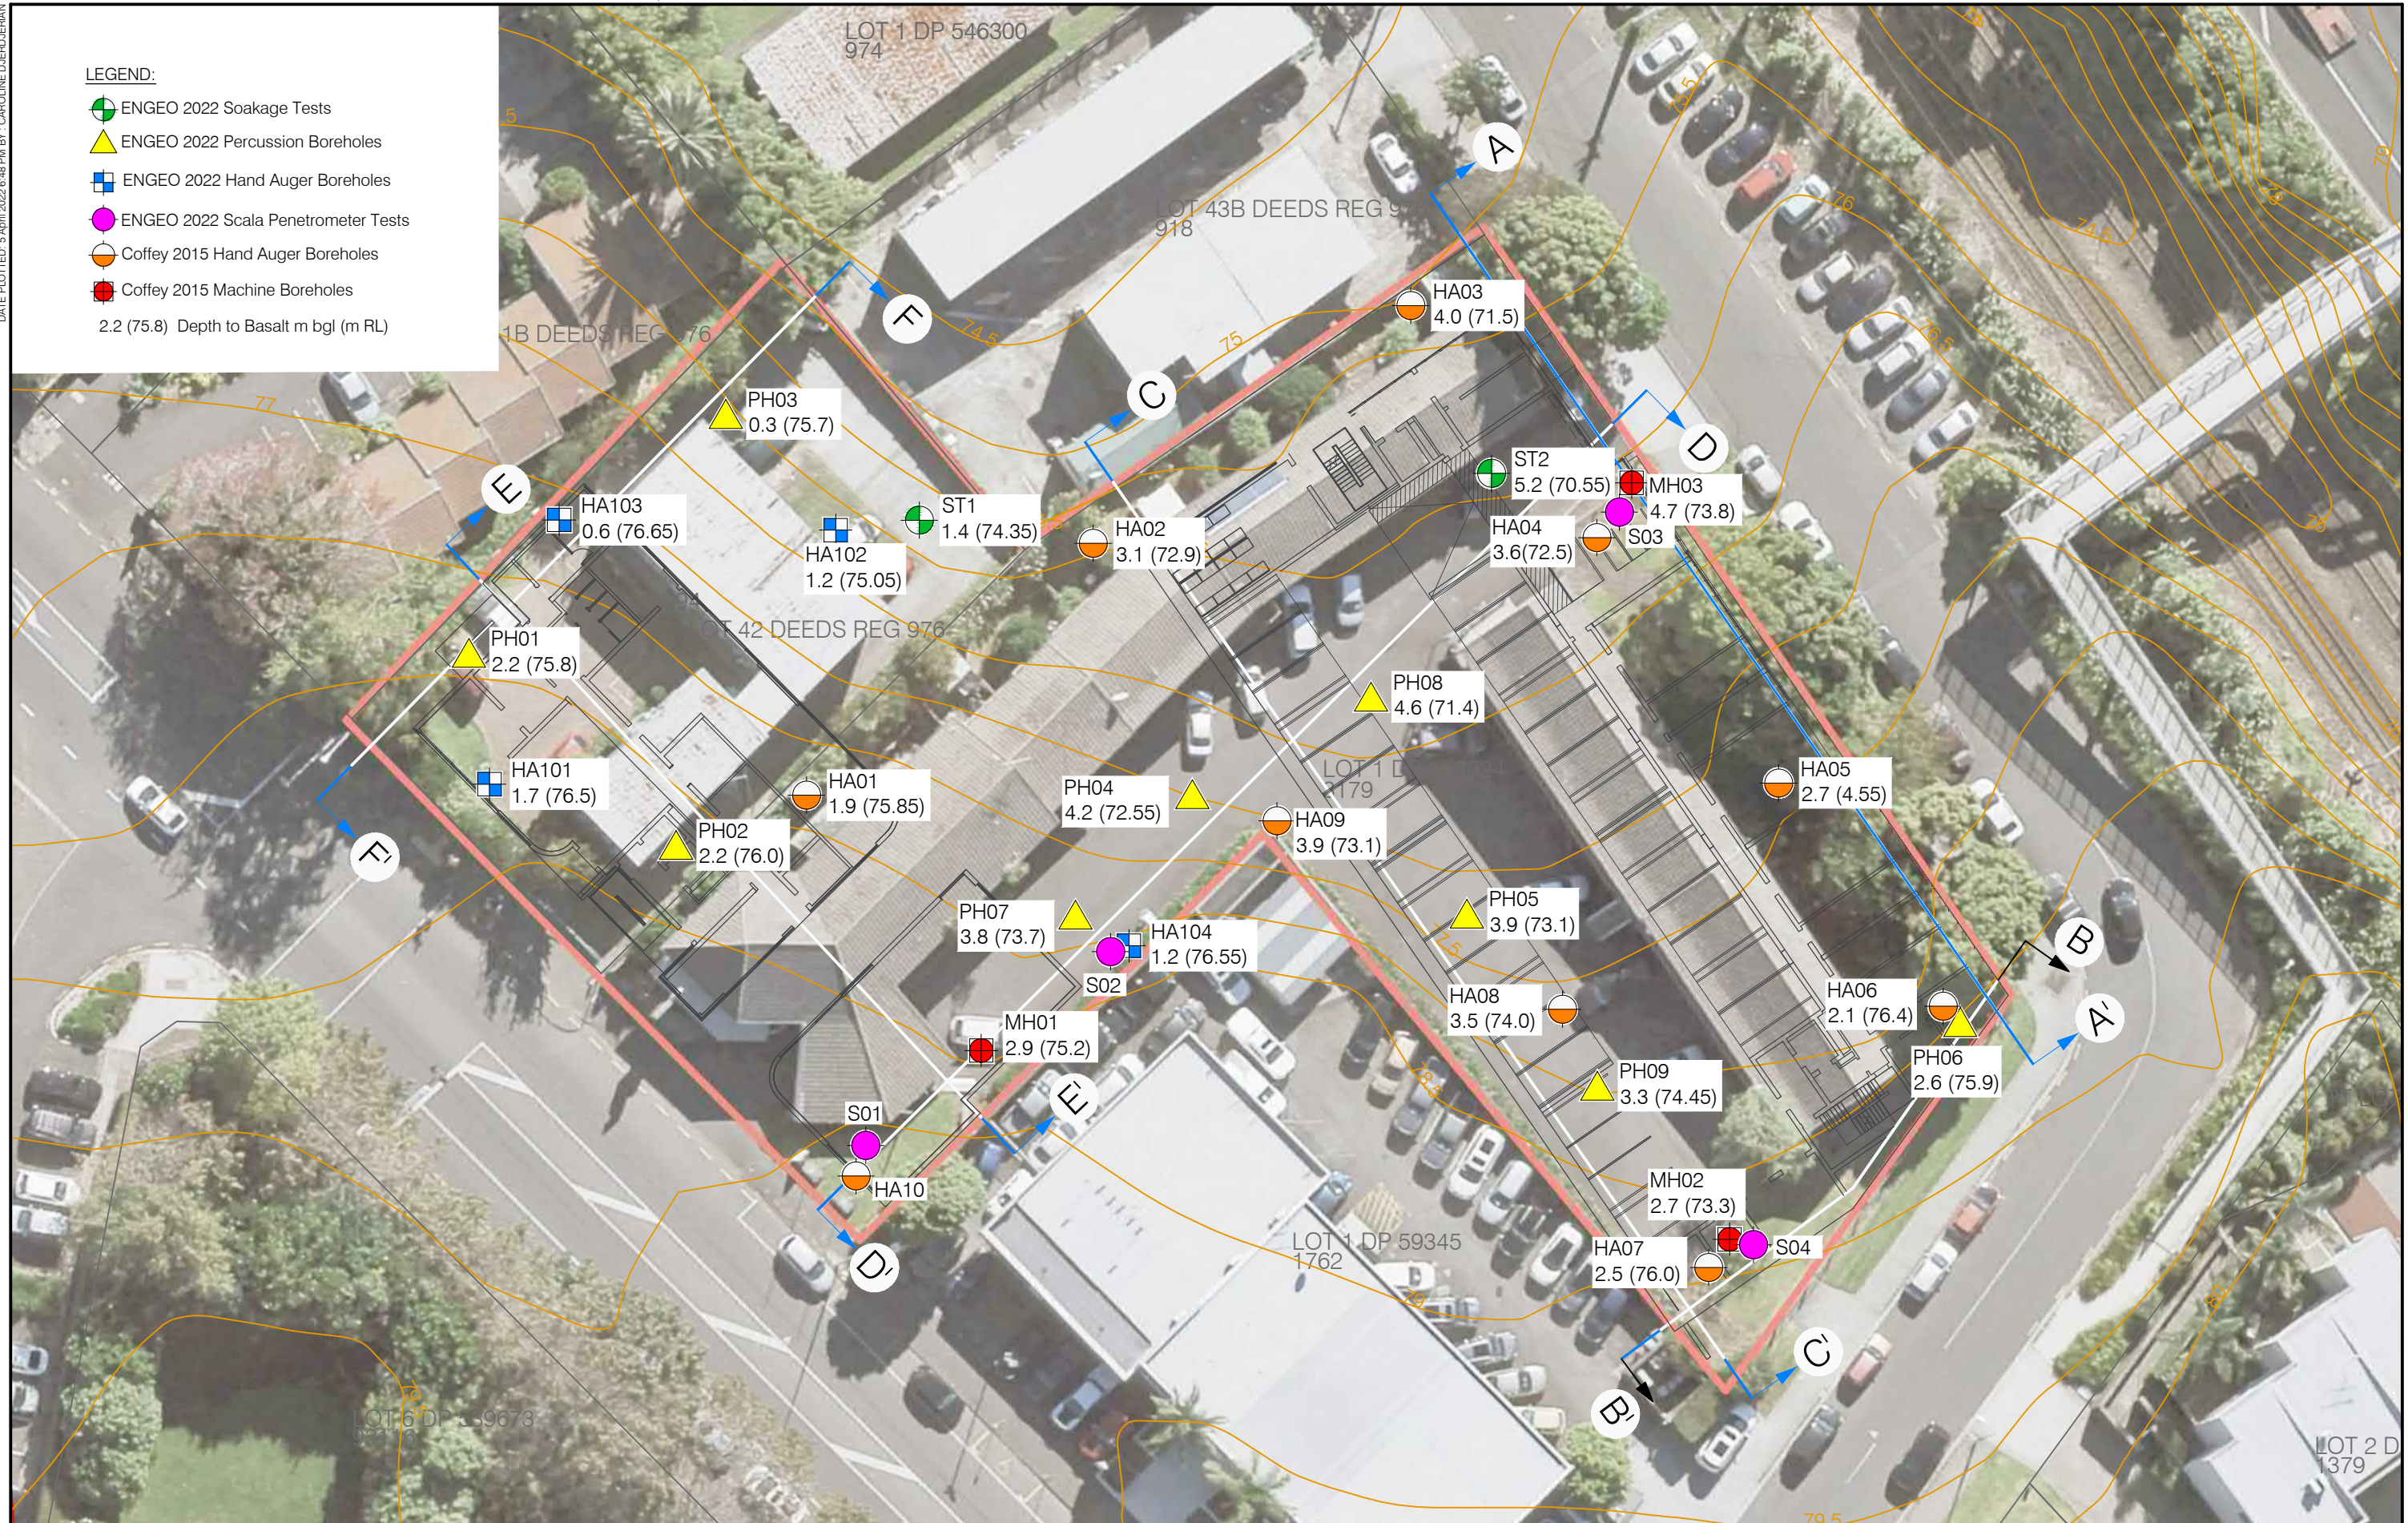
- ENGEO 2022 Soakage Tests
 - ▲ ENGEO 2022 Percussion Boreholes
 - ENGEO 2022 Hand Auger Boreholes
 - ENGEO 2022 Scala Penetrometer Tests
 - Coffey 2015 Hand Auger Boreholes
 - Coffey 2015 Machine Boreholes
- 2.2 (75.8) Depth to Basalt m bgl (m RL)

- AVF Basalt was encountered across the entire site, the upper surface ranging from 2.2 m to 5.2 m bgl. Based on surrounding boreholes, (Section 4.3) the basalt is inferred to be in the order of 20 m+ thick. The basalt was observed to be typically slightly weathered to unweathered with strengths ranging from moderately strong to very strong. The top of basalt is undulating across the site which is likely representative of the landform prior to basalt flows covering the site.

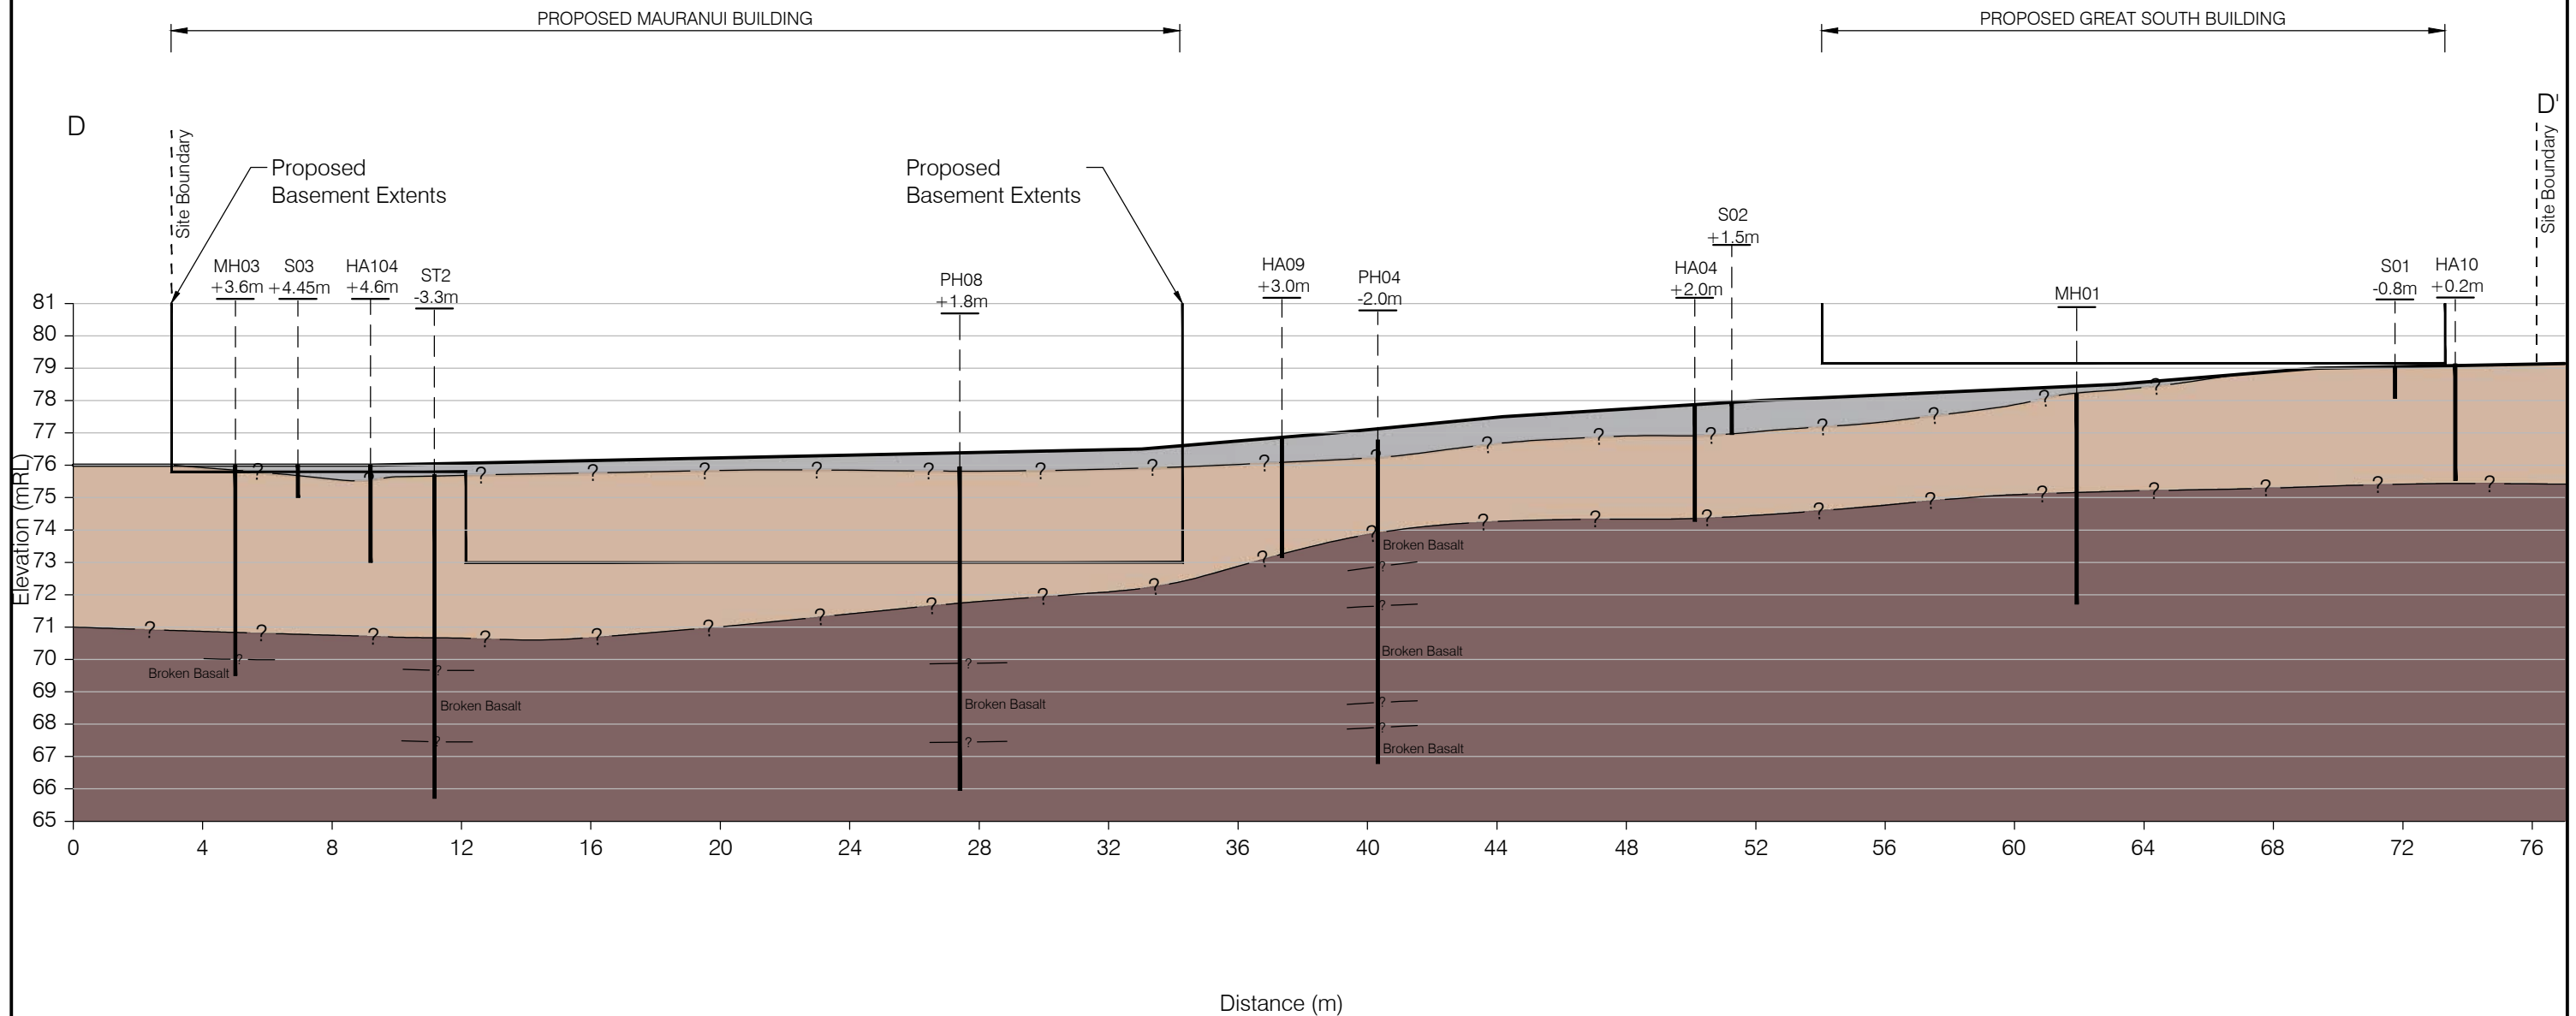
CROSS SECTION D-D'
SCALES 1:200

- FILL
- AUCKLAND VOLCANIC FIELD - TUFF (VERY STIFF TO HARD)
- AUCKLAND VOLCANIC FIELD - BASALT (MODERATELY STRONG +)

Sections of broken or fractured rock and cavities were logged in the percussion boreholes (Appendix 6), with thicknesses ranging between 0.5 m to 3.5 m, however due to the drilling methodology the structure and continuity of the fractured zones could not be determined. The zones of inferred fracturing are shown to be spaced through the investigation rock mass rather than a continuous horizon based profile. It could be assumed that on excavation, sections of broken / fractured basalt may perform similar to cobbles and boulders and ravel from an exposed face or cut. The sections of inferred broken basalt are shown on the conceptual ground model.
