Project Number 18670.000.001

Combined Preliminary and Detailed Site Investigation

76 - 80 Great South Road, Newmarket,
Auckland

Submitted to:
Dilworth Trust Board
2 Erin Street
Epsom
Auckland 1051

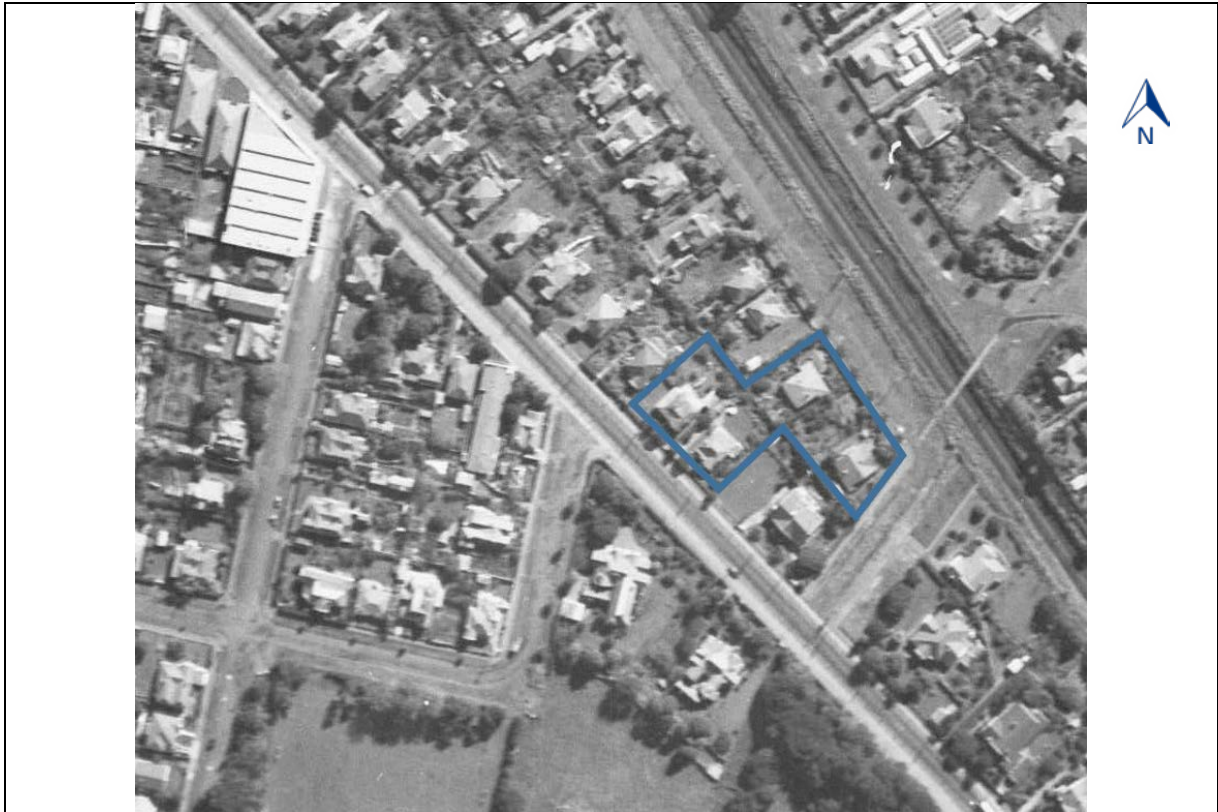
1940 (Retrolens NZ)

Date	Description
1940	The site is comprised of residential lots with single-family dwellings. The surrounding area is generally residential land. Great South Road is present to the southwest and the NIMT rail line is present to the northeast. Dilworth School grounds can be observed to the south, across Great South Road
1951	No significant changes to the site or surrounding area observed.
1961	A tennis court has been constructed in the northeast portion of 80 Great South Road.
1967	Mauranui Avenue is present between the site and the NIMT rail line. The Southern Motorway has been constructed to the north of the rail line.
1972	No significant changes to the site or surrounding area observed.
1979-81	A motel building has been constructed adjacent to the western boundary of 76 Great South Road. The dwelling at 76 Great South Road has been removed and replaced with an apartment building and carpark.
1986	The dwelling in the southern portion of 80 Great South Road has been removed.

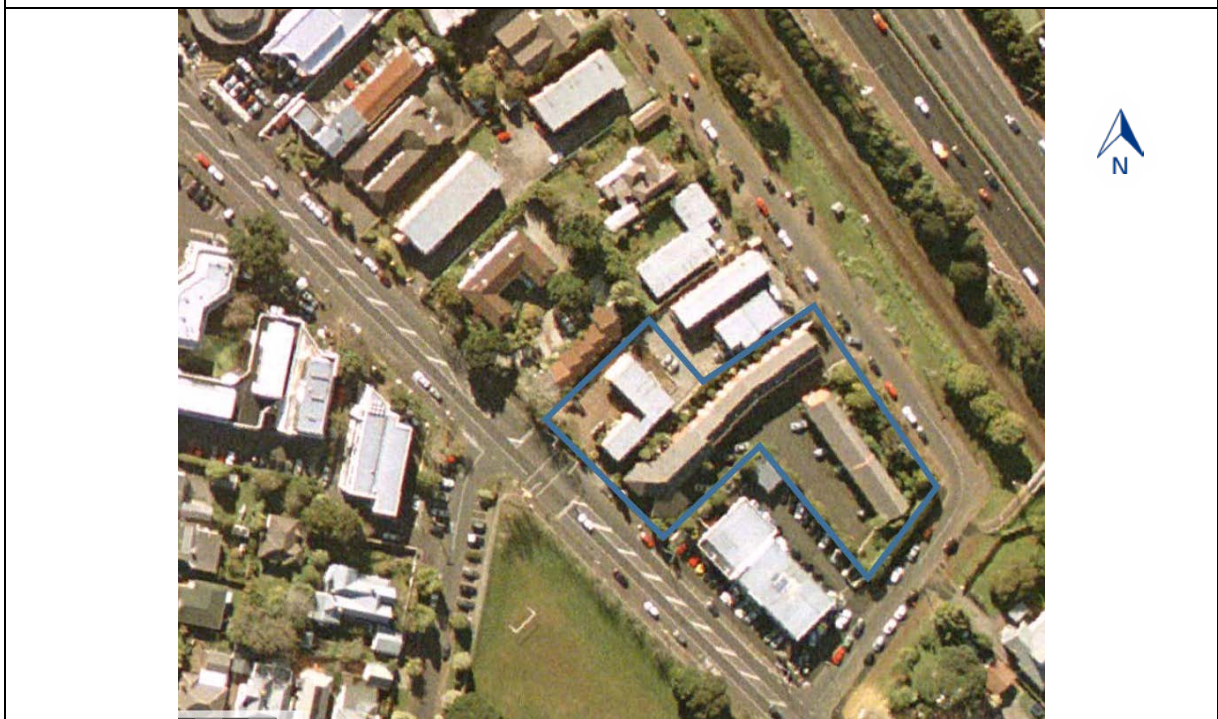
2001 (Auckland Council GeoMaps)

1996	<i>Poor image quality – two motel buildings have been constructed on 80 Great South Road. Due to poor image quality, this aerial photograph has not been included in the appendix.</i>
2001 – 2012	No significant changes to the site or surrounding area observed.
2017	The Dilworth Footbridge has been constructed over the Southern Motorway to the northeast of 80 Great South Road.
