## Memo

| Subject: | 8 Stevensons Crescent, Albany Heights: Fast Track Referral: Ecology assessment | | |

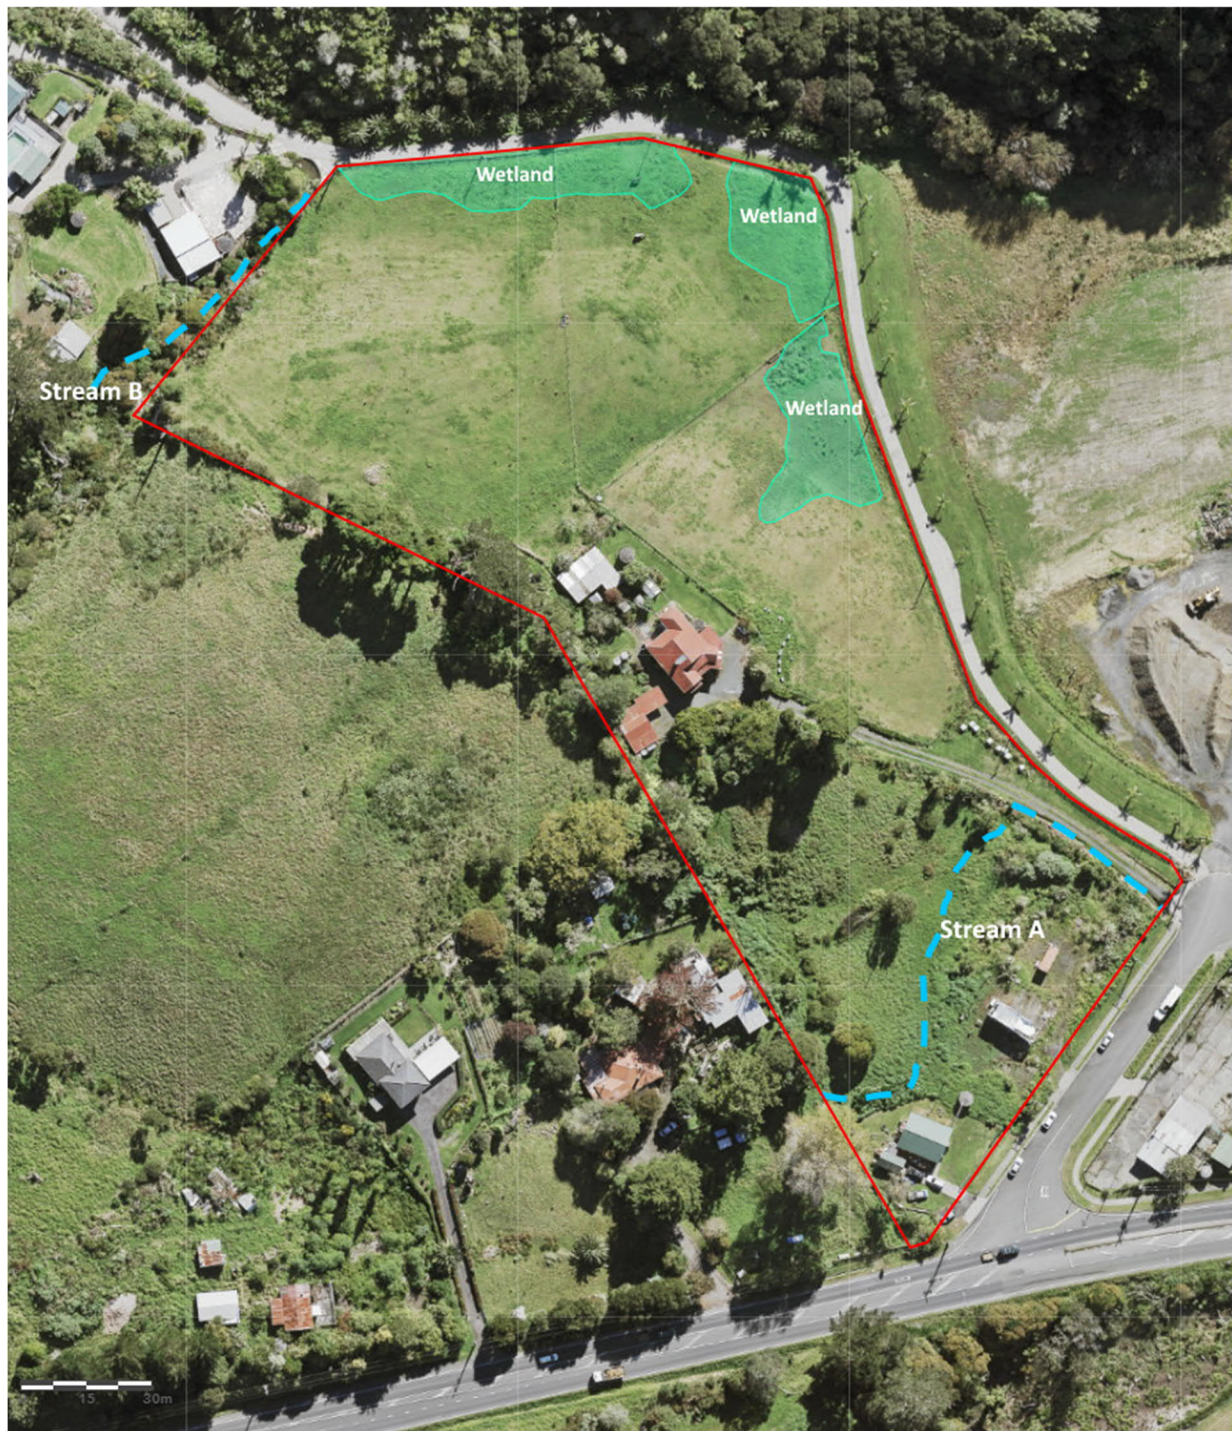
Figure 1. The site showing mapped streams (blue dotted line) and natural inland wetlands (green shaded polygons). The existing extent of 8 Stevenson Crescent is shown as red line.

The site supports one (1) intermittent stream in its southern section (hereafter 'Stream A'; Figure 1). The stream through the site is supplied with water from several small catchments uphill alongside the eastern part of the Dairy Flat Highway, as well as slopes and a small overland flow path catchment on the site.

A second stream (Stream B; Figure 1) is located adjoining the western boundary of the site. No part of that stream is within the site; however, if a 10 m margin to the stream is proposed, part of that margin lies within the site.

Several natural inland wetlands exist on the site; all are located along the toe slope on the north-eastern portion of the site (Figure 1). The vegetation communities at these sites range from dry-adapted wet pasture grass and pasture weed communities, through to wet-adapted invasive rush and exotic weed communities. Native plants are absent. The wetlands are grazed as part of the surrounding pasture area.

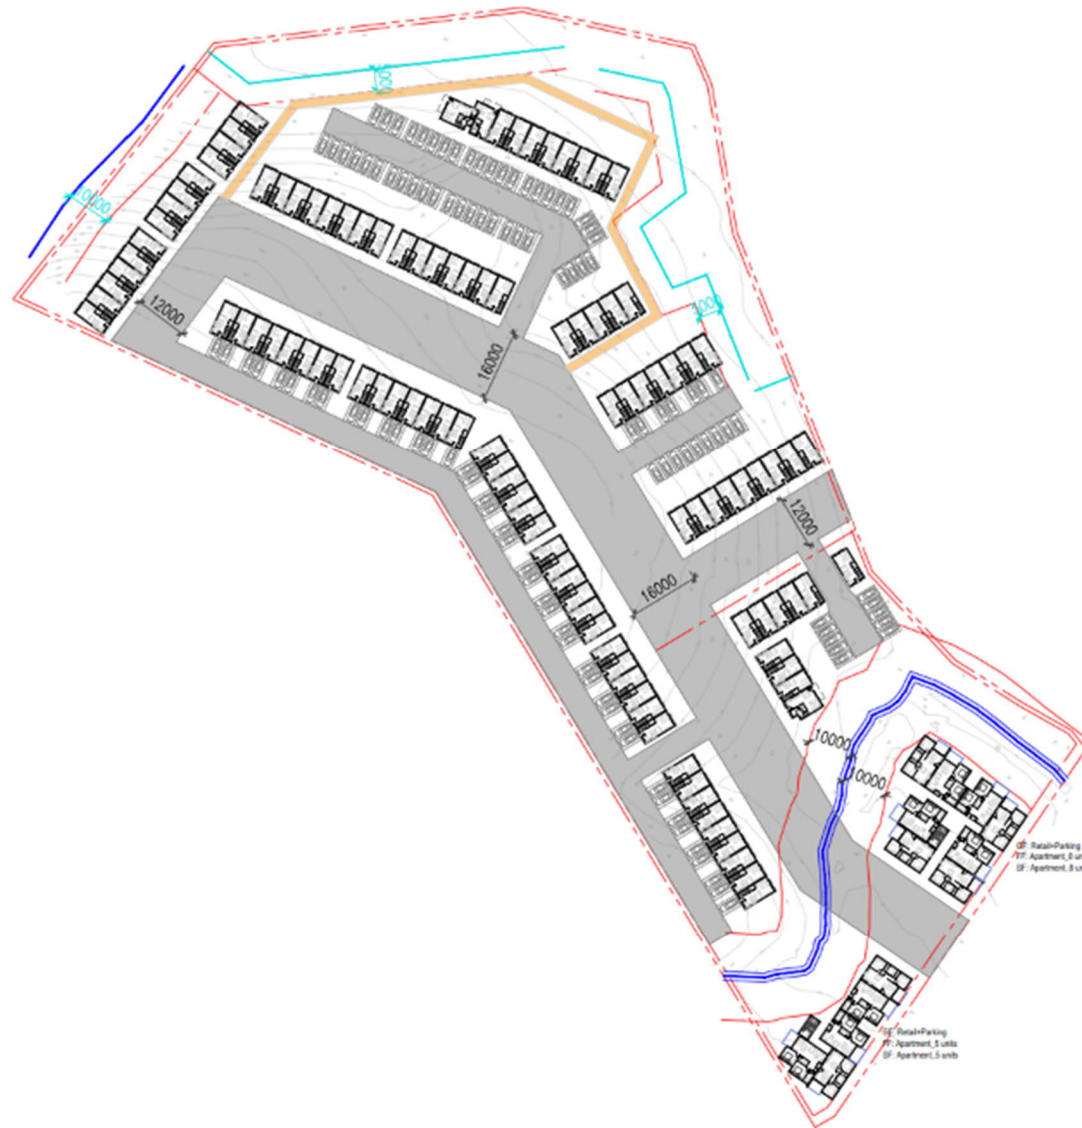
Master Plan 1:1000@A3

Zoning: Mixed Housing Urban Zone  
Site Area: 25112m<sup>2</sup>

Unit Number: 138  
Terrace: 112  
Apartment: 26

Figure 2. Concept plan showing proposed layout and protection of most areas of ecological value (Stream A and wetlands), including buffers and restoration of buffers for each.

The concept plan layout for the site is shown in Figure 2.

Avoidance of effects on these key ecology features is a fundamental design driver for the development layout. The concept plan layout avoids most effects on Stream A and the wetlands, and provides for
