## **ATTACHMENT H**

# Te Puru Business Park, Beachlands

# Ecological assessment for fast-track referral

# FAST TRACK APPLICATION FOR PLAN CHANGE 885 WHITFORD-MARAETAI ROAD, BEACHLANDS

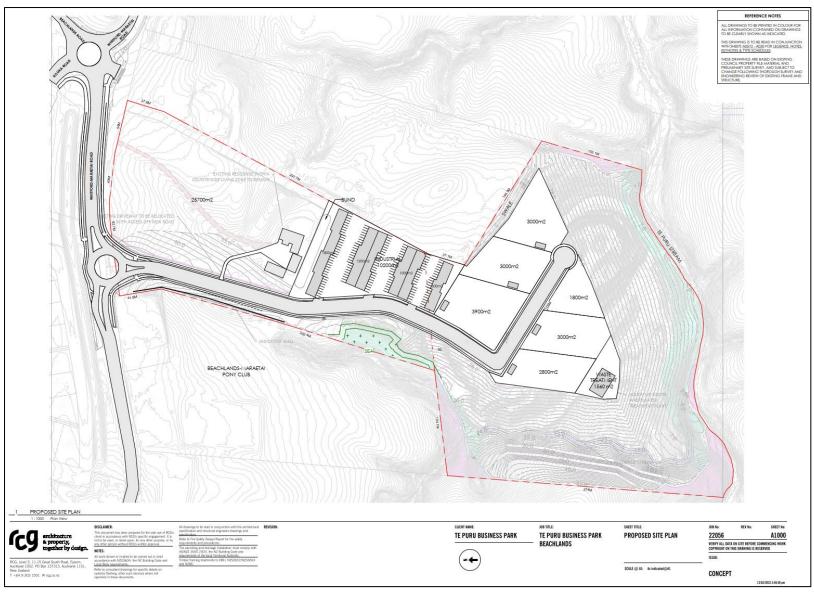
**Figure 1.** The Fast Track Application Area (red border).

The project is located at the eastern fringe of Beachlands at 885-867 Whitford-Maraetai Road. The earthworks extent of this Fast Track Application is shown on **Figure 1** (hereafter referred to as 'the site').

Knight Investments Limited is proposing to utilise the rehabilitated quarry for light industrial activities including constructed buildings and yards (**Figure 1**). Notably, the existing quarry activities have begun the rehabilitation works over part of the site, and these will continue to enable the platform areas for the development.

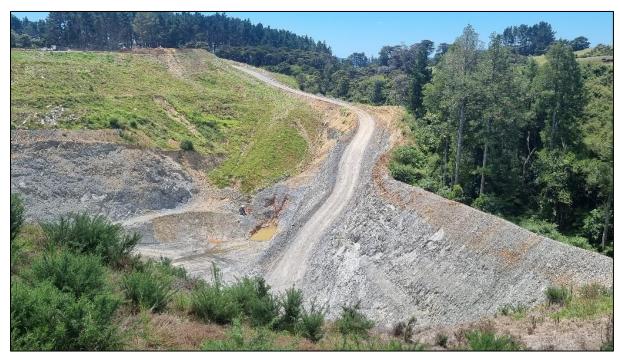
**Plate 1.** A photo of the quarry pit taken from the southern boundary of the site. The tall vegetation on the right is along the true right of Te Ruangaingai Stream.

Presently, there is 4,787 m<sup>2</sup> (c. 4 % of the total site area; **Plate 1**; **Figure 2**) of native vegetation remaining at the site, which is dominated by native kānuka (*Kunzea robusta*). The vegetation community is self-sustaining as a native community and displaying signs of succession, but is degraded by a range of competing pest plants. The rest of the site supports either scattered exotic trees amongst exotic pasture or exposed rock, gravel, cleanfill and herbaceous exotic plants associated with the quarry.

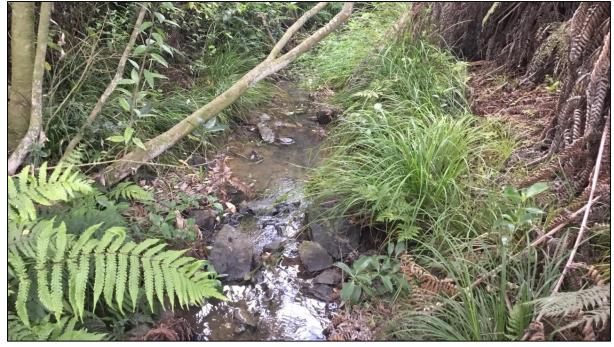
Plate 2. Pony Club Creek where it flows through native vegetation upstream of where it enters the quarry pit.

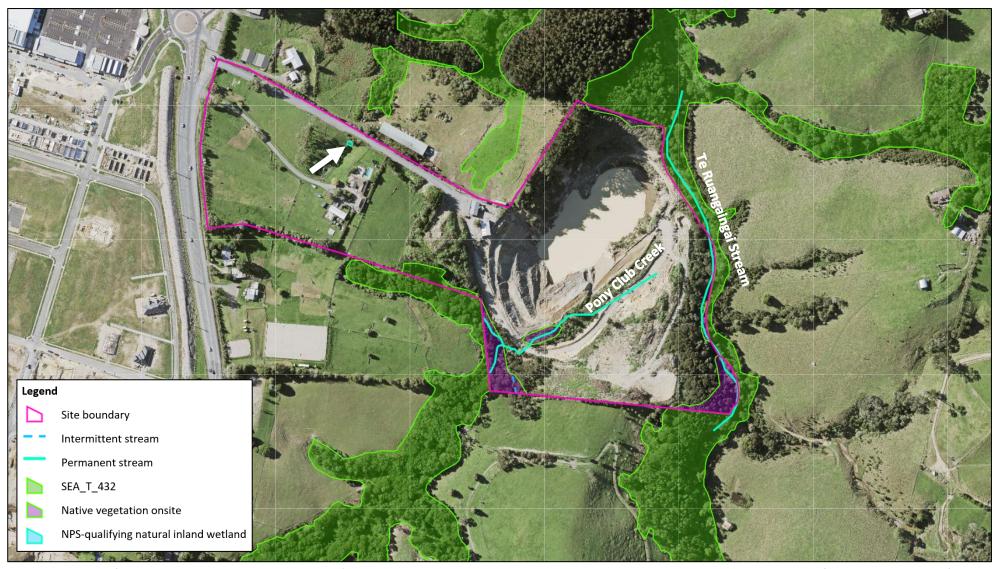
**Figure 2.** Ecological features at the site and the adjacent SEA. (Note: the singular small wetland is emphasised by a white arrow. Note: streams are not fully mapped outside of the site. Note: the aerial imagery shows a larger spatial extent of woody vegetation at the site than was actually present during the site visit.)

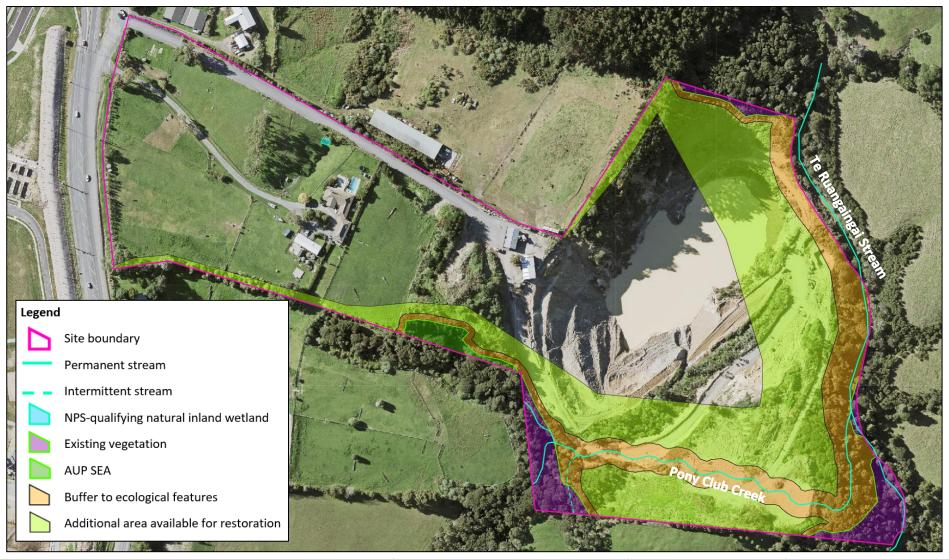
**Figure 3.** Proposed restoration layout. Note the extensive restoration of streams, riparian margins and connecting forest areas that is proposed for the north-east, east and southern portions of the site.

- All remaining native vegetation at the site will be retained, restored (including a 5 m buffer)
  (Figure 3), and effects on the remaining native vegetation avoided (except the area
  alongside Pony Club Creek which has been previously consented for removal);
- The SEA within the site will be retained and restored, including a 5 m buffer (Figure 3);
- The sole wetland at the site will be retained and direct effects (e.g., infilling) avoided;

- An intermittent stream will be reconnected to Pony Club Creek;
- Te Ruangaingai Stream will be retained along its current alignment;
- A 20 m wide riparian area will be planted with appropriate eco-sourced native vegetation along Te Ruangaingai Stream within the site wherever there is currently no native vegetation (Figure 3);

- A 10 m wide riparian area will be planted with appropriate eco-sourced native vegetation along all other streams at the site wherever there is currently no native vegetation (Figure 3); and

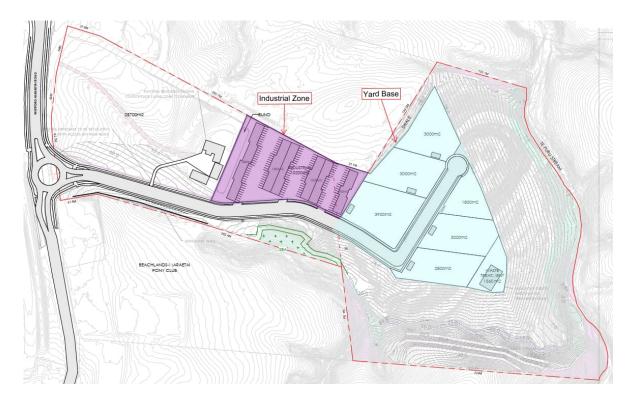
Development Concept

The proposed development seeks to enable light industrial uses (referred to as the "Industrial Zone") and light industrial yard based activities (referred to as the "Yard Base") as depicted by the purple and blue shaded areas on the concept inset below (base plan source: RCG Ltd).

# 4.1 'Industrial Zone' (Purple Area on Inset page 2)

# 4.2 'Yard Base' (Blue Area on Inset page 2)

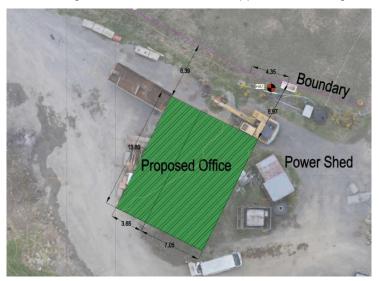
the drilling a one hand auger borehole to a depth of 2m, as depicted (inset left). This test is located within the proposed 'Industrial Zone' (purple area).

Beneath a 1m thick well compacted hardfill layer (which prevented the test being located within the actual building footprint), very stiff silty clays with fine gravel sized inclusions are present (WG). No groundwater was identified at the time of the site investigation.

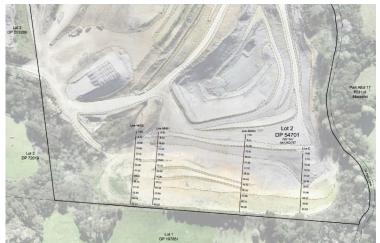
of three rotary cored machine boreholes to depth of up to 27.5m, in the alignments depicted on the inset (left). These tests are located east of the proposed 'Yard Base' (blue area).

The investigation found completely weathered overburden soils typically up to 8m in thickness, underlain by highly weathered to less weather deposits of approximately 10m thickness, in turn underlain by unweathered strong Greywacke rock (WG).
