Subject: Kauri Road Development Fast Track; Ecological Impact Assessment

Introduction

Appendix 1. Map of key ecological features.

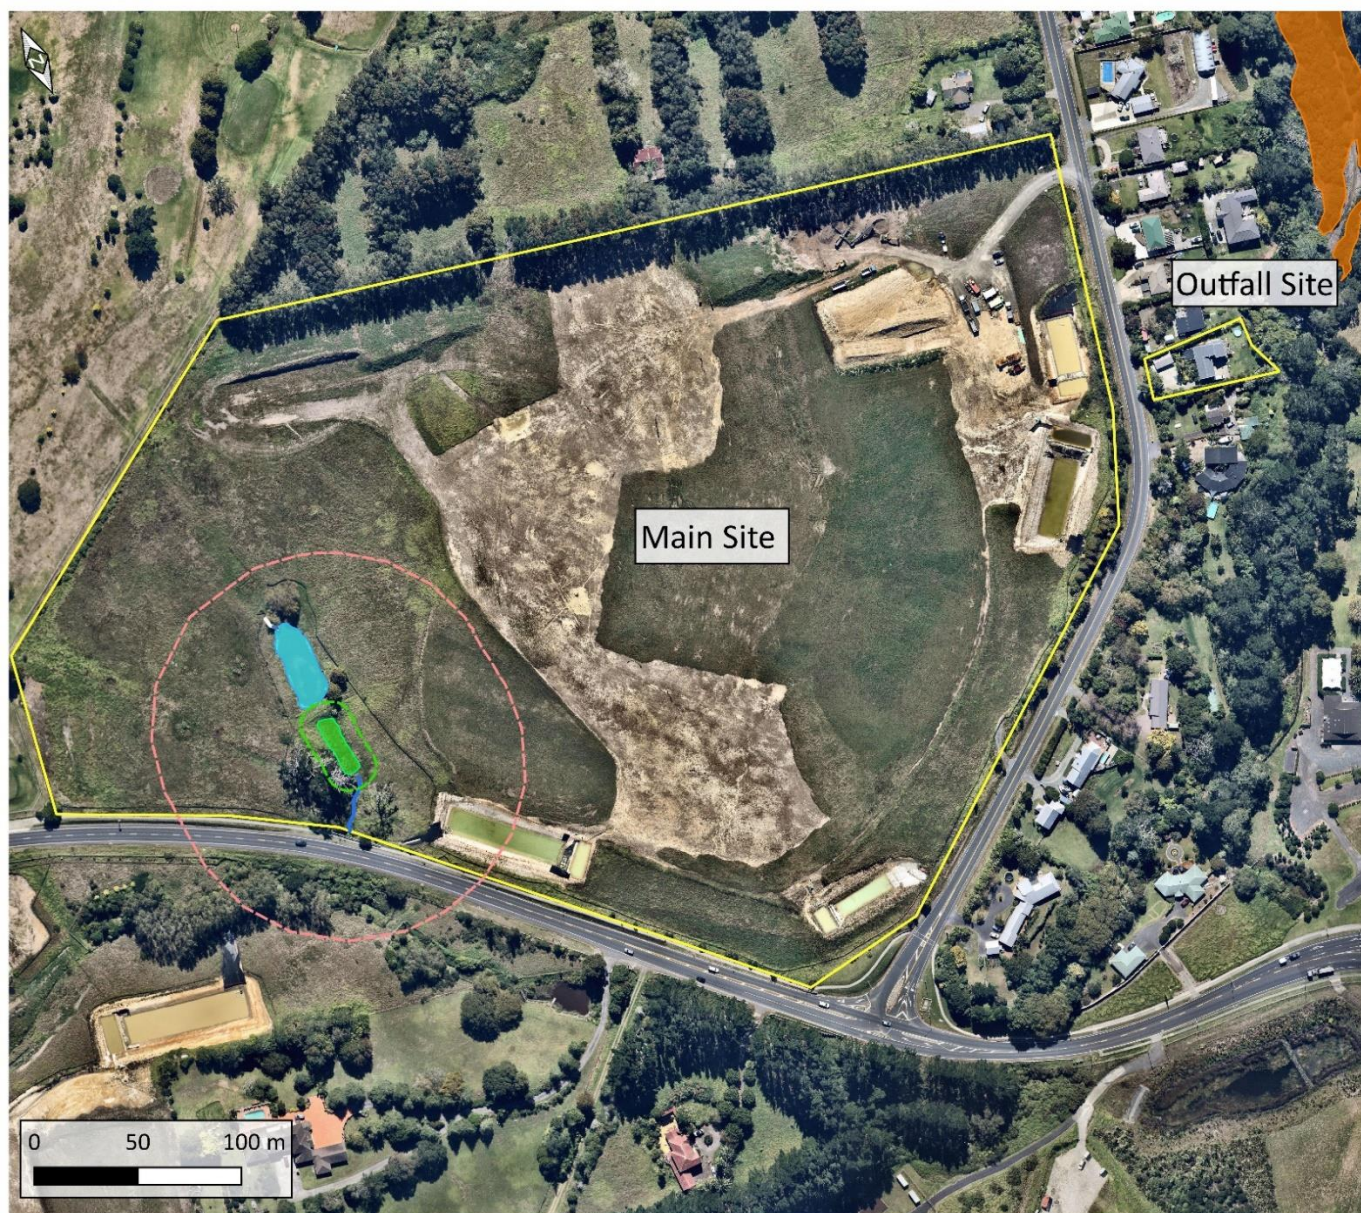
- Ephemeral overland flow path*
- Intermittent stream
- Freshwater wetland
- 100 m setback
- 10 m setback
- Artificial pond
- Coastal wetland
- Site boundary

Kauri Road
Ground-truthed ecological
features

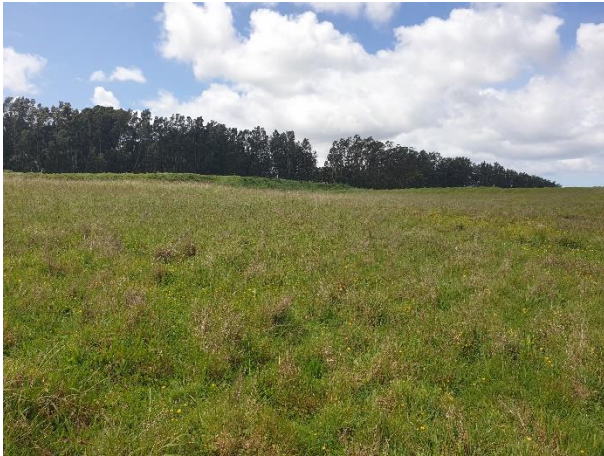
Photo 1. Typical vegetation throughout the site.

The botanical value of the vegetation within the sites was assessed to be of low ecological value, consisting predominantly of pasture and exotic trees, with common, low stature indigenous vegetation sparse. The vegetation provides low-quality fauna habitat, as the habitat is of low stature, lacks ecological complexity and is subject to high edge effects and limited terrestrial connectivity.

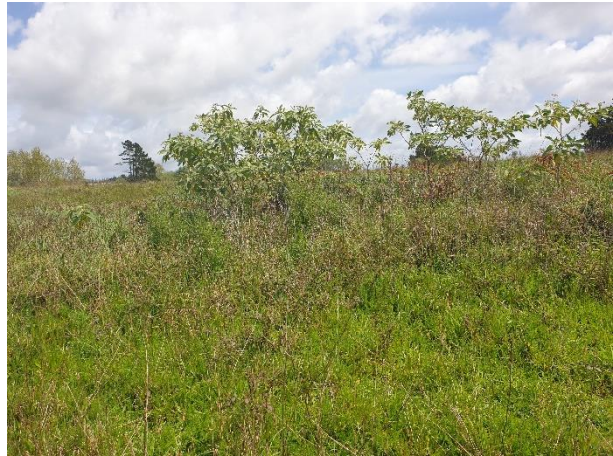
Photo 2. Pest plants, including woolly nightshade and blackberry were present.

Currently, the main site predominantly consists of earthworked land and unkept pasture with exotic shelter belts established around the site boundary. Several pest plant species were identified within the site, including blackberry (*Rubus fruticosus*), and woolly nightshade (*Solanum mauritianum*). Within the riparian yard, sparse willow (*Salix* sp.), and pine (*Pinus* sp.) was present alongside the rank long grasses, providing the only shade to the freshwater features.

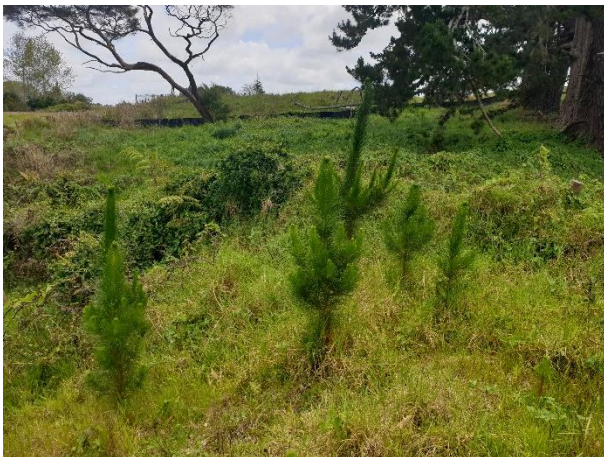
Photo 3. Juvenile pine trees establishing within the site.

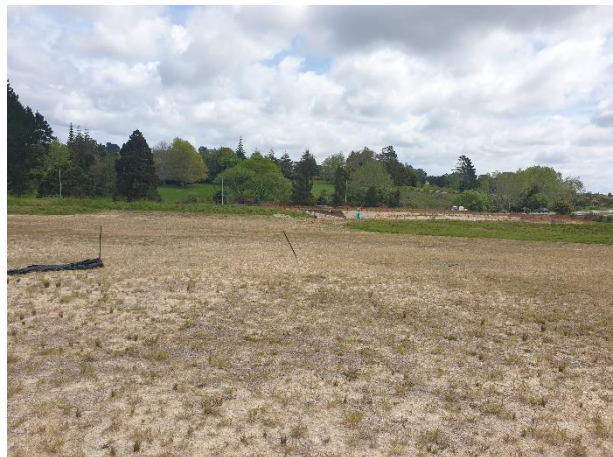
Photo 4. Previously earthworked land within the site.

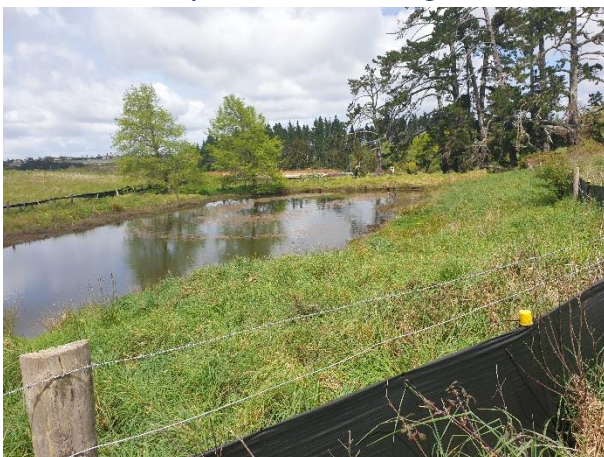
The artificial pond was located at the headwaters of the freshwater features on site. The pond was unnaturally large in relation to the contributing catchment, and historic aerial images show it was constructed prior to 1996. As such, this pond was not classified as a natural wetland under the NPS-FM.

Photo 5. Artificial pond upstream of the natural wetland.

The freshwater value of the site was considered to be of low ecological value, providing little habitat to indigenous fauna and lacked complexity and biodiversity. The reclamation of the pond is proposed, which represents the potential for the harm or mortality of indigenous fish. To mitigate the potential loss of aquatic life, a Native Fish Rescue and Relocation Plan should be undertaken in the days prior to pond works occurring.

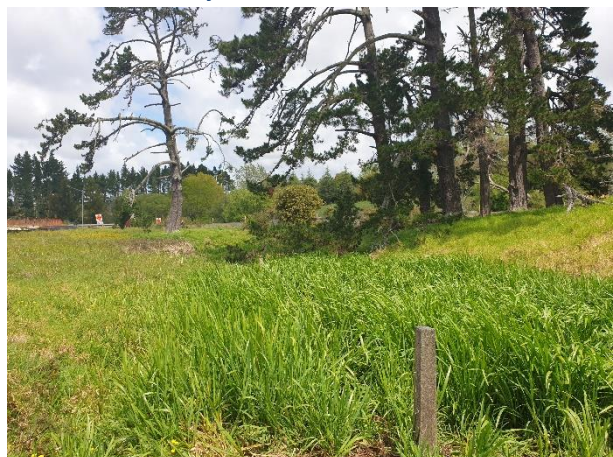
Downstream of the artificial pond, the gully path widened forming an induced wetland. Reed-sweet grass (*Glyceria maxima*; OBL), dominated the area, forming a monoculture with a very low biodiversity. The wetland met the rapid assessment for wetland vegetation based on the dominance of obligate species. Primary hydrological indicators including standing water, approximately 0.1 m deep, and boggy ground around the outer margins of the wetland were evident. The wetland extent is not visible in aerials prior to 1996, however a shallow flow path is observable in historic aerials. Due to the presence of obligate wetland species, and permanent wetland hydrology present, the area was classified as a natural wetland under the NPS-FM.

Photo 6. Downstream view of the reed-sweet grass wetland.

No works are proposed within the natural wetland. The proposed development will result in the loss of upstream catchment and an increase in impervious surfaces within the wetlands contributing catchment. The hydrology of the wetland has been considered when designing the development. Hydrological mitigation is proposed through the reticulation and discharge of stormwater into the wetland to achieve net hydrological neutrality, to ensure that there is no drainage or partial drainage of the natural wetland.

The proposed development has the opportunity to significantly increase the ecological value of the natural wetland through appropriate native riparian planting and restoration planting within the wetland body.

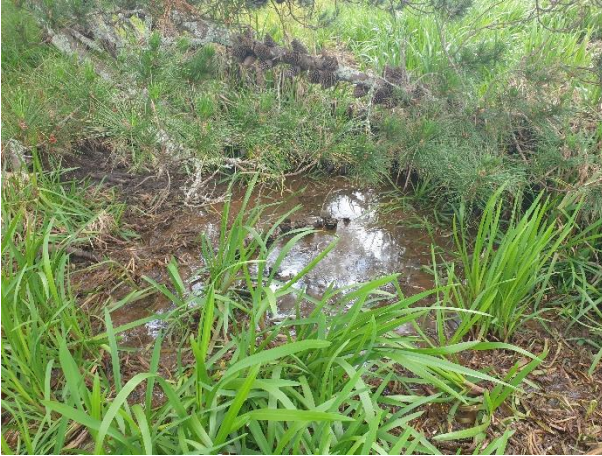
Photo 7. Standing water present within the wetland.

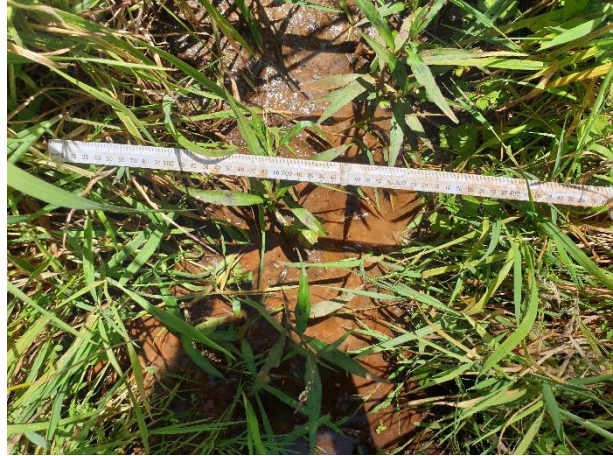
Downstream of the natural wetland, an overland flow path was present which had been previously classified as an intermittent stream, due to the present of surface water, defined channel banks and the lack of rooted terrestrial vegetation within the channel.

Photo 8. Intermittent channel downstream of the wetland.

All other identified aquatic habitats and ecosystems within the site are proposed to be retained. No building infringements or removal of vegetation within the 10 m setback of the wetland, or 10 m riparian yard of the intermittent stream is proposed. Indirect adverse effects, for example, erosion, scouring, sedimentation and stormwater contaminants, are proposed to be mitigated through appropriate controls and following best practice guidelines to ensure adverse effects on aquatic life are no more than minor.

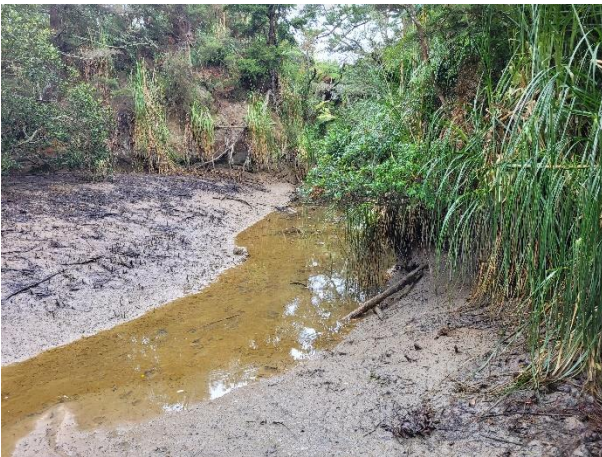
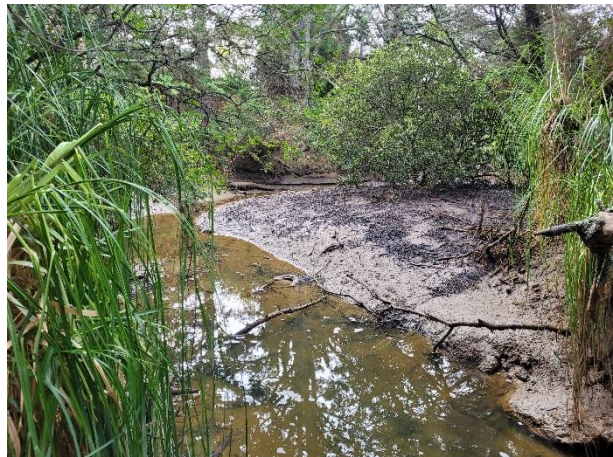
Photo 9 & Photo 10. & Typical estuarine environment near the Outfall Site.

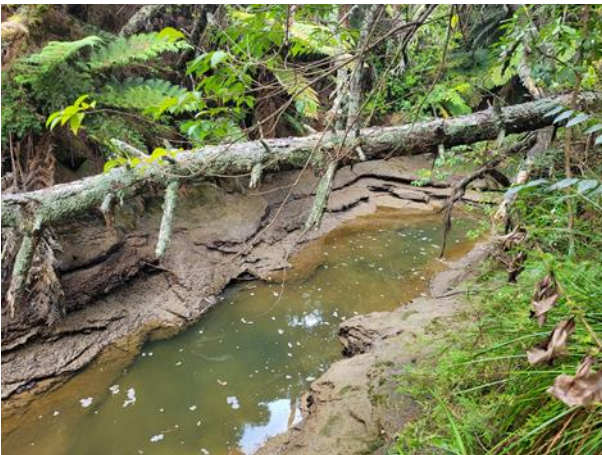
Photo 11. No freshwater wetlands were observed within the Outfall Site

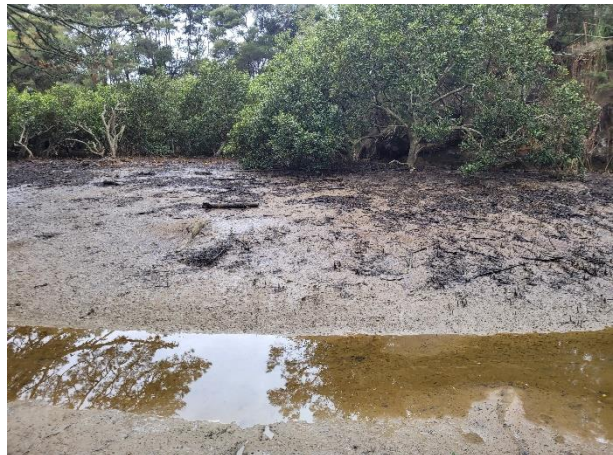
Coastal wetlands are located within 100 m of the proposed development, east of the Outfall Site, which supports the recognised ecosystem type 'Mangrove Scrub'. The coastal wetland formed a monocultural of mangrove (*Avicennia marina* subsp. *australasica*), an obligate wetland plant, and would contain permanent, coastal hydrology. Therefore, the mangrove forest met the definition of a natural wetland under the NPS-FM, following the High Court decision.

Photo 12. Mangrove forest present near the proposed outfall, on the opposite bank.

Additionally, the project proposes to discharge water within 100 m of a natural coastal wetland. The outfall does not extend into the mangrove forest, and the removal of wetland vegetation will not be required. As the wetland is coastal, and therefore primarily hydrologically supported by the tidal regime, the discharge of stormwater will have a negligible magnitude of effects on the hydrological regime of the coastal wetland. Stormwater flows will be attenuated through the implementation of erosion control through rip rap and a scruffy dome. Therefore, potential erosion and scour at the

outfall will be minimised, and reduce the level of fine sediments entering the coastal wetland. The discharge will not represent a change in the hydrological regime of the coastal wetland and will not adversely affect the extent and function of the coastal wetland or result in the partial or complete drainage of the natural wetland.
