TO: Matvin Group  
COPY TO: Burnette O'Connor, The Planning Collective  
FROM: Annabelle Coates, Senior Ecologist

Date: 1 September 2021  
Job No: 64831

## 1092 COATESVILLE RIVERHEAD HIGHWAY – ECOLOGY ASSESSMENT

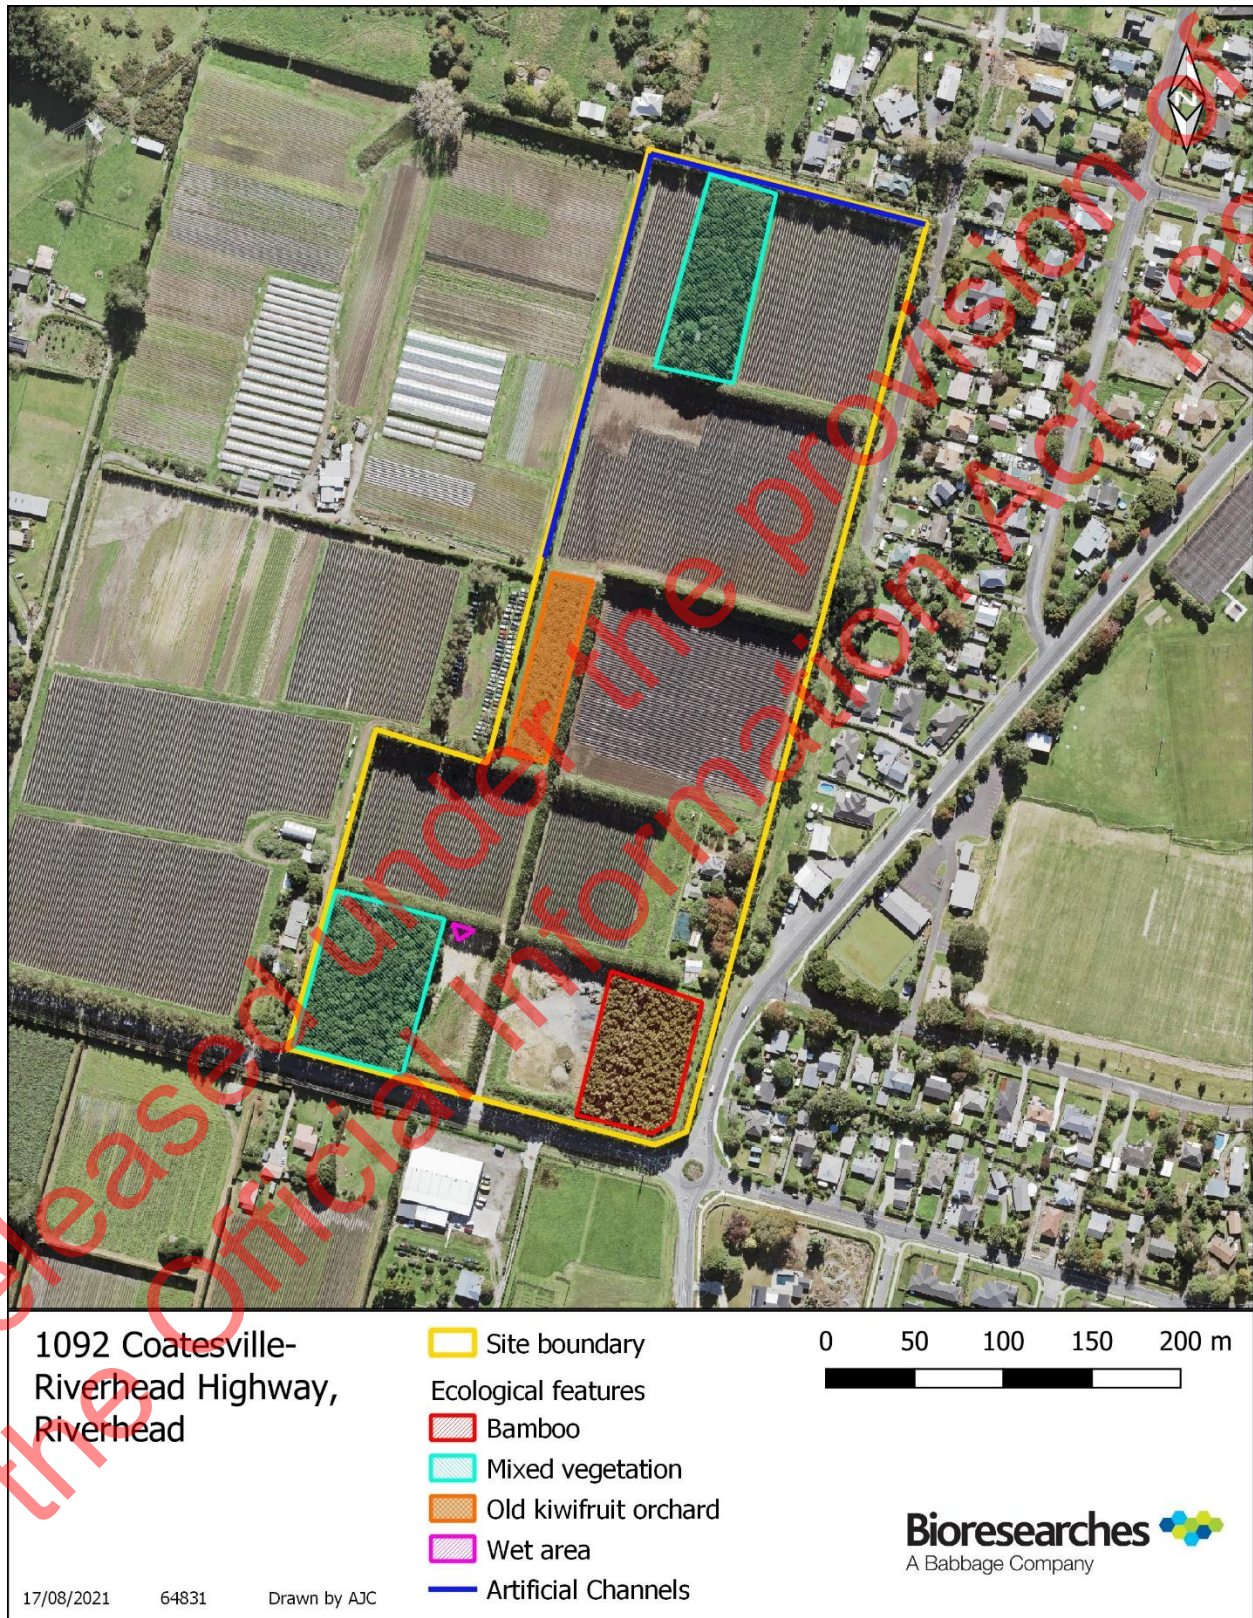
## Appendix I: Identified Ecological Features

The site predominately consists of strawberry cultivation with associated exotic shelterbelts. In addition, there was an area of overgrown kiwifruit orchard, an area of what appeared to be cultivated bamboo, and two areas of scrub/mixed vegetation (Appendix I). The mixed vegetated area in the south western corner of the site consisted of tall mature Australian blackwood (*Acacia melanoxylon*) with a mixed understory of privet, cabbage tree, arum lily, wild ginger and woolly nightshade. A similar vegetation mix was present in the vegetated area at the northern end of the site. However, in this northern area, it appeared the majority of the blackwoods had been felled. This northern area also contained a small number of māpou (*Myrsine australis*) and *Coprosma robusta*. The shelterbelts were almost exclusively exotic, however there were points where relatively young isolated native plants such as silver ferns (*Cyathea dealbata*) were present at the base of the shelter belt.

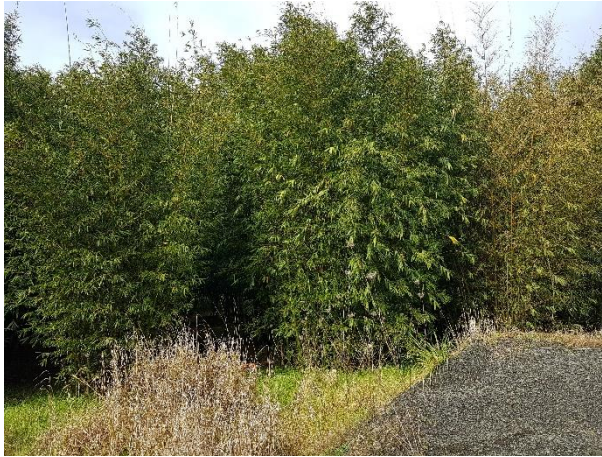
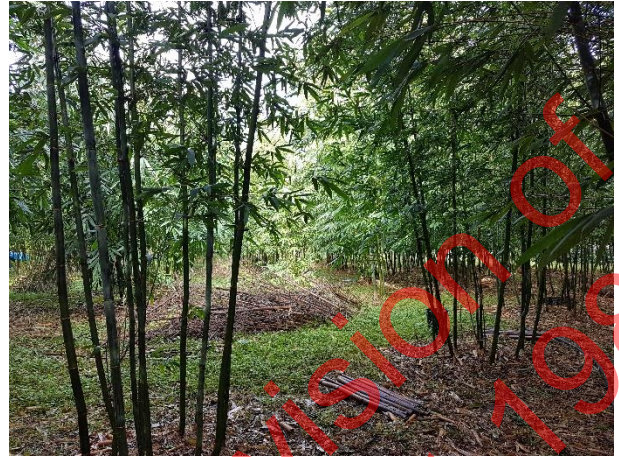
***Photos 1 & 2: Bamboo stand in the south east corner of the Site.***

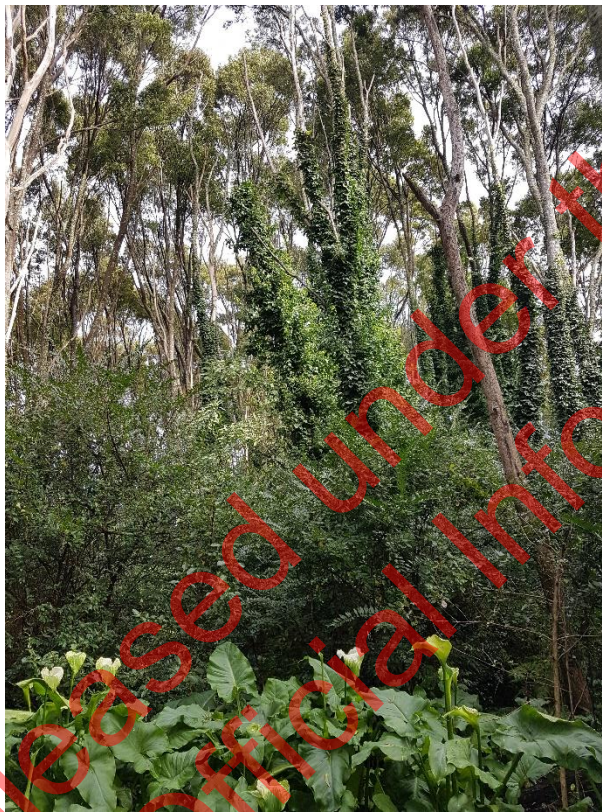
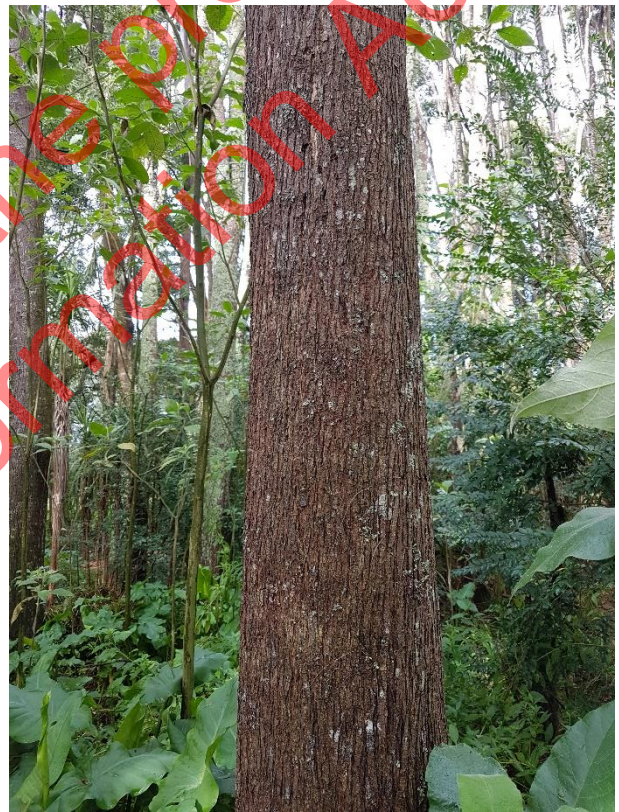
The botanical value of the vegetation within the site was very-low, being heavily dominated by exotics, including the understory within the vegetated areas in the north and south west. There were very few large native trees, and overall, the site provided low-quality fauna habitat due to the lack of complexity, high edge effects and low terrestrial connectivity.

***Photos 3 & 4: Mixed vegetation dominated by Australian blackwood in the south west of the Site.***

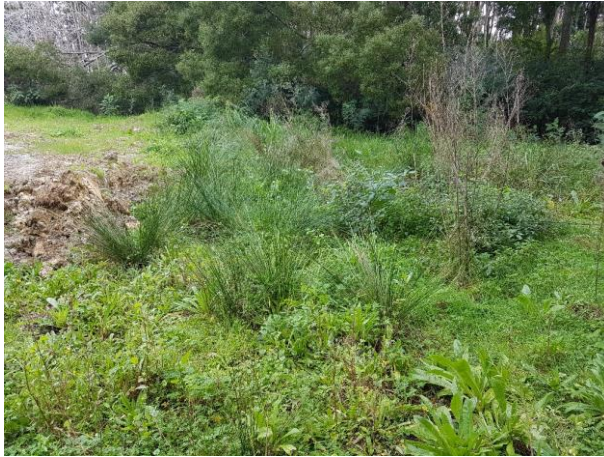
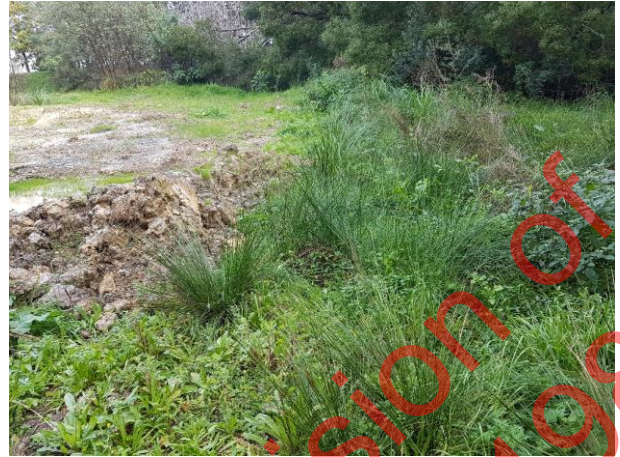
Directly to the east of the vegetated area in the south west of the Site was an area where soil had been stockpiled and this had resulted in an area with poor drainage and the establishment of *Juncus effuses*, and *Ranunculus repens*. No native species were identified and most species present in this area are considered weeds. As this area contained hydrophytic vegetation, it was assessed under the Wetland Delineation Protocols<sup>1</sup> to determine whether the area should be classified as an induced 'natural wetland' under the NPS-FM. The vegetation within the representative plot failed the Rapid Test, Dominance Test and Prevalence Index (Table 1). As such the vegetation was assessed as not 'wetland

vegetation' and the area was assessed as not a 'natural wetland' under the NPS-FM. In this instance, it was considered that the area was clearly not a 'natural wetland' and no further investigations (i.e. hydric soil testing) was required. It is considered that once the stockpile is removed, the wet conditions would not remain and hydrophytic vegetation would not be able to persist.

***Photos 5 & 6: Damp area (prevalence index determined not a wetland), with part of the stockpiled soil on left of the photos.***

There are no wetlands within the Site that meet the definition of a natural wetland under the NPS-FM and no natural streams. It is expected that the damp area, which was determined not to be a wetland, will permanently dry out once the stockpile of soil is removed. No adverse ecological effects are anticipated as result of this removal.

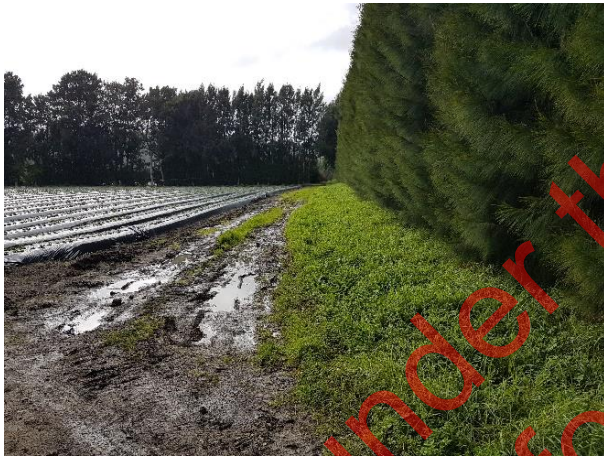
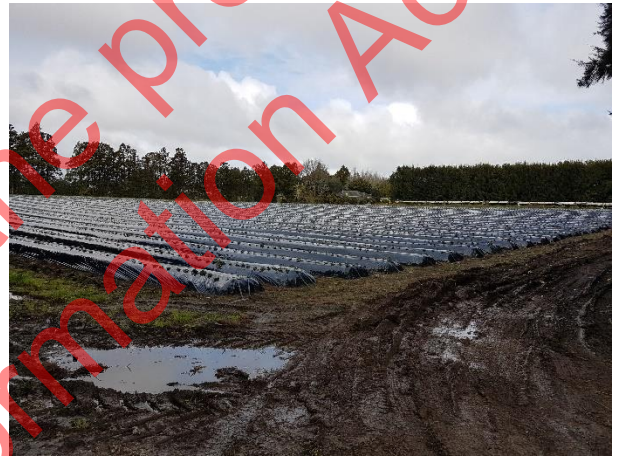
***Photos 7 & 8: The majority of the Site is occupied by strawberry fields.***

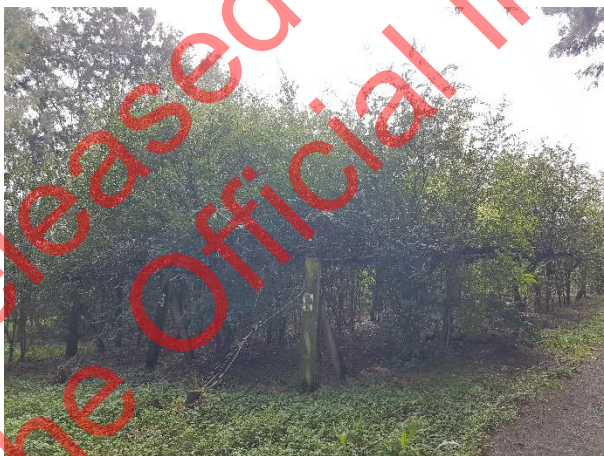
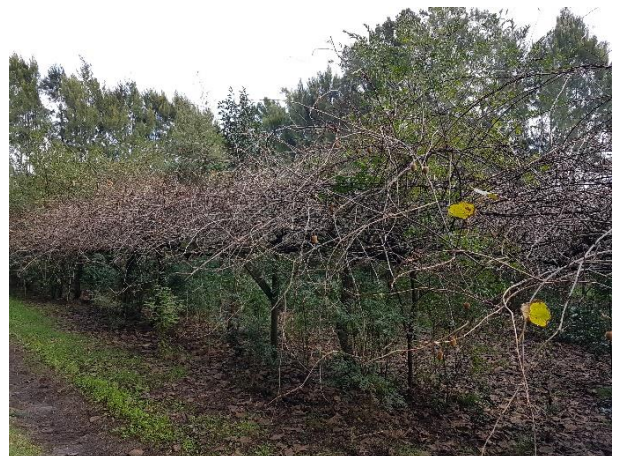
***Photos 9 & 10: Unmaintained kiwifruit orchard.***

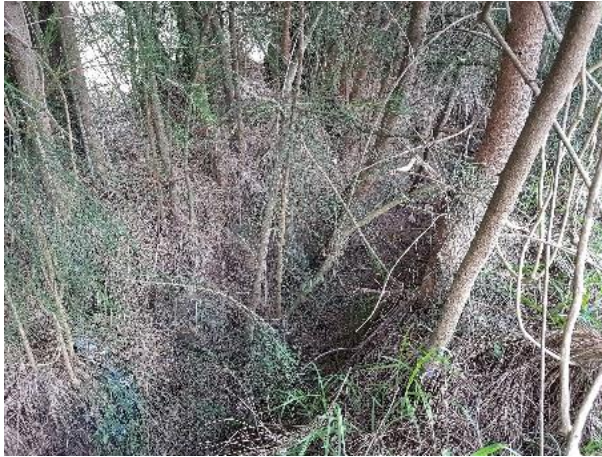
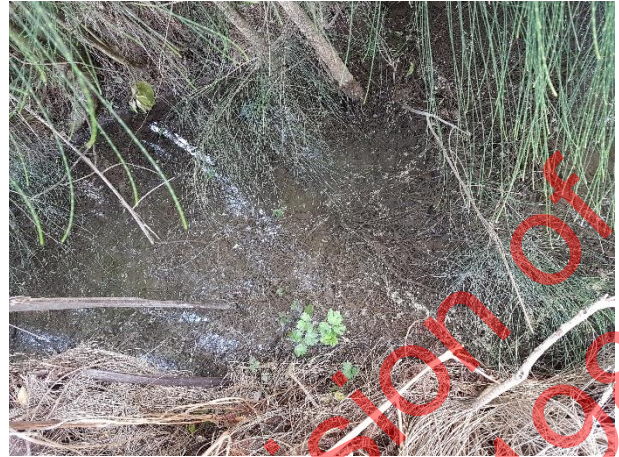
Auckland Council GeoMaps lists a number of overland flow paths within the site, predominantly draining very small areas. None of the indicated natural flow paths could be found on site, however the tracks around the edges of each paddock were very wet and could provide the flow path for runoff. Two artificially constructed channels were present along the northern boundary and along the northern half of the western boundary, both these channels appear to drain to the west rather than the north as indicated by Auckland Council Geomaps. Both channels had no flow (despite sustained moderate rainfall in the preceding days and weeks), but contained areas of standing water of variable depth, as well as extensive dry reaches. The areas of standing water were not considered natural pools, as these have been artificially cut below the wet season ground water level.

The channels were located directly underneath the shelterbelts and therefore did not contain any vegetation within their channels. Both channels contained high amounts of dry leaf litter, exhibited no evidence of substrate sorting, no evidence of scouring/undercutting and no evidence of organic debris within the floodplain, despite the abundance of organic material within the channels.

***Photos 11 & 12: The ephemeral channel on the western boundary.***

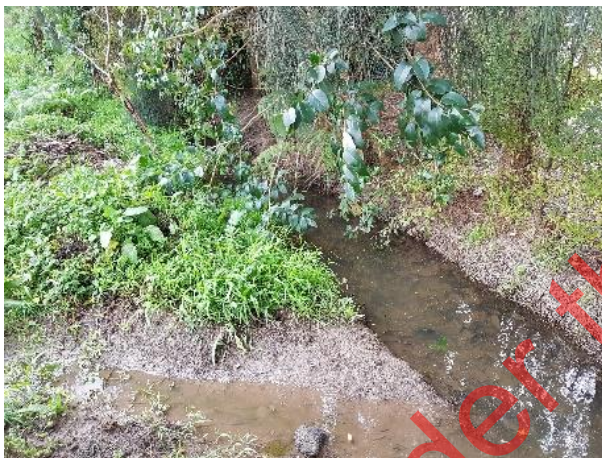
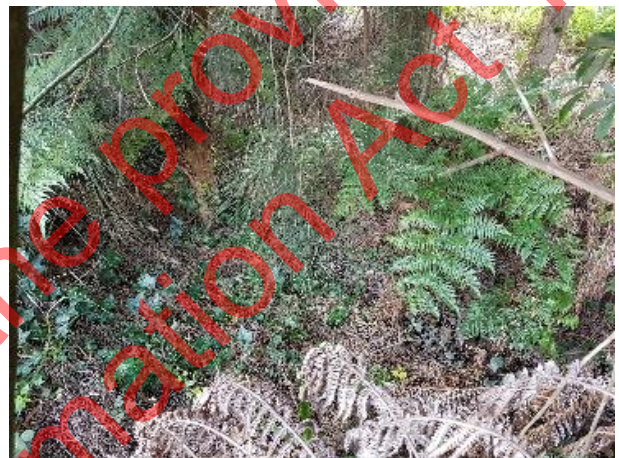
The channels within the Sites were classified as 'artificial watercourse' as per the AUP-OP definitions, due to:

- The defined channels were artificially created through deepening and straightening.
- No stream flow, despite the sustained rain in the preceding weeks and days.
- No evidence of natural pools – areas of evident standing water were artificially created by the channel being cut below the wet season groundwater level.
- No evidence of substrate sorting processes.
- No evidence of organic debris on the floodplain, despite the abundance of organic material within the channels.
- No natural portions from their confluence to their headwaters - The northeast watercourse has been reclaimed and is now non-existent and the Site now drains artificially to the west.

***Photos 13 & 14: Artificial watercourse on the northern boundaries.***

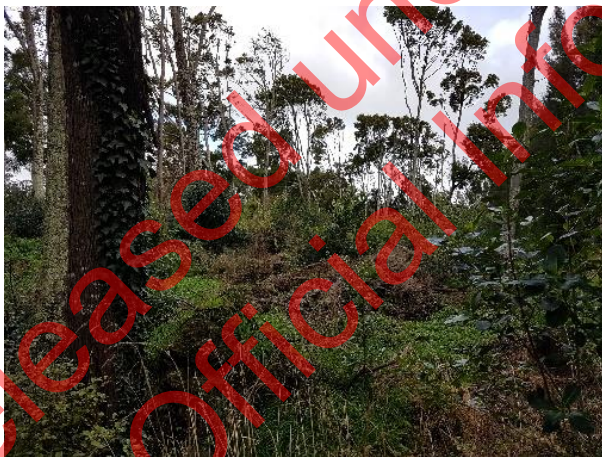
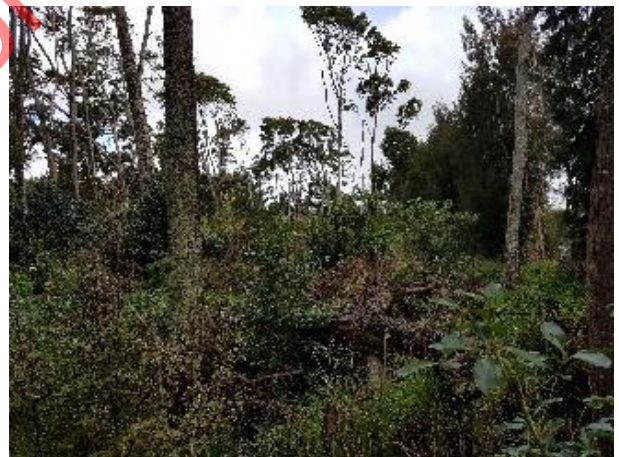
***Photos 15 & 16: Mixed vegetation in the north of the Site.***

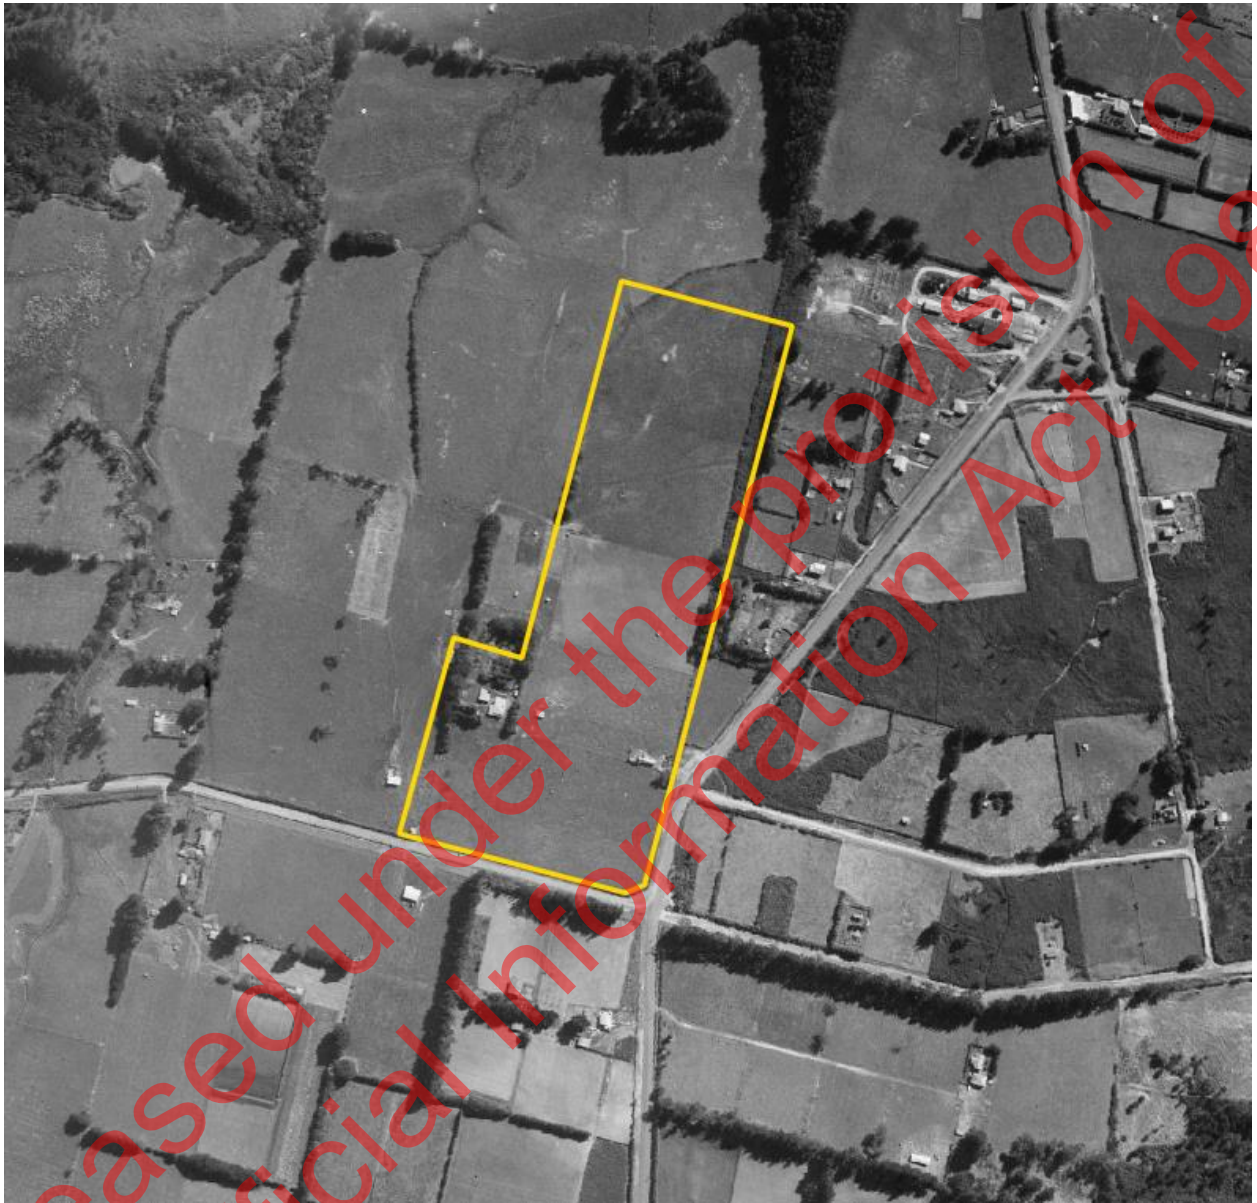
### Appendix III: 1950 Aerial Image

Earliest historical aerials available, indicate that the Site and much of the surrounding landscape has been devoid of native vegetation and managed as agricultural land for at least the last 80 years (Appendix III).

The 1950 historical aerial (Appendix III) shows a form of channel located in the northwest corner of the Site. However, this channel is located at the very top of the catchment and was likely an ephemeral watercourse that would have flowed to the northeast. This channel to the northeast has been reclaimed and is now non-existent. As such, the channels within the Site contain no natural portions from their confluence to their headwaters.

\*Base image sourced from Retrolense. Yellow polygon represents the approximate Site boundary.
