# **PROPOSED RESIDENTIAL DEVELOPMENT 617-619 NEW NORTH ROAD, KINGSLAND, AUCKLAND: ARCHAEOLOGICAL ASSESSMENT**

Prepared for 617 New North Ltd

November 2022  
(Updated from June 2022)

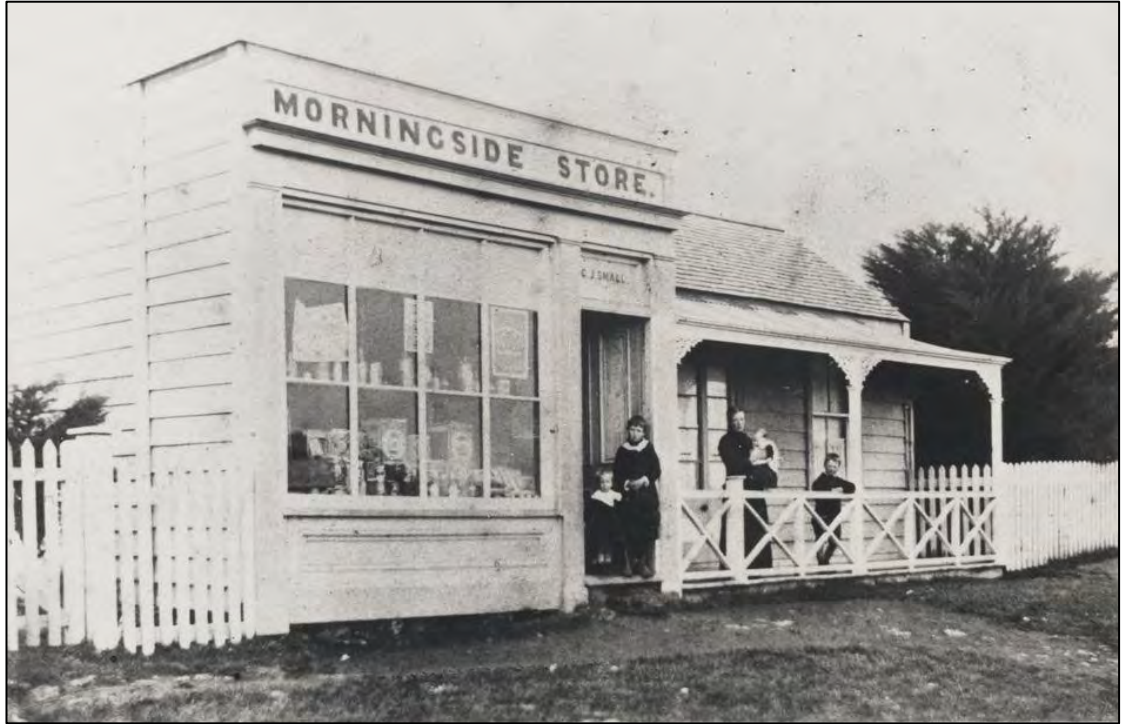
**Figure 6 Showing the Morningside Store, proprietor C J Small, with family standing outside. Photographer unknown, c1880s. Auckland Libraries Heritage Collections 255A-123**

Figure 6 shows the Morningside Store during the 1880s, appearing to incorporate a shop to the left and a residential portion to the right. A later image (Figure 7) shows an extension to the residence has been undertaken, the extent of the addition can be seen in the joins of weatherboards and the slight colour variation on the shingle roof.

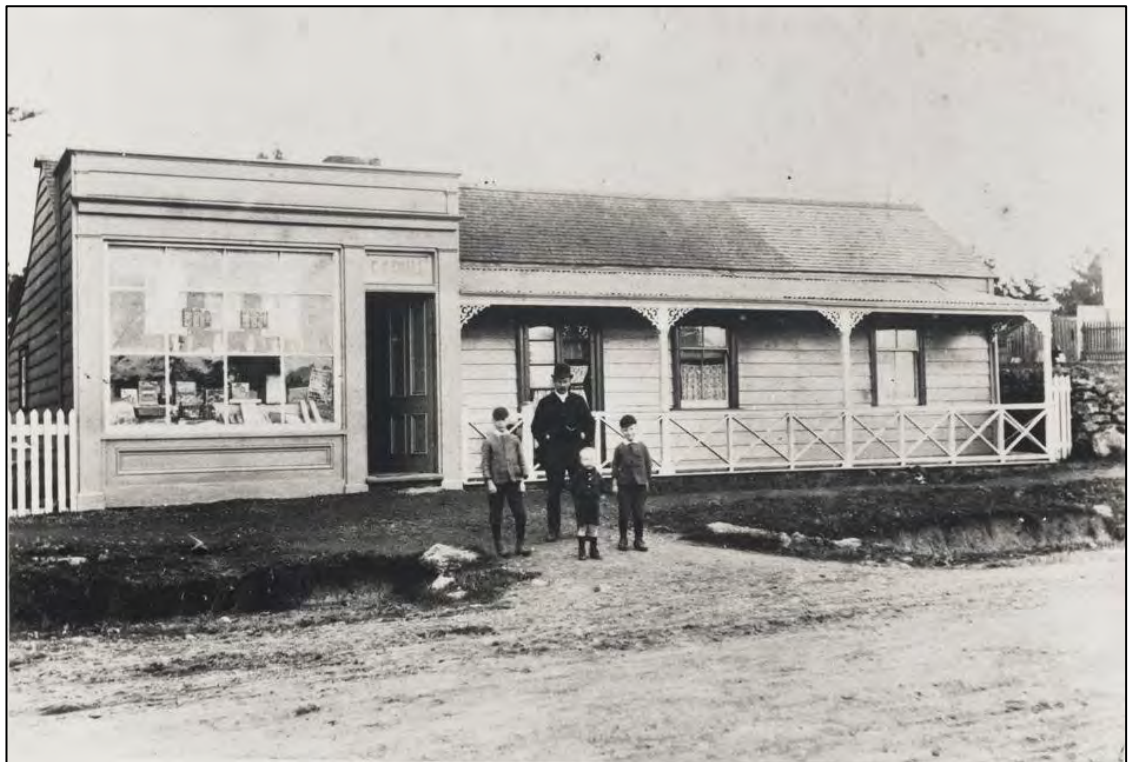
**Figure 7 Showing the Morningside Store, proprietor C J Small, with a man and children standing outside. Photographer unknown, c1880-1890s. Auckland Libraries Heritage Collections 255A-124. Note addition to right side of premises.**

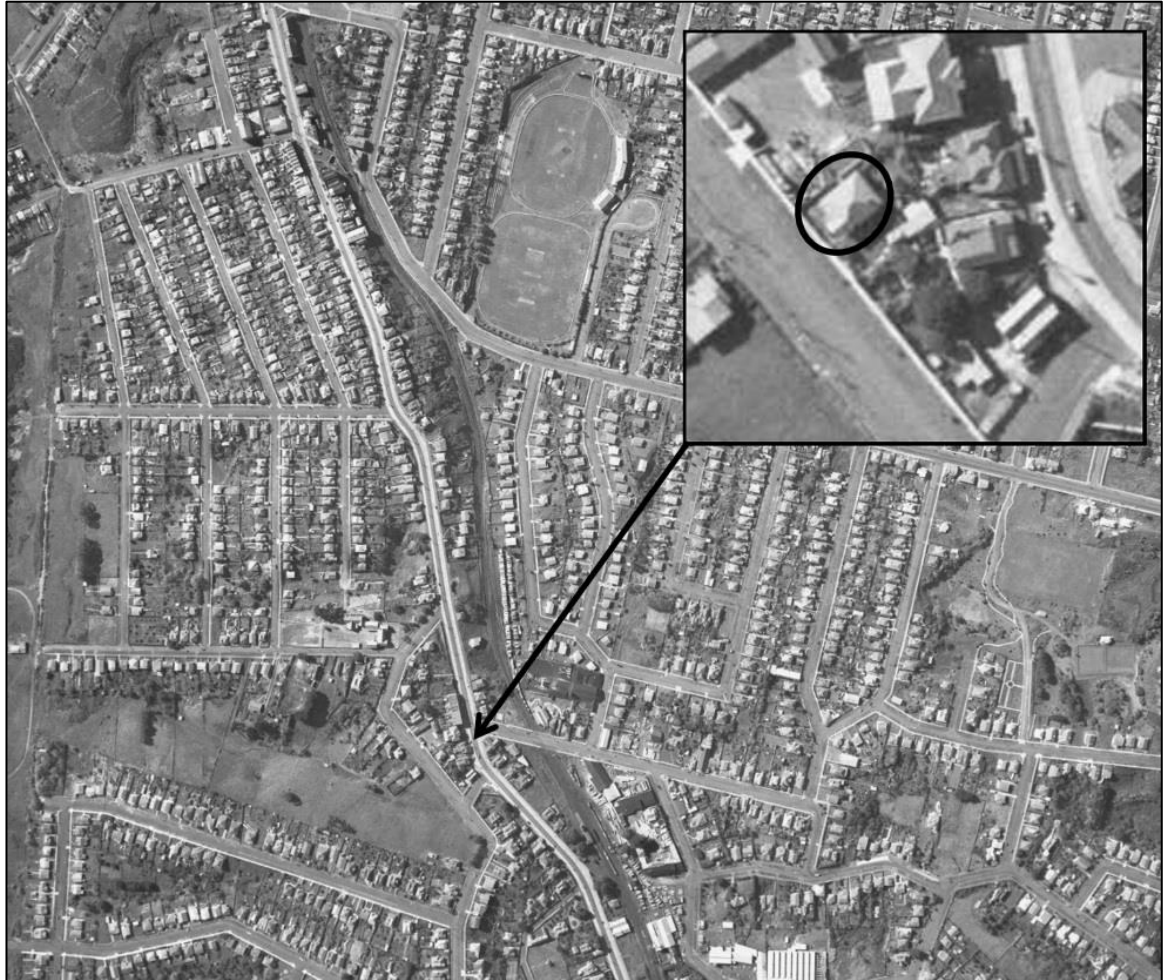
**Figure 10 Aerial photograph taken on 22 April 1940 which illustrates that at that time there was a house situated at the rear of the property that fronted onto Western Springs Road (circled inset). Retrolens ref. SN146. Source: Retrolens Historical Image Resource.**

A search of historical images on Retrolens produced six aerial photographs dating between 1940 and 1985 that depicts the 617-619 New North Road property. An aerial photograph taken on 22 April 1940 depicts the historical villa at the front of the property on the New North Road frontage, while what appears to be a timber built structure fronting onto Western Springs Road is visible at the rear of the property (Figure 10). The house is subsequently present on five further aerial photographs taken between 1951 and 1972. However, an aerial photograph taken in 1985 illustrates that the present brick built structure had been constructed by that time.

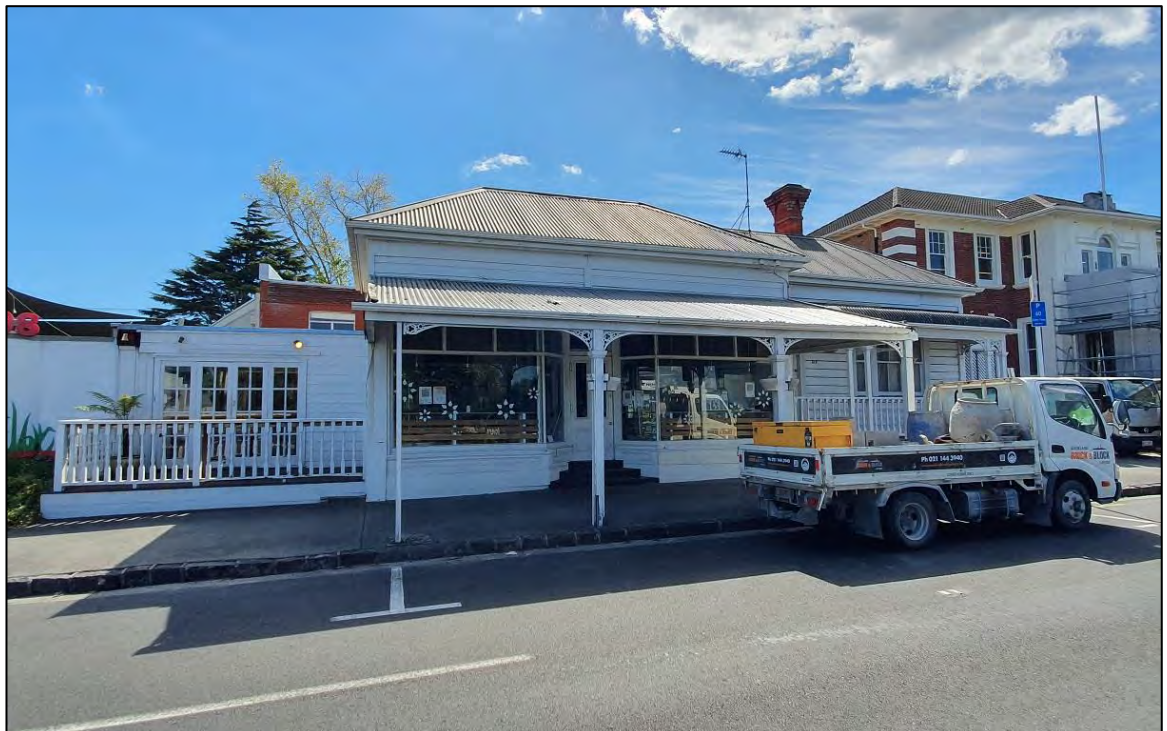
**Figure 11 The 617-619 New North Road frontage with the c1880 villa building currently operating as the Peel to Pip Café.**

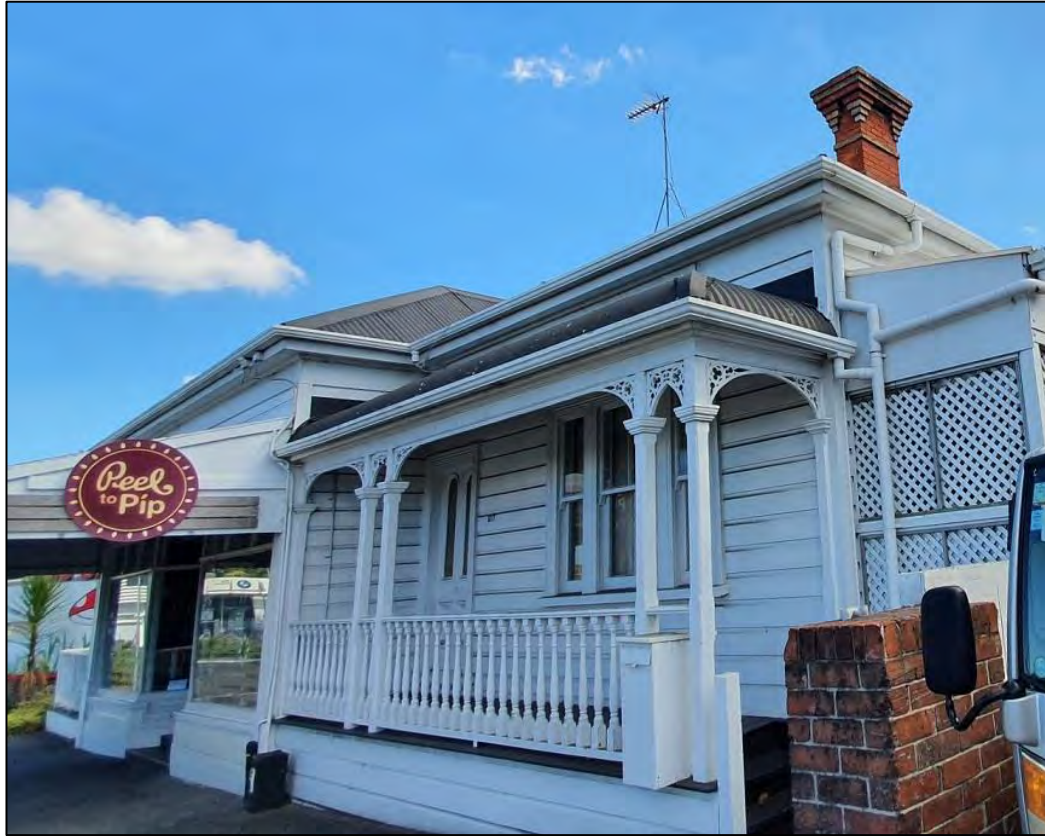
**Figure 12 Northwest facing view of the eastern frontage of the historical villa building with a brick chimney visible and roll top verandah with fretwork.**

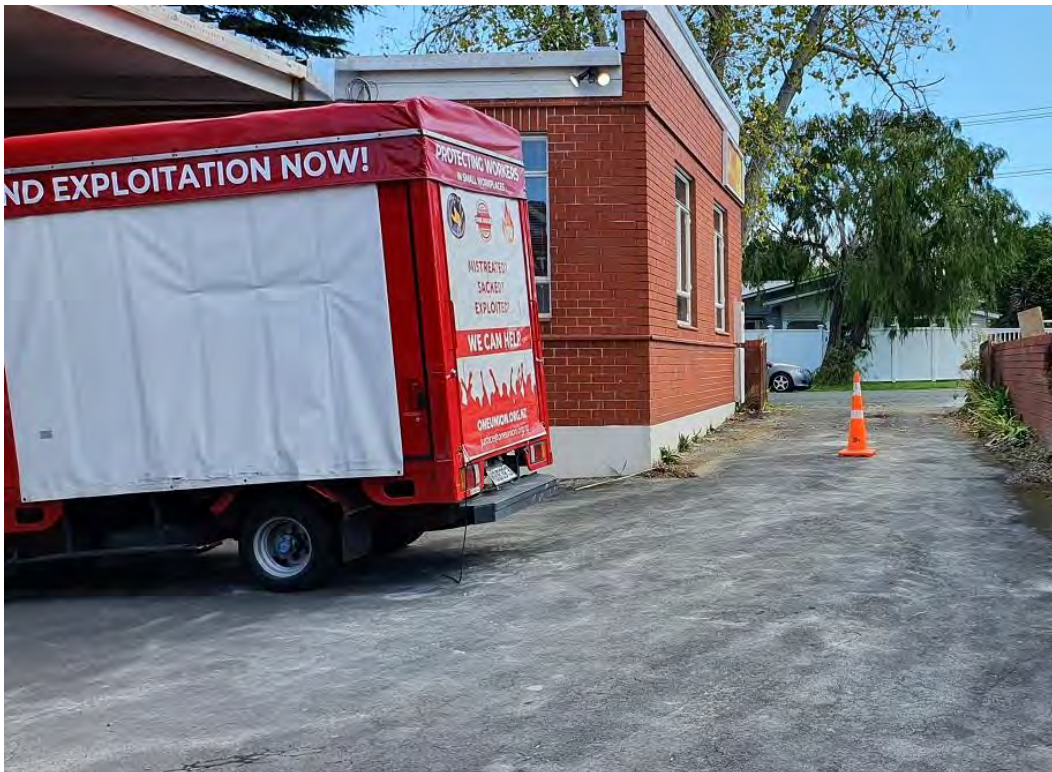
**Figure 13 Looking north along the driveway and the eastern side of the later 20<sup>th</sup> century brick built offices currently occupied by the Unite Union.**

The rear half of the property consists of a tar sealed driveway that appears to follow the original contours of the site, and the later 20<sup>th</sup> century brick built office building currently occupied by the Unite Union (Figure 13 and Figure 14).

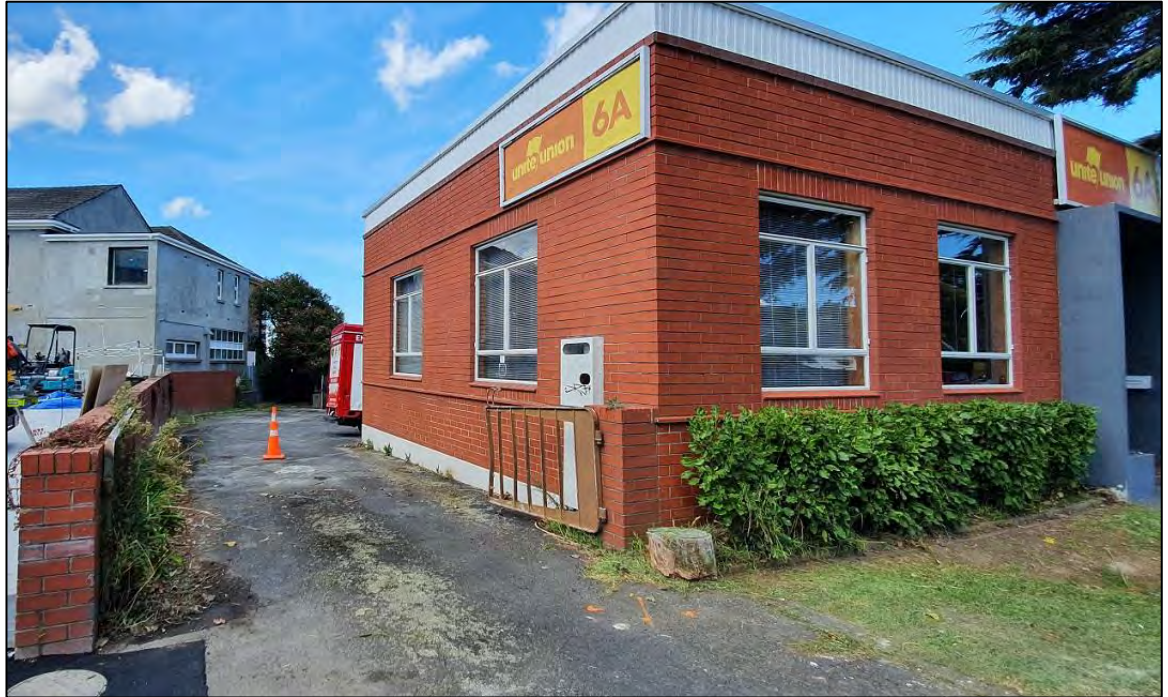
**Figure 14 Looking southeast at the entrance to the office building and driveway fronting onto Western Springs Road.**

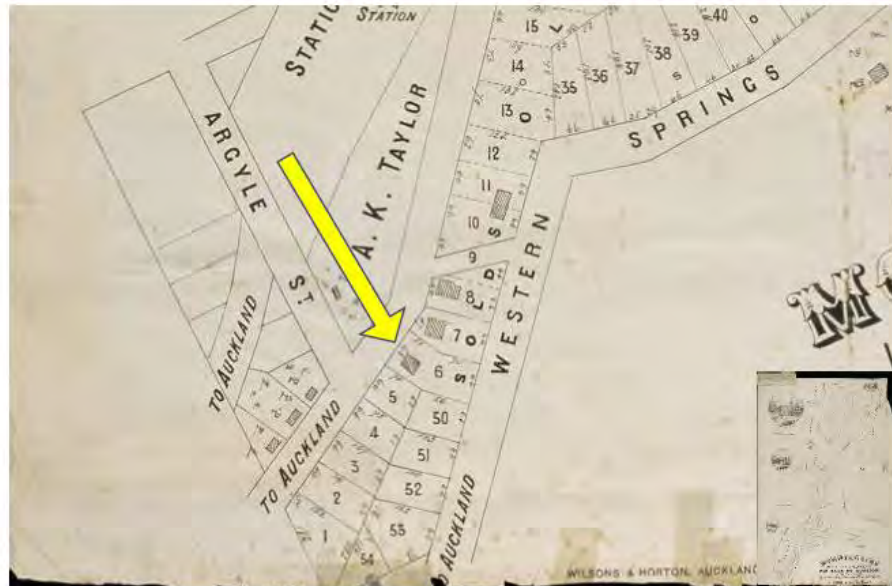
Fig. 4 Extract view of 1882 "Morningside - Villa sites and allotments for sale by auction" map, with annotations of the subject site (lot 6) being sold with a building erected thereon. (full image inset). (Auckland Libraries Heritage Collections Map 4497-7)

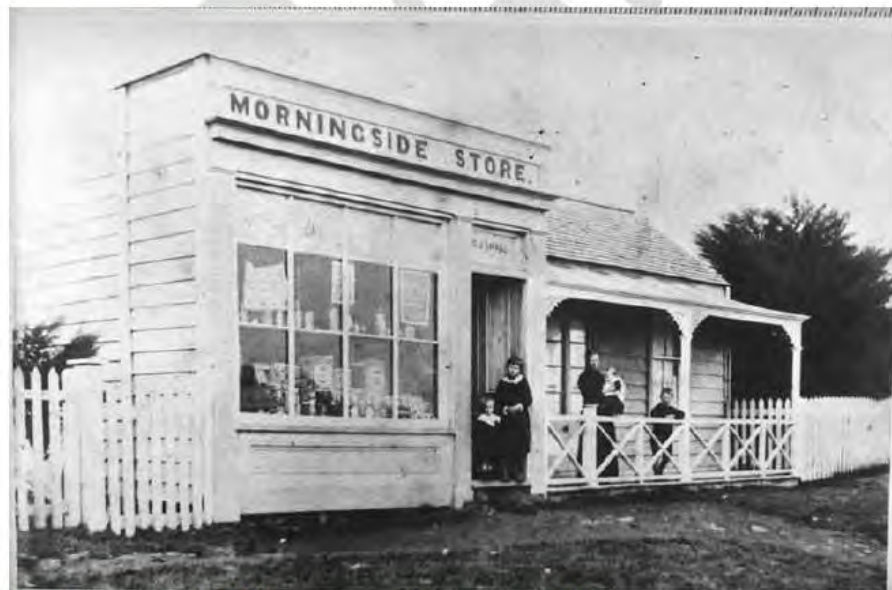
Fig. 5 Photograph showing the Morningside Store on the subject site circa 1880s. (Auckland Libraries Heritage Collections 255A-123)

The earliest available photograph of 617 New North Road (figures 5 and 9) from circa 1880s shows a modest building of timber construction integrating the original building Morningside Store into the right hand portion of the building (that portion of the building serving as private residence). It is unknown when this structure was originally constructed. Figure 9 (over the page) gives an indication that the building had previously been subject to alterations, with the misalignment of the weatherboards on the side of the building suggesting the shopfront window as being a later addition.

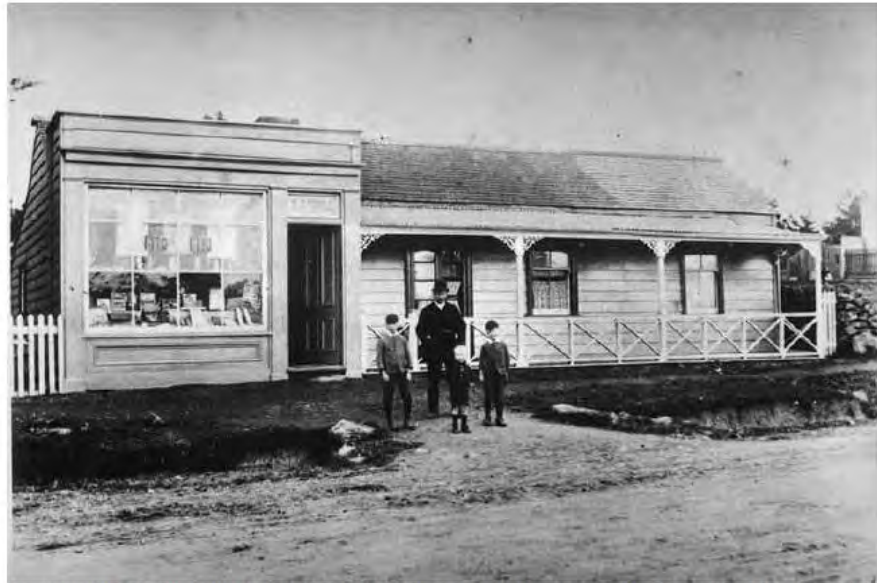
Fig. 6 Photograph showing the Morningside Store on the subject site circa 1880-1890s. The extent of the later addition to the right is distinguishable due to the colour variation on the shingle roof and the butt joins to the weatherboard. (Auckland Libraries Heritage Collections Map 4497-7)

A later photograph circa 1890s (figures 6 and 18) shows an extension to the residential portion of the building which is distinguishable due to the colour variation on the shingle roof and the joins of the weatherboard. From the 1890s till mid-1900s, there are no other readily available photographs or documents which record the extensive additions and alterations that had been undertaken to achieve the built form of the existing building at 617 New North Road.

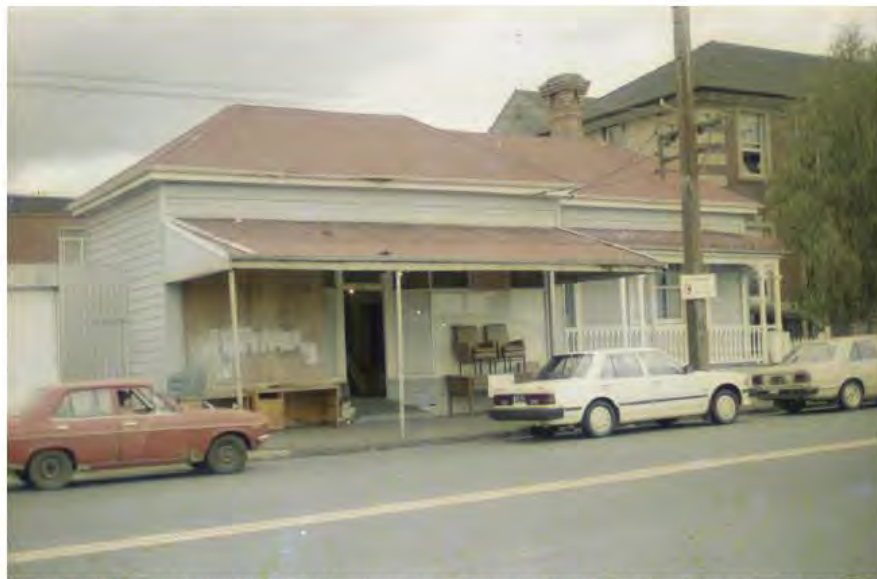
Fig. 7 The building at 617 New North Road has been subject to various additions and alterations between the earliest known photograph taken in c1880s and the photograph above taken in 1985. Note the extension to the shopfront window, the addition of a chimney, the change of the roof form, and alteration of the building's fenestration. (Auckland Libraries Heritage Collections Map 4497-7)

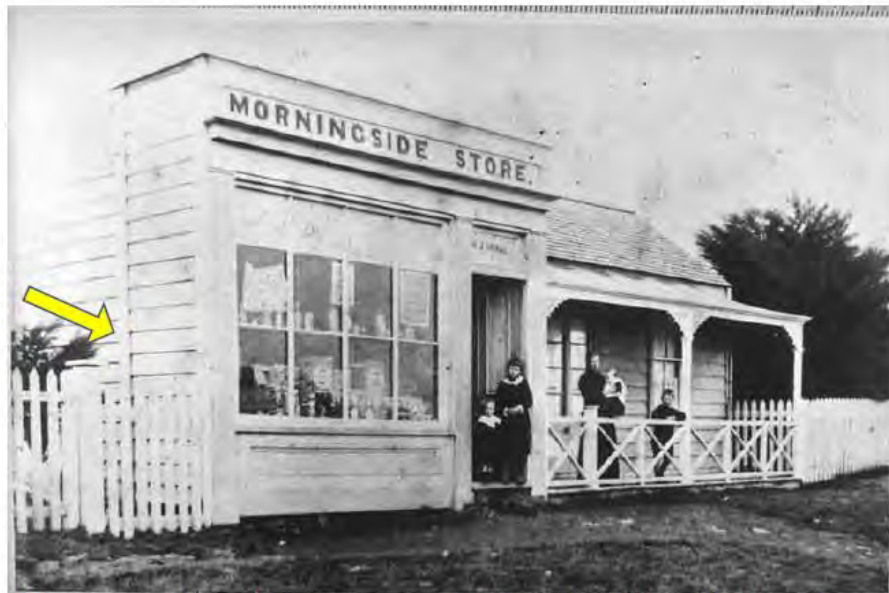
Fig. 9 Photograph showing the Morningside Store on the subject site circa 1880s. Note the misalignment of the weatherboards (indicated by the yellow arrow) suggests the shopfront window bay being a later addition to the original building (to the right).  
(Auckland Libraries Heritage Collections 255A-123)

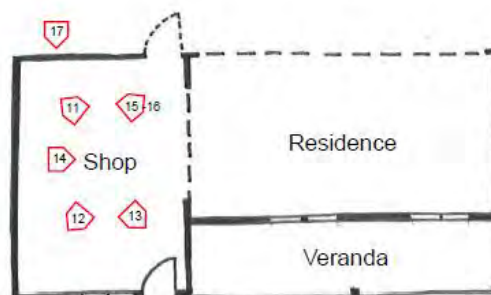
Fig. 10 Sketch of the presumed c1880s building plan. Dashed lines indicate assumed building elements and built form. The extent of the built form beyond what is shown in the available photographs is unknown. Arrows indicate areas of investigations illustrated in the images below and numbers correspond to figure numbers.

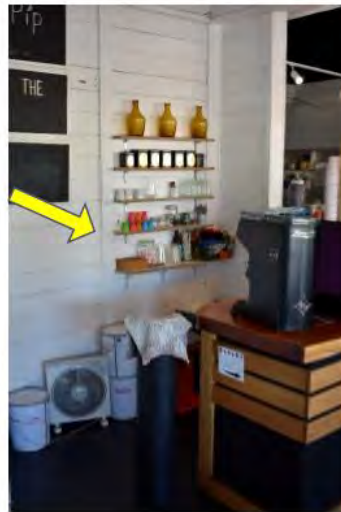
Fig. 15 The vertical batten and slight misalignment of the interior panels suggests that there may have been previously an opening within the back wall of the store.

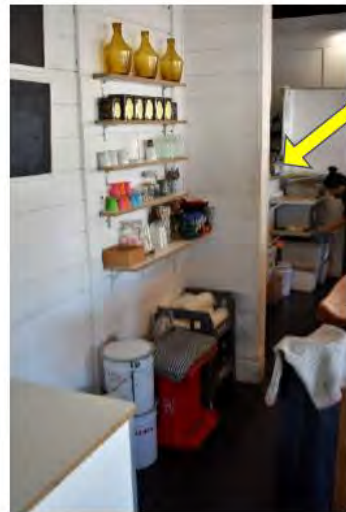
Fig. 16 Return wall within the café front of house appears to be the extent of the original store and aligns with the proportions of the original store.

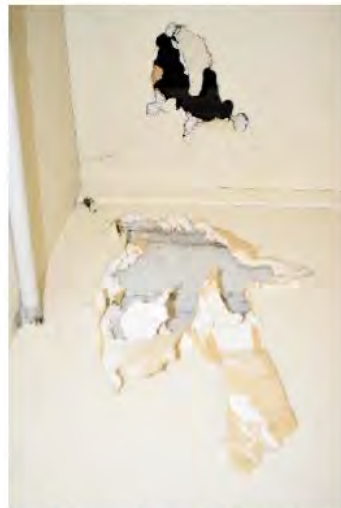
Fig. 17 An area of damaged GIB plasterboard from the space behind the front of house revealed an exterior weatherboard cladding suggesting the extent of the original building and store.

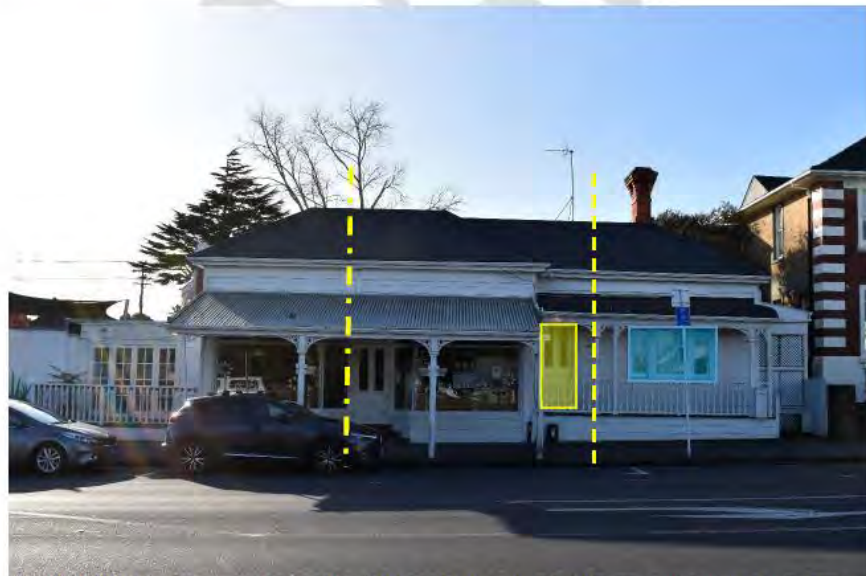
**Fig. 19** 617 New North Road as existing. Dash dotted line indicates the extent of the original shopfront c1880. Dashed line indicates the extent of the original building prior to the addition noted in the image above. The window and door have been highlighted to indicate their relation the c1890s building.  
(Auckland Libraries Heritage Collections Map 4497-7)

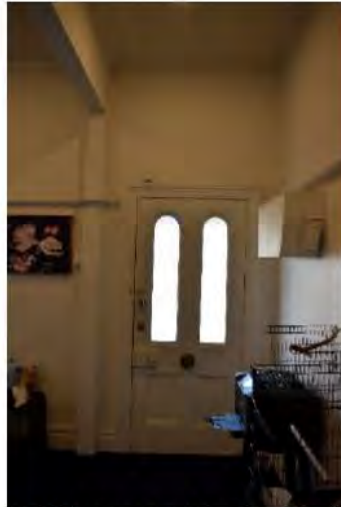
Fig. 22 The entry door into the residential portion of the building replaced a window following the extension of the store. (Indicated by yellow square in figures 20 and 21)

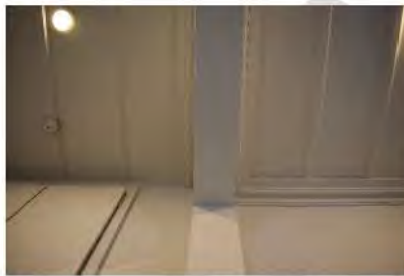
Fig. 24 Slight variation noted in the ceiling battens between the original c1880s building and the c1890s addition.

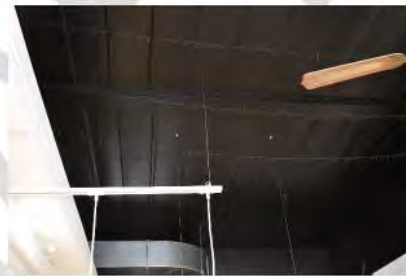
Fig. 25 Ceiling beam aligns with the extent of the original store / front of house area suggesting the extent of the residence.

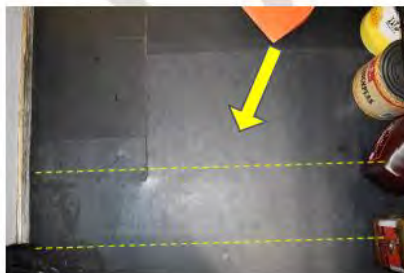
Fig. 26 Slight raise within the kitchen floor area aligns with the ceiling beam, indicating the edge and extent of original residential building.

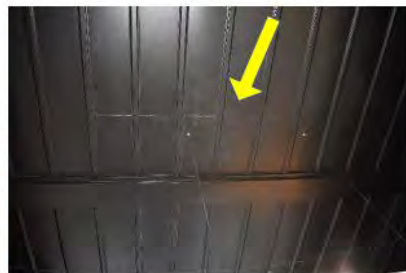
Fig. 27 A scarfing joint in ceiling suggests the presence of a chimney. Markings align with chimney shown in figure 18 and 20.

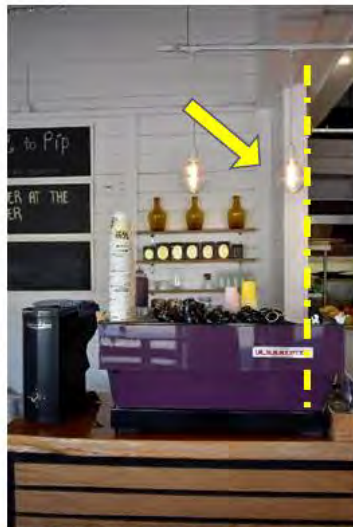
Fig. 28 As indicated in figure 16 and 18, the return wall within the front of house area appears to be the extent of the original Momingside Store.

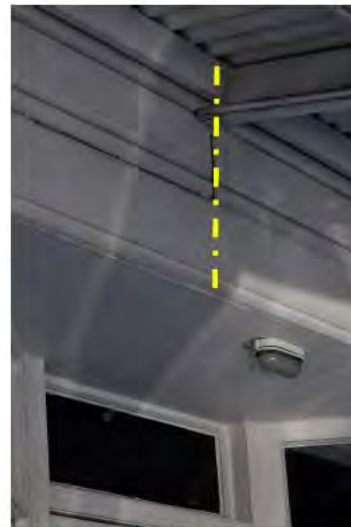
Fig. 29 A join within the weatherboards along the street front elevation indicates the extent of the original shopfront, aligning with the return wall within the café in figure 28.

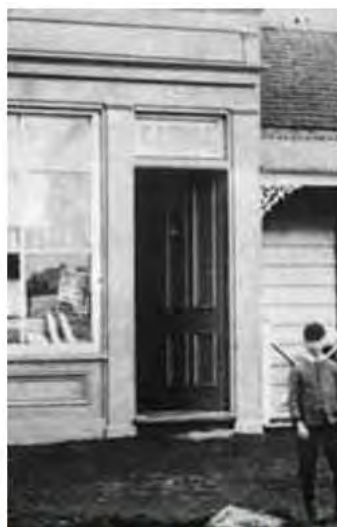
Fig. 30 The original door and transom window of the Momingside Store c1890s.

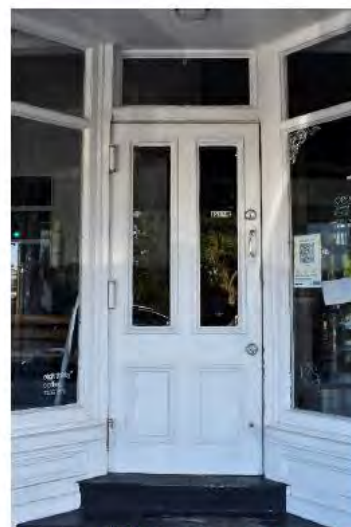
Fig. 31 The existing door and transom window of the café display similar architectural details that can be seen in the c1890s photograph suggesting these to be original features.

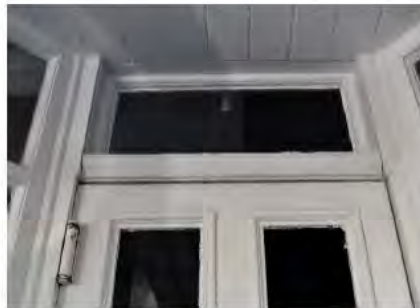
Fig. 32 The windowsill appears to be separate to the head and side jamb of the window, suggesting the transom window to be an inserted element.
