**Project Number #20034.000.001**

**Geotechnical Investigation**

617 New North Road, Kingsland, Auckland

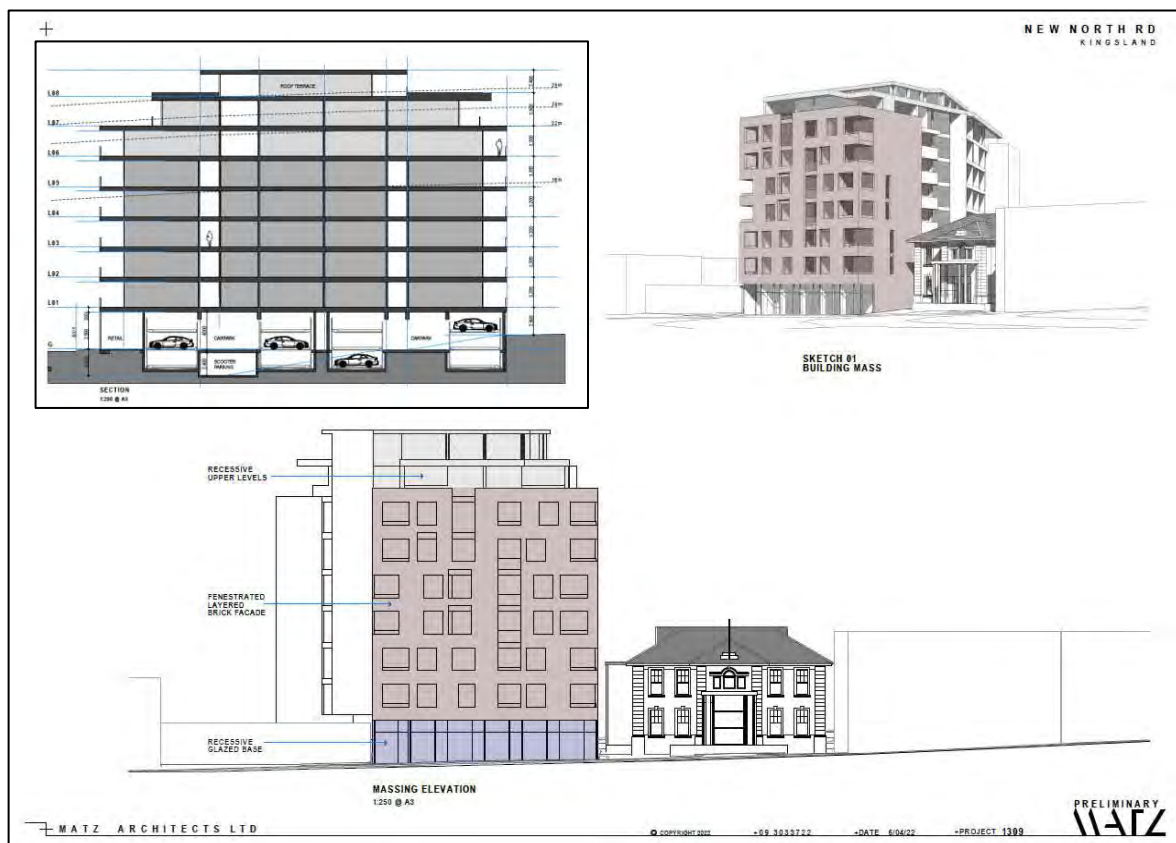
**Figure 2: Proposed Development**

These plans indicate that the basement will require cuts of up to 2.8 m on the southern side and 3.8 m on the northern side of the site. No structural, foundation, basement or earthworks plans were provided at this stage of the development.

Image sourced from Matz Architects Limited Conceptual Plans dated 6 April 2022.

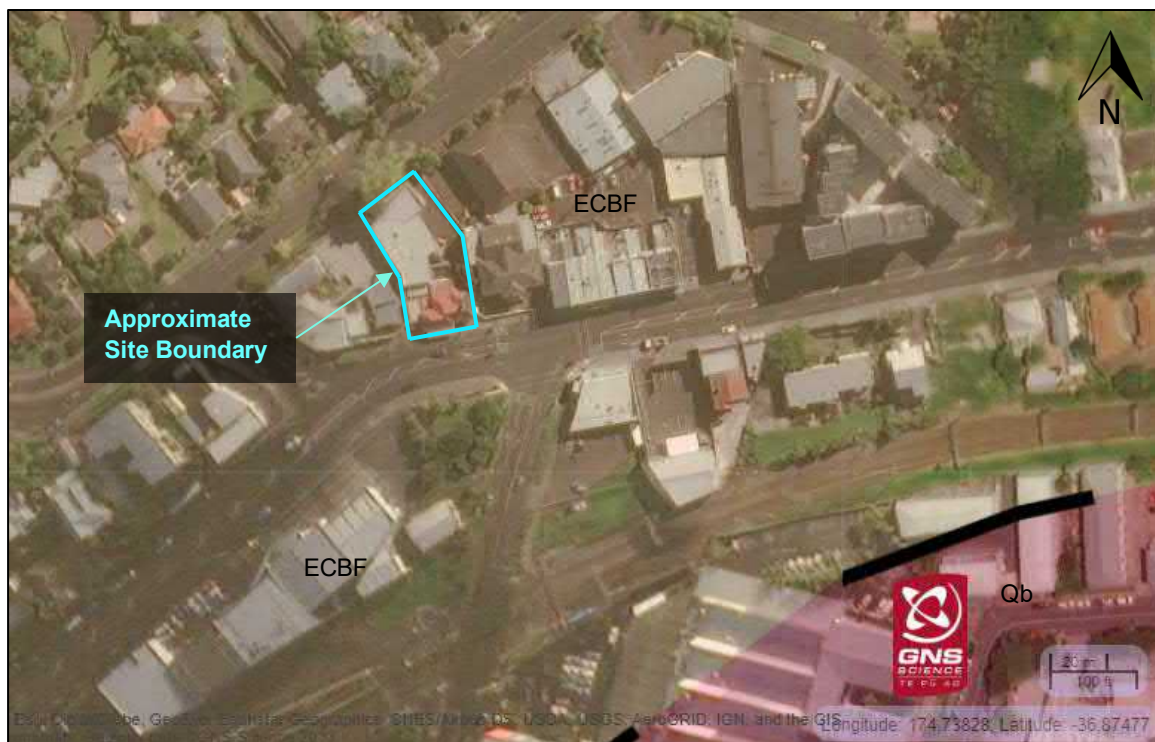
**Figure 3: Mapped Geology**

GNS Science mapping indicates a boundary between the ECBF and Auckland basalt (Qb) volcanic tuff (Auckland volcanic Field), is approximately 150 m southeast of the site (Figure 3). The volcanic tuff is described by GNS as *lithic tuff, comprising comminuted pre-volcanic materials with basaltic fragments, and unconsolidated ash and lapilli deposits*.

Note: Images sourced from GNS 1:250,000 Zealand Geology Map overlay.

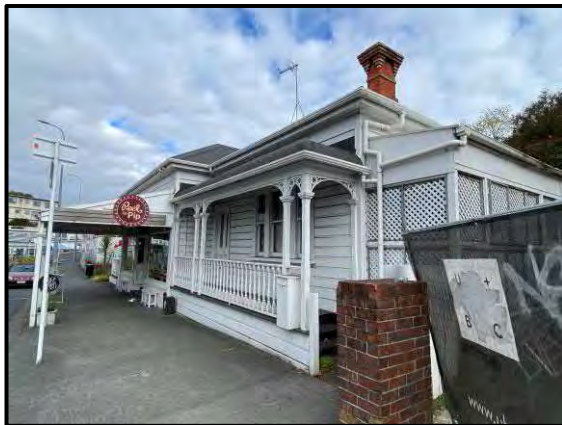
Photo 1: View of the dwelling which has been converted into a café at the southern side of the site (New North Road side), photo facing northwest.

- The dwelling accessed from New North Road is currently used as a café. The building fronting Western Springs Road is utilised as office space (Photo 1).
- The site currently slopes gently toward the south from Western Springs Road (RL 40 m) toward New North Road (RL 38 m). A small landscape and partially integrated retaining wall is adjacent to the existing café and office building.
- 615 New North Road (directly east of the site) is an historically listed, heavy clad and concrete two storey building currently being renovated (Photo 2). The building footprint for this site is directly adjacent the eastern property boundary (within 2 m of the boundary).
- 621 New North Road (directly west of the site) is currently a two-storey heavy clad childcare facility. The carpark and children's play area currently borders the western building perimeter (Photo 4).

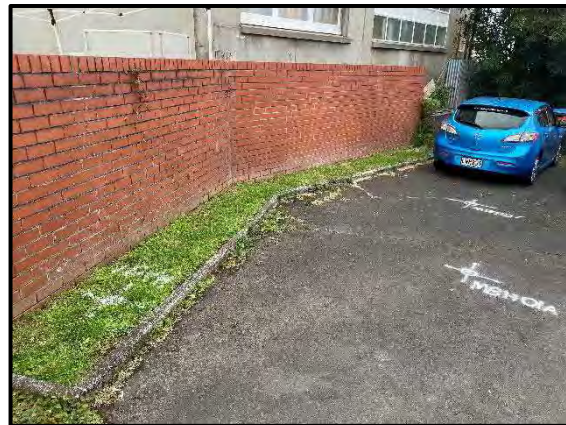
Photo 2: Eastern boundary toward the rear or the existing dwelling / café. Note: proximity of adjacent building to eastern property boundary, photo facing southeast.

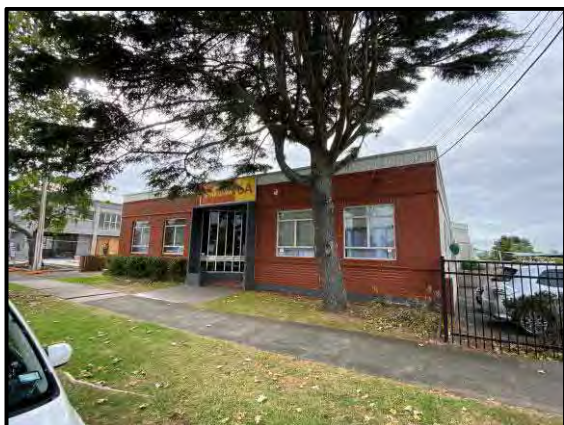
Photo 3: Existing office building on the northern side of the site, photo facing south.

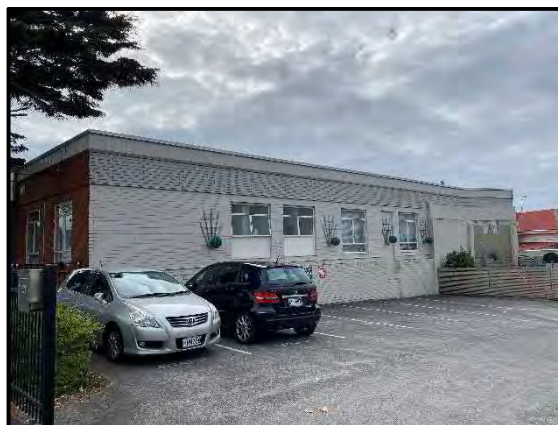
Photo 4: Carpark and play area of adjacent site looking toward the existing office building onsite, photo facing southeast.
