**Project Number 021483.000.001**

**Geotechnical Review**

19-25 Verran Road and 19 West Glade  
Crescent, Birkenhead, Auckland

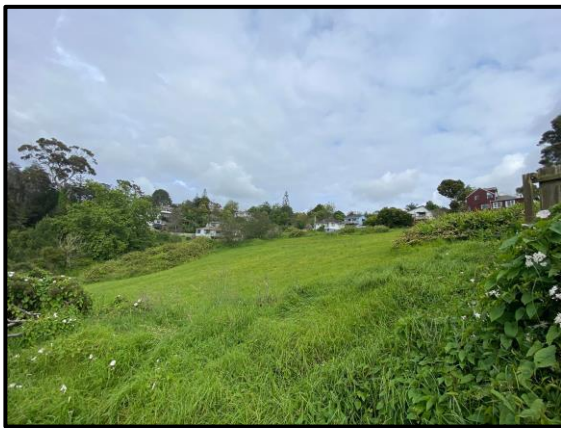
Photo 1: Looking over the site from the West Glade Crescent entrance. Photo facing west.

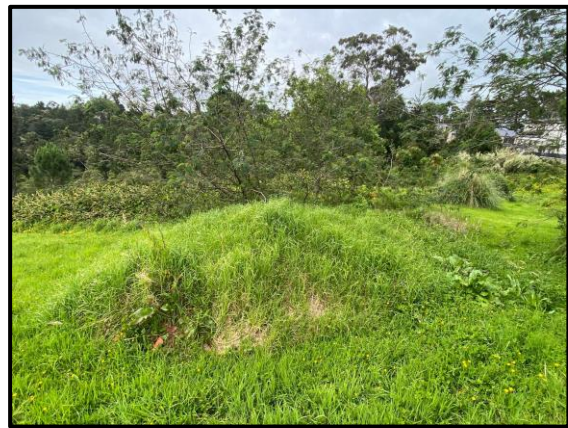
- Within the grassed portion on the northern side of the site, multiple stockpiles likely comprising uncontrolled fill were observed (Photo 2).
- A grassed accessway was observed on the north-western side of the site (Photo 3), which runs downslope toward the stormwater pond in the central area of the site. The stormwater pond mantles the RL 65 m contour, is heavily vegetated and we observed standing water within the pond.

Photo 2: Various stockpiles were observed across the site. Photo facing southwest.

These measures are likely to comprise a combination of underfill and counterfort drainage to suppress and control groundwater across the site, specifically designed retaining walls where integrated into buildings and on the downslope edge of buildings and fills proposed adjacent to the gullies in the southern portion of the site, and localised undercuts to remove undocumented fill previously stockpiled at the site.

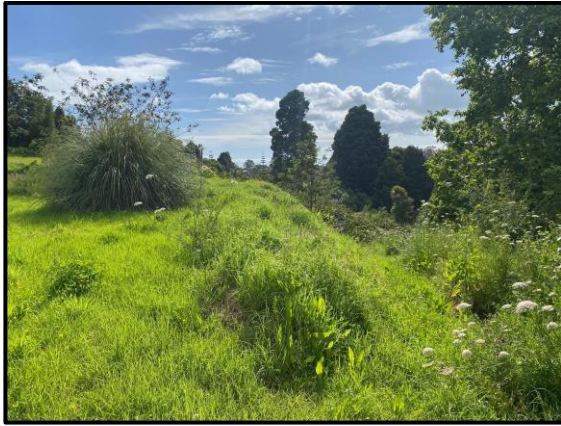
Photo 3: Accessway previously cut downslope toward the sediment pond location. Photo facing east.

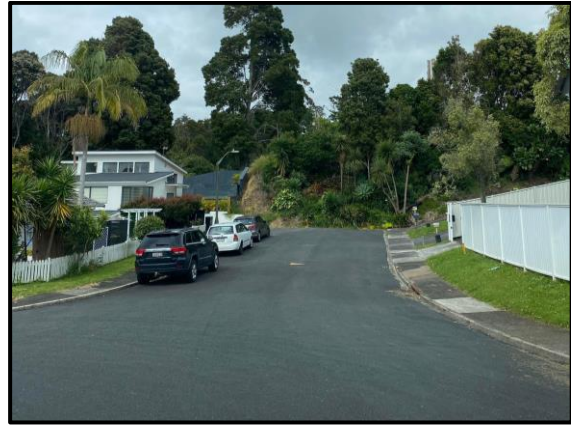
- The accessway from West Glade Crescent is currently backfilled with a fill stockpile and heavily vegetated (Photo 4).
- We observed some evidence of shallow soil creep and hummocky ground within the northern grassed portion of the site. As the remainder of the site is heavily vegetated, other evidence of soil movement and instability may have been concealed during our site visit.

Photo 4: Photo of the West Glade Crescent accessway into the site. Photo facing southwest.

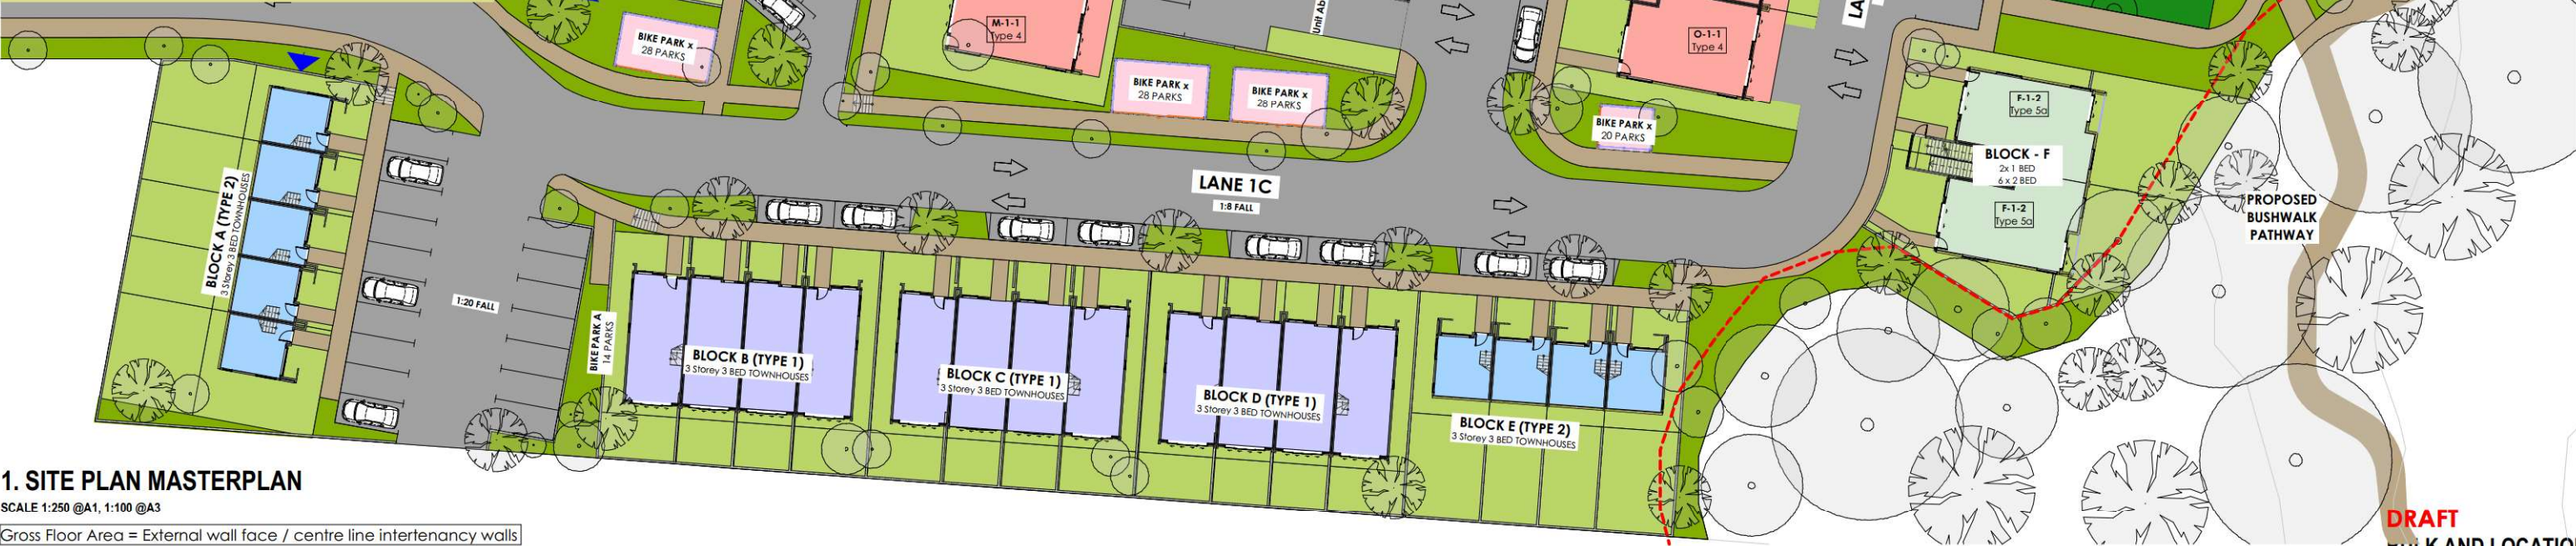
1. SITE PLAN MASTERPLAN

We have been provided with the BDG Architects Limited plan set for the site dated 28 November 2022 (referenced 2570, refer to Appendix 1). These plans depict a proposal to construct a new residential development that comprises a combination of apartment blocks and townhouses up to four storeys high, and a new preschool and communal area. The development will cover 25,861 m<sup>2</sup>. The new residential development will be accessed by the existing driveways from Verran Road and West Glade Crescent.

These plans indicate that the buildings will mantle the existing landform to the south, with cuts and fills less than 3 m proposed (partial single level basements) on the northern side of the buildings to step the building platforms into the existing slope. No structural, foundation, basement or earthworks plans were provided at this stage of the development.

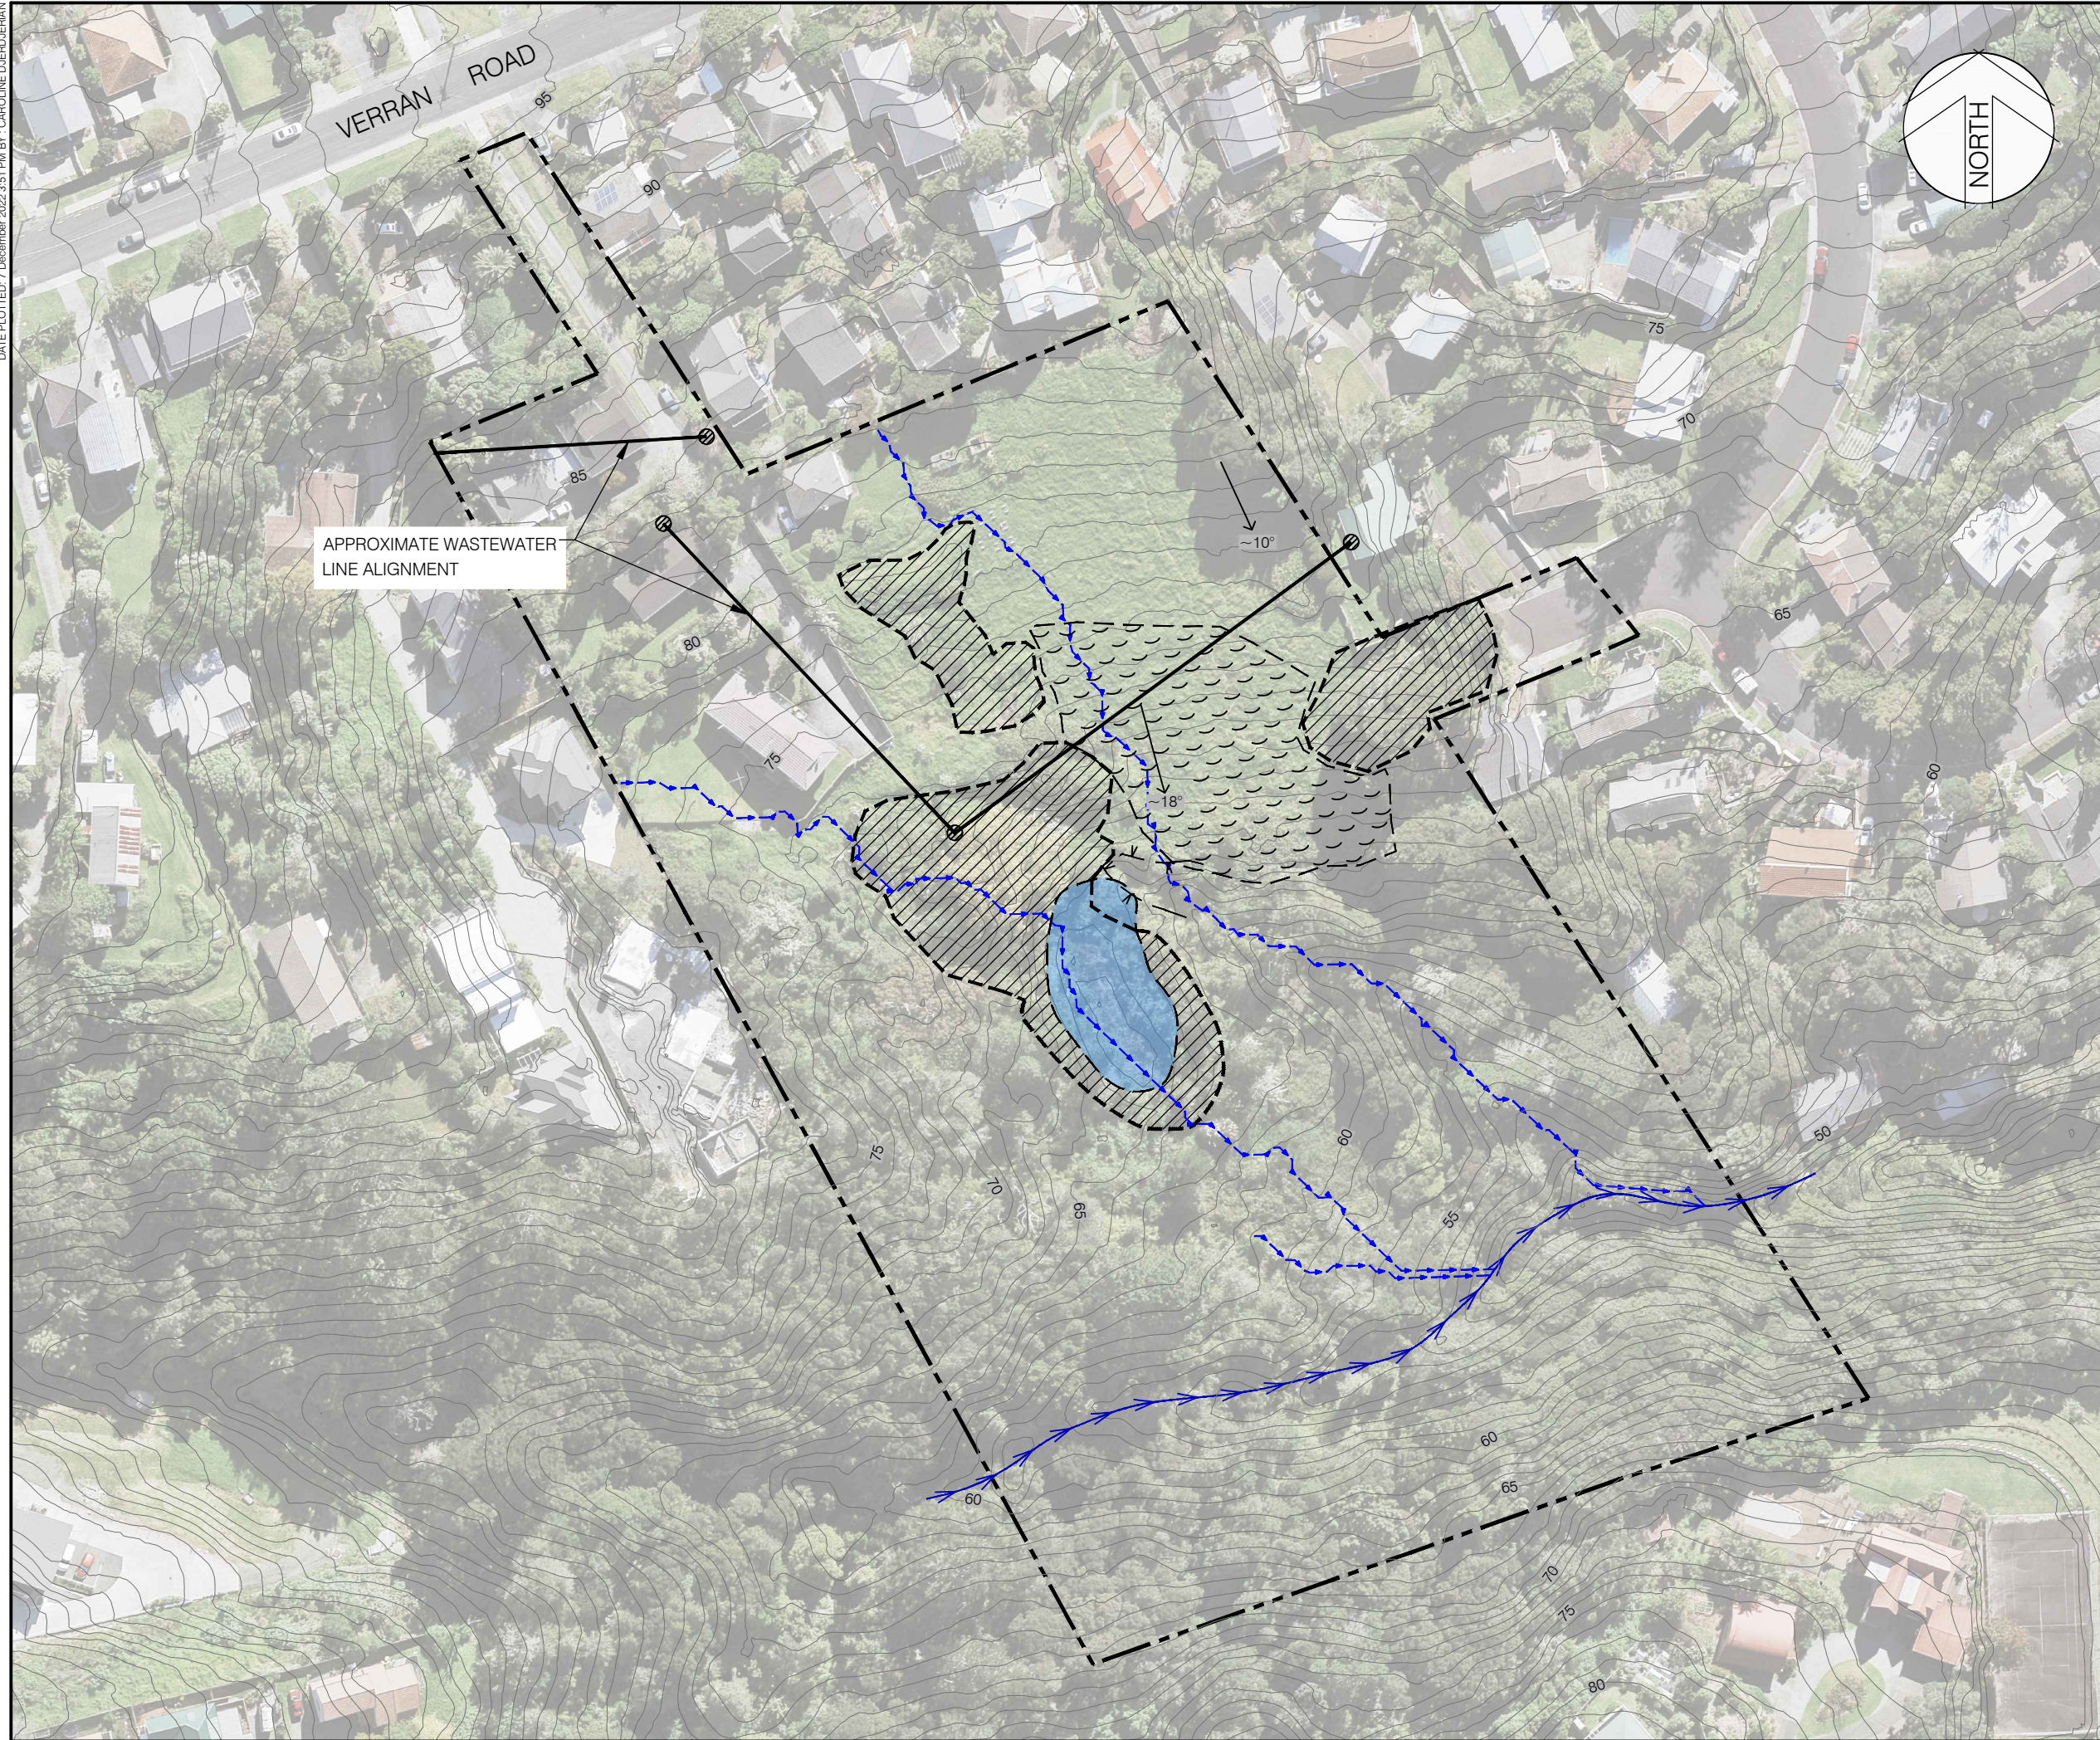
# GEOMORPHOLOGY MAP

The proposed development is located over the gently to moderately sloping areas on-site extending toward the overland flow path / gully head locations. Two overland flow paths, oriented approximately northwest-southeast, extend downslope partially intersecting the proposed building platforms for Block C, Block N, Block O and the sediment pond toward the small stream at the base of the slope.

Geomorphic evidence of shallow soil creep was observed in the northern grassed portion of the site as a broad, hummocky ground surface. No obvious evidence for active or historical instability in the form of defined head scarps or debris lobes were observed in heavily vegetated areas in vicinity of the proposed development area, both during aerial photograph review and during our site walkover. However, ground cracks or other evidence of localised soil creep may be obscured by dense vegetation.

A summary of the geomorphic site features observed during the site walkover are presented on the Geomorphological Map presented in Appendix 2.

- Hummocky Ground:** Represented by a cluster of small, dark, irregular shapes at the top left.
- Stormwater Pond (Approximate):** Represented by a light blue, irregular shape below the hummocky ground.

- Approximate Areas of Fill:** Represented by a hatched (diagonal lines) area below the stormwater pond.
- Measured Slope Angle:** Indicated by a line segment with an arrow and the label "10°" below it.

- Watercourse (Permanent):** Represented by a blue line with arrows indicating flow direction, located below the slope angle measurement.
- Overland Flow Path (From Auckland Council Geomaps):** Represented by a dashed blue line with arrows indicating flow direction, located below the permanent watercourse.

- Head of Gully:** Represented by a dashed line with arrows pointing towards a central point, located below the overland flow path.
- Approx. Site Boundary:** Represented by a thick, solid black line, located below the head of gully.
