**To:** CIVIX**Date:** 8 December 2022**Attention:** Alvin Jung**Ref:** 66209**Subject:** Verran Road and West Glade Crescent – Fast Track Ecology

Sweet NZ Partnership Limited, (“the applicant”) proposes to lodge an application for a referred project under the Covid-19 Recovery (Fast-track Consenting) Act 2020 (the “Act”) to utilise the fast-track consenting process. This application relates to a residential development located at 19a, 21, 23, 25 Verran Road and 19 West Glade Crescent, Birkenhead, Auckland, collectively referred to as “the Site”. This memorandum provides a high-level assessment of ecological aspects of the proposal.

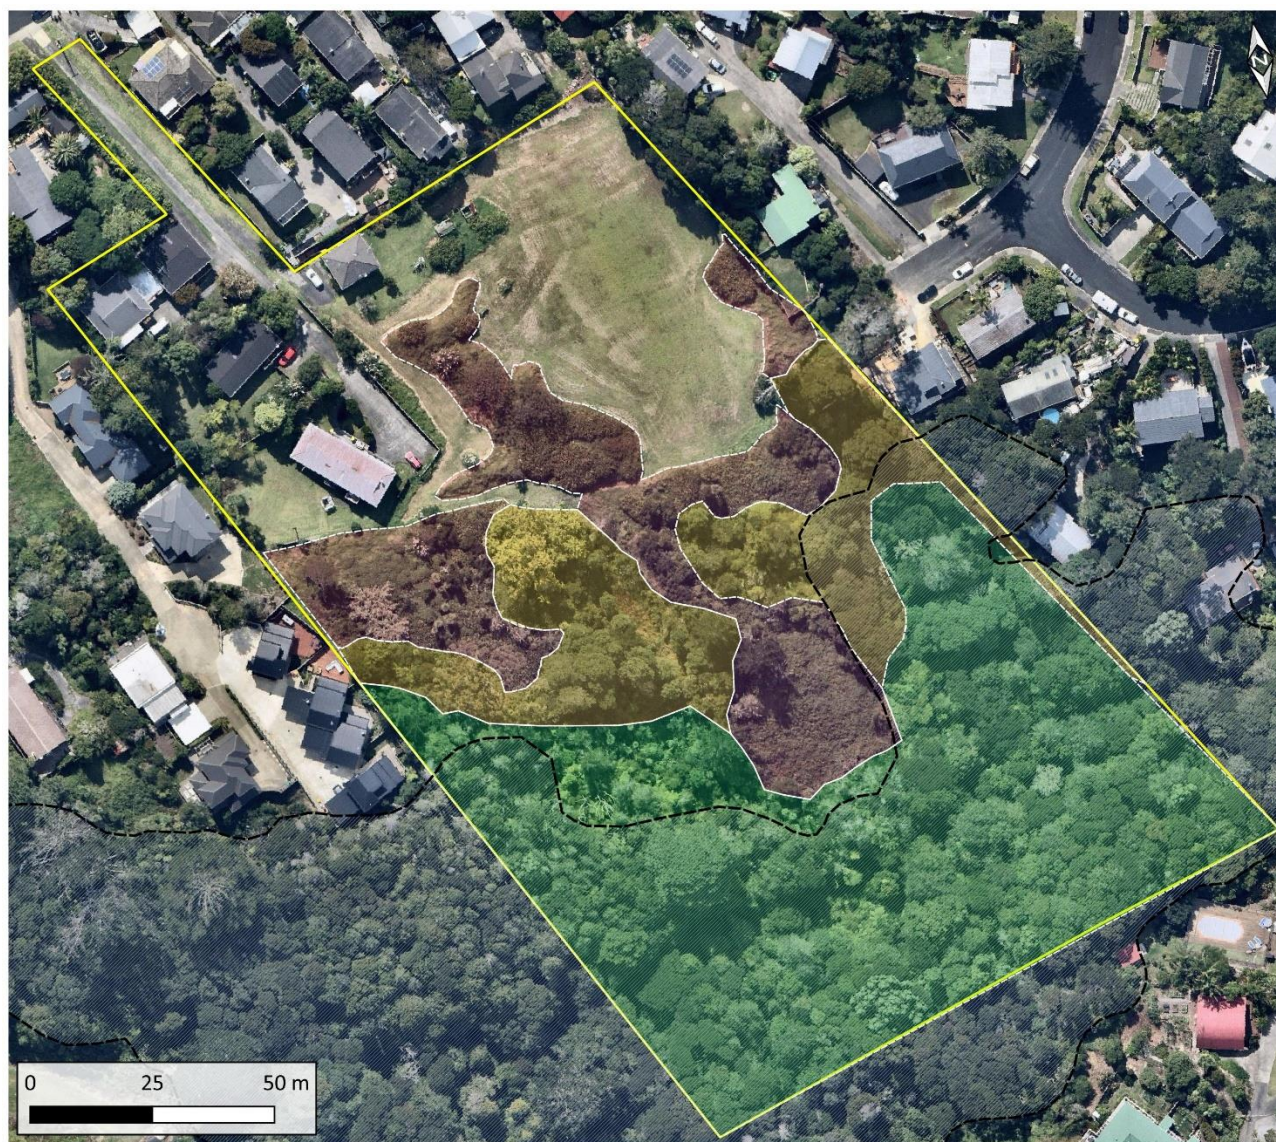
## Appendix 1. Identified terrestrial ecological features within the Site.

The Site predominantly consists of four distinct vegetation types, managed grasses, pest plant infestations, mixed exotic and native, and indigenous bush. Within the centre and southern area of the site, severe pest plant infestation is present with dense sections of blackberry (*Rubus fruitcosus*), ginger (*Hedychium gardnerianum*), tradescantia (*Tradescantia fluminensis*) and pampas (*Cortaderia selloana*) present, which are overgrown by Japanese honeysuckle (*Lonicera japonica*). This pest infestation, particularly ginger and tradescantia, infringes upon the indigenous bush, indicating it is susceptible to edge effects. Within the indigenous bush, there was a diverse range of native vegetation including but not limited to kānuka (*Kunzea robusta*), mānuka (*Leptospermum scorparium*), tawa (*Ceilschmiedia tawa*), mamaku (*Cyathea medullaris*), whēkī (*Dicksonia squarrosa*), kanono (*Coprosma autumnalis*) and tātarāmoa (*Rubus cissoides*), with the indigenous epiphyte kōwharawhara (*Astelia solandri*) present.

The botanic value of the entirety of the Site was low – moderate, with the northern area of the Site predominantly of low value due to the dominance of mown grasses, exotic trees and severe pest infestation. The southern area of the Site was considered to be of moderate value as is consisted of diverse, indigenous forest, however edge-effects are apparent. The indigenous vegetation provides high-quality fauna habitat as the vegetation is highly complex with emergent, canopy, sub-canopy and groundcover layers present throughout.

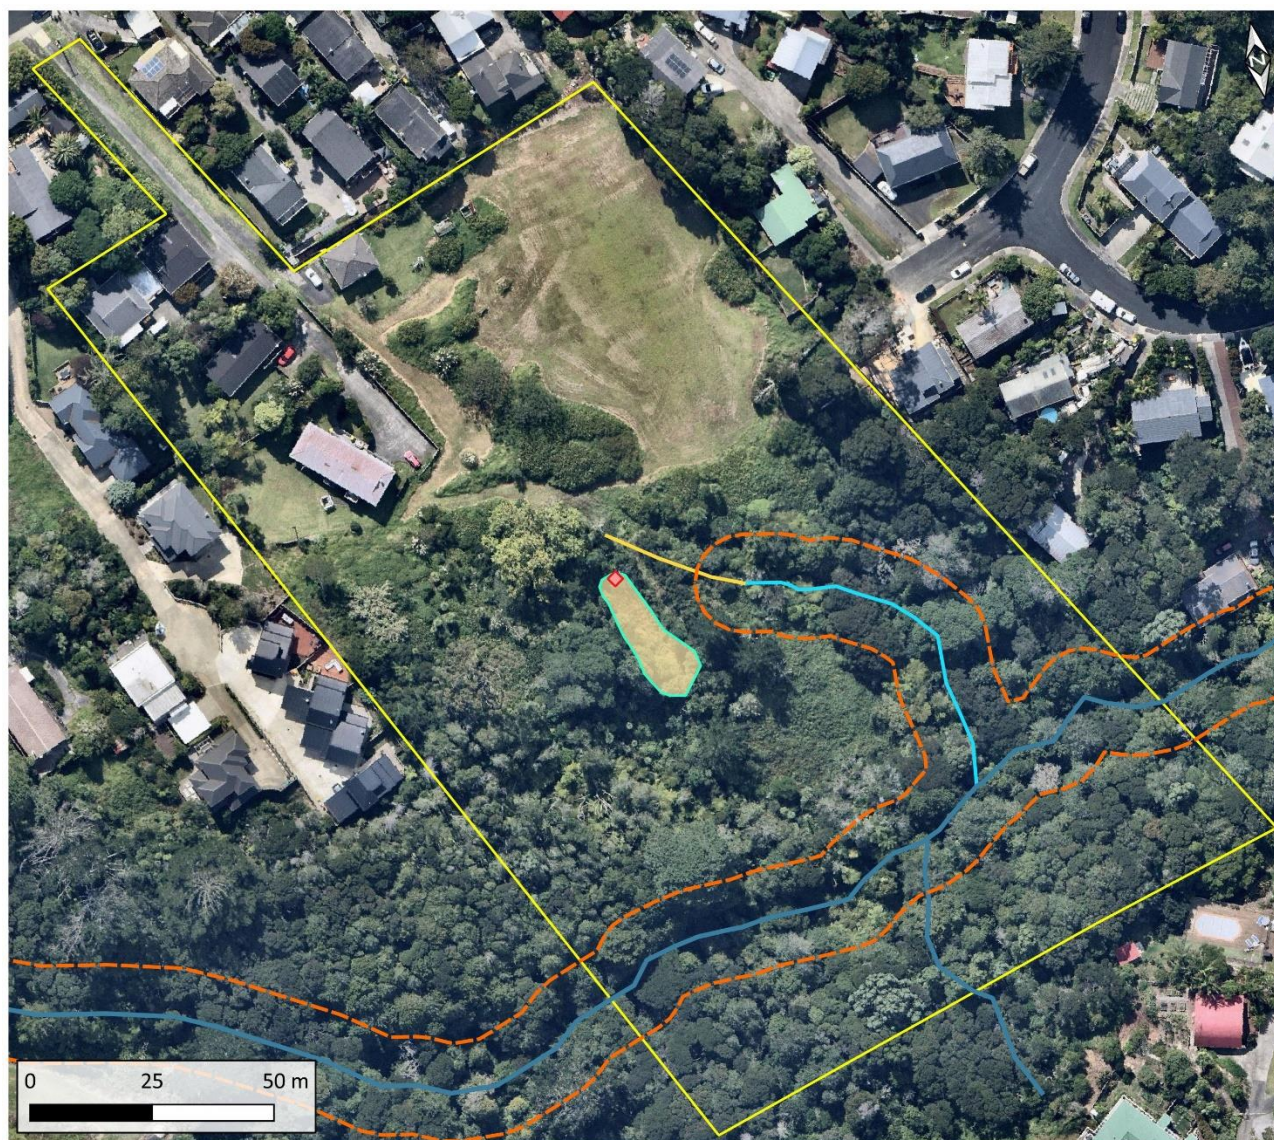
## Appendix 2. Identified freshwater ecological features within the Site.

Two streams, one artificial channel and one constructed wetland was identified within the Site. An intermittent stream flows through the centre of the Site in a north to south direction and flows into a permanent stream which flows in a west to east direction and drains into a north-western arm of the Waitemata Harbour.

A constructed wetland is present within the centre of the Site, with raupō (*Typha orientalis*), and standing water present throughout. The wetland was clearly constructed as it was located within a uniform depression with a raised bund around the edges and a scruffy dome on the upper area. No channels were observed flowing into, or draining away from the wetland, indicating it is an offline pond. Construction phases of the wetland, are observable on aerial images, with pre-construction (i.e. lack of wetland; 2006), construction (2008) and post construction and operation (2010) clearly visible (Appendix 4 - Appendix 6). The wetland is indicated to be a stormwater pond/wetland on Auckland Council Geomaps: Stormwater assets. The wetland was constructed as a stormwater treatment device, meeting the definition of a constructed wetland, and therefore exempt from the NES-F.

The artificial channel was present on the upstream reach of the intermittent stream, and was determined to be artificial due to its uniform channel shape and its absence from historical aerials. The channel is absent from aerial images prior to 2008 and appears to have been constructed during the same time period as the constructed wetland. The transition from artificial to natural stream channel was obvious, with the channel forming into a natural flow path, consisting of a wide, shallow meander.

The project has avoided stream reclamation, with the intermittent and permanent stream to be retained. The constructed wetland and artificial reach are proposed to be removed, which is a permitted activity under the AUP OP. If reclamation of natural streams is required, a functional need will need to be proven and adverse effects appropriately mitigated and offset under the NPS-FM and RMA. The freshwater ecological value of the artificial channel and constructed wetland was considered to be of negligible ecological value due to the low abundance and diversity of aquatic habitat. The reclamation of the artificial channel and constructed wetland is expected to have a low-level effect on ecological values.

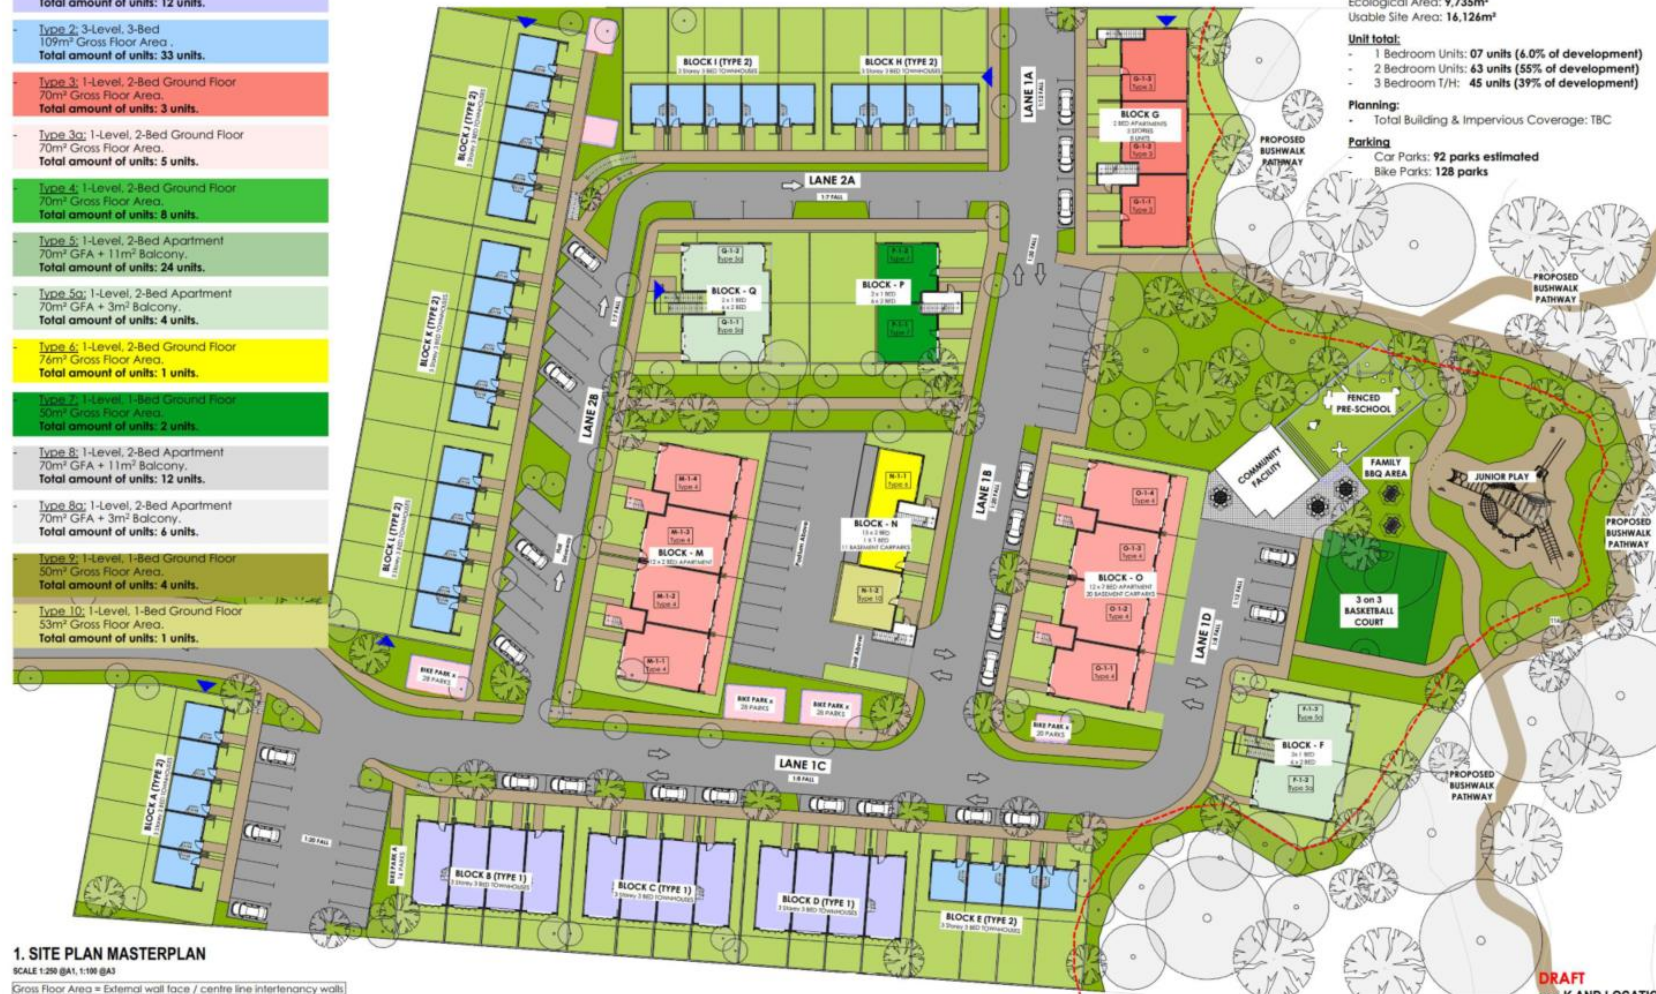
CD-01

Total Site Area: 25,861m<sup>2</sup>  
Ecological Area: 9,735m<sup>2</sup>  
Usable Site Area: 16,126m<sup>2</sup>

- 1 Bedroom Units: 07 units (6.0% of development)
- 2 Bedroom Units: 63 units (55% of development)
- 3 Bedroom T/H: 45 units (39% of development)

Proposed Masterplan

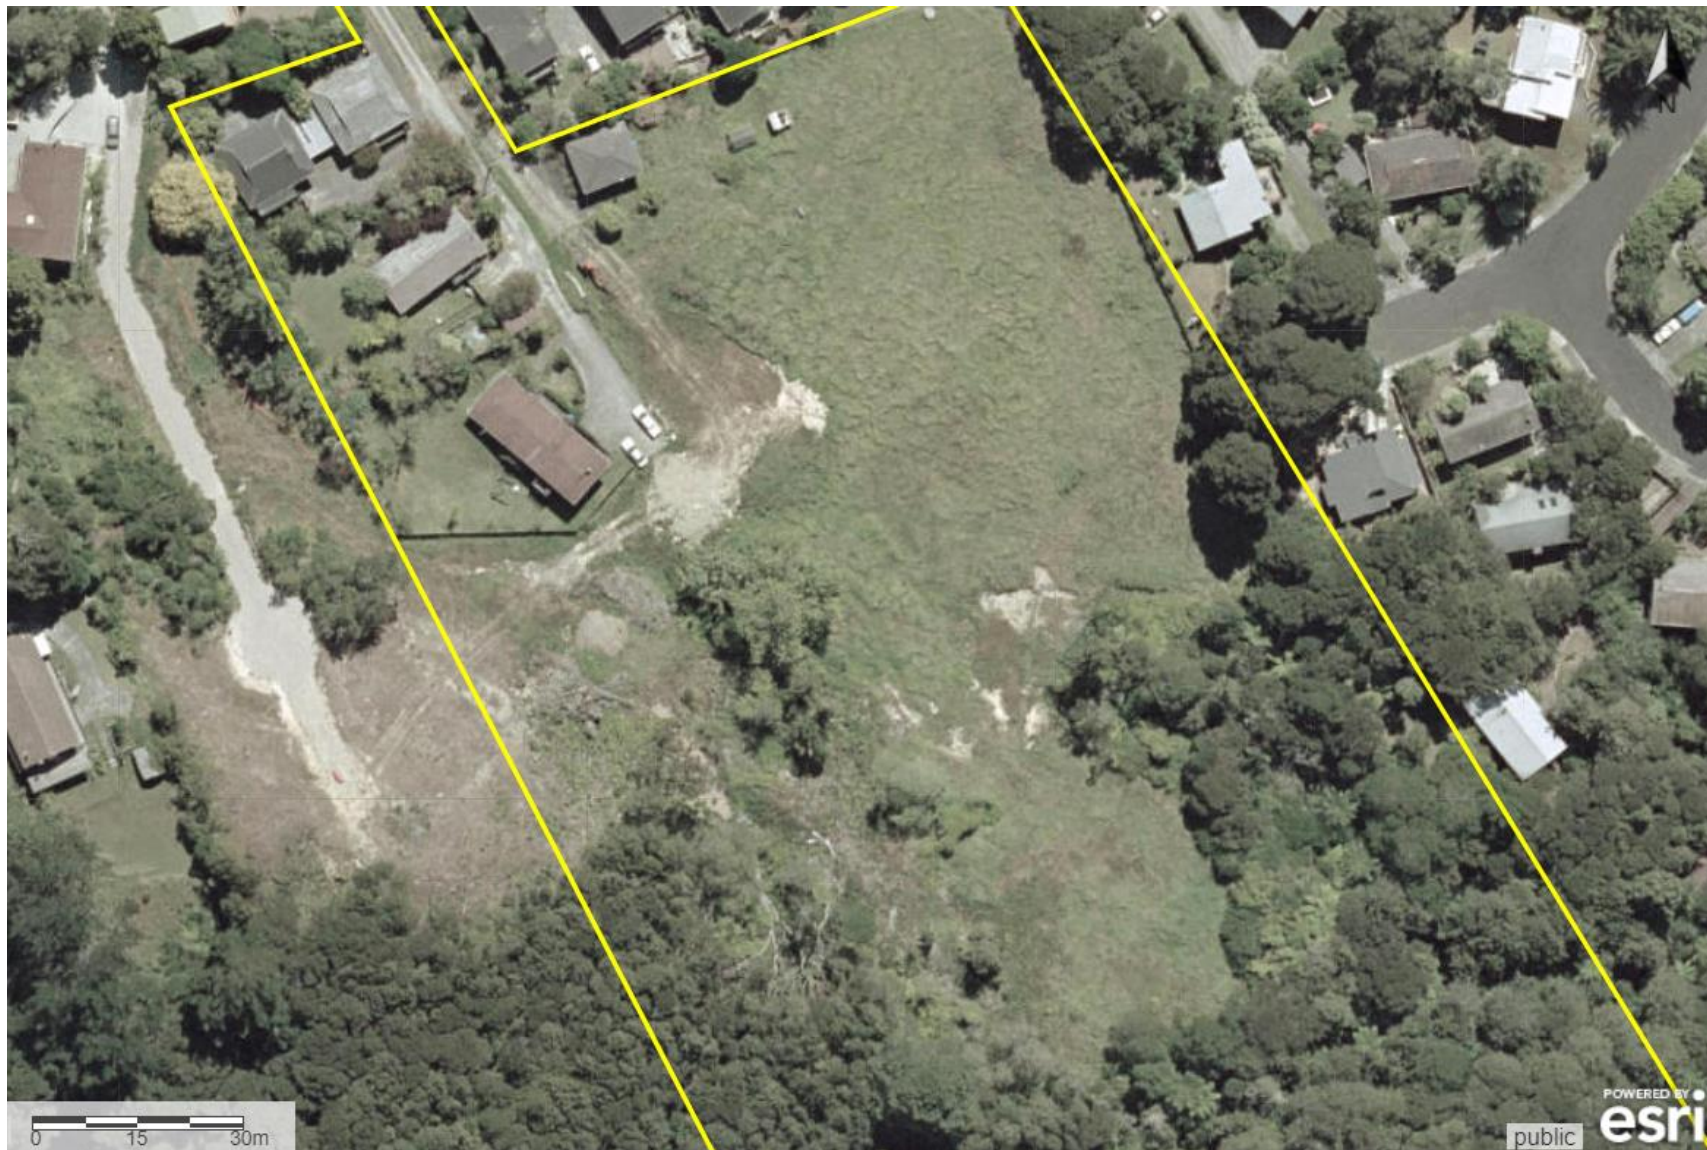
Appendix 4. Aerial image from 2006 showing the lack of wetland

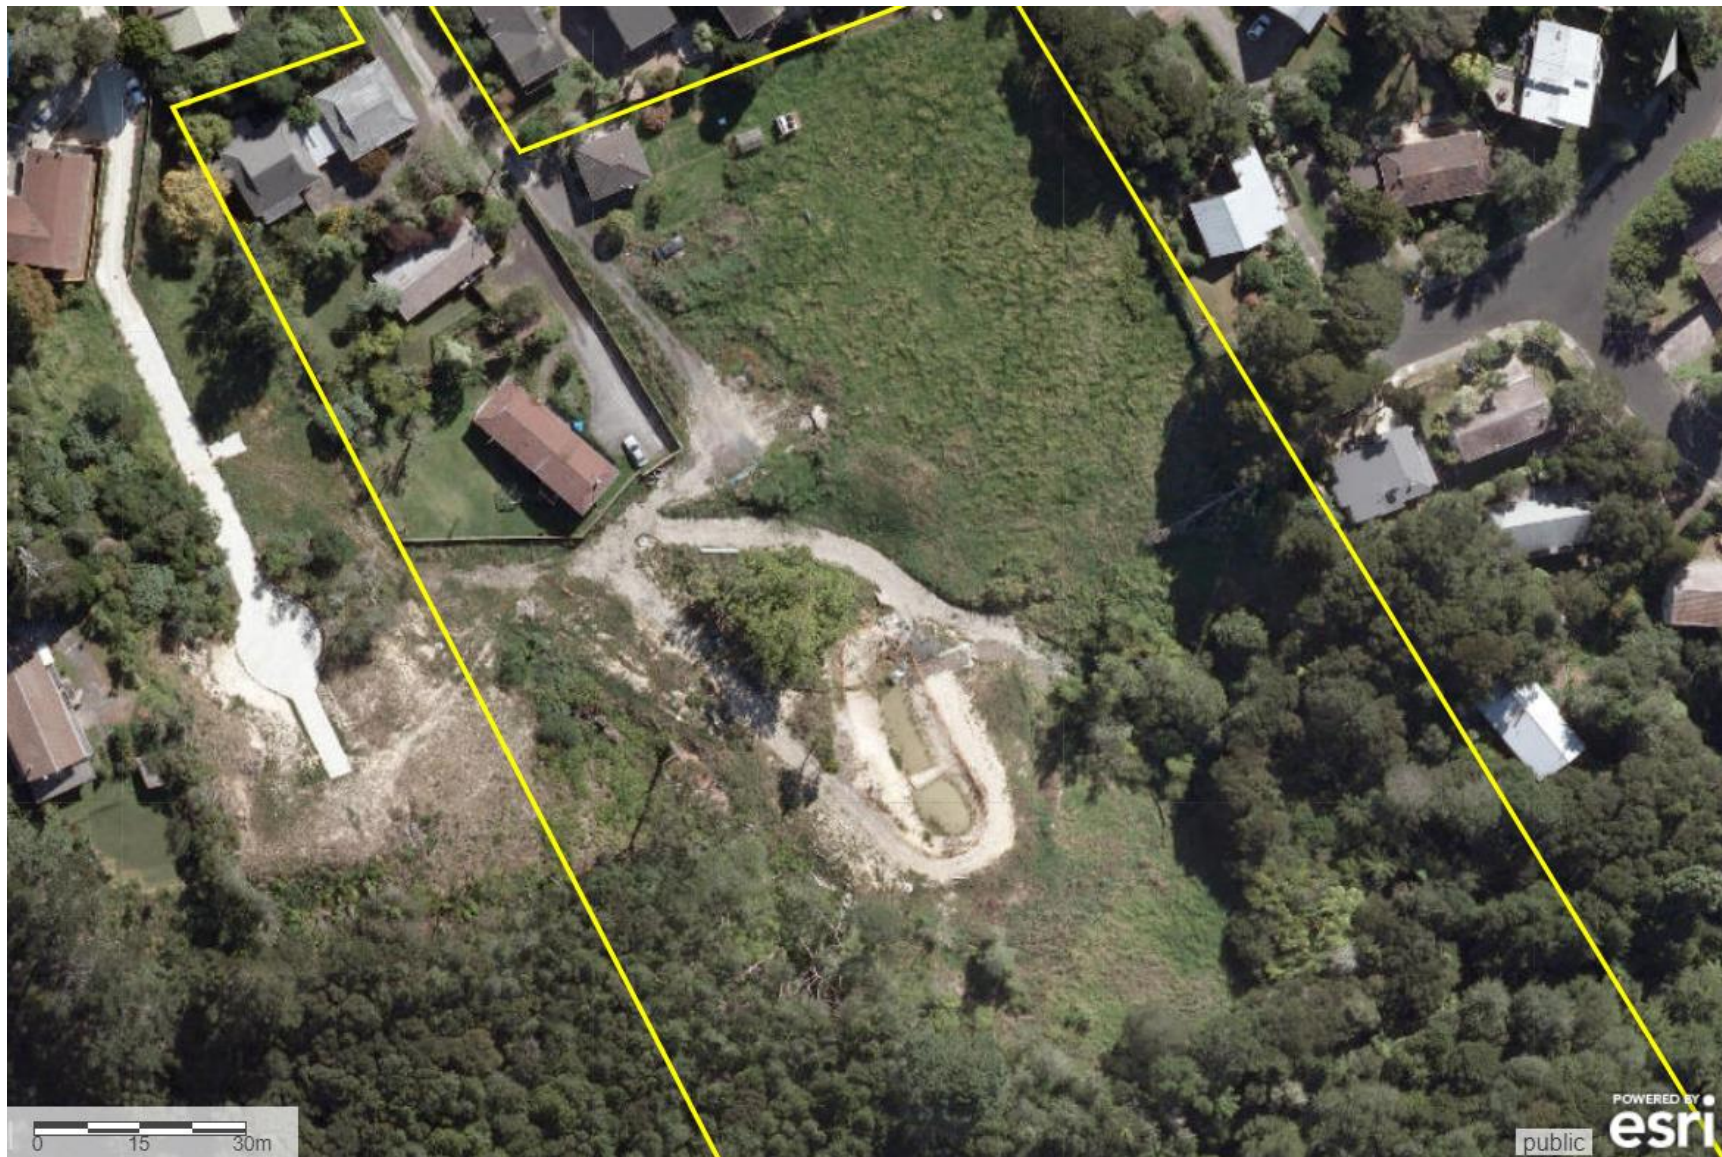
Appendix 5. Historic aerial image from 2008 showing the construction phase of the constructed wetland and artificial channel.

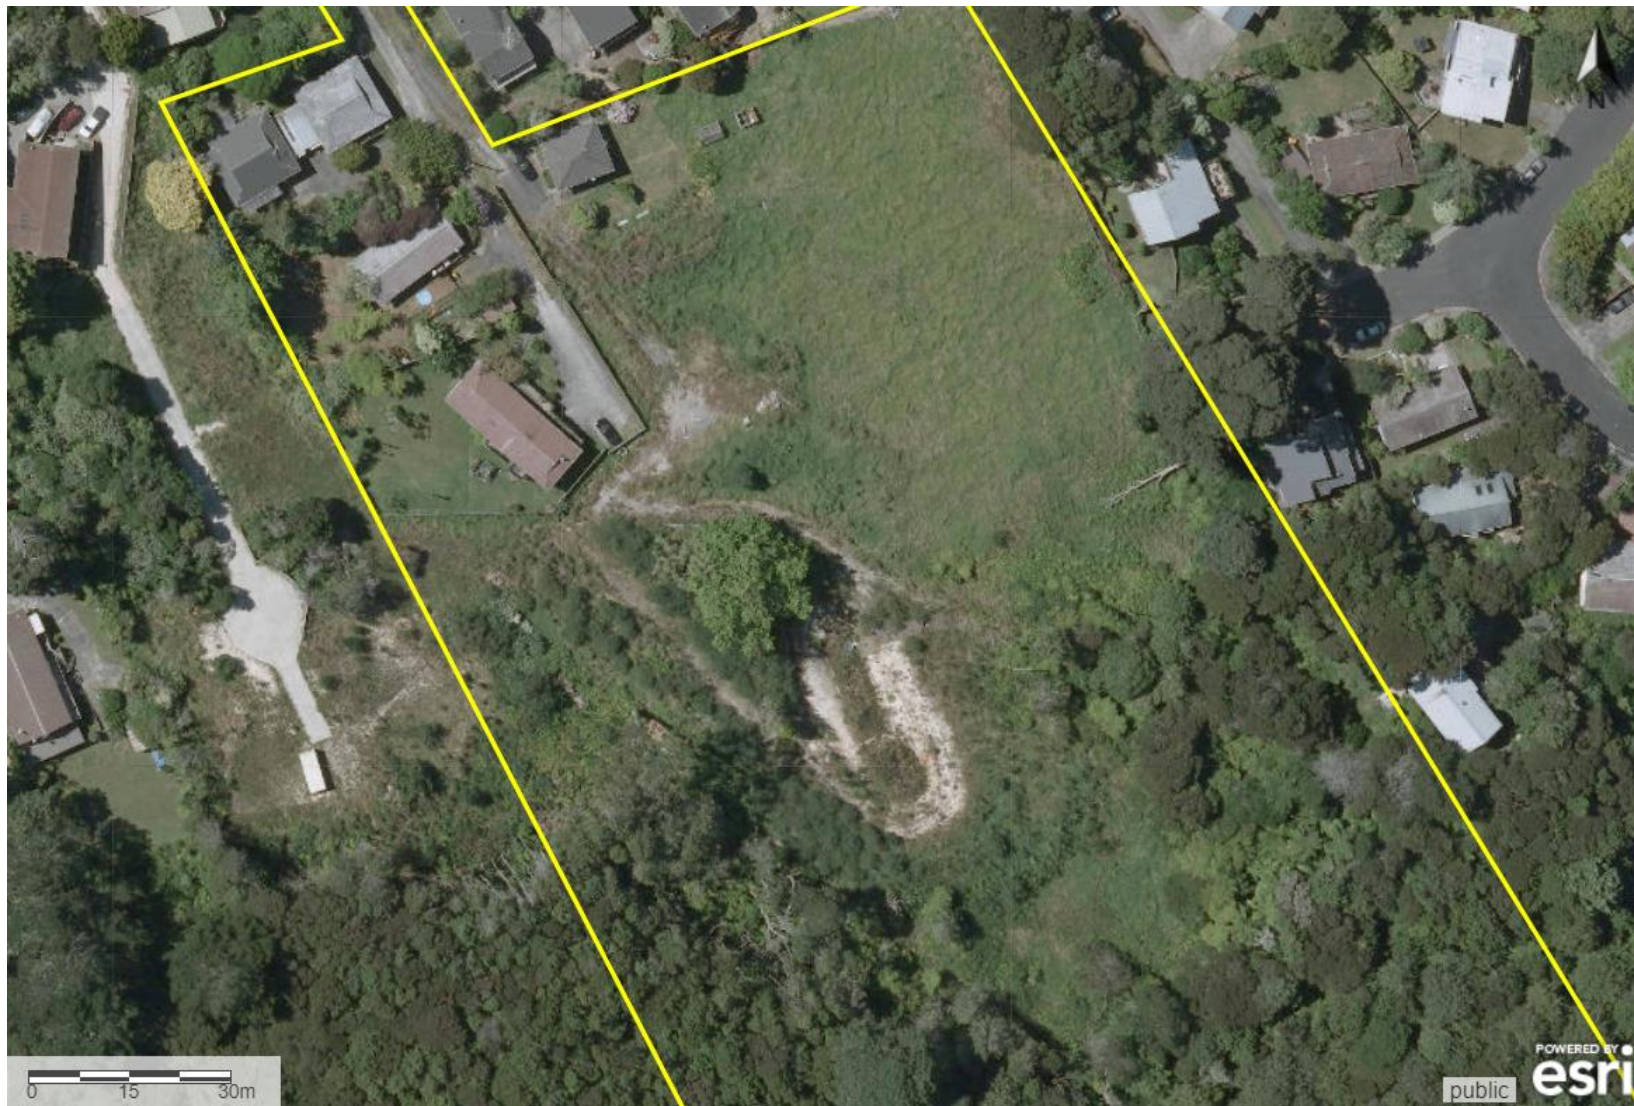
Appendix 6. Historic aerial image from 2010 showing the operational phase of the constructed wetland and artificial channel.

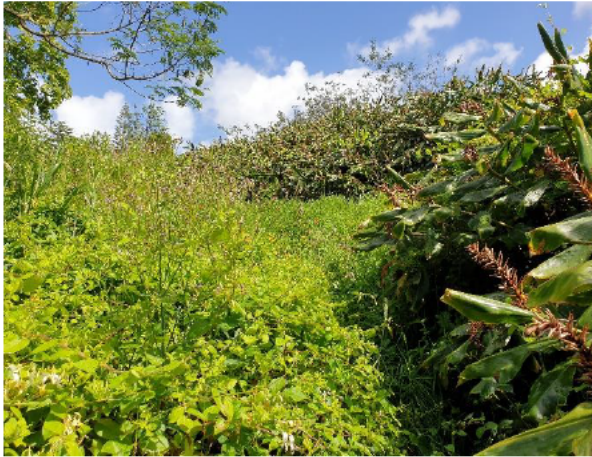
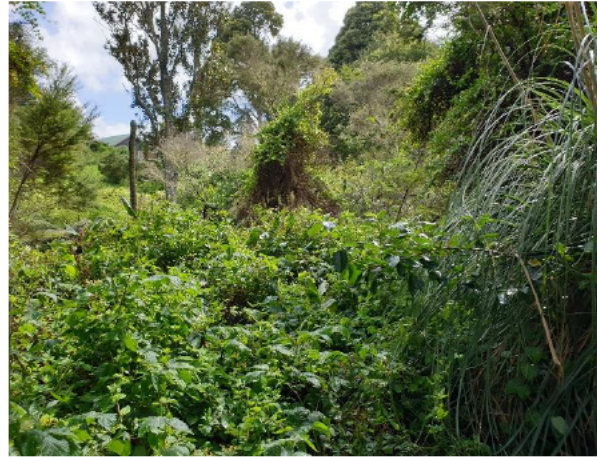
*Photo 3 & Photo 4. Areas of severe pest plant infestation within the central area of the site.*

The proposed development has the opportunity to increase the ecological value of streams and SEA habitats through appropriate pest plant and animal control, restoration planting and buffer planting around the freshwater habitats, SEA and the development footprint.

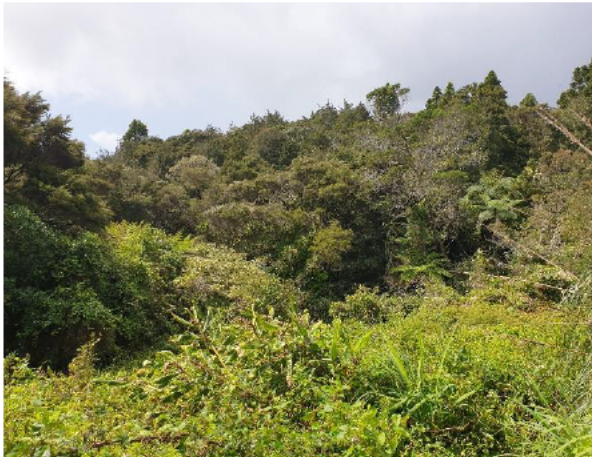
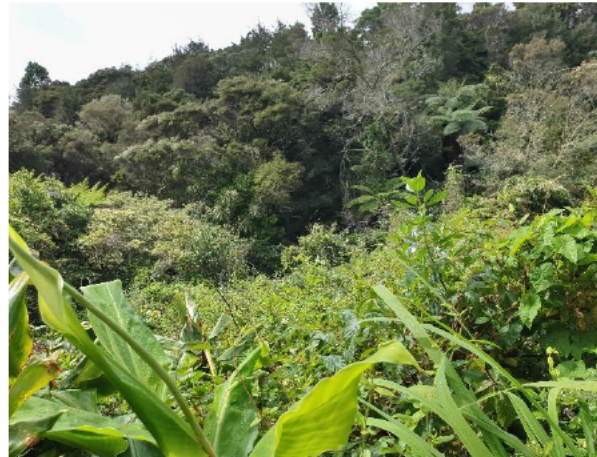
*Photo 5 & Photo 6. View looking south to the SEA showing large section of pest plant infestation in foreground.*

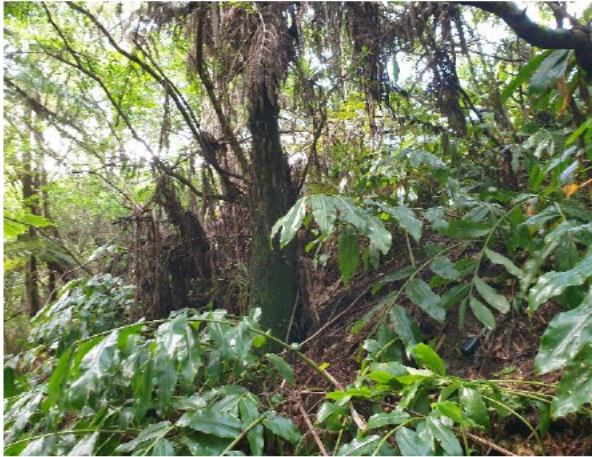
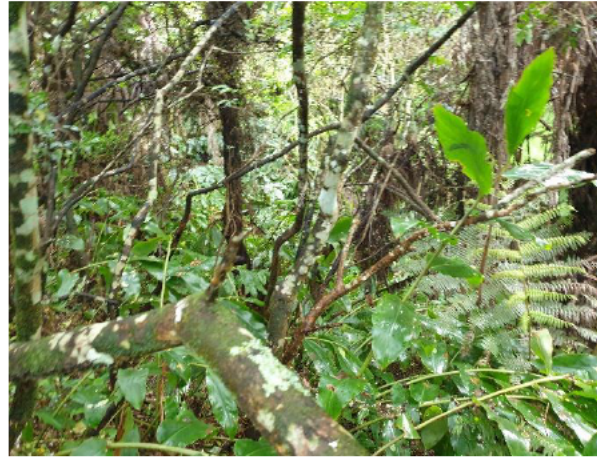
*Photo 7 & Photo 8. Pest plant infestation within the SEA indicating it is susceptible to edge effects.*

Minor encroachment into the SEA is proposed, for the construction of a recreational bushwalk track. It is recommended the bush track located on the inside edge of the SEA is shifted to the outer edge of the SEA to reduce the amount of SEA vegetation removal. Furthermore, the construction of the track within the SEA should follow the Department of Conservation walking track standards and removal of mature, indigenous tree is avoided. Vegetation removal should be limited to common, immature trees and replacement planting undertaken where appropriate. Additionally, it is recommended that streams should be bridged rather than culverted where the proposed track crosses a watercourse.

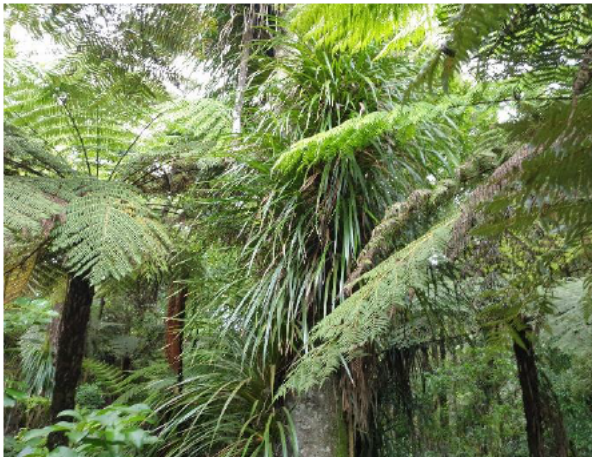
*Photo 9. Mature indigenous vegetation within the SEA*

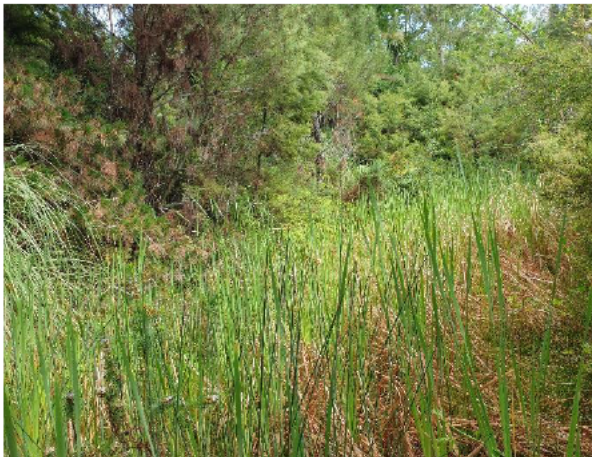
*Photo 11. Constructed wetland dominated by raupō*

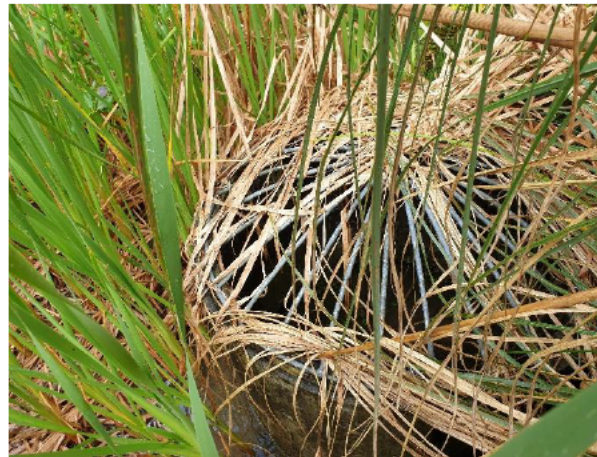
*Photo 12. Scruffy dome installed within the constructed wetland.*

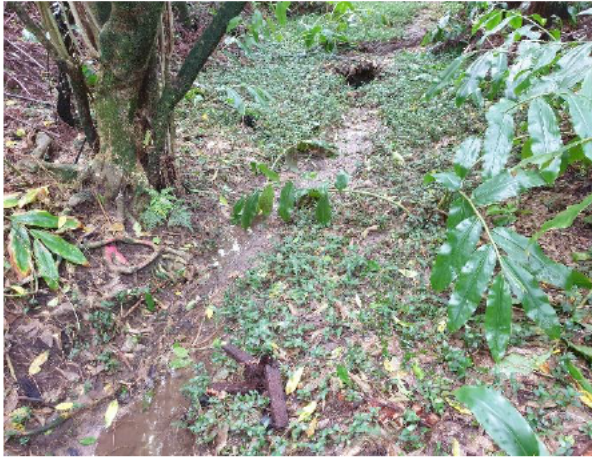
The intermittent stream was approximately 0.3 m wide with shallow flowing water, with an average water depth of 0.06 m and flowed for approximately 75 m before forming a confluence with the permanent stream. The upper reach of the intermittent stream was predominantly soft bottomed, with hard substrates more common downstream, however the reach was subject to high loading of fine sediments. Hydrological heterogeneity was considered to be low and restricted to runs and pools. Stream banks were variable with near-flat sloping and highly incised and undercut banks present. Approximately 20 m prior to the confluence with the permanent stream, stream channel and bank collapse was present forming a barrier to fish passage. The permanent stream consisted of a wide and deep flow path dominated by hard substrates with a large waterfall forming at a confluence with another permanent stream. The streams contained similar characteristics in regards to riparian vegetation, which was dominated by indigenous forest, however ground cover throughout the intermittent stream was largely dominated by tradescantia and ginger. The riparian vegetation provided a very high degree of shade, filtration and organic matter inputs. Aquatic habitat quality and abundance was highest within the permanent stream with available habitat consisting of riffles, deep pools, undercut banks and leaf litter/woody debris.

The intermittent stream was considered to be of low ecological value due to the low abundance of aquatic habitat, downstream barrier to fish passage, and pest plant groundcover. The permanent stream was considered to be of high ecological value, as it would provide a permanent source of high-quality aquatic habitat and hydrological heterogeneity. The artificial channel and constructed wetland were considered to be of negligible ecological value due to their highly modified nature, and very low aquatic habitat and hydrologic diversity.

*Photo 13. Intermittent stream.*

All other aquatic habitats and ecosystems within the site is proposed to be retained. Minor building infringements and vegetation removal within the 10 m riparian yard of the streams may occur to facilitate the construction of community and recreational facilities. However, in regards to the intermittent stream, the vegetation removal is predominantly within an area of severe pest plant infestation, which can be mitigated through additional planting and pest plant removal. No direct adverse effects (e.g. removal or reclamation) on those natural ecosystems will occur, which cannot be mitigated or remedied.

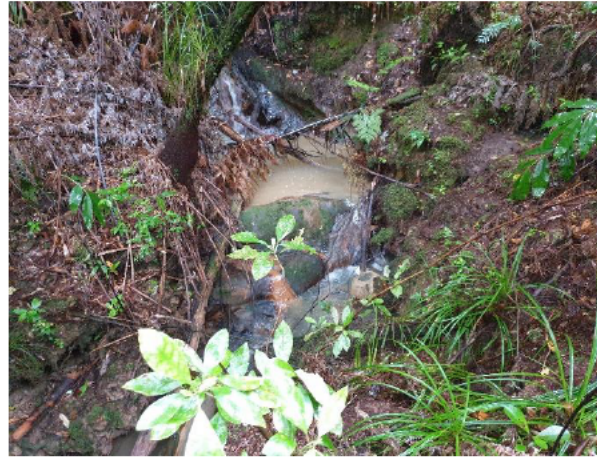
*Photo 14. Permanent stream.*
