KO Waikanae Due Diligence

Ecological assessment

15 June 2022

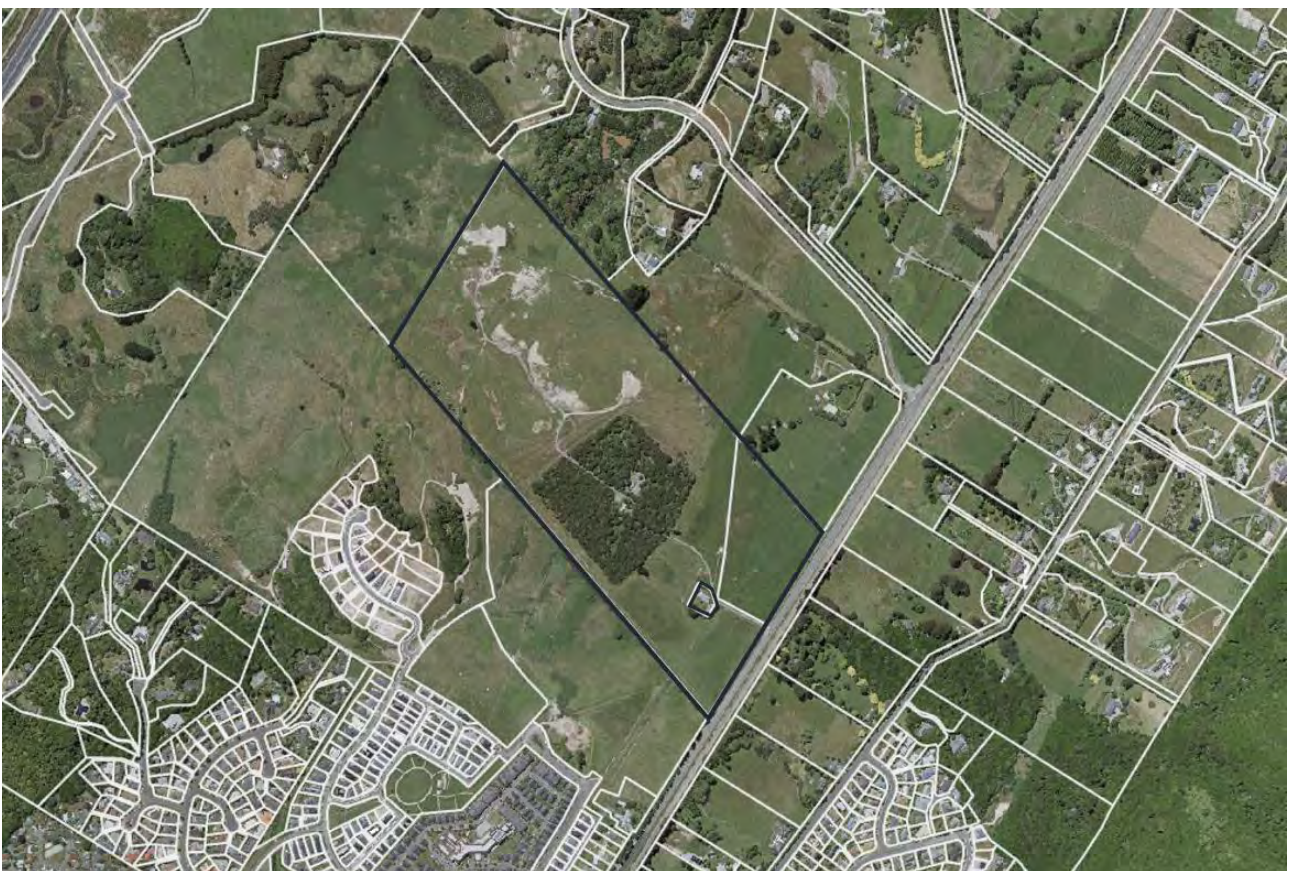
Figure 1: Site location (sourced from KCDC online maps).

The site is located in Waikanae (Figure 1). The site contains the KO65 Ecological site under the Kapiti Coast District Council. The portion of the site that adjoins the road is located within an area that is known for ponding and contains two known stream corridors (Figure 2).

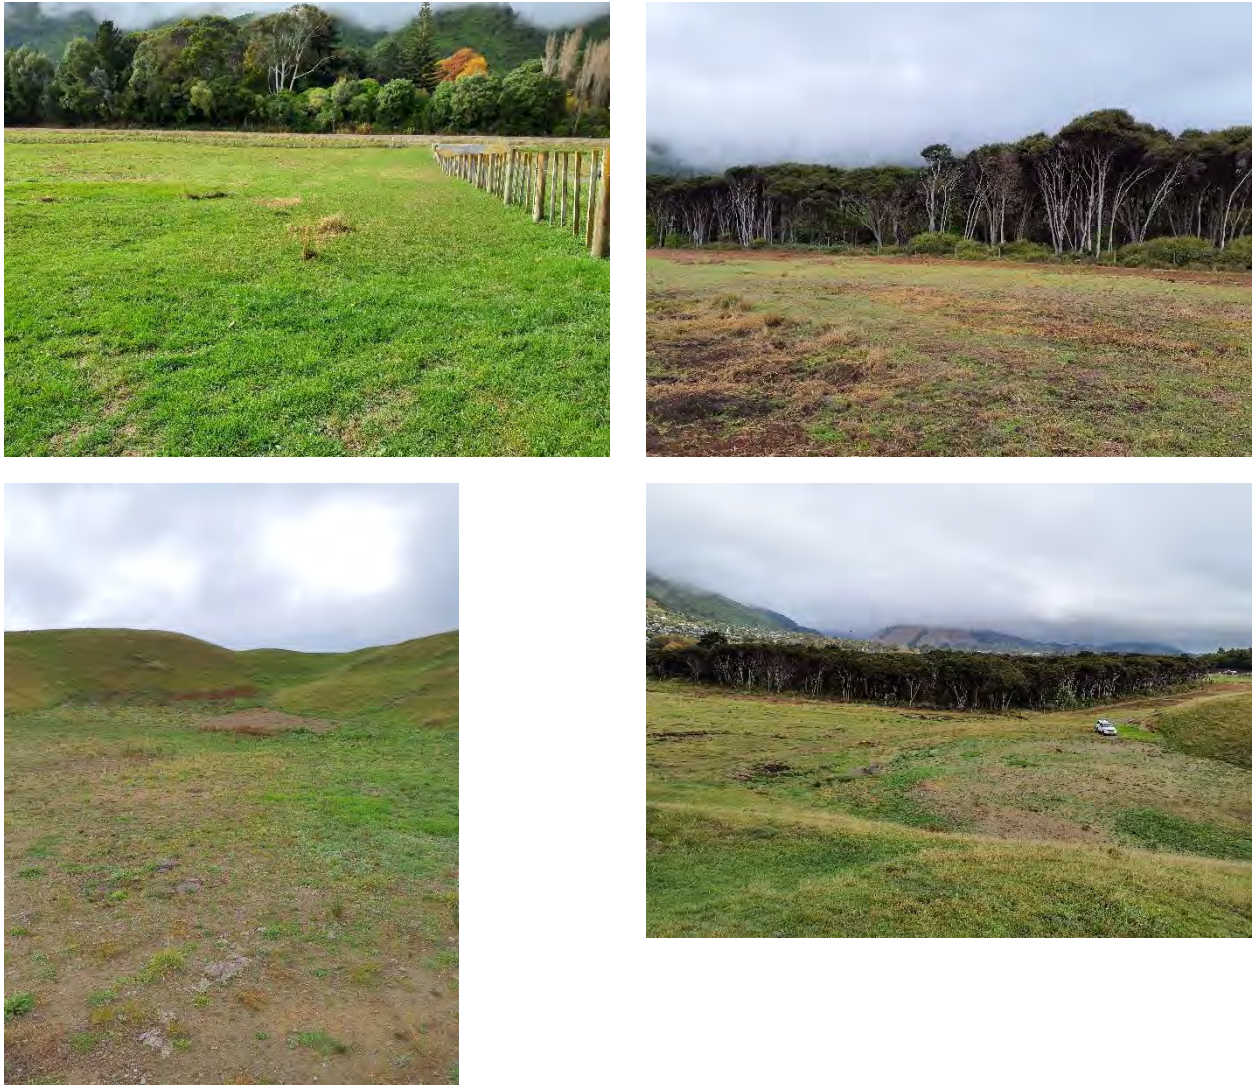
Figure 4: Photos showing the dominant vegetation types present on the site.

The vegetation of the site was dominated by grazed pasture species (Figure 4). The dominant species in the pastoral areas were multiple common pasture grass species, buttercup (*Ranunculus repens*), willow weed (*Persicaria maculosa*), curled dock (*Rumex crispus*), plantain (*Plantago lanceolata*), prickly sow thistle (*Sonchus asper*), white clover (*Trifolium repens*), blackberry (*Rubus fruticosus*).

Around the multiple waterways (discussed in later sections of this report) there were areas of *Carex* species, *Juncus* spp, *Isolepis* species and *Isolepis prolifera*.

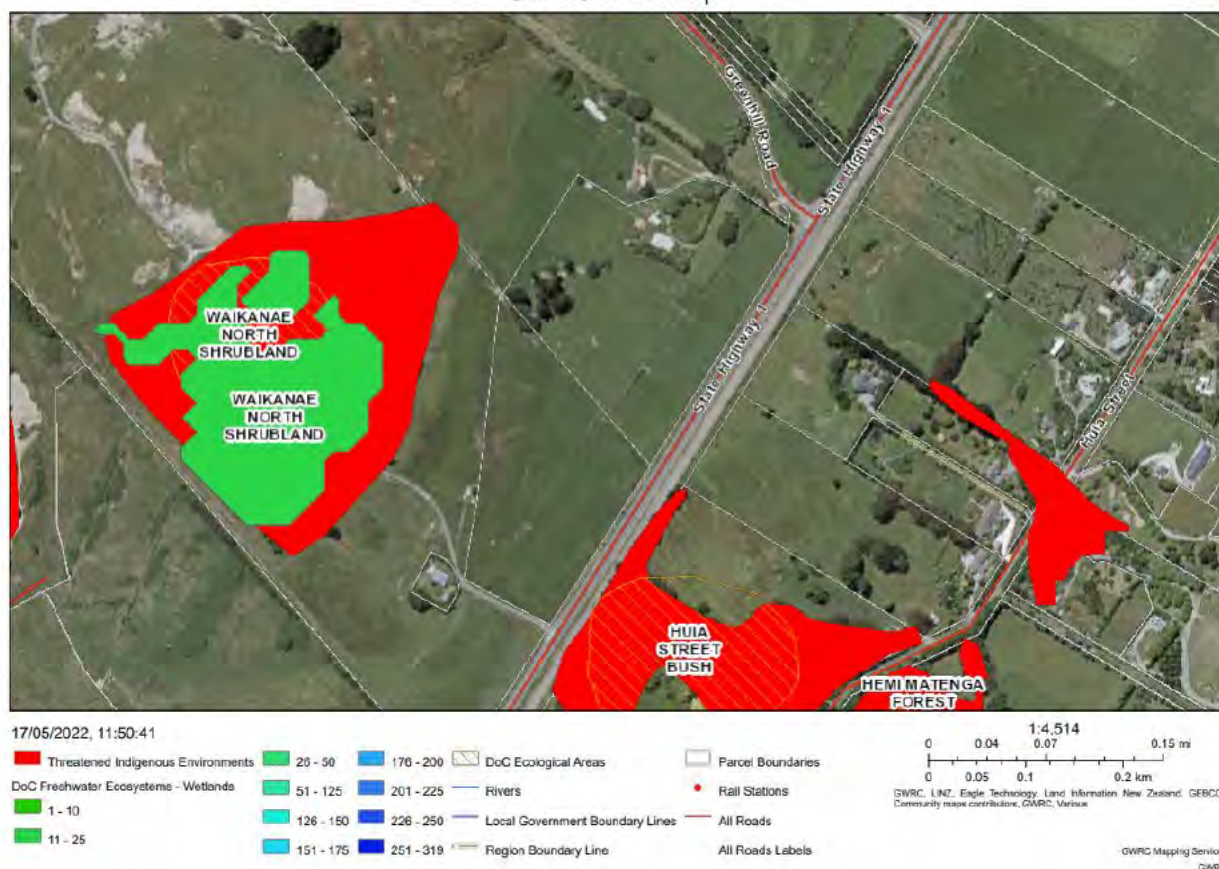
Figure 5: Known ecological features shown on GWRC mapping system.

The greater Wellington Regional Council (GWRC) mapping system identifies the vegetated block in the centre of the site (Figure 5) as:

- DoC Ecological Area (Waikanae North Shrubland),
- DoC Freshwater Ecosystem – Wetland (Regional Rank – 13)
- Threatened Indigenous Environment – 8.03ha.

The area identified in Figure 5 as Waikanae North Shrubland is an area dominated by mature kanuka forest, the areas to the west of the site are regenerating with young sapling kanuka (likely a case of kanuka re-invading the pasture due to a reduction in grazing pressure of the site (Figure 6a & c).

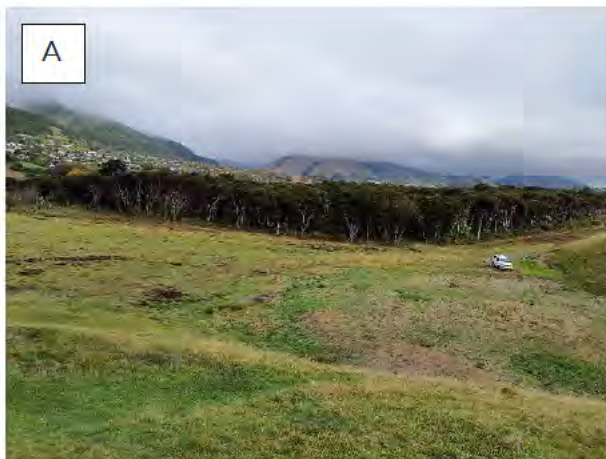
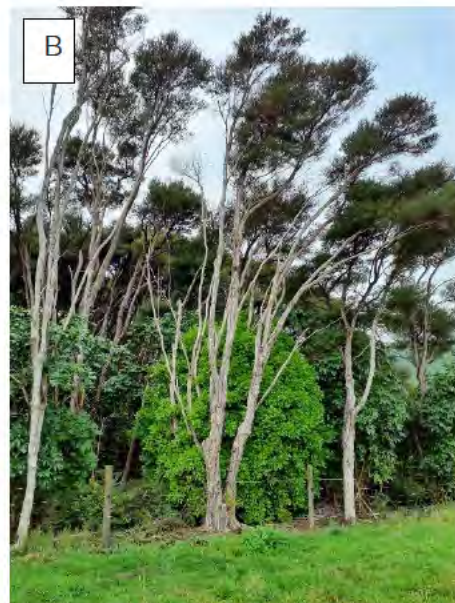
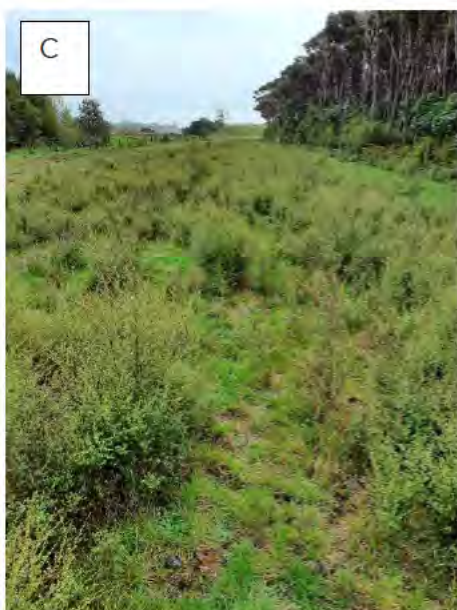
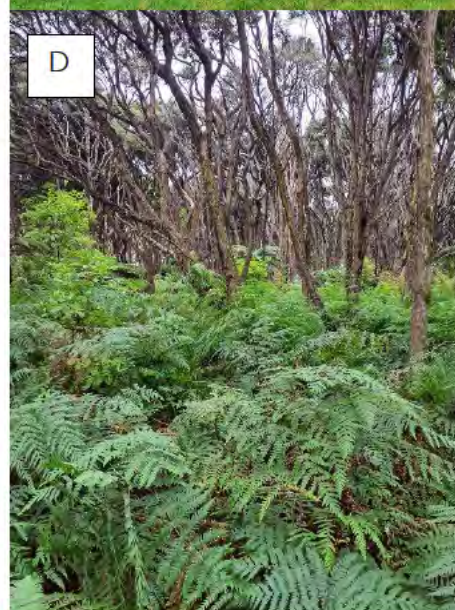
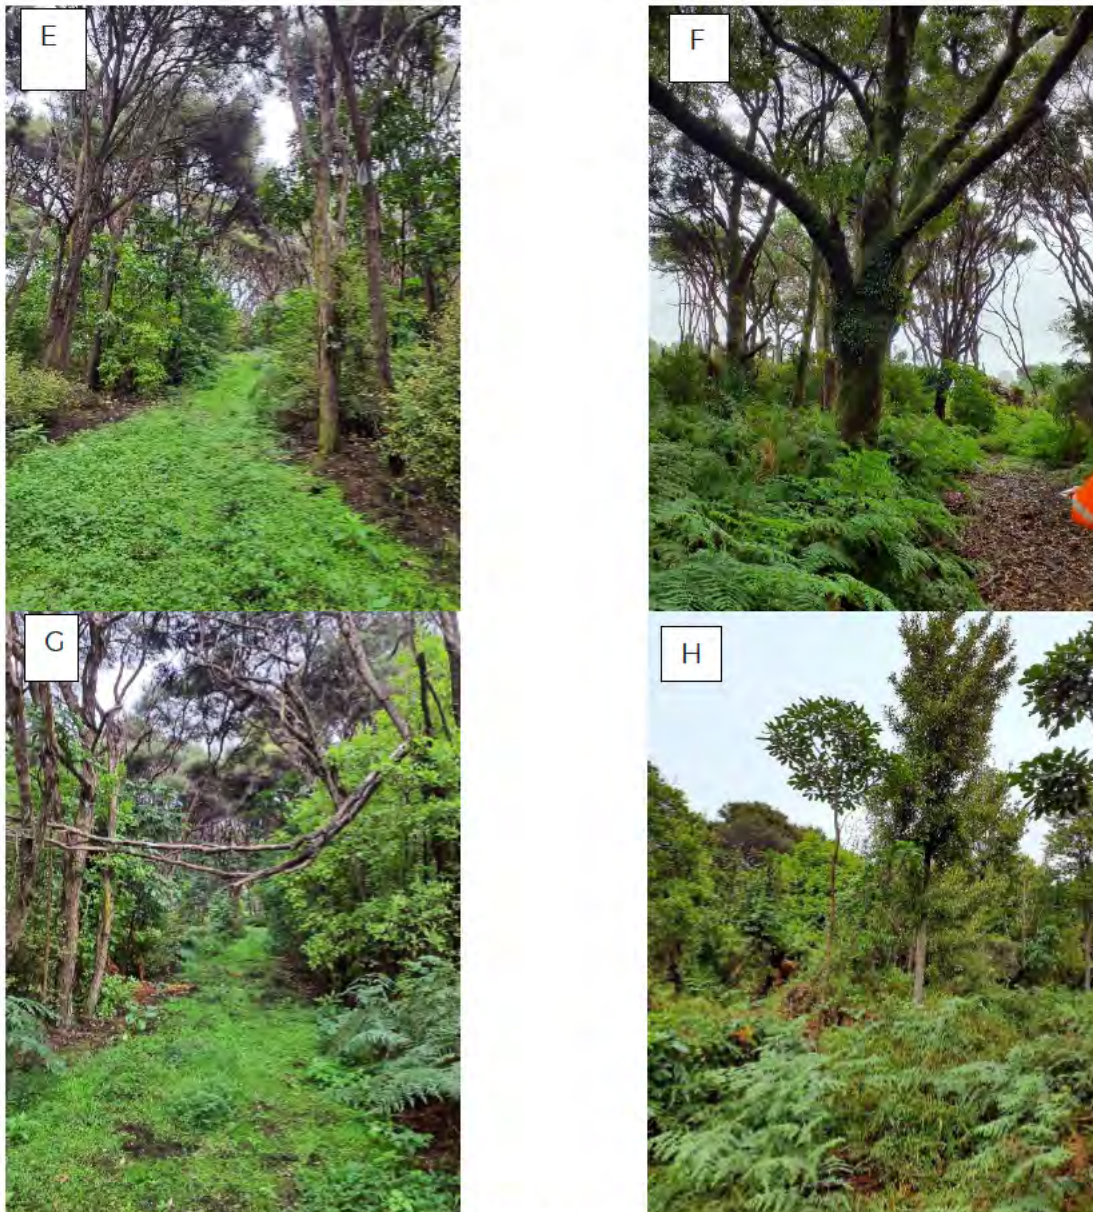
Figure 6: Site photos of Kanuka Shrubland area. A: overview of the site, B: marginal vegetation, C: kanuka regeneration outside the fenced boundary, D-H: internal site photos showing understorey and tracks through the site.

The dominant species in this forested area is kanuka which is a Nationally Vulnerable species, therefore, this particular vegetated area is classed as having a high value ecological value. It is important to note that while Kanuka is classified as a Nationally Vulnerable species this is due to the threat it faces from Myrtle rust, there is currently no evidence that populations of this species are being significantly impacted by the disease within New Zealand. Furthermore, the species is a common species throughout New Zealand. Consequently this species has been assigned a low value for the purposes of this assessment. This forested area is also identified as significant under the district plan.

It was noted during the site visit that there was a very high rabbit/hare population on site, this has likely had a significant adverse effect on the existing vegetation and regeneration of the Kanuka Shrubland area itself.

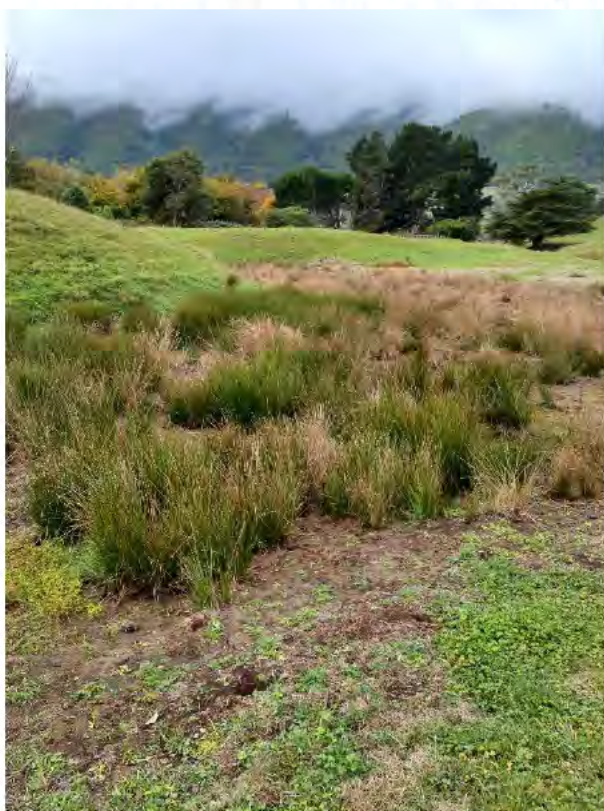
Figure 7: Wetland 1.

This wetland is approximately 972m² and appears to dry up in the warmer months (Figure 7). This wetland has a palustrine hydrosystem due to its hydrology. Appendix A to this report provides the wetland delineation. This wetland is located in duneland, which is grazed as part of a managed farm. This wetland does not contain an area of open water.

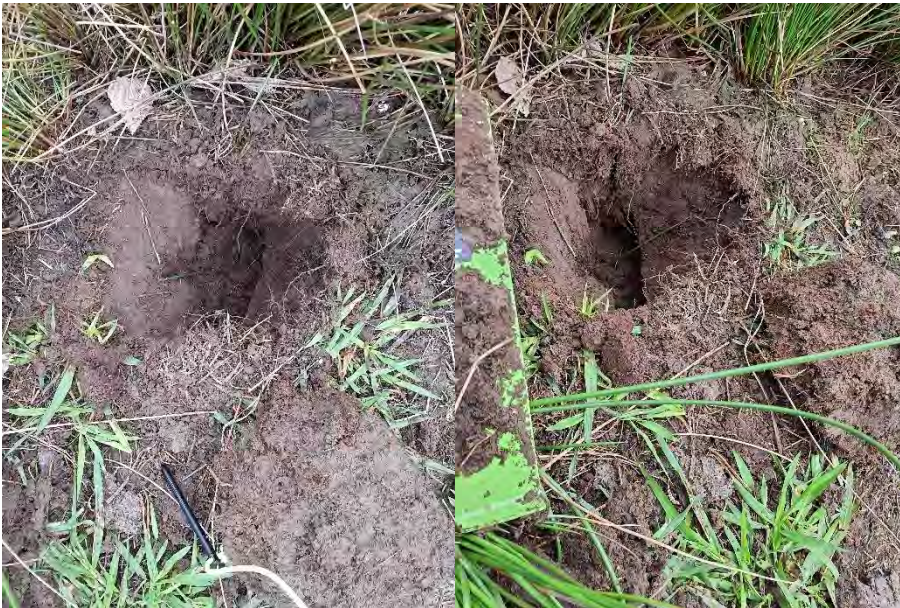
Figure 8: Soil pits dug Wetland 1.

It is important to note that part of this wetland appeared to be dying and these areas are likely to dry up and disappear. A soil pit was dug at each plot looking for hydric soils Figure 8. Both pits were dug to approximately 30cm depth and contained organic soils.

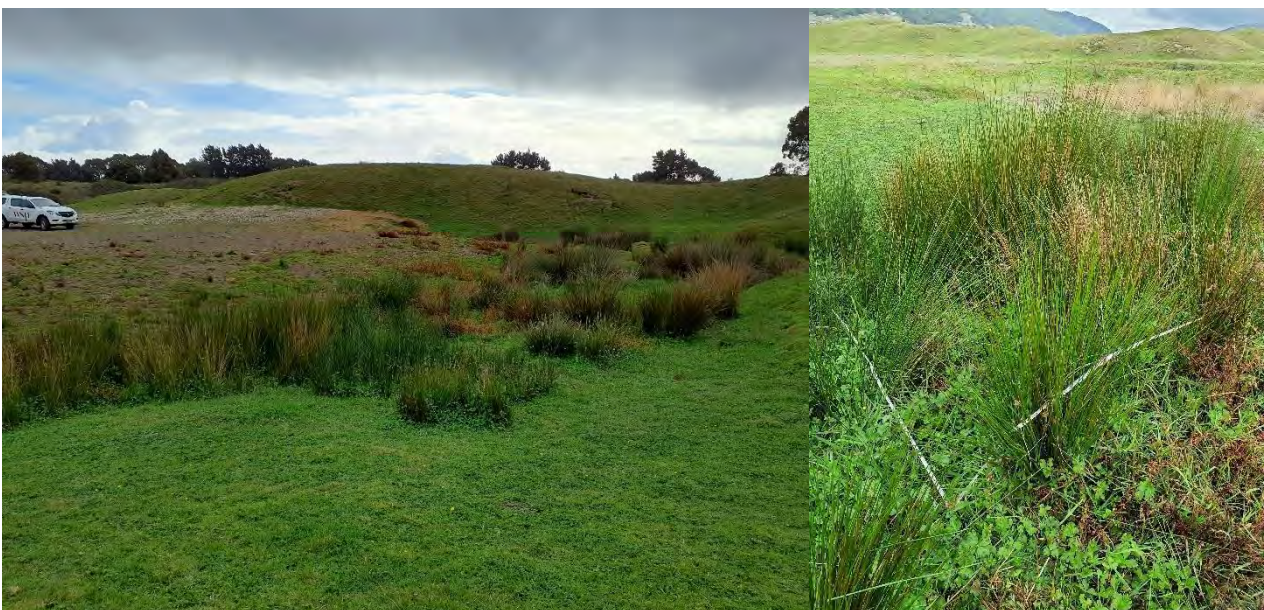
Figure 9: Wetland 2.

This wetland is approximately 9m² and appears to dry up in the warmer months (Figure 9). This wetland also has a palustrine hydrosystem due to its hydrology. Appendix A to this report provides the wetland delineation. This wetland is located in duneland, which is grazed as part of a managed farm. This wetland does not contain an area of open water.

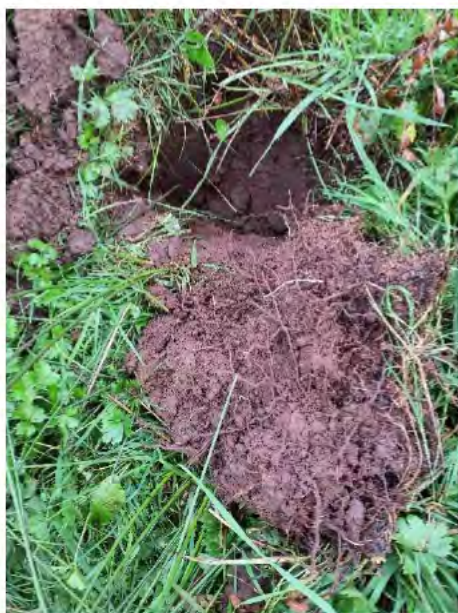
Figure 10: Soil pit dug for Wetland 2.

A soil pit was dug at the above plot looking for hydric soils Figure 10. This pit was dug to approximately 30cm depth and contained organic soils.

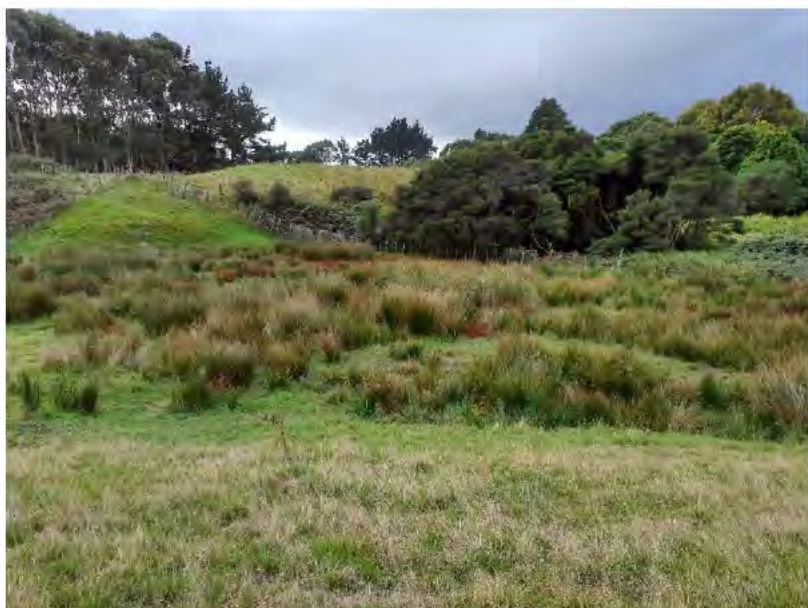
Figure 11: Wetland 3.

This wetland is approximately 282m² and seems to be very similar to the two discussed above (Figure 11). Appendix A to this report provides the wetland delineation. This wetland is located in duneland, which is grazed as part of a managed farm. This wetland also does not contain an area of open water.

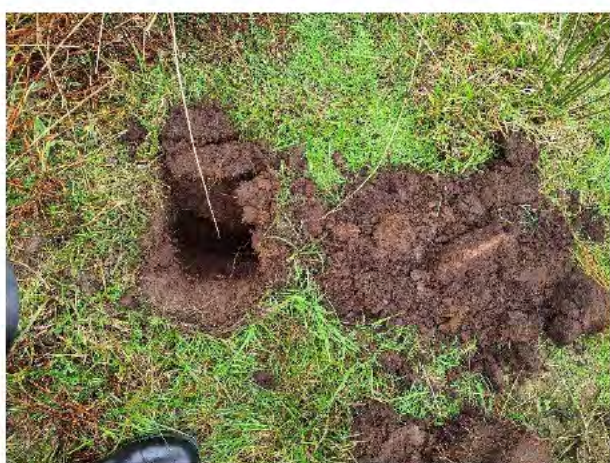
Figure 12: Soil pit dug for Wetland 3.

A soil pit was dug at the above plot looking for hydric soils Figure 12. This pit was dug to approximately 30cm depth and contained organic soils.

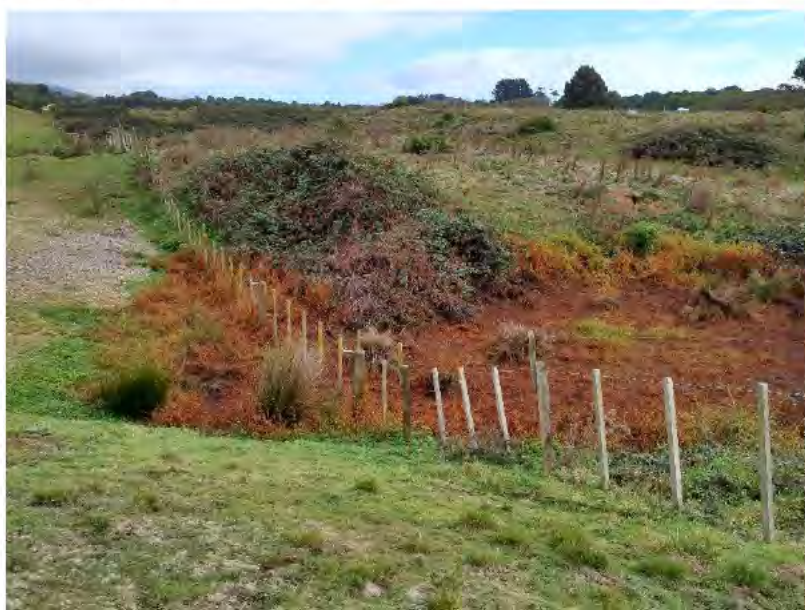
Figure 13: Wetland 4.

This wetland is located in a lowland area between two dunes (Figure 13), this wetland was full of dead/dying willow weed and is predominantly on the adjacent landowners' land. This wetland has a palustrine hydrosystem and is surrounded by pasture and blackberry. It is 91m² and is unfenced for stock exclusion.

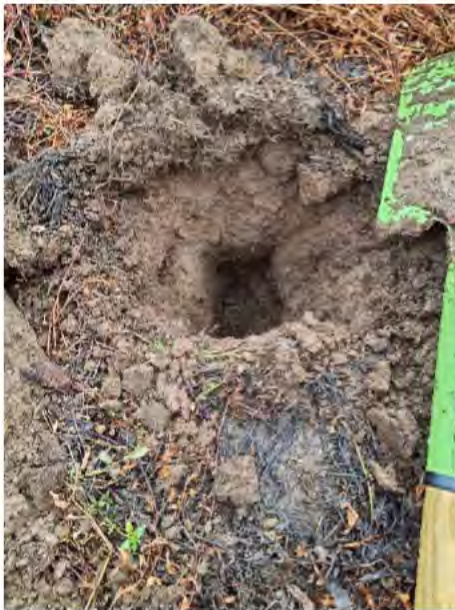
Figure 14: Soil pit dug for Wetland 4.

A soil pit was dug at the above plot looking for hydric soils Figure 14. This pit was dug to approximately 30cm depth and contained organic soils. Hydric soils were not found.

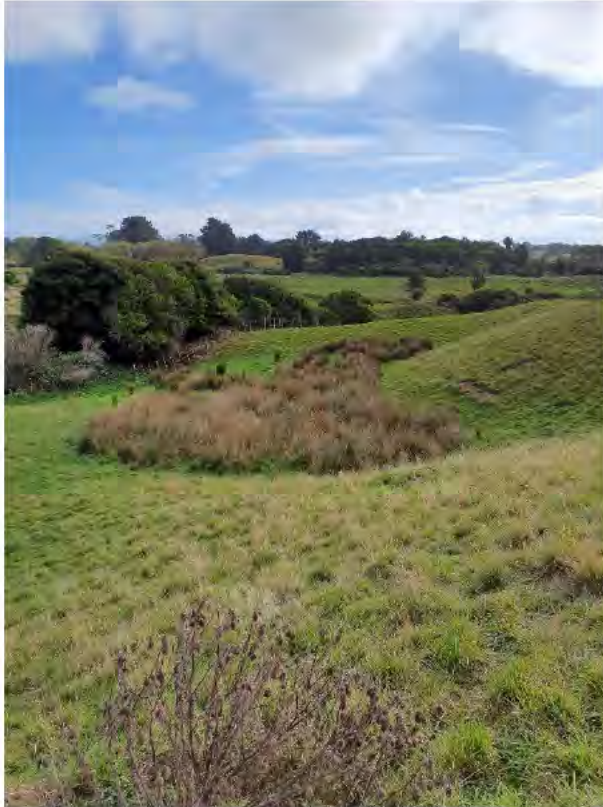
Figure 15: Wetland 5.

This wetland is of a similar vegetation composition and overall condition as wetlands 1-3 described above. This wetland has a palustrine hydrosystem and is surrounded by pasture species (Figure 15). It is 335m² and is unfenced for stock exclusion.

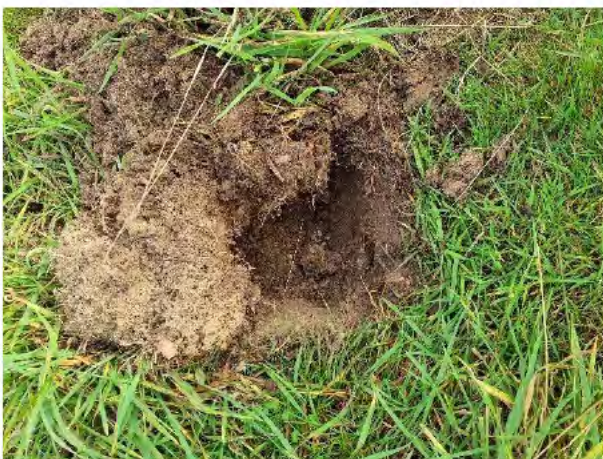
Figure 16: Soil pit dug for Wetland 5.

A soil pit was dug at the above plot looking for hydric soils Figure 16. This pit was dug to approximately 30cm depth and contained organic soils. Hydric soils were not found.

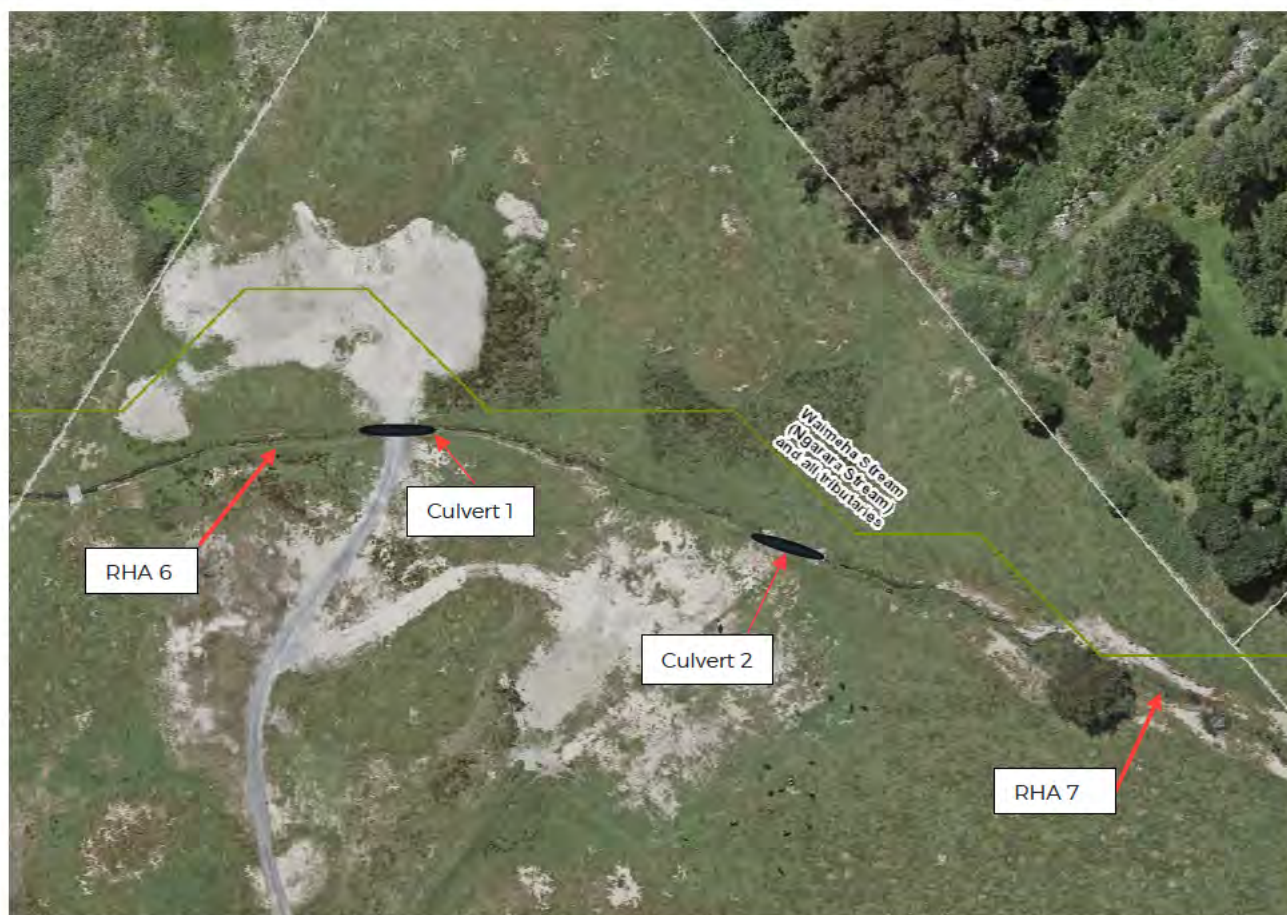
Figure 17: Locations of RHA along the Waimeha Stream within the property boundary (image sourced and modified from GWRC maps).

A site visit was conducted on 3 May 2022. Rapid Habitat Assessments (RHA) were conducted at two locations (RHA site 6 and RHA site 7) on the Waimeha Stream, within the site boundary (Figure 17), in accordance with Clapcott (2015).

The Waimeha Stream was observed to be flowing and soft-bottomed across its length within the property boundary. There are two small single barrel culverts along the Waimeha Stream within the property boundary (Figure 17). There is very little in the way of riparian vegetation along the length of the stream. Surrounding vegetation was predominantly grazed pasture and soft rush (*Juncus effusus*). There was a large macrocarpa tree at RHA site 7. It was noted during the site visit that there are many rabbit holes along both banks of the Waimeha Stream within the property boundary. Figure 18 shows key features of the Waimeha Stream within the property boundary. A summary of the RHA conducted on the Waimeha Stream can be seen in Table 11. RHA 6 and RHA 7 scored 33 and 28, respectively.

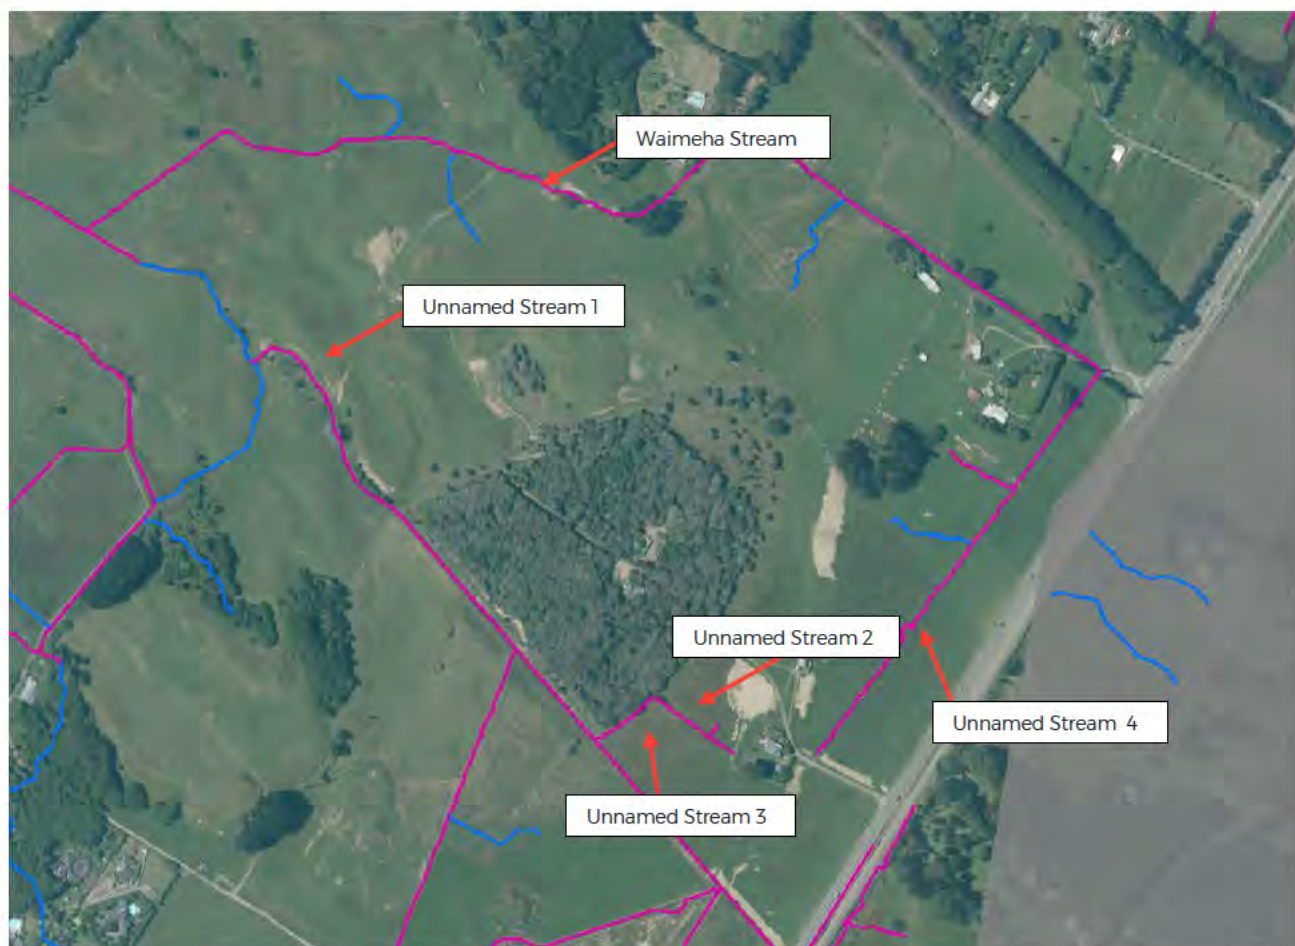
Figure 19: Highly modified streams within the site boundary (GWRC, 2019),

Under GWRC PNRP multiple watercourses within the site boundary fall within the definition of a highly modified stream (GWRC, 2019). Figure 19 shows in purple all streams within the site area that have been mapped as a highly modified streams by GWRC. Blue indicates natural streams within the site boundary. Stream names and assigned names for unnamed tributaries of the Waimeha Stream have been added. Under the PNRP many watercourses that are considered to be drains are natural watercourses that have been highly modified, often over many decades, and includes channels dug to drain natural wetlands. All watercourses that were flowing at the time of the site visit (3 May 2022) were assessed. For reporting purposes all unnamed watercourses within the property boundary were assigned a number from 1-4. Locations of these streams within the property boundary is provided in the following sections summarising the ecological assessment at each site. Unnamed streams 1, 2, 3 and 4 are all highly modified and are discussed in more detail below.

Unnamed Streams 2 and 3 (refer to Figure 22) are highly modified watercourses in accordance with the GWRC highly modified streams classification for the area (Figure 19).

Unnamed Stream 4 (refer to Figure 24) is a highly modified watercourse according to the GWRC highly modified streams classification for the area (Figure 19).

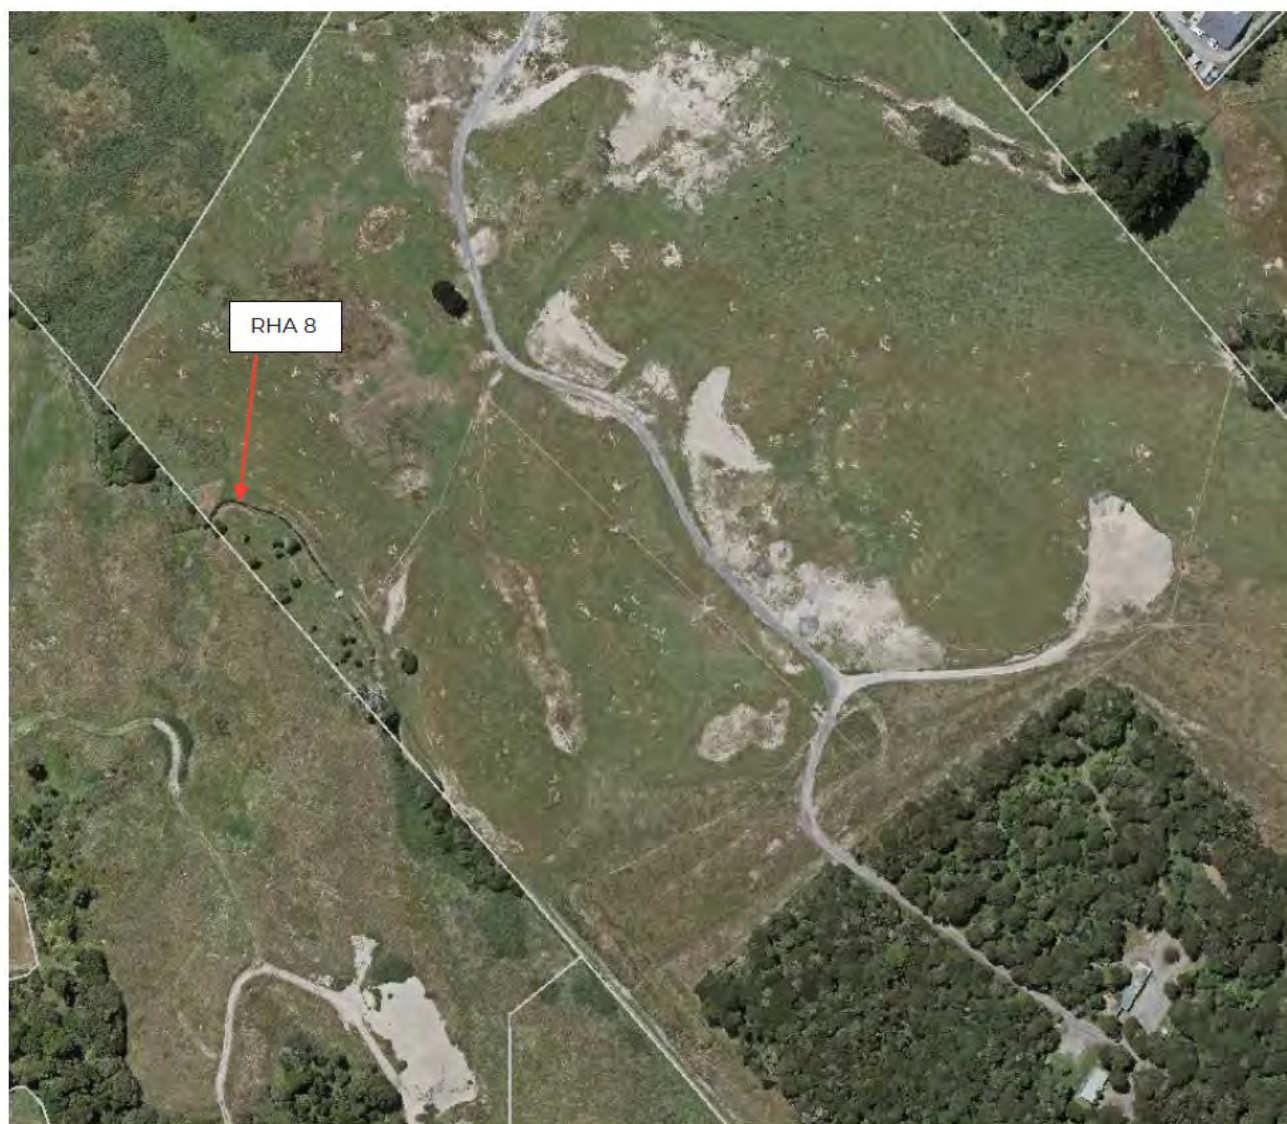
Figure 20: Location of RHA site 9 along the Unnamed Stream 1 within the property boundary (image sourced and modified from GWRC maps).

Unnamed Stream 1 (Figure 20) is a tributary of the Waimeha Stream that runs mostly through the neighbouring property on the left-hand side of the property boundary. There is a section of this stream, approximately 100m long, that flows through the property before entering the neighbouring property once more.

The Unnamed Stream 1 was observed to be flowing and hard bottomed on the neighbouring property. Observations of substrate within the property boundary were unable to be made due to the strong incision of the channel within the stretch of stream located in the property boundary. Stream features observed can be seen in Figure 21. There was little in the way riparian vegetation along the stream, some regenerative kanuka seedlings (*Kunzea ericoides*) and blackberry (*Rubus fruticosus*) could be seen along the banks. Within the channel there was watercress (*Nasturtium officinale*). Surrounding vegetation was predominantly grazed pasture. A RHA was conducted at one location (RHA site 8) on Unnamed Stream 1, within the site boundary (Table 13), in accordance with Clapcott (2015).

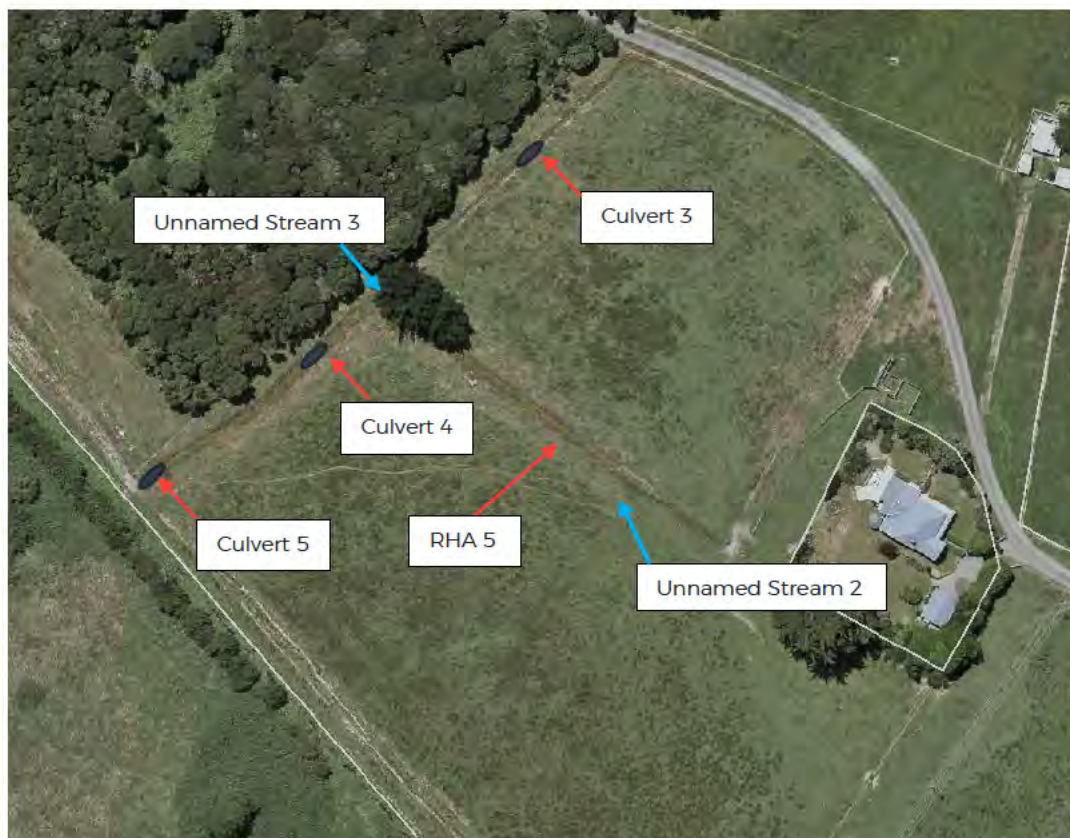
Figure 22: Location of RHA site along the Unnamed Stream 2 and 3 within the property boundary (image sourced and modified from GWRC maps).

A site visit was conducted on 3 May 2022. Rapid Habitat Assessments (RHA) were conducted at one location on Unnamed Stream 2, within the site boundary (Figure 22), in accordance with Clapcott (2015). Unnamed Streams 2 and 3 enter Unnamed Stream 1 just outside of the property boundary.

There are three small single barrel culverts and crossings along the Unnamed Stream 3 (no culverts on Unnamed Stream 2 were identified) (Figure 22). Stream features can be seen in Figure 23. Physical stream characteristics are shown in Table 16 for the Unnamed Stream 2 where the RHA assessment was conducted. An initial assessment of the bank full width and the current culvert size indicates that the culverts located within the Unnamed Stream 3 are undersized and would not comply with the NES-F (2020) regulations. All culverts on Unnamed Stream 3 were heavily congested with weeds.

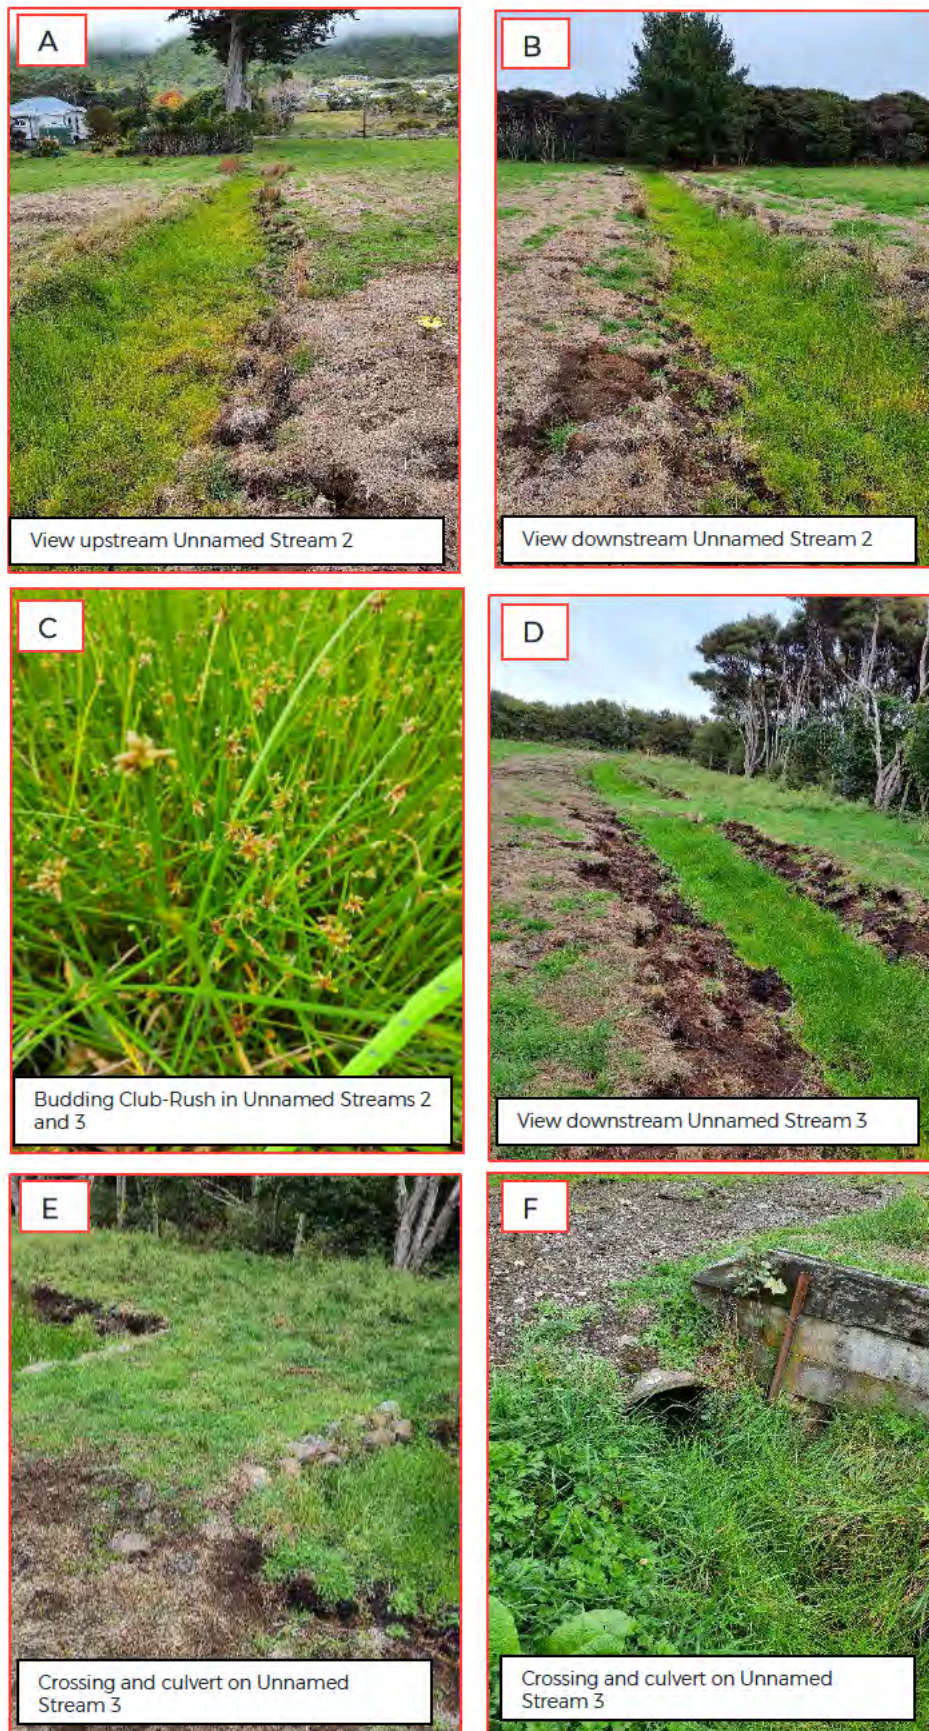
Figure 23: Photographs of the Unnamed Stream 2 and 3 (WSP site visit, 3 May 2022).

The Unnamed Streams 2 and 3 were heavily vegetated in budding club-rush (*Isolepis prolifera*), as such observations of substrate within the stream were unable to be made but it has been assumed that Unnamed Streams 2 and 3 are soft bottomed. Flow was relatively stagnant in Unnamed Streams 2 and 3, as a result of the high proportion of aquatic vegetation within the channel. There was little in the way riparian vegetation along Unnamed Stream 2, some regenerative kanuka seedlings (*Kunzea ericoides*) could be seen along the bank and there was a small row of pine trees (*Pinus radiata*) on the true right. Unnamed Stream 3 bordered the bush block (discussed above). Surrounding vegetation to both streams was predominantly grazed pasture. There was clear evidence of stock access to the stream channel on the right-hand bank of Unnamed Stream 2 which showed pugging and erosion of the channel into the stream. A summary of the RHA conducted on the Unnamed Streams 2 is provided in Table 15.

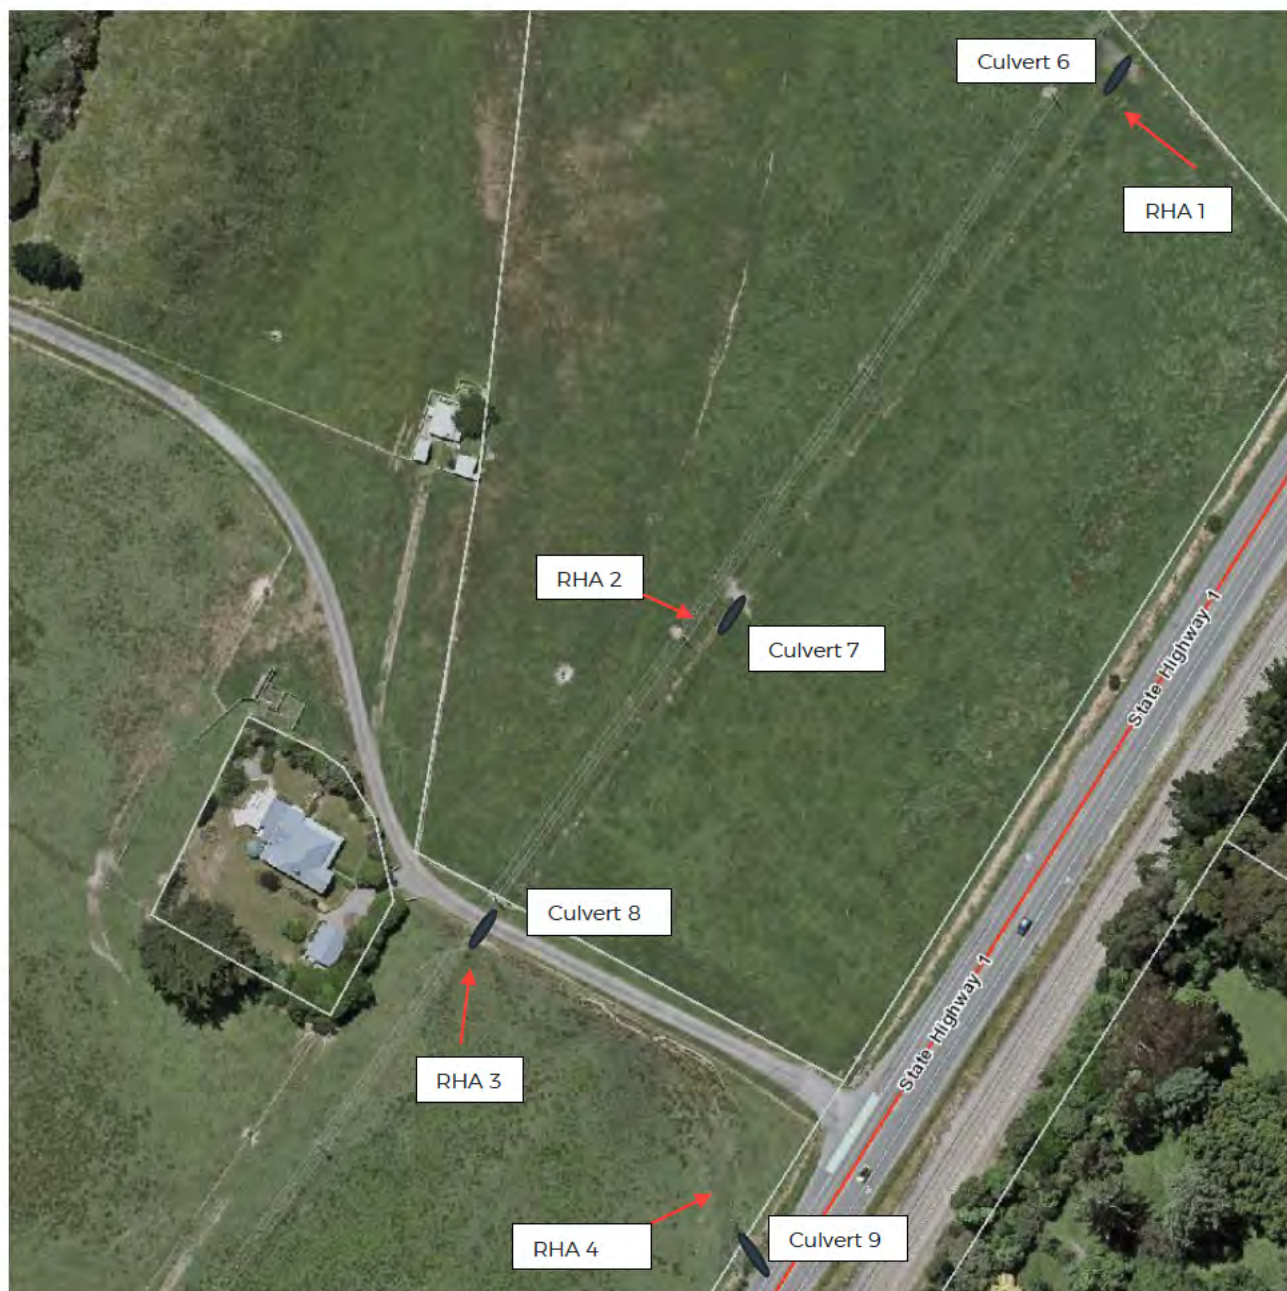
Figure 24: Locations of RHA along the Unnamed Stream 4 within the property boundary (image sourced and modified from GWRC maps).

A site visit was conducted on 3 May 2022. A RHA was conducted at four locations on Unnamed Stream 4, within the site boundary (Figure 24), in accordance with Clapcott (2015).

Unnamed Stream 4 enters the property boundary through a culvert underneath the Old SH1 (culvert 9). Where it enters the property, it is hard bottomed with visible gravel substrate within the wetted channel. There is a twin barrel culvert (culvert 8) that conveys flow beneath the main driveway to the property (noting there are also buried cables at this location). Further downstream there are another two single barrel culverts (culverts 7 and 6). Riparian vegetation along the length of Unnamed Stream 4 includes soft rush (*Juncus effusus*), common duck weed (*Lemna minor*) and grazed pasture. Stream features observed on-site can be seen in Figure 25. A summary of the RHA conducted on the Unnamed Stream 4 can be seen in

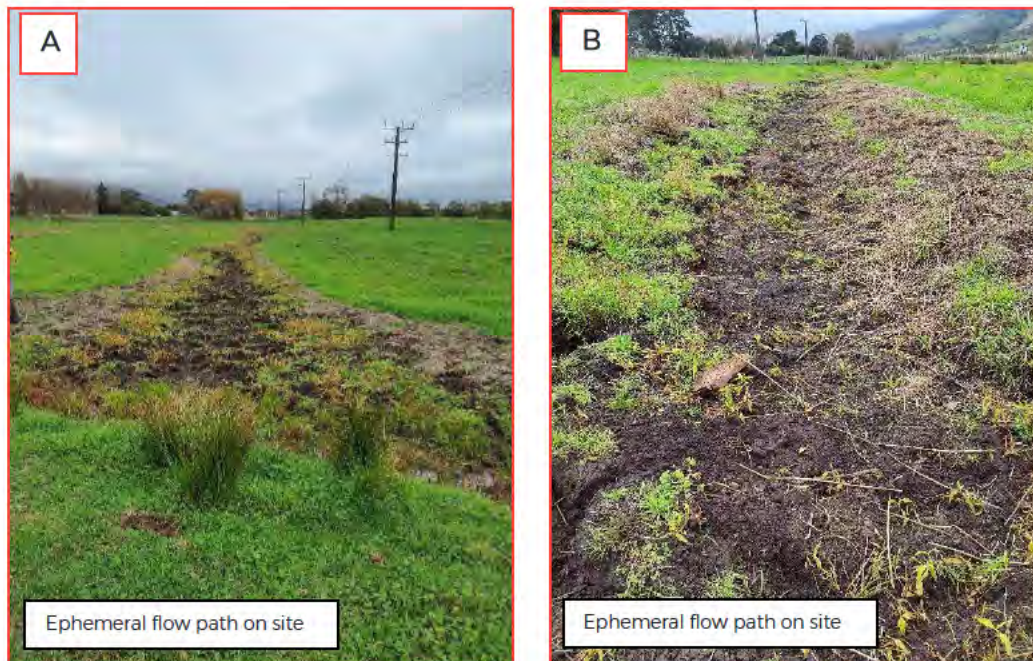
Figure 26: Photographs of the ephemeral flow paths (WSP site visit 3 May 2022).

There is an ephemeral flow path within the site boundary (refer to Figure 3). At the time of the site visit on 3 May 2022 there was no water within the channel. Substrate was mostly grazed pasture with some willow weed (*Polygonum persicaria*) present.
