KO Waikanae Due Diligence

Ecological assessment

15 June 2022

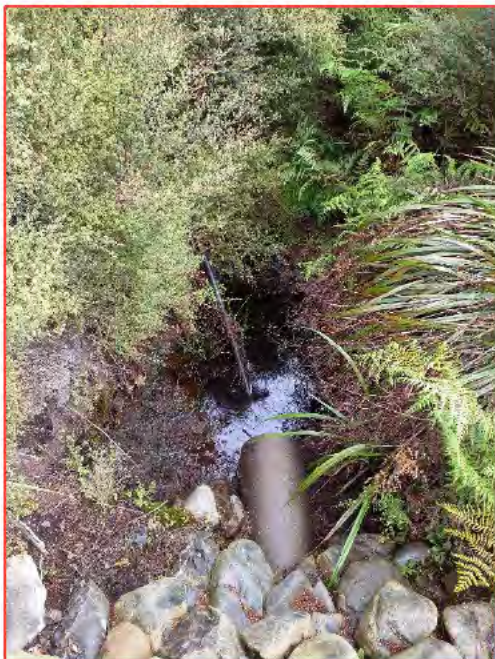
Figure 27: Photographs of a drain on-site (WSP site visit, 3 May 2022).

There appeared to be a drain running parallel with the bush block on the property (Figure 27). Access was hindered by vegetation growth, but the waterway is not mapped as a highly modified stream according to GWRC PNRP. There appeared to be a perched culvert that ran underneath the gravel access track through the bush block.
