819 RIDDELL ROAD AND 43A & 45 WAIMARIE STREET, GLENOWIE, AUCKLAND: ARCHAEOLOGICAL ASSESSMENT

Prepared for Sanctum Projects Limited

October 2021

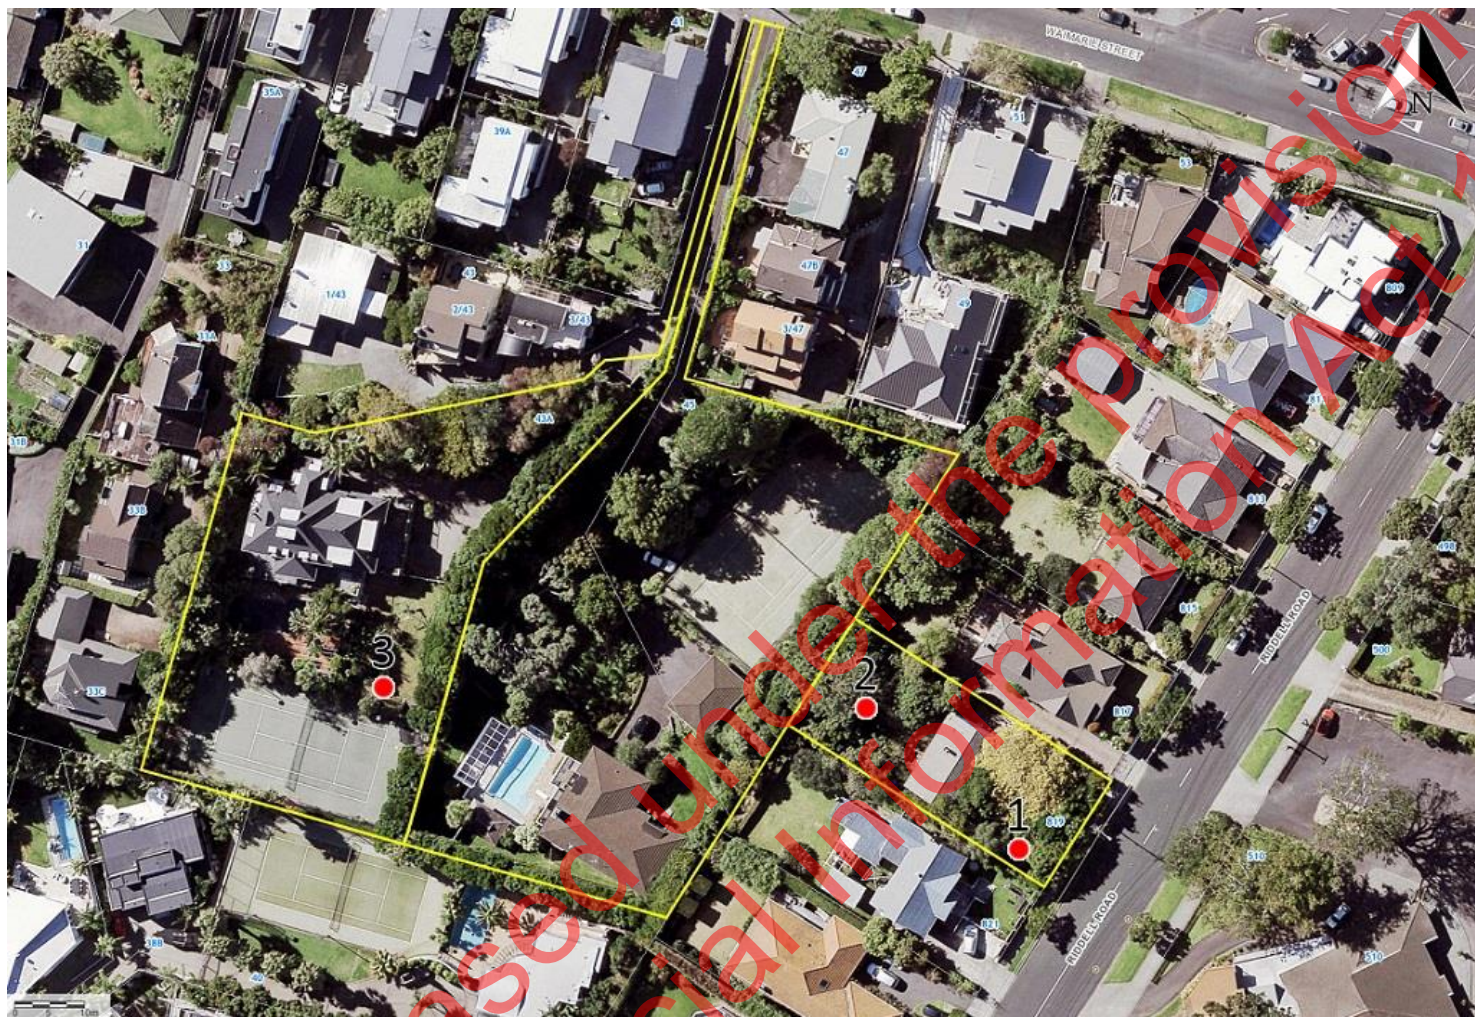
Figure 2. Aerial view of project area with properties at 819 Riddell Road and 43A & 45 Waimarie Street bounded in yellow (numbered dots indicate the locations of test pits excavated during the site assessment). Source: Auckland Council Geomaps GIS Viewer

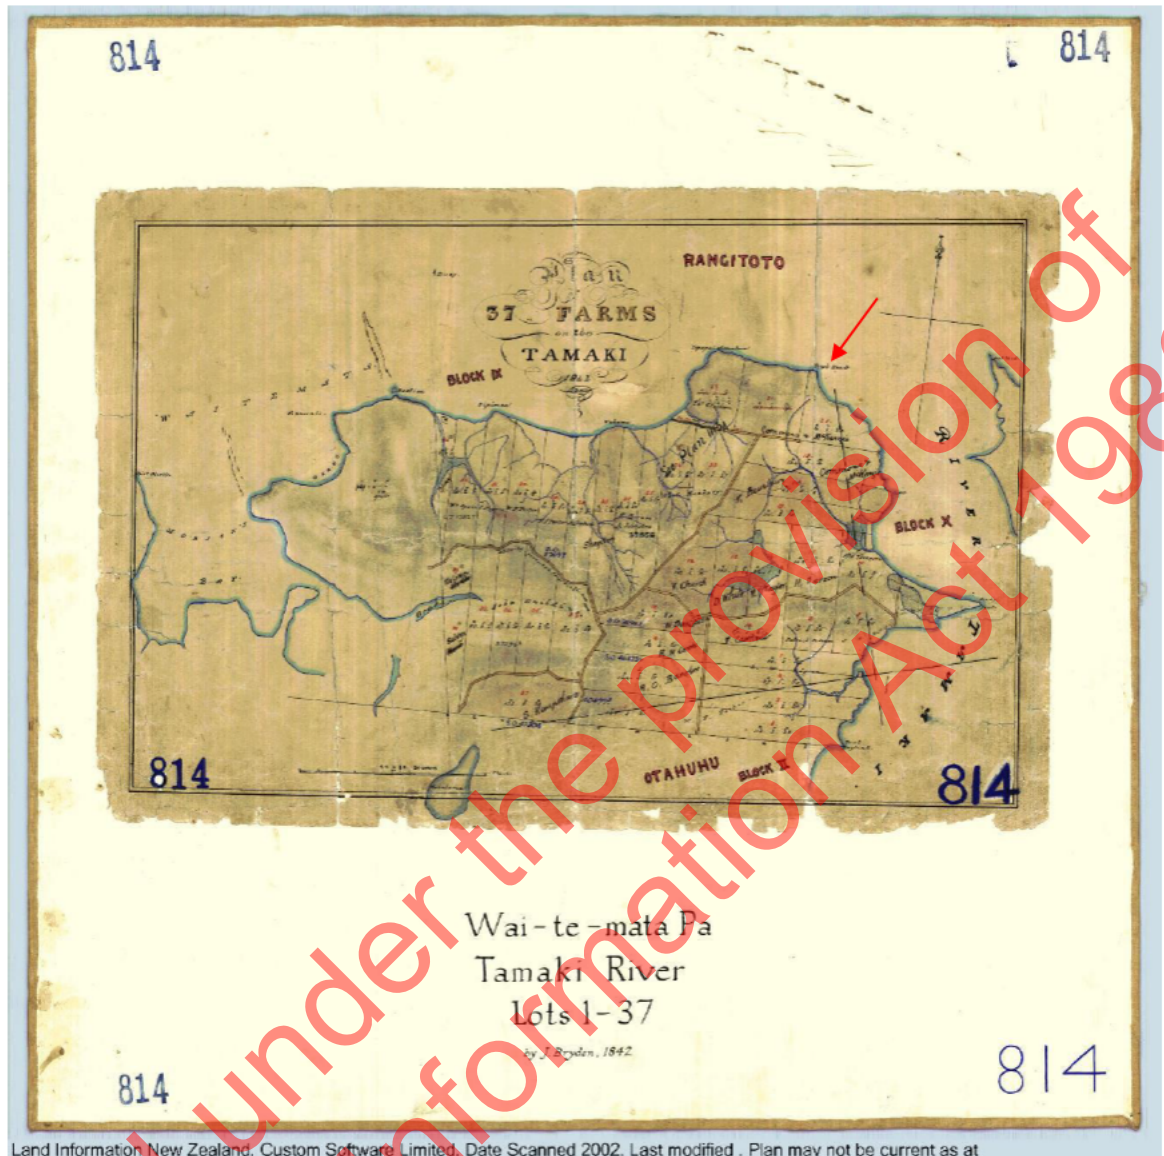
Figure 6. SO 814, dated 1842, titled 'Plan of 37 Farms on the Tamaki' and 'Wai-te-mata Pa Tamaki River Lots 1-37'. The western headland is named West Head (red arrow). Source: Quickmap

Early LINZ plans of the area show the subdividing of the area from the 1840s onwards (Figure 6–Figure 8). The 1842 plan of the ‘Wai-te-mata Pa Tamaki River Lots 1-37’ shows the western headland named West Head even at that early date (Figure 6).

The modern extent of the subject properties is situated within the southern side of what was Lot 21, Parish of Waitemata. Lots 20 and 21 were owned by Commons and McKenzie in 1842 (Figure 6 and Figure 7). The plan indicates that the size of Lot 21 was 129 acres, 3 roods and 19 perches. Commons and McKenzie held the land for only a short period, selling to Taylor in 1845. The land was held by various members of the Taylor family until at least the 1890s (Deeds Index A2/20-21) (Figure 8 and Figure 9).

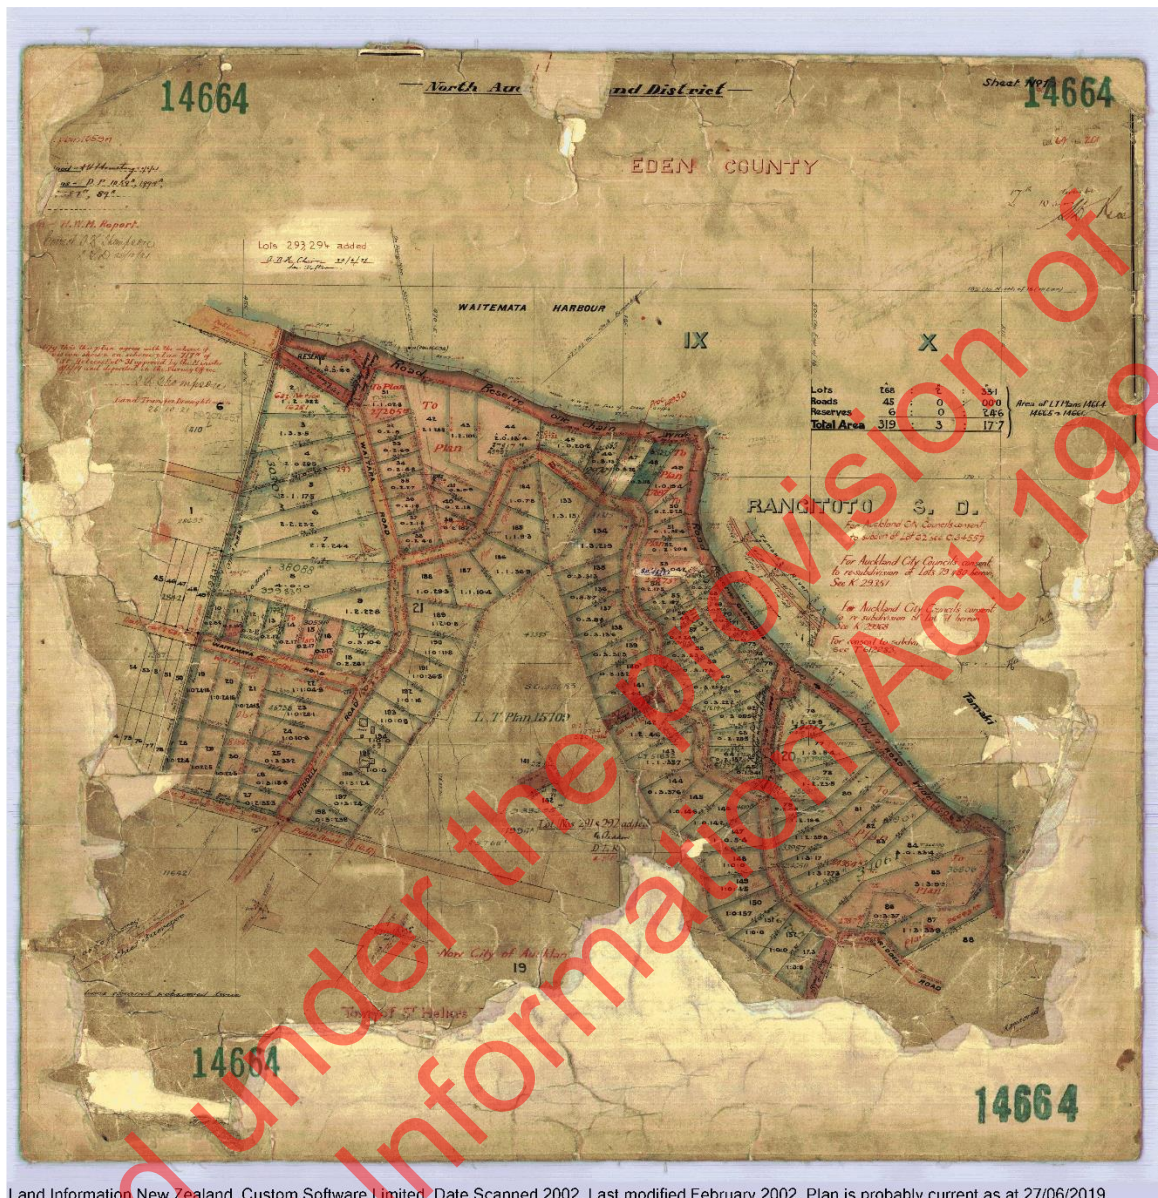
Figure 10. DP 14664, dated 1921, showing the subdivision of land at that time (source: Quickmap)

The area appears to have remained as large open farms until 1921. At that date a large 198 lot residential subdivision was made in the area around Riddell Road and Waitara Road (Figure 10). A 1924 plan of the subdivision of the Glendowie Estate just to the southeast of the project area shows the development of the broader area during the early 20th century (Figure 11).

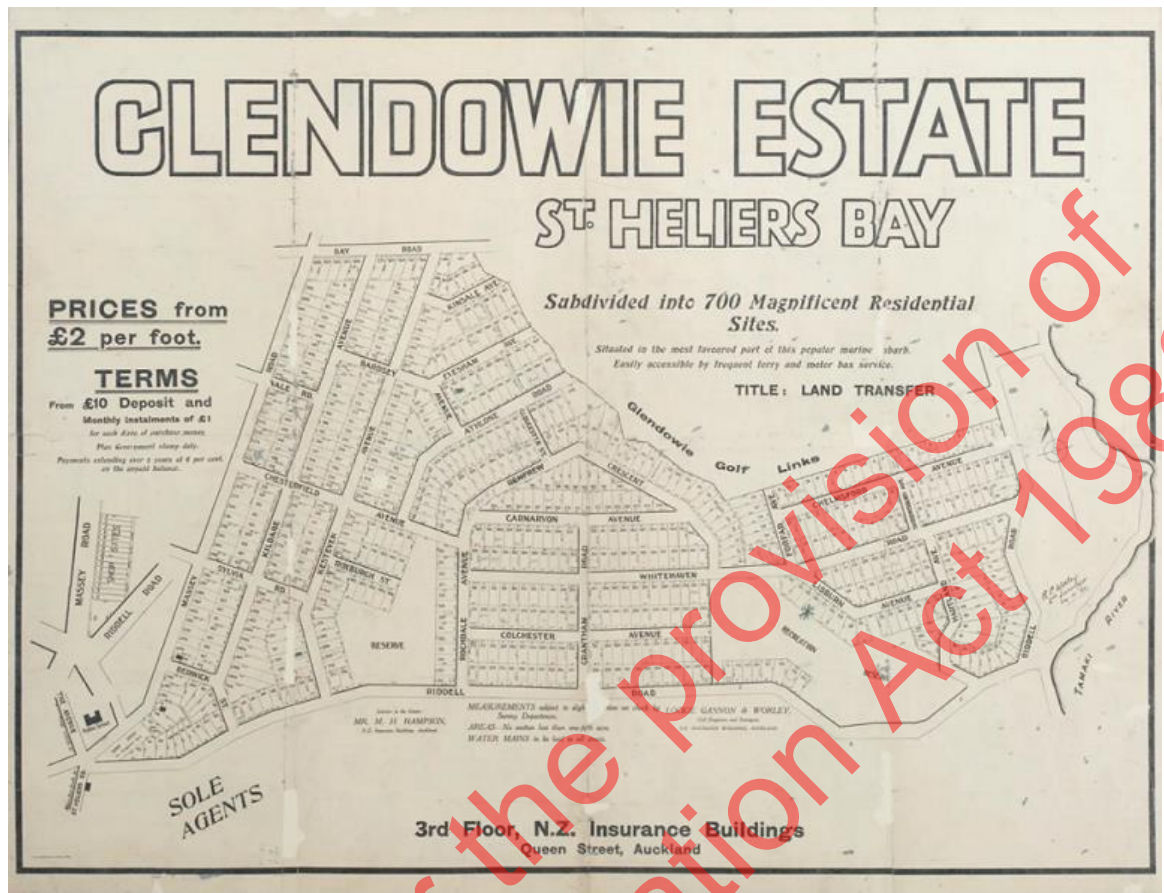
Figure 11. Plan of Glendowie Estate, St Heliers Bay, dated 1924, titled 'Glendowie Estate, St. Heliers Bay: subdivided into 700 magnificent residential sites' / R.P. Worley (source: Auckland Museum Collections Online, Call No. G9081.G46G2)

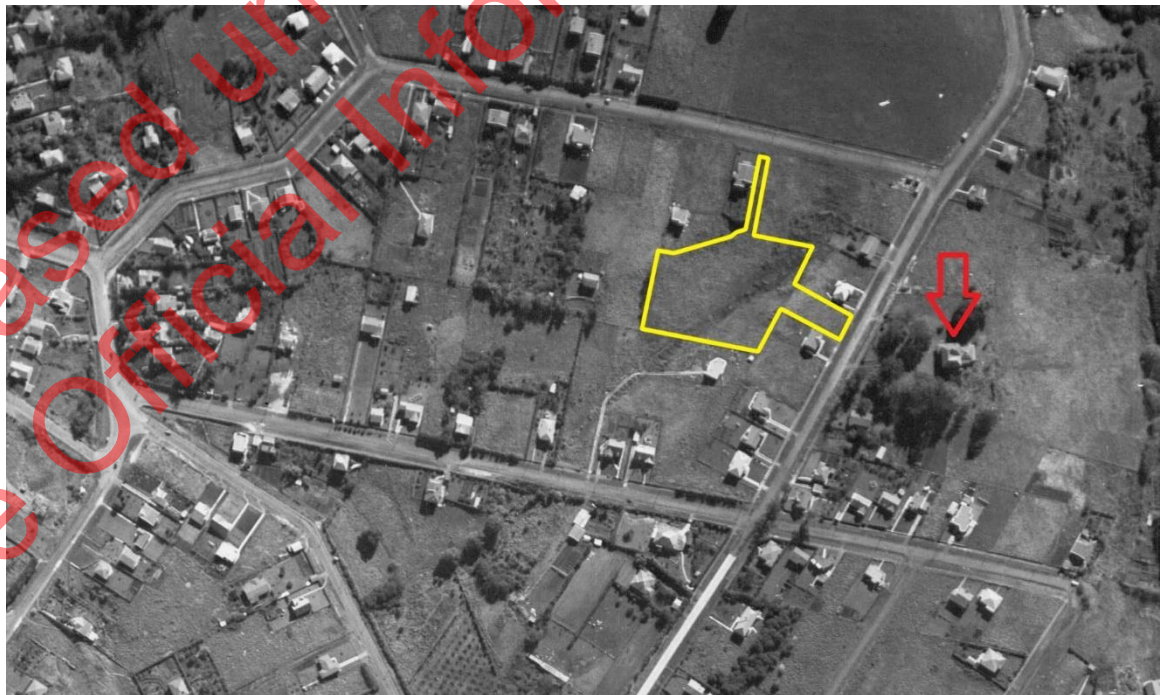
Figure 12. 1940 aerial showing project area outlined in yellow and the Glendowie Homestead indicated by red arrow (source: Retrolens SN145, Run 64 No.22)

Aerial photography reveals the progression of development in the project area and surrounds. A 1940 aerial shows that no residential buildings existed within the project area at the time, but numerous residential buildings had been constructed in the surrounding area (Figure 12). A 1950 aerial shows that more residential buildings had been built, but there were still no buildings within the project area at this time (Figure 13). By 1963 the

A historic homestead was located across the road from the project area at what is now 510 Riddell Road (Mother of Perpetual Help Church). This would have been part of the original Lot 21 that also includes the project area. Its location is identified on the aerials in Figure 12–Figure 15. Not much is known about the house prior to its use as a church. A newsletter from the Mother of Perpetual Help Church, the current church that now sits on the location of the former historic homestead, states that the building was formerly known as the Glendowie Country Club (Figure 17), which was bought with 5 acres of land from a Mrs Burton for £13,000 in approximately 1950, thereafter being used as a Catholic Church. The newsletter describes the homestead as containing 14 rooms, and that the structure was ‘... a very old building “that moved on its foundations when the wind blew”.’ The newsletter goes on to describe how the building was modified over the years during the mid-20th century to accommodate a growing Catholic community. These additions included a small chapel and classrooms. However, by 1972 a new church was built followed by a Parish centre in 1991 (Redemptorist Diamond Jubilee 2010).

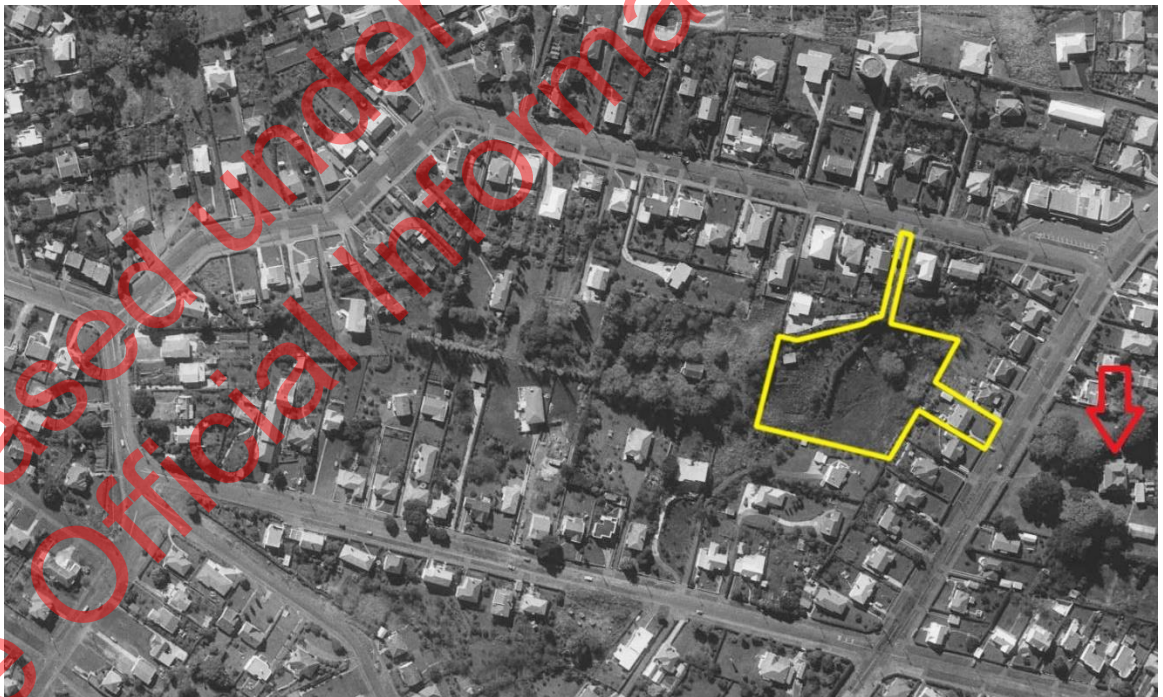
Figure 14. 1963 aerial showing project area outlined in yellow and the Glendowie homestead indicated by red arrow. Note the additions on its southeast side and a separate classroom building to the southeast of the homestead (source: Retrolens SN1392 Run 3234 No. 46)

residential building at 819 Riddell Road had been constructed by this time, but the properties at 43A and 45 Waimarie Street remained undeveloped (Figure 14). A 1972 aerial shows a residential building at 45 Waimarie Street (Figure 15), while the earliest aerial found showing a residential building at 43A Waimarie Street dates from 1996 (Figure 16).

The additions to the homestead become visible from the 1963 aerial (Figure 14) onwards, where classrooms can be seen as a separate building to the southeast (see also Figure 18) and the chapel can be seen as an extension to the southeast side of the building (Figure 14, Figure 15 and Figure 19). The church was not yet built at the time of the 1972 aerial (Figure 15). However, the homestead and additions are still visible in the 1975 aerial (Figure 19), with the 1972 church built on its west side. A 1980 aerial shows that nothing had changed up to this point (Figure 20). By 1987 the classroom building had been removed, however, the homestead was still standing (Figure 21). However, the 1996 aerial (see Figure 16) shows that the homestead had been removed by this point. Thus, it is likely that the old homestead was removed some time during or after the construction of the parish in 1991, and certainly by 1996.

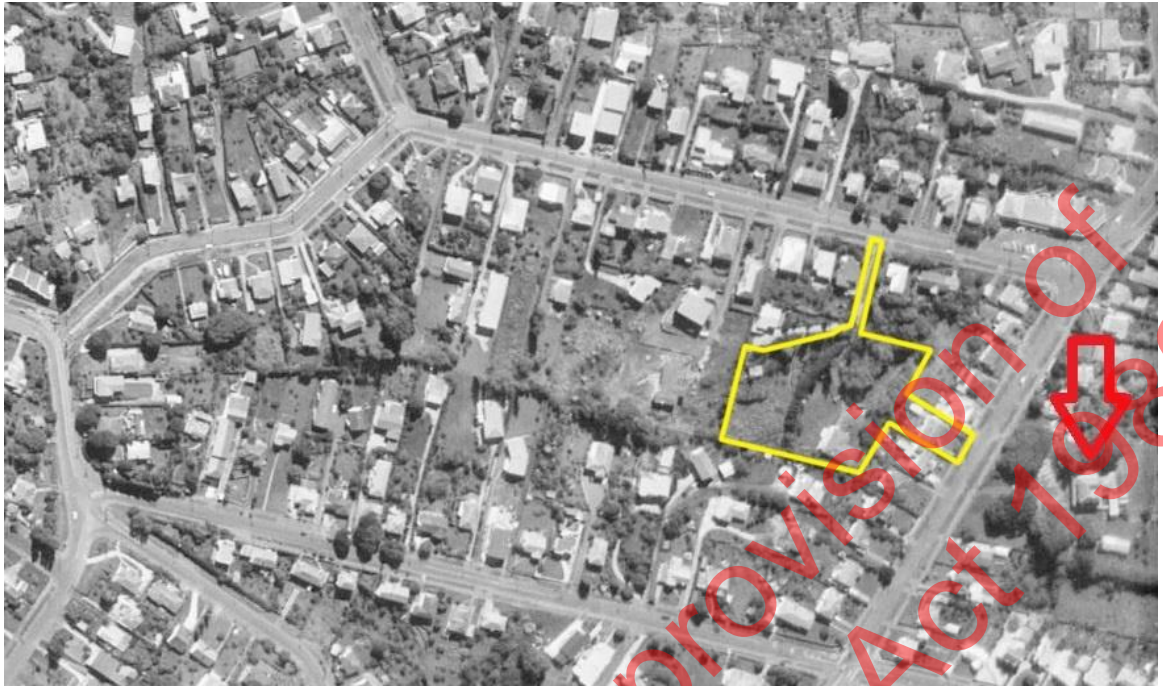
Figure 15. 1972 aerial showing project area outlined in yellow and the Glendowie homestead indicated by red arrow. Note the additions on its southeast side and a separate classroom building to the southeast of the homestead (source: Retrolens SN3552, Run 4600 No. 15)

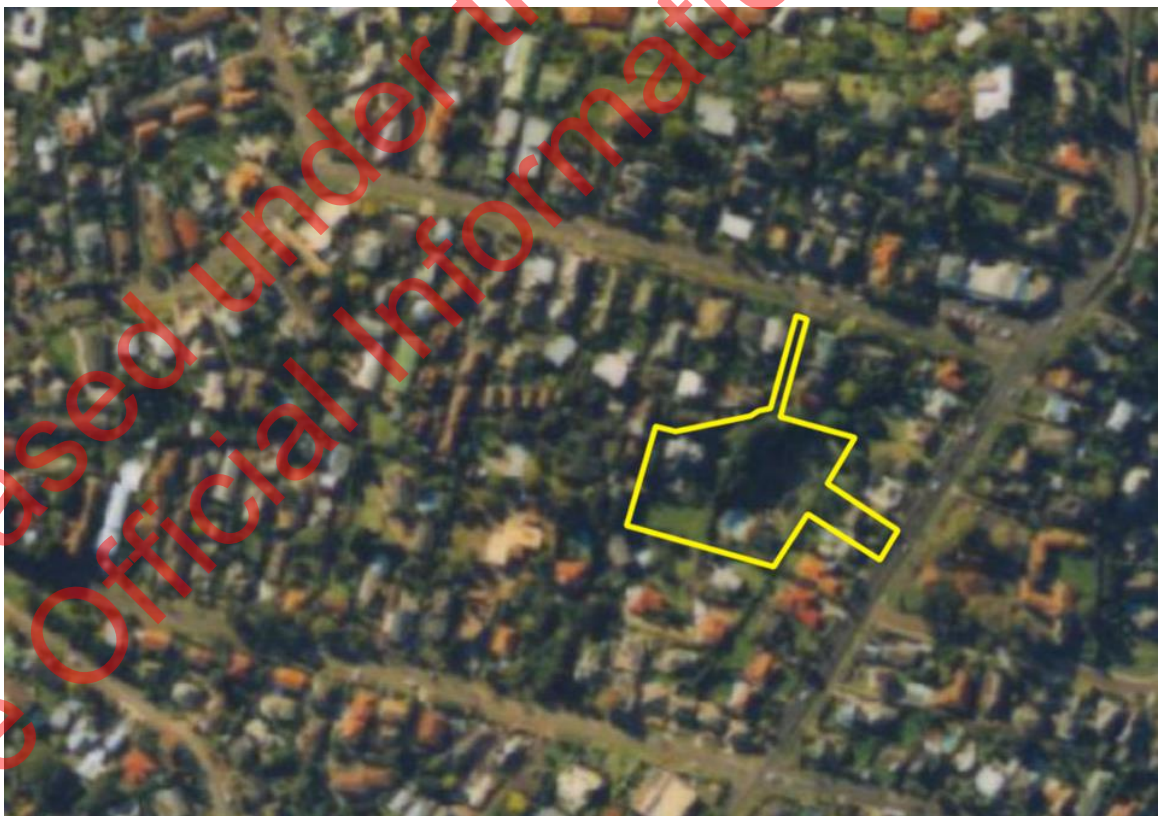
Figure 16. 1996 aerial showing project area outlined in yellow. Note the Glendowie homestead has been removed by this time (source: Auckland Council Geomaps)

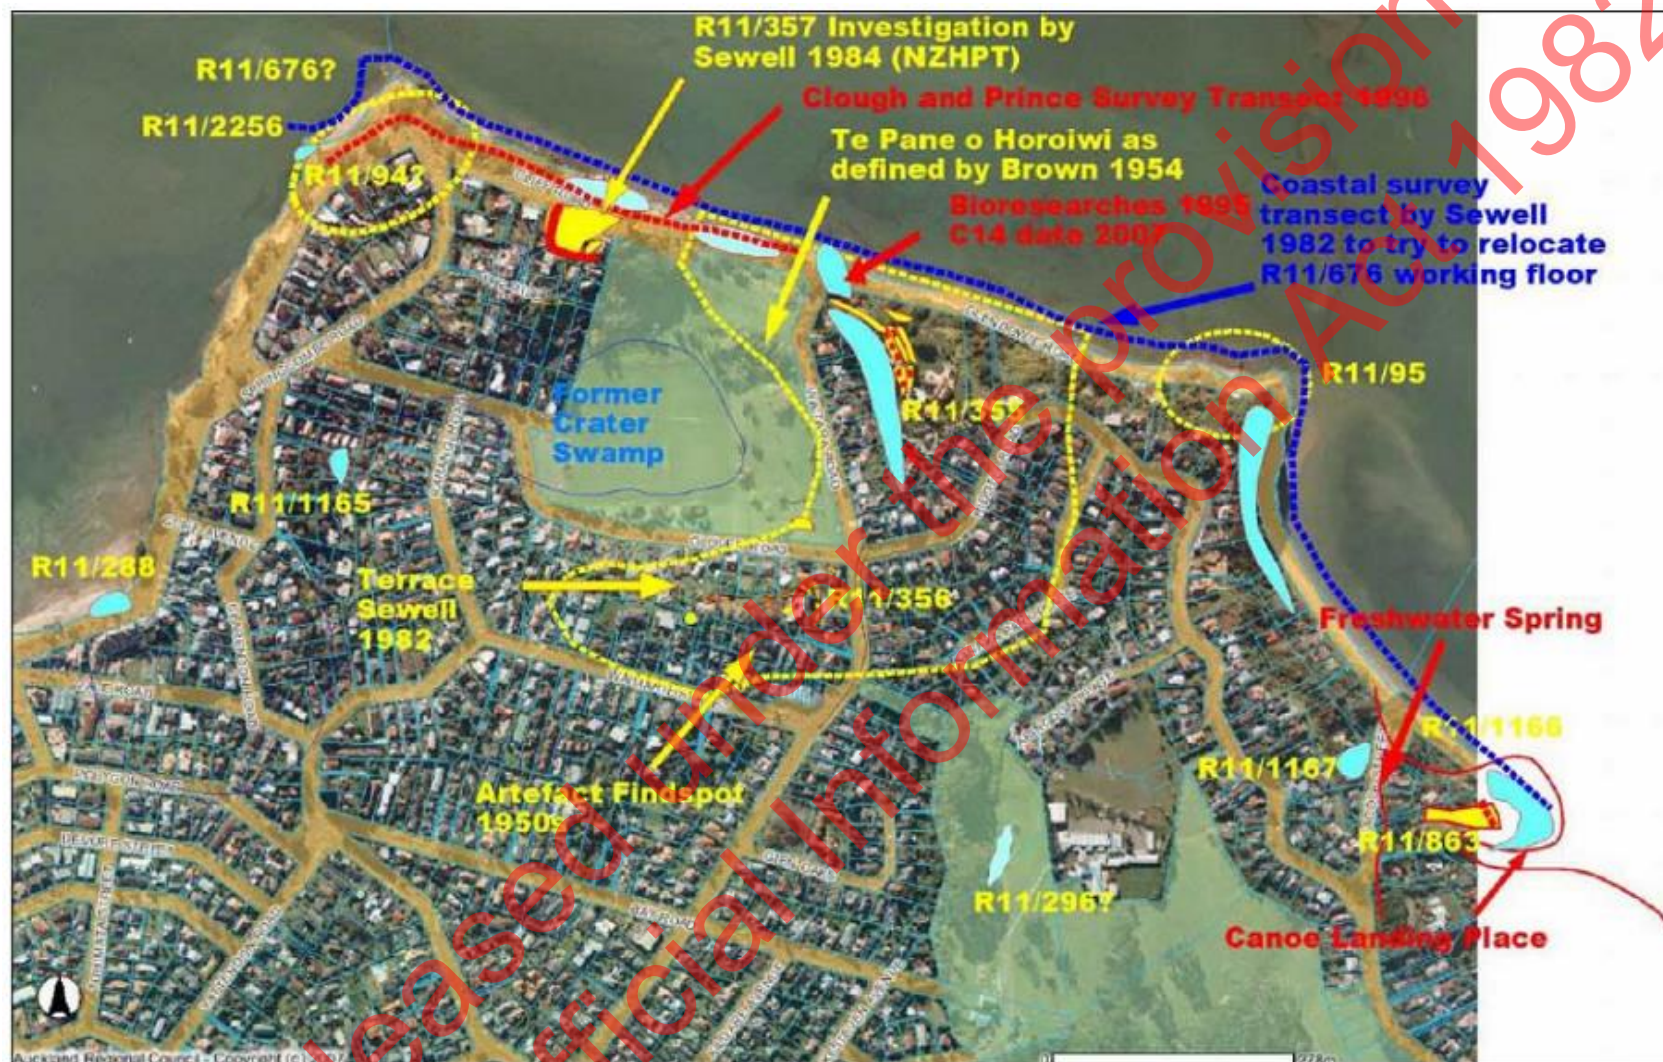
Figure 22. NZAA records summarised on 2001 aerial photography by Felgate (2007b: Figure 19). Light blue areas indicate shell midden while yellow areas are terracing

Felgate (2007) excavated a disturbed shell midden at 40 Rarangi Road, although the archaeological results were limited. The report does not include the results of any analysis apart from a discussion of shell sizes; however, Bickler and Baquié (2016) do provide the radiocarbon results from Felgate's research as a point of comparison with their own investigation results at 12 The Rise. The midden at 40 Rarangi Road is dated to 1462-1665 AD (95.4%).¹ Felgate provided an overview of the archaeological record in St Heliers Bay, clarifying some of the confusion relating to the recording of sites near Cliff Road (Figure 22).

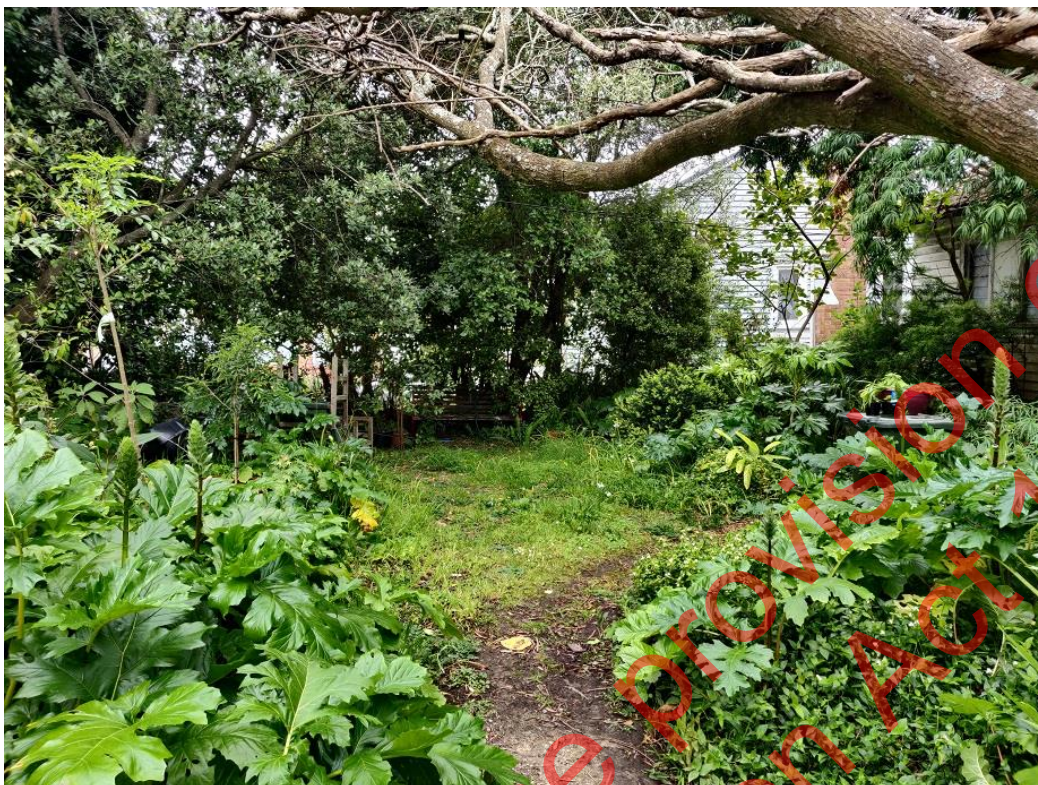
The property at 819 Riddell Road contains two lawns, on the front and rear (east and west sides) of the property (Figure 25 and Figure 26). A domestic dwelling stands at the approximate centre (Figure 27) with a shed/garage on the central north side just behind the house (Figure 28).

Figure 25. Front lawn of property at 819 Riddell Road, facing southwest

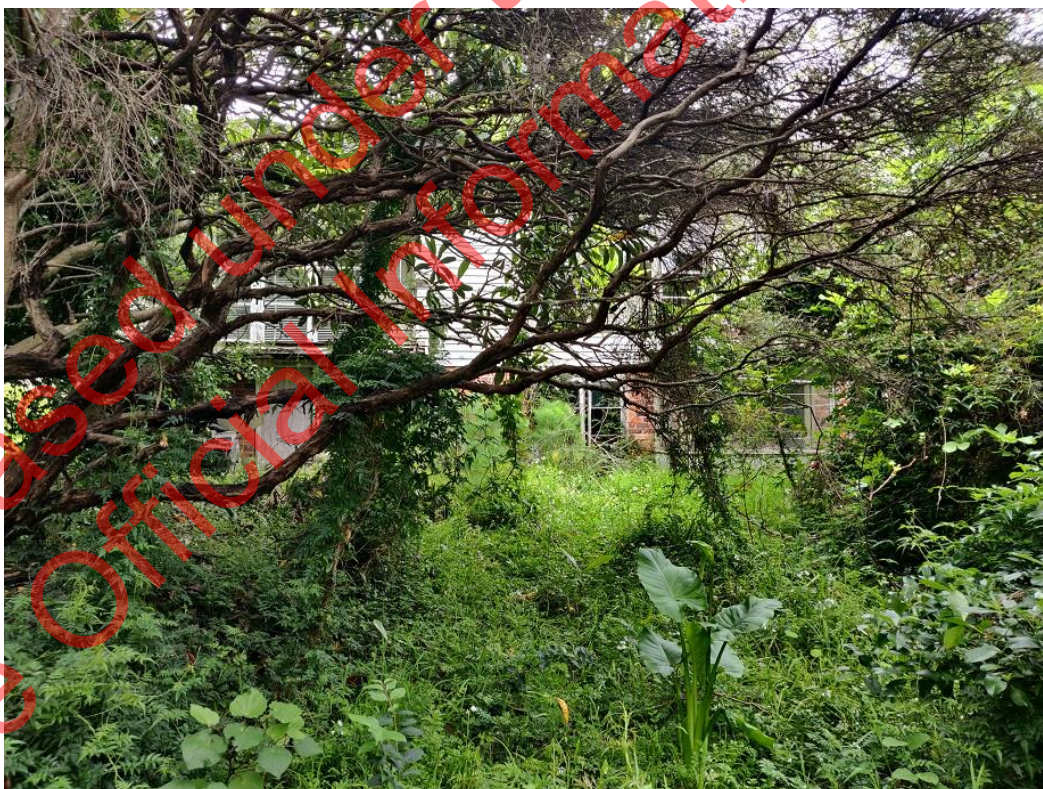
Figure 26. Rear lawn of property at 819 Riddell Road, facing east

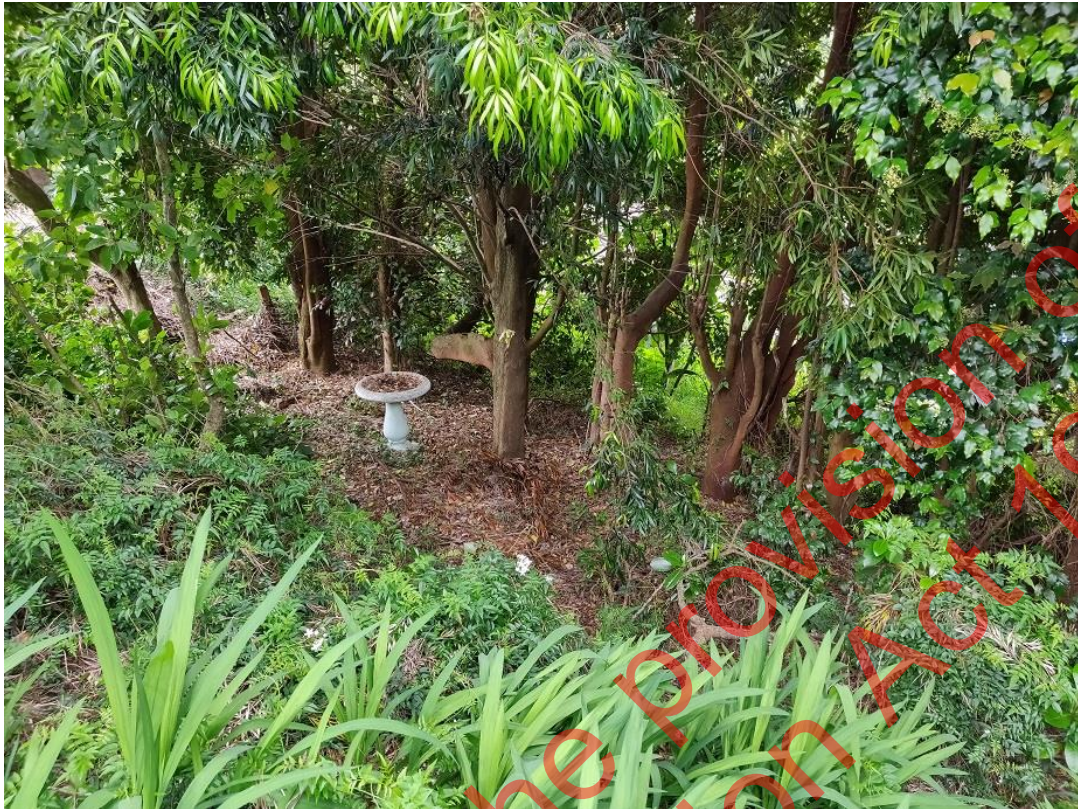
The property is significantly overgrown with vegetation including grasses, shrubs, bushes and trees (see Figure 25–Figure 28). Numerous trees and bushes border both the east (road facing) and west (rear) sides of the property (Figure 29 and Figure 30). The terrain on the property is generally flat, except for the far west side (rear) which contains a relatively steep slope leading down to the western property boundary.

Figure 29. West border (rear) of property at 819 Riddell Road, facing west

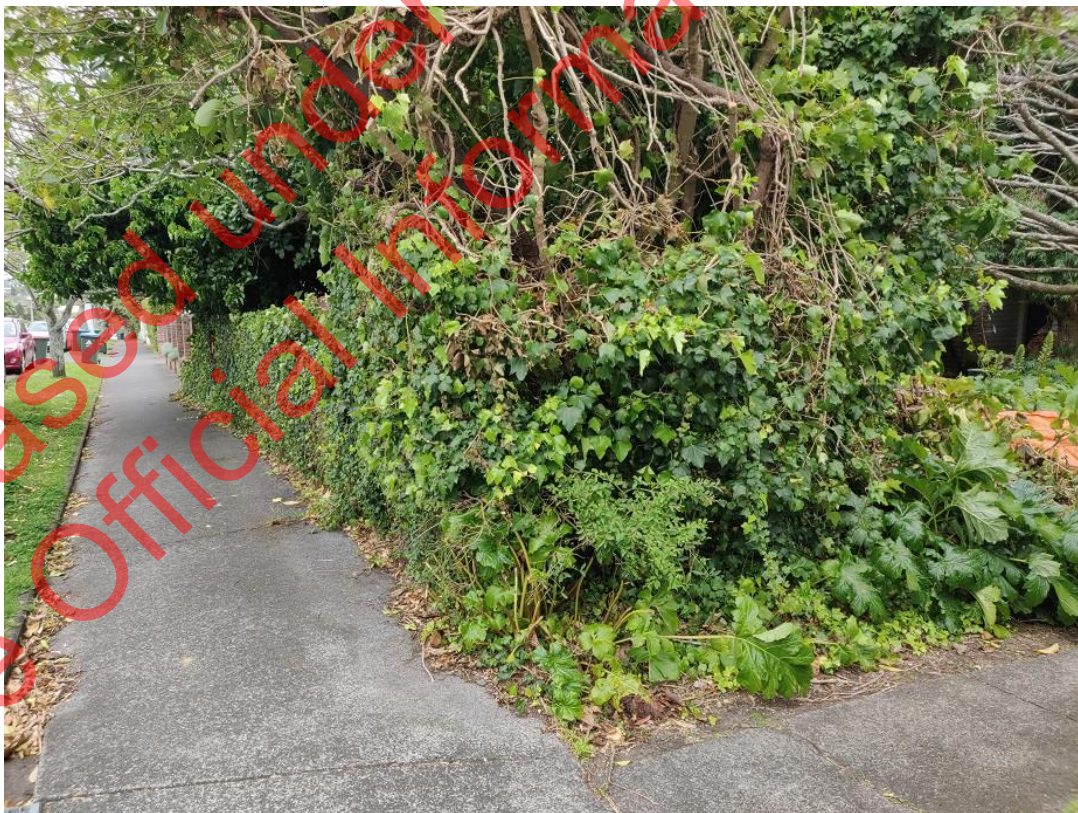
Figure 30. East border (front) of property at 819 Riddell Road, facing southwest

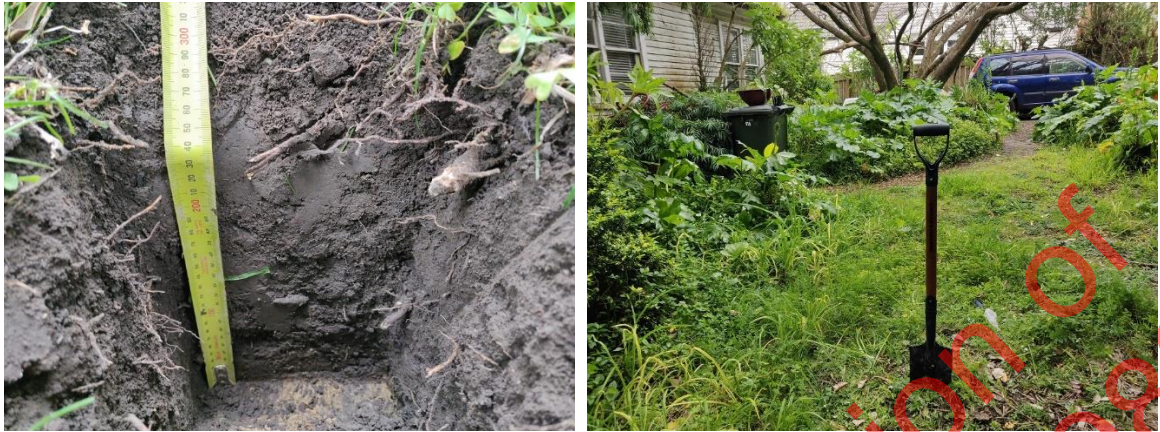
In order to obtain a subsurface stratigraphic profile, two test pits were excavated on the property: one on the east side (front) and one at the rear (west). The east test pit (marked test pit 1 in Figure 2) was placed at NZTM coordinates 1766587 5920010 ± 3 m (Figure 31), was 28cm deep and the stratigraphy was as follows:

- Layer 1: 27cm of a loose, medium brown-grey soil with occasional root disturbance.
- Layer 2: 1cm+ of a compact, light brown clay.

The stratigraphic profile from the east (front) side of the property revealed a moderately undisturbed soil profile. The stratigraphic profile from the west (rear) side of the property revealed a disturbed soil profile, likely as a result of development on the property. Nothing of archaeological significance was found on the property within the test-pits or through probing, nor were there any discernible features on the ground surface. The property appears to have been moderately modified. The only potentially unmodified areas are the front lawn (east side) and possibly a portion of the rear lawn (west side).

Figure 31. Left: Stratigraphic profile of test pit 1 placed on east side of property at 819 Riddell Road. Right: Location of test pit 1, facing northeast

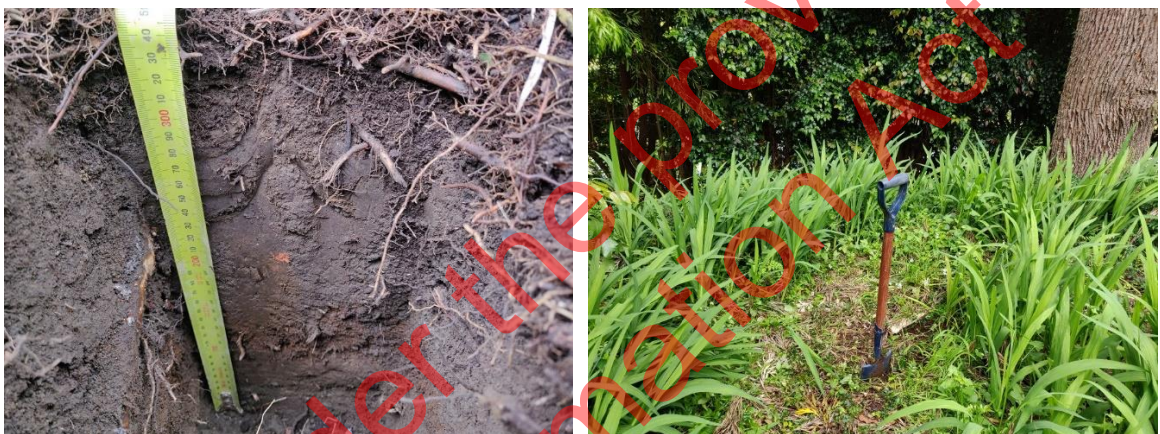
The west test pit (marked test pit 2 in Figure 2) was placed at NZTM coordinates 1766564 5920031 ± 3 m (Figure 32), was 35cm deep and the profile exposed was as follows:

- Layer 1: 15cm of a loose, medium brown-grey soil with moderate root disturbance.
- Layer 2: 20cm of a moderately loose, medium brown soil with occasional root disturbance. Occasional deposits of clay within layer.
- Further excavation was not possible due to dense roots/rocks at base. However, it appeared as though the clay layer had just been reached.

Figure 32. Left: Stratigraphic profile of test pit 2 placed on west side of property at 819 Riddell Road. Right: Location of test pit 2, facing northwest

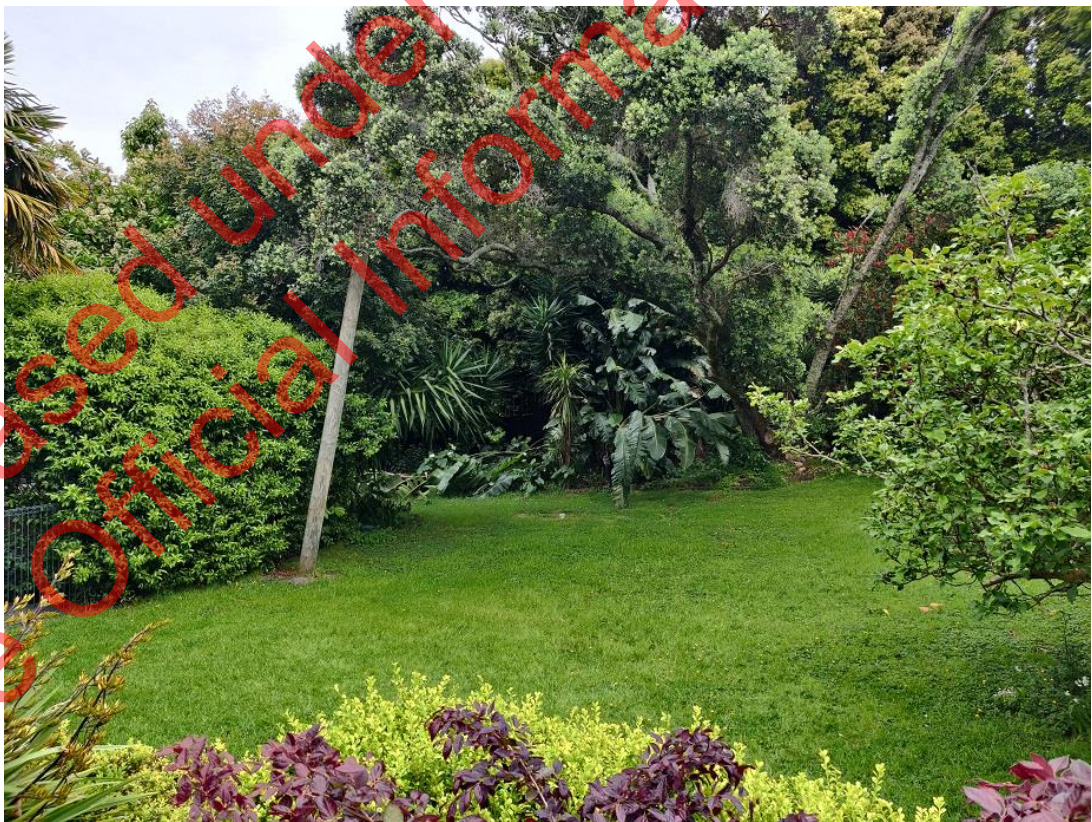
Although no test-pitting or probing was conducted, no archaeological features were visible on the ground surface. The property appears to have already been extensively modified. The only potentially unmodified areas are the lawns to the northeast and northwest of the house. However, a septic tank breather could be seen on the lawn on the northwest side of

the house (see Figure 37). This lawn is therefore likely to have been significantly disturbed by the installation of the septic tank exists.

Figure 37. Lawn on northwest side of house, facing southwest. Note septic tank breather in background

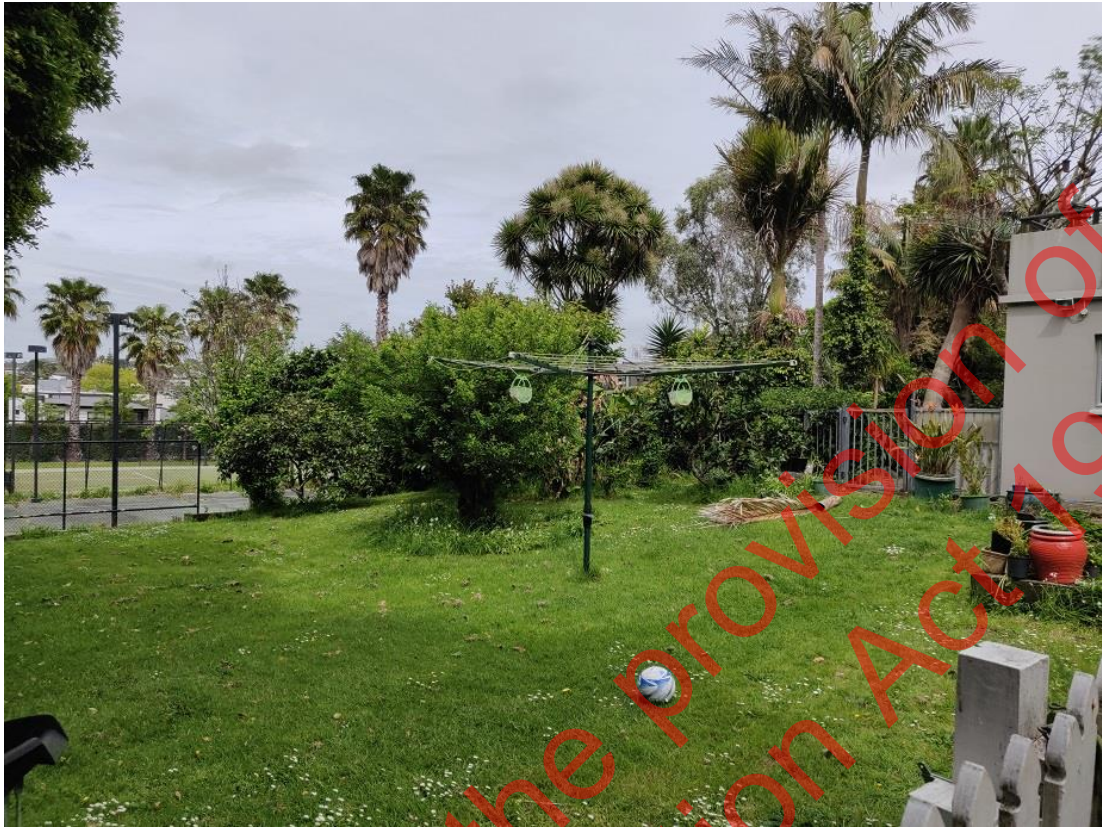
Figure 45. Lawn on southeast side of house, facing southwest

In order to obtain a subsurface stratigraphic profile, a test pit was excavated on the lawn on the southeast side of the house (central east side of the property). The test pit (marked test pit 3 in Figure 2) was placed at NZTM coordinates 1766494 5920034 ± 3 m (Figure 47), was 29cm deep and the profile exposed was as follows:

- Layer 1: 29cm of a loose, medium brown-grey soil. Occasional mottling of clay within layer.
- Layer 2: 1cm+ of clay appeared to be at the base of pit, however, there were significant relatively large rocks/gravel at the base of the test pit, thus this layer could not be well photographed.

This stratigraphic profile from the central east side of the property revealed a slightly disturbed soil profile (evident from clay mottling), likely as a result of development on the property. Nothing of archaeological significance was found on the property within the test-pits or through probing, nor were there any discernible features on the ground surface. The property appears to have been extensively modified, and the only potentially unmodified area on the property may be a portion of the lawn on the central east side.

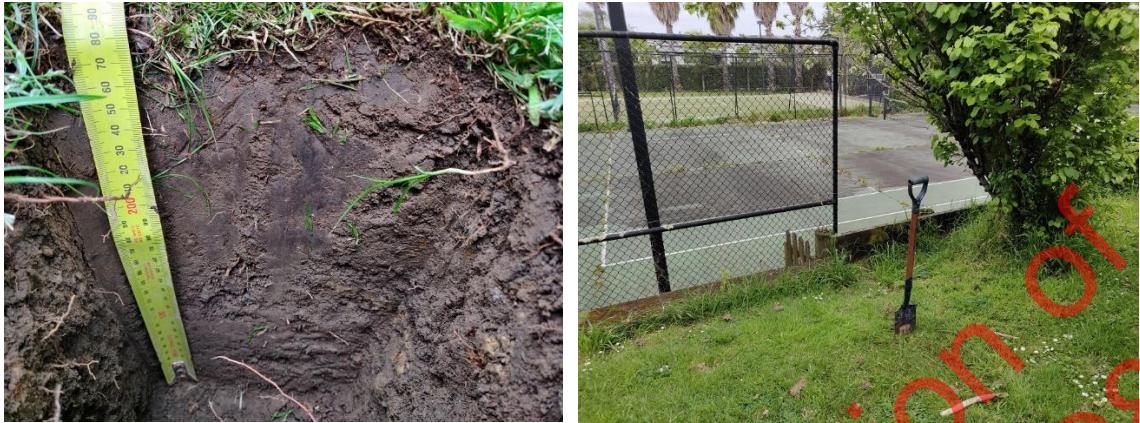
Figure 47. Left: Stratigraphic profile of test pit 3 placed on the central east side of property at 43A Waimarie Street. Right: Location of test pit 3, facing south/southwest
