# PRELIMINARY SITE INVESTIGATION

## 238 STOCK ROAD & 49a DUNDEE DRIVE FLAXMERE

PROJECT NO. EAM2122-REP-01

PREPARED FOR  
ARATAKI PROPERTY

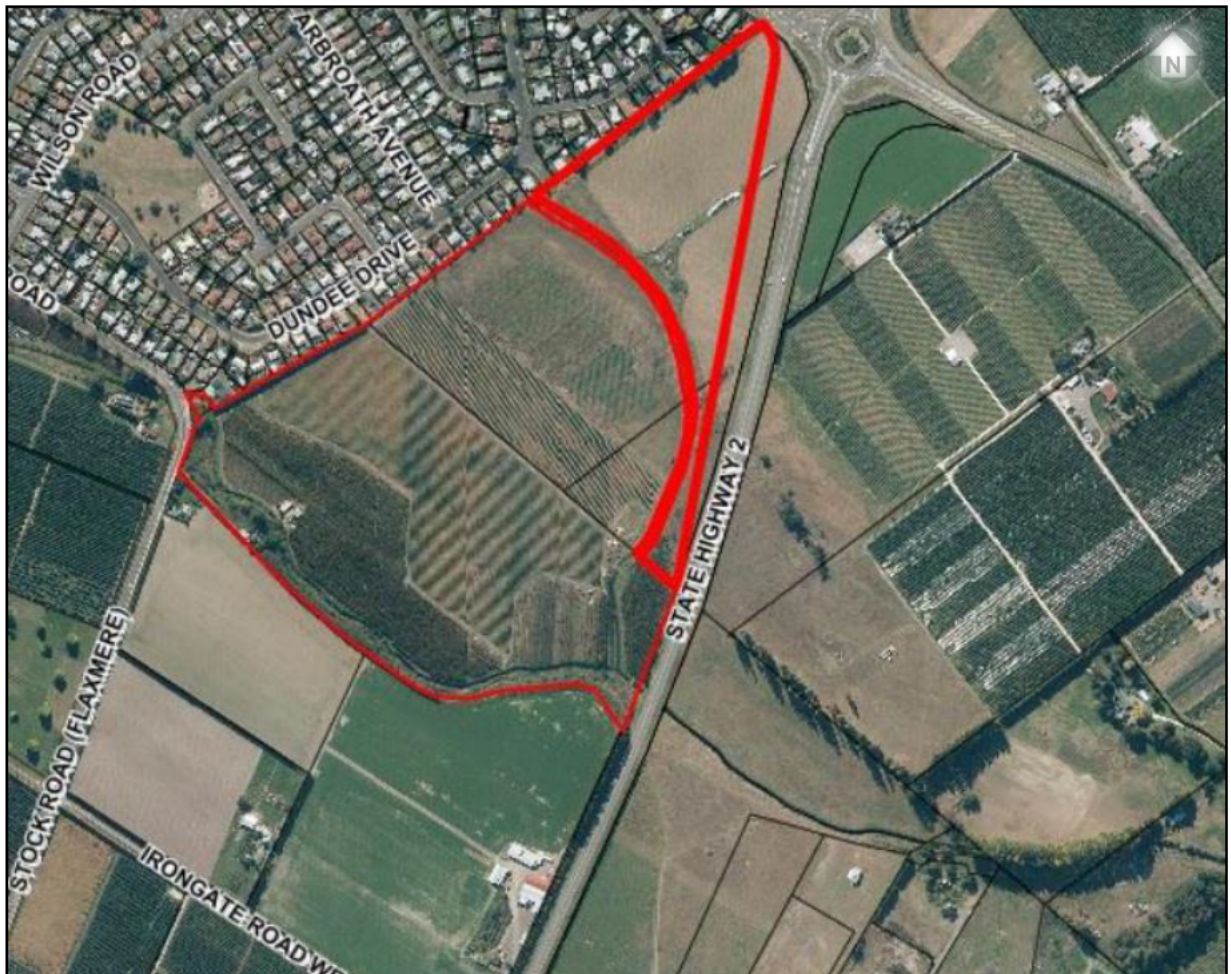
FIGURE 2. BOUNDARY OF 238 STOCK ROAD AND 49A DUNDEE DRIVE

The Site is classified as general residential/plain's production. It is predominantly used for orchard and vineyard but also encompasses a house section, and an area of implement shedding. The legal description for the Site is SEC 1 9 SO 454705 (49a Dundee drive) and PT LOT 5 DP 2976 SECS 18 20 22 SO 438108 (238 Stock Rd). The combined land area of both titles is 28.16ha. Figures 1 and 2 illustrate the property location, and the boundary of the property.

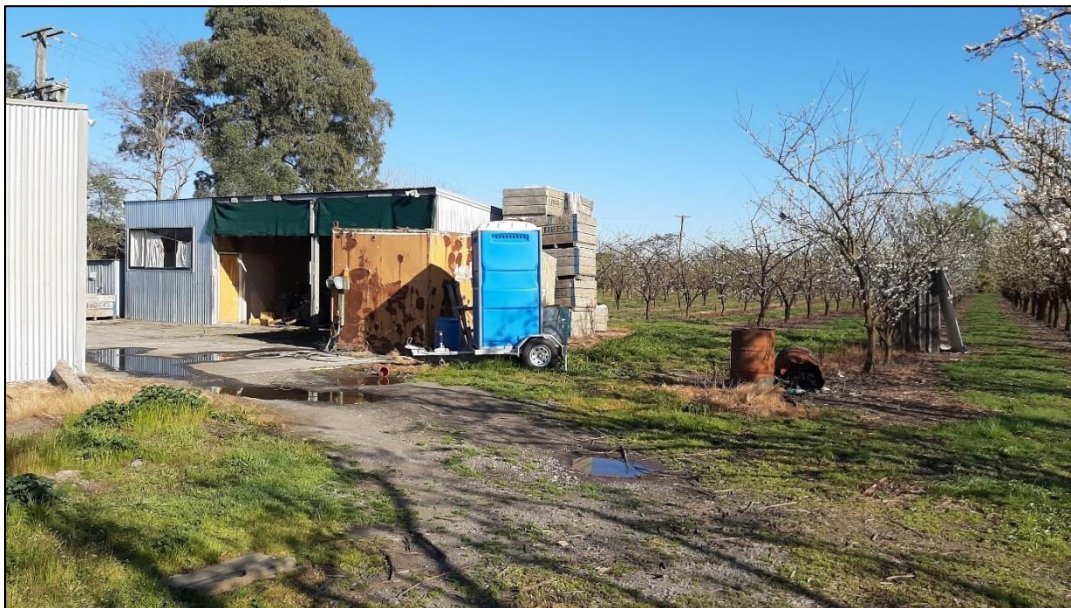
**FIGURE 3. AREA AROUND MAIN IMPLEMENT SHEDS**

A site visit was completed on Friday 3<sup>rd</sup> September. The site entrance is at 238 Stock Road and is via gravel driveway. To the right, the Irongate stream enters the property, alongside the driveway. Firmly packed vehicle track leads off to the left and right, and travels around and throughout the site. The track to the left ventures along the back of housing on Dundee drive, looping through the vineyard and meeting up with the right-side track. The track to the right leads to a series of implement sheds, approximately 150m in from the entrance. Two main implement sheds face each other with a concrete sealed area extending beneath both, and an open area in between. Two small chemical sheds are present either side of the sheds, one locked and in good condition, the other open and dilapidated. An above ground fuel tank is located to the side of the sheds. The surrounds are used for storage of drums, fruit crates and other materials. Two 44-gallon drums used as burn bins are present, and full of burnt material. The shedding area is surrounded by the orchard. Track extends past the implement shed area and through the orchard and vineyard. There are many areas of piled up posts, fruit crates, netting and rubbish which appear in piles mounded up as if to be burned.

A burning bin was observed during the site visit, in the implement shed area, with spillage and ash on the grounds surrounding it. A test for Polycyclic Aromatic Hydrocarbons, was therefore considered at this area.

Sample #7 was collected from the soil around two drums used for burning off. Laboratory analysis reported concentrations of PAH below the laboratory detection limits.

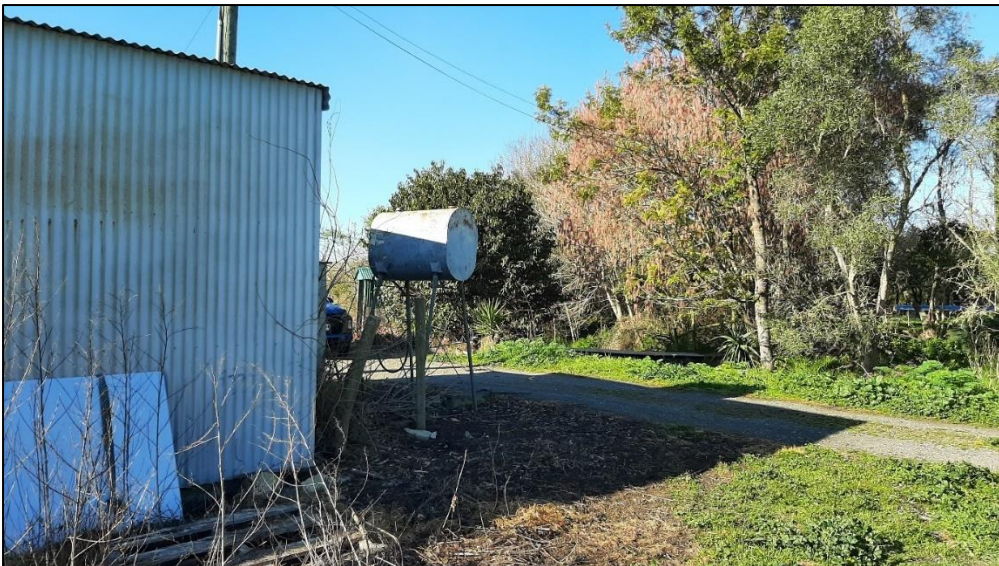
**FIGURE 5. ABOVE GROUND FUEL TANK**

Total Petroleum Hydrocarbons were analysed to assess spillage/ leakage from the above ground fuel tank.

Sample #6, collected beneath the above ground fuel tank was analysed for TPH. Laboratory analysis reported acceptable concentrations.

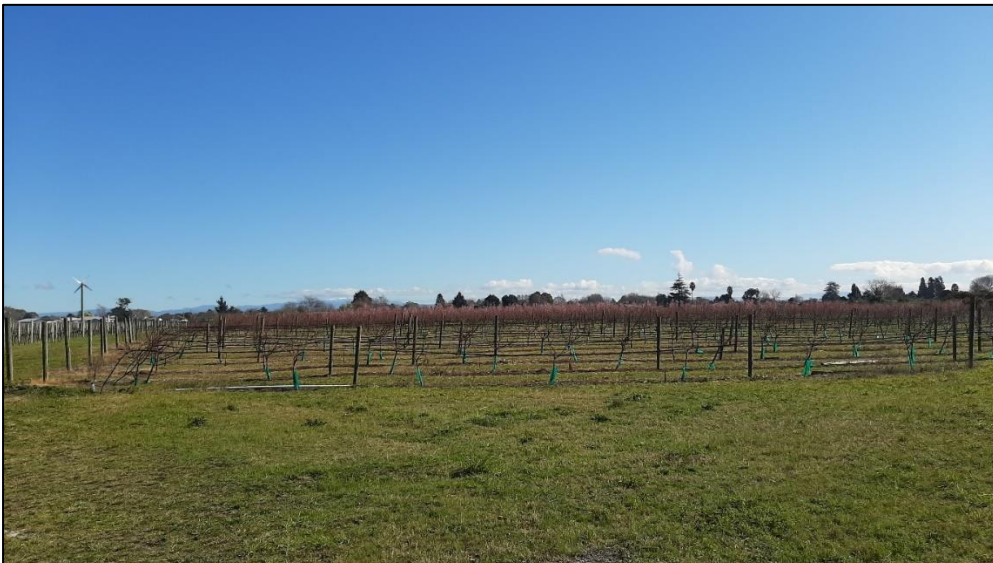
**FIGURE 8. VINEYARD**

Metal results were all within the NES guidelines except for sample 12. Sample 12 was collected from soil next to a treated post in the vineyard and reported concentrations of arsenic (62mg/kg) in exceedance of the residential (10% produce) guideline of 20mg/kg. This sample was collected based on the known ability for CCA treated posts to leach into the soil. Site soils exceed all background metal concentrations except for cadmium and nickel.

The assessment has identified that the soils at this site currently do not meet the NES, and further work will be required.

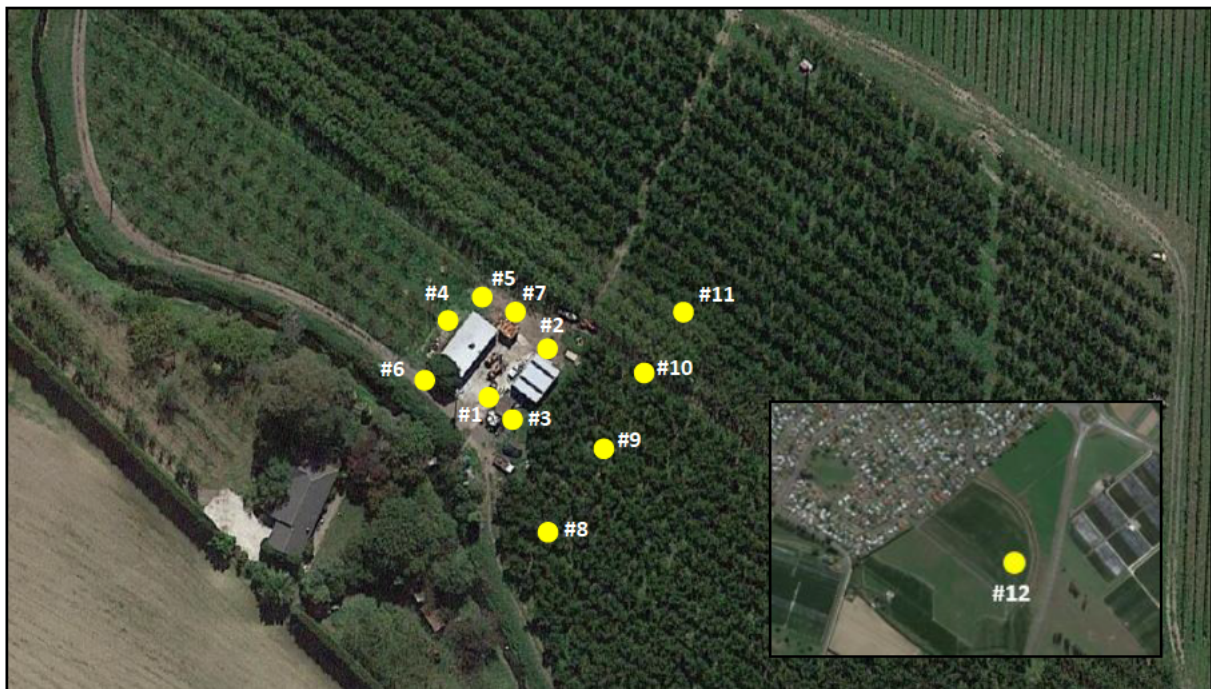
FIGURE 9. TRIAL PIT LOCATIONS

Samples were collected from 12 sample locations across the site, with the locations shown in Figure 9. Soil samples were collected using a 150mm soil augur.
