DETAILED SITE INVESTIGATION (DSI)

69 TRIG ROAD 149-151 & 155-157 BRIGHAM CREEK ROAD,
WHENUAPAI, AUCKLAND

Reference Number: REP-1475/DSI/JUN20(REV1)

PREPARED FOR: NEIL CONSTRUCTION LIMITED

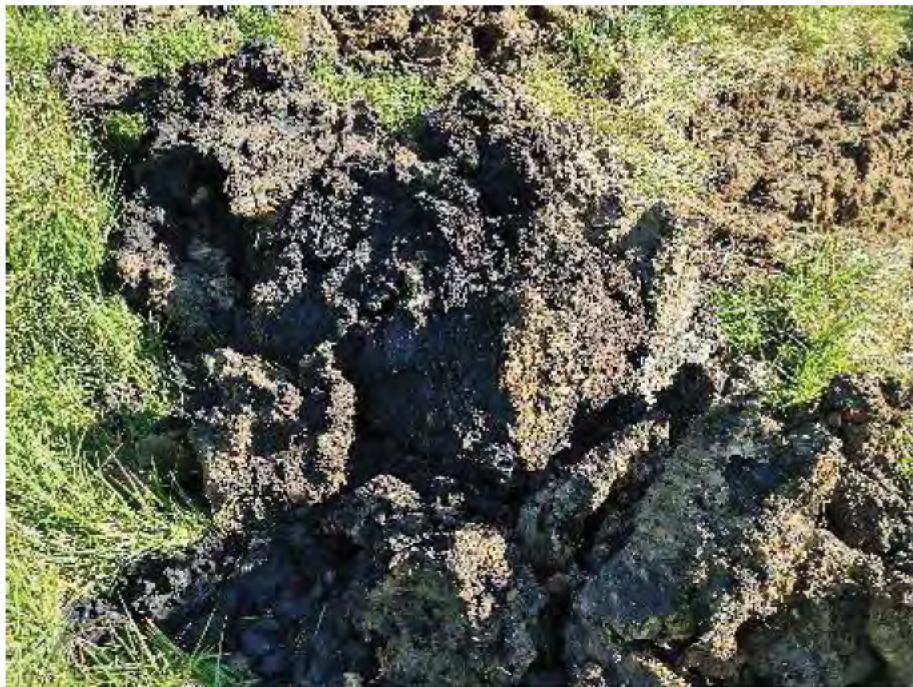
PLATE 4: excavated buried organic rich topsoil layer

Fill encountered in all test pits was predominantly silty clay material overlying an organic rich, peaty buried topsoil horizon inferred to be the historic ground / gully surface observed in historic aerial photographs. A strong organic odour was noted in the buried topsoil horizon where encountered alongside black staining and a sheen similar to hydrocarbon, in light of the analytical results documented below, and the context of the horizon encountered this is considered to be a result of anaerobic organic decaying matter, not hydrocarbon discharge.

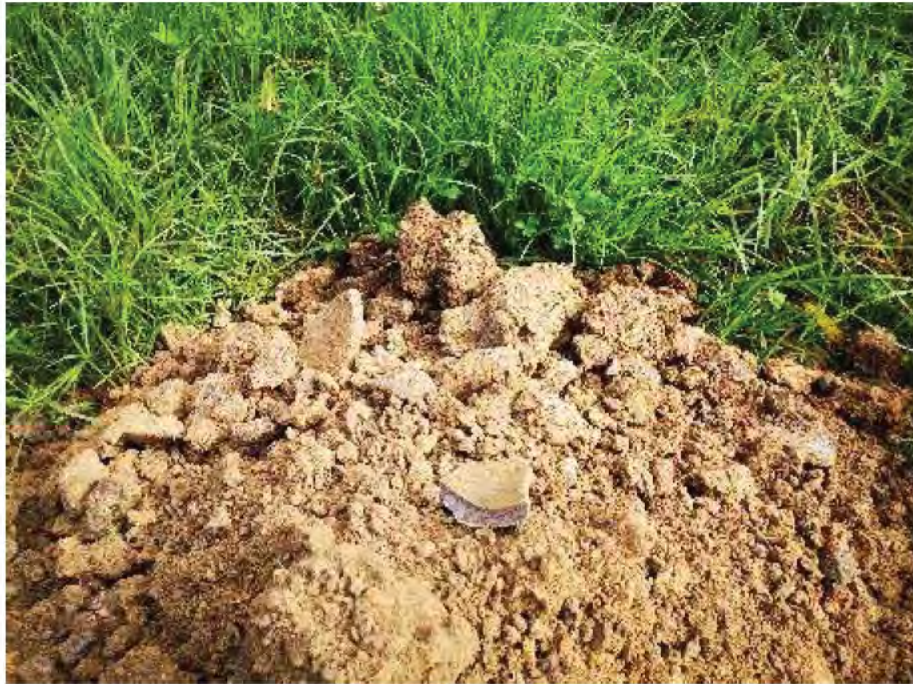
PLATE 9: ACM pipe fragment from TP11

Throughout the full extent of the fill foreign materials were identified including minor plastics / weed-mat / textiles, and building materials including timbers, brick and ceramic fragments, broken concrete, and minor fragments of fibre cement materials. Minor, isolated fragments of potentially ACM material was encountered in surficial horizons of the fill in test pits TP2 and TP4 while fragments of ACM pipe were identified in test pit TP11. Soil samples were collected from the highest risk horizons in test pits where building rubble was identified. While minor isolated fragments of ACM were identified in the fill, the risk of widespread ACM impacts are considered low given the test pit observations. The only area of concern for ACM contamination is surrounding test pit TP11 where broken fragments were more pervasive. Burnt material including timber, ash and organic material was noted at the base of the fill in test pits TP9, TP11 and TP12.
