Job No: 63907

Subject: 98 & 100-102 Totara Road, Whenuapai – Wetland Assessment

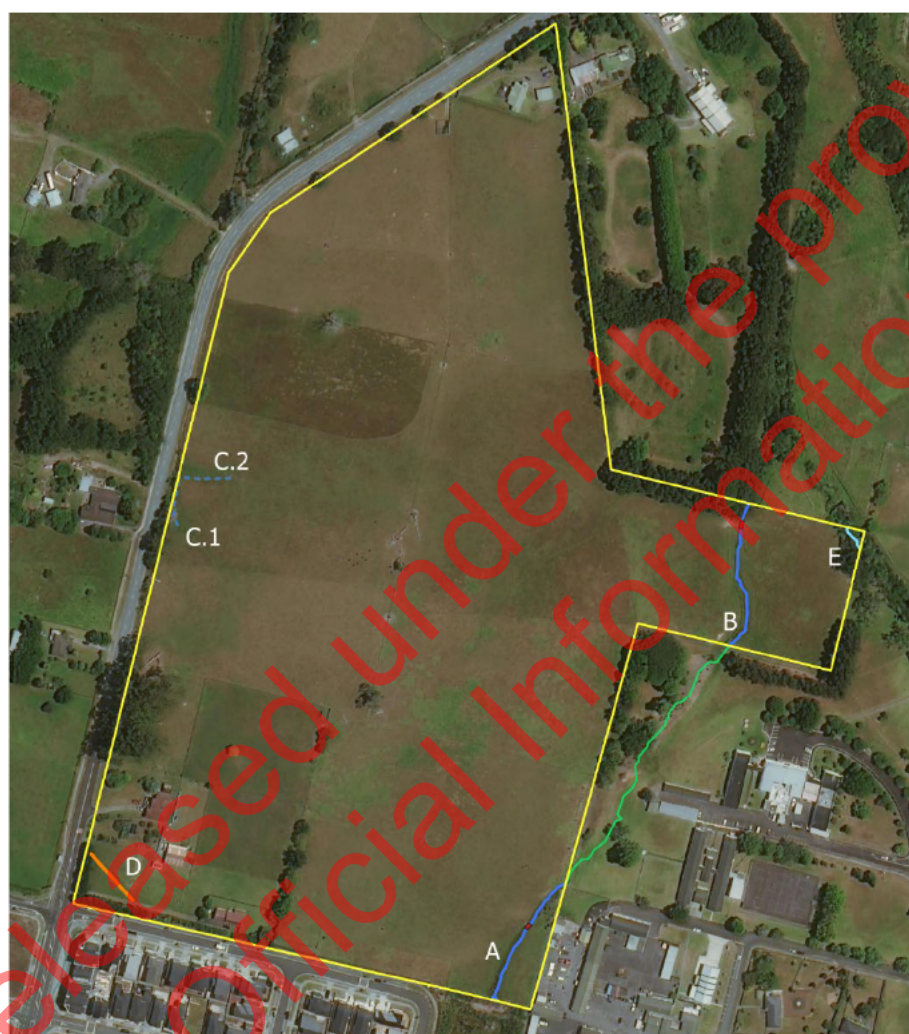
**Figure 1. Classified watercourses within the Site.**

Five features (A-E) were identified as potential aquatic habitat (Figure 1). The site was assessed via a desktop review and site visit. The desktop assessment noted factors such as changes in vegetation and surface water on current and historical aerial images, and a review of data such as the Current Biodiversity layers, predicted watercourses and contours on Auckland Council's Geomaps was undertaken.

- Property Boundary
- Farm Crossing (culvert)
- Permanent Watercourse
- Intermittent Stream
- Ephemeral overland flow path
- Artificial Watercourse

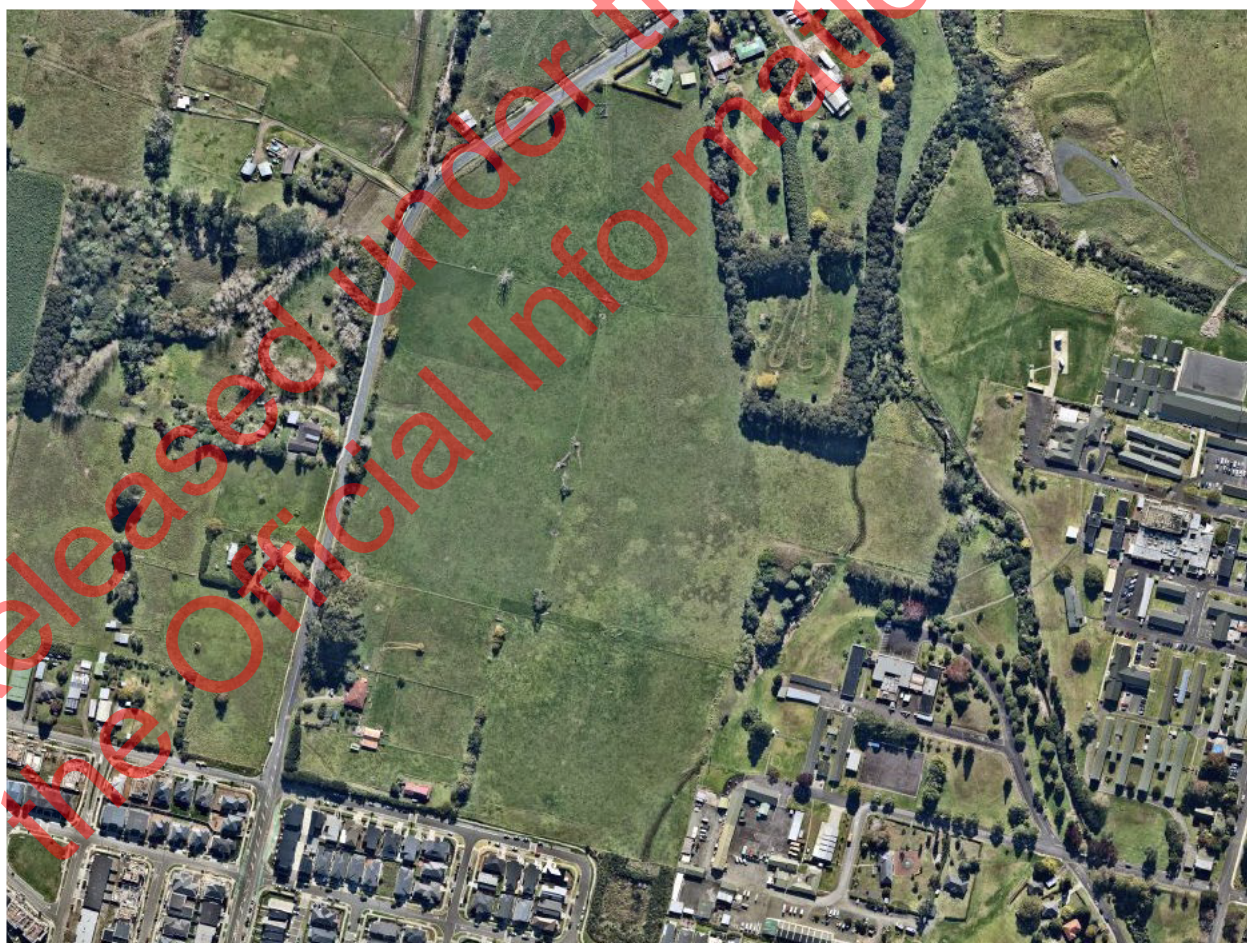
Figure 2. May, 2021 aerial showing the Site.

Features A and B were classified as intermittent streams<sup>1</sup>. The stream channel edges have been eroded due to stock access which have caused ill-defined channels in areas. Recent aerals (May 2021) show a clear stream channel with no surrounding wetland features (Figure 2). Hydrophytes were present but were largely confined to within the stream channel and were considered stream macrophytes. Macrophyte species included watercress (*Nasturtium officinale*) and water celery (*Apium nodiflorum*). Riparian vegetation was dominated by upland or facultative upland pasture species. Due to the almost complete dominance of pasture species within the riparian yard no wetland vegetation assessments were considered necessary. Features A and B were considered 'non-wetlands' (i.e. not a 'natural wetland' as defined by the NPS-FM) and should still be classified as an intermittent stream.

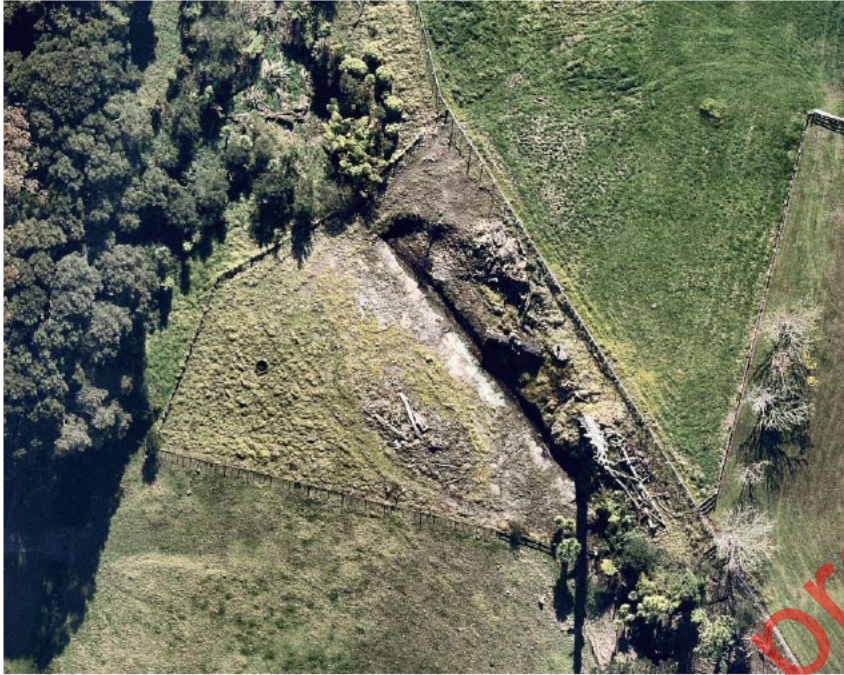
*Figure 3. Ratara Stream within the Site (Feature E), May 2020.*

Feature E is a reach of the Ratara Stream. The stream had clearly defined banks with a permanent flow of water. No macrophytes were present within the channel and no wetland features such as hydrophyte species or saturated soils were evident within the riparian margin of Feature E. The feature is clearly not a ‘natural wetland’ and as such, no wetland assessments were considered necessary. The feature should still be classified as a permanent stream.
