DETAILED SITE INVESTIGATION

71 TRIG ROAD, WHENUAPAI, AUCKLAND

Reference Number: REP-1525B/DSI/JUL21

PREPARED FOR: NEIL CONSTRUCTION LTD

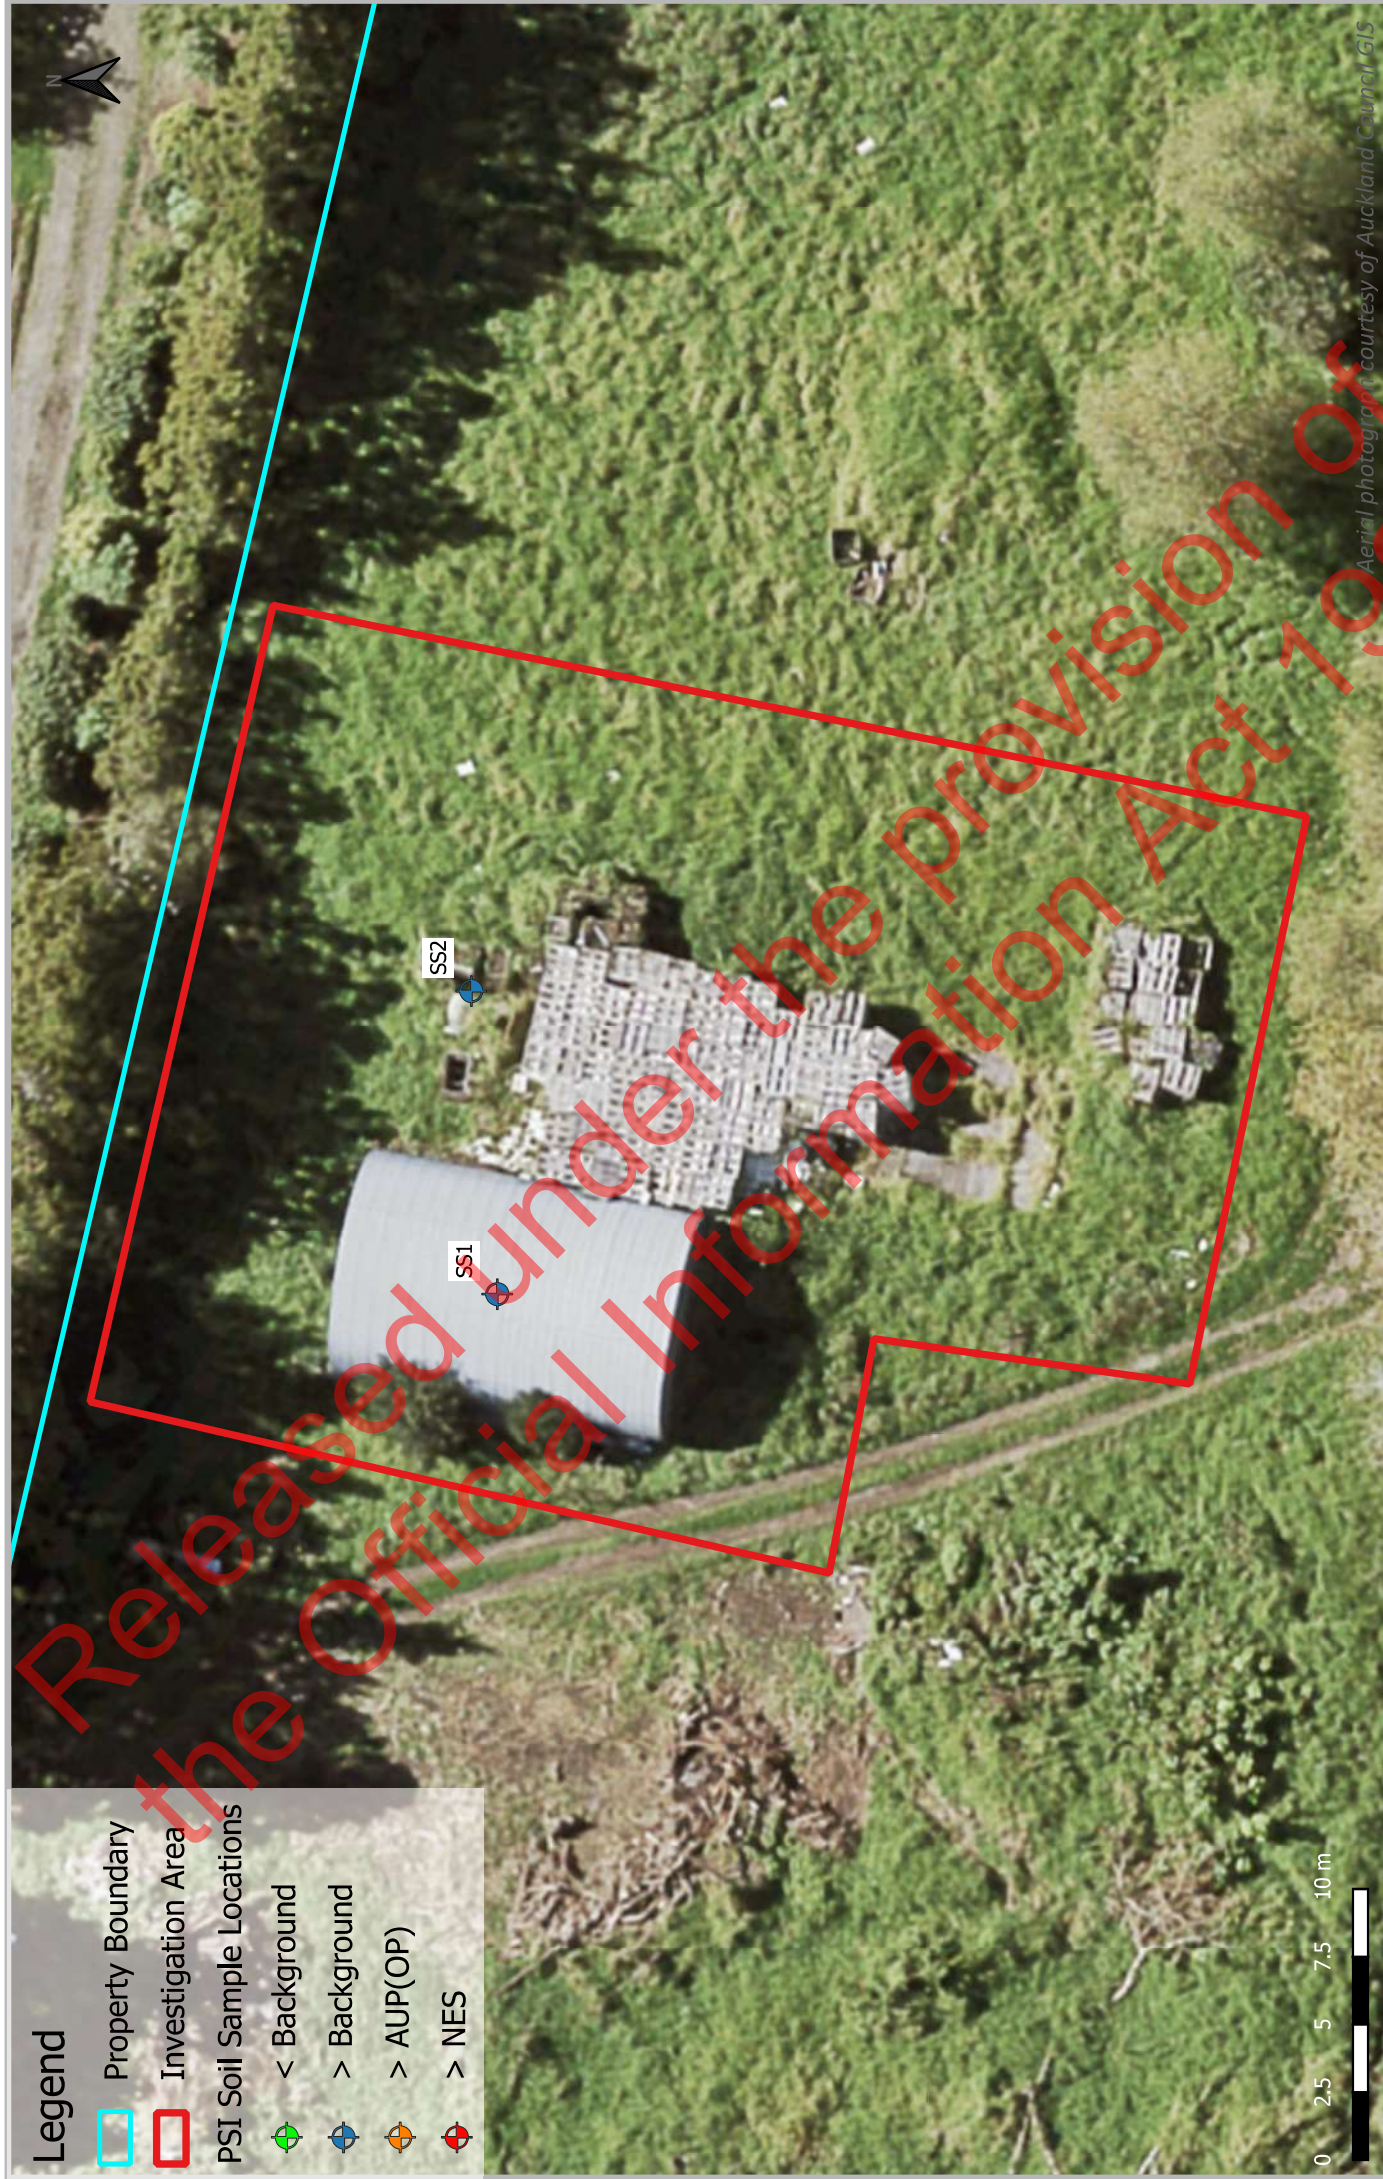
The soil sampling plan from the investigation is provided in Figure 2, while tabulated analytical results of this investigation are attached in Table 1 below.

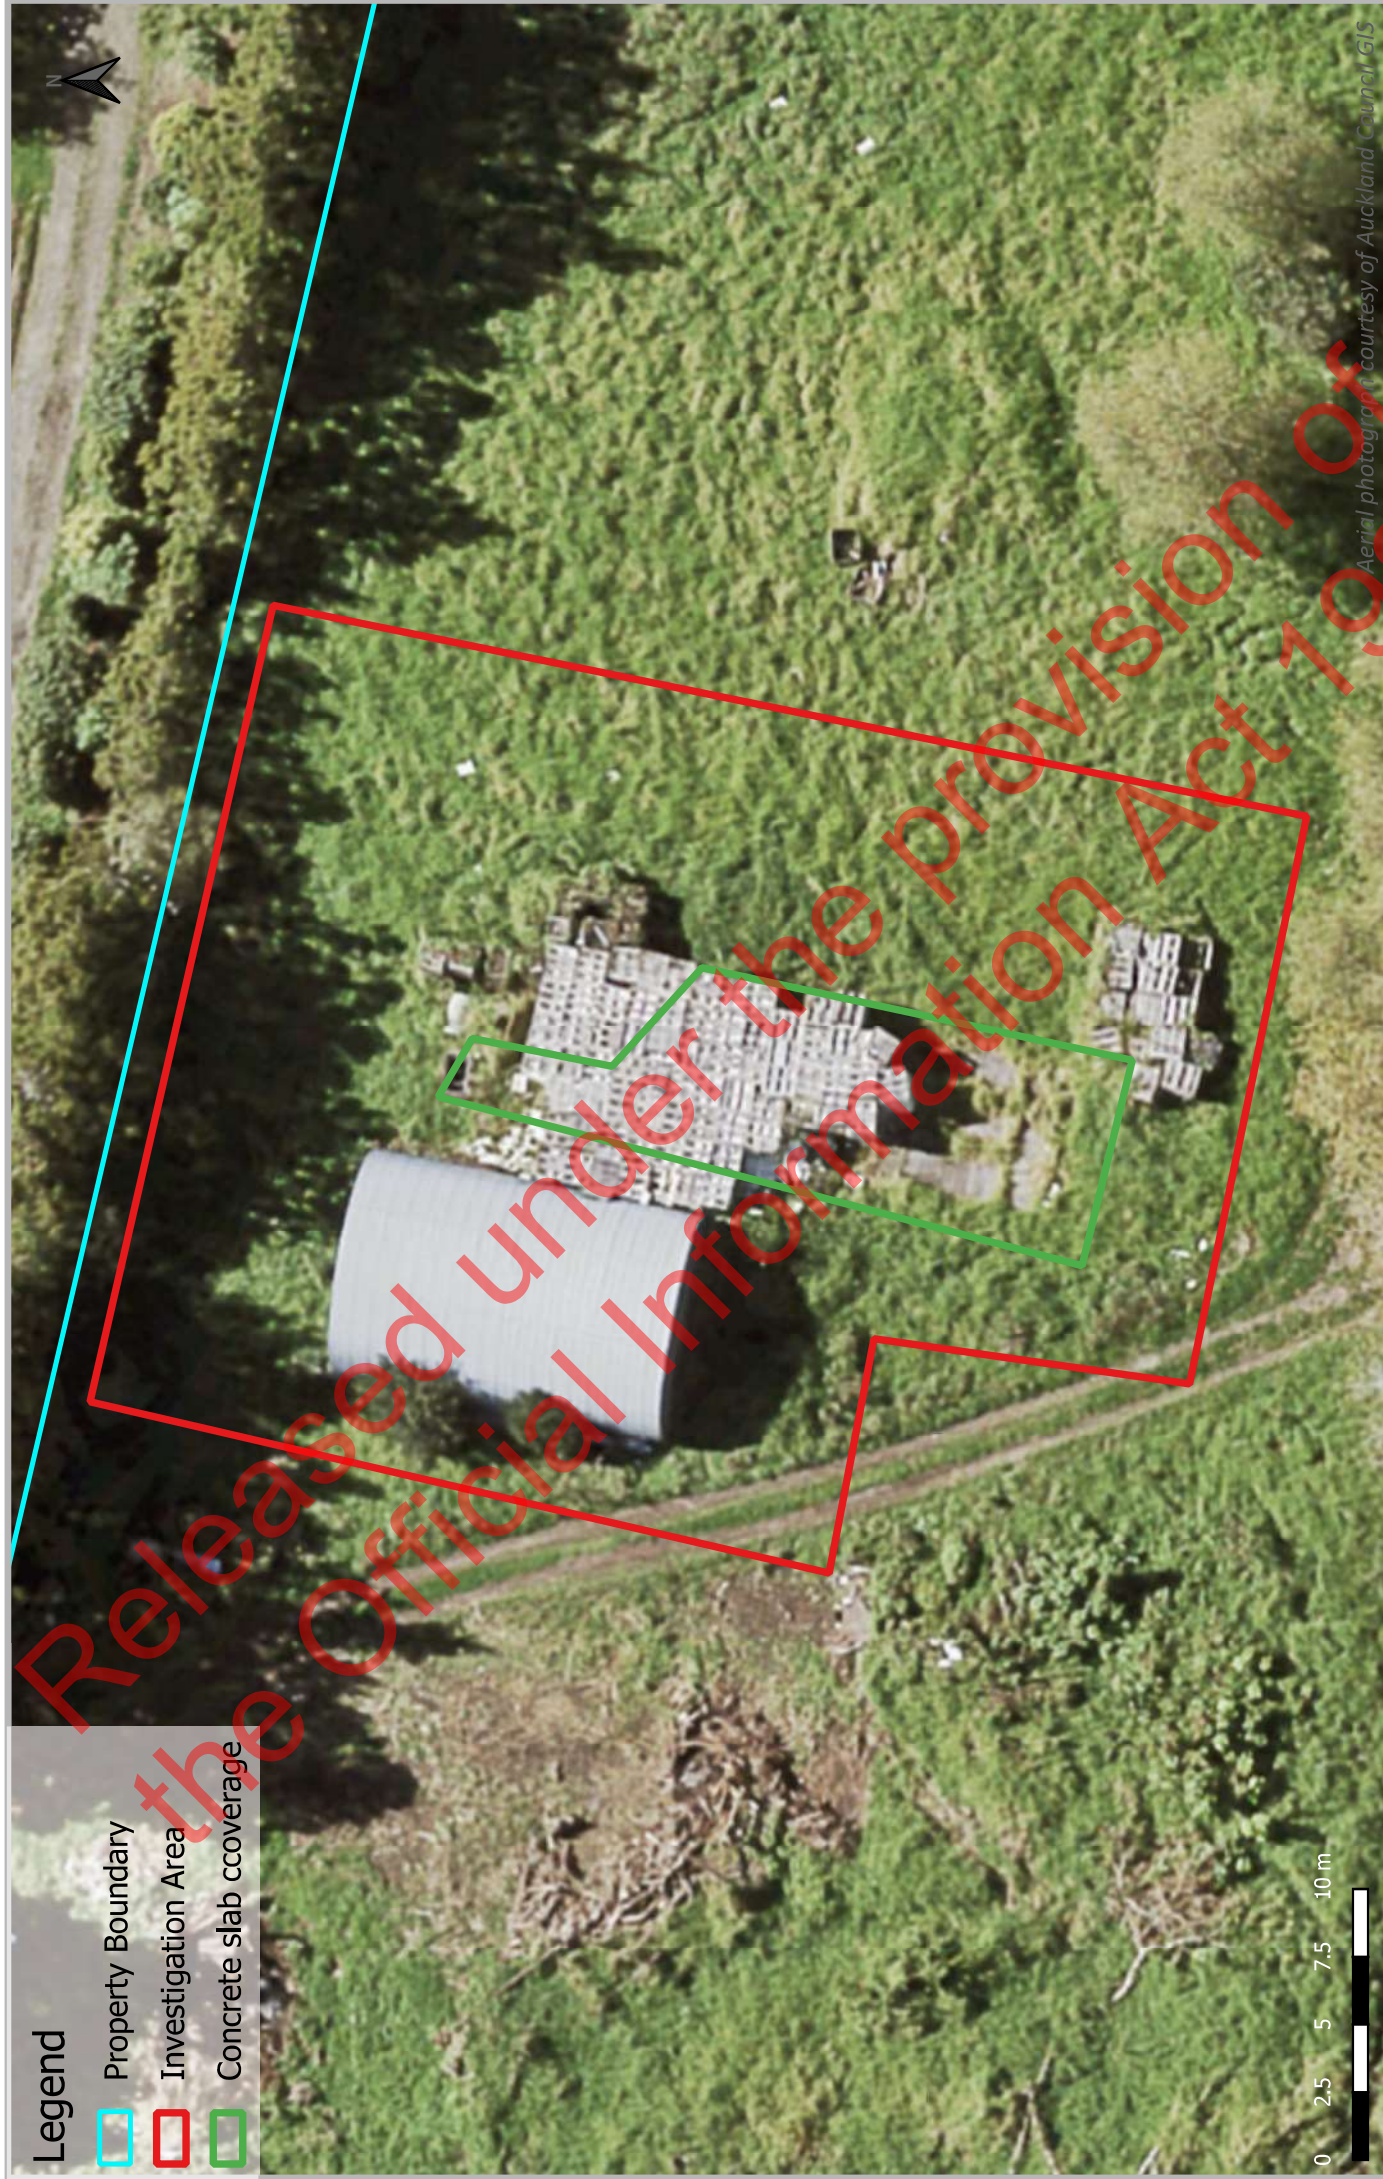
During the visual inspection it was clear that the bulk of the polystyrene packing materials and refuse to the east of the barn were stockpiled on a residual concrete slab, the extent of which is mapped on Figure 3. Additionally, the location of the two discarded above ground fuel storage tanks noted in the PSI site inspection appears to have been at the northern edge of the slab,

however, as indicated on Figure 3, the norther and northeast corner of the slab had been partially removed at some stage. It was unclear from inspection of the ground surface where the tanks may have originally been situated as there were no visual or olfactory indications, such as staining, or hydrocarbon aromas noted anywhere on the site during the inspection that would have identified their location.

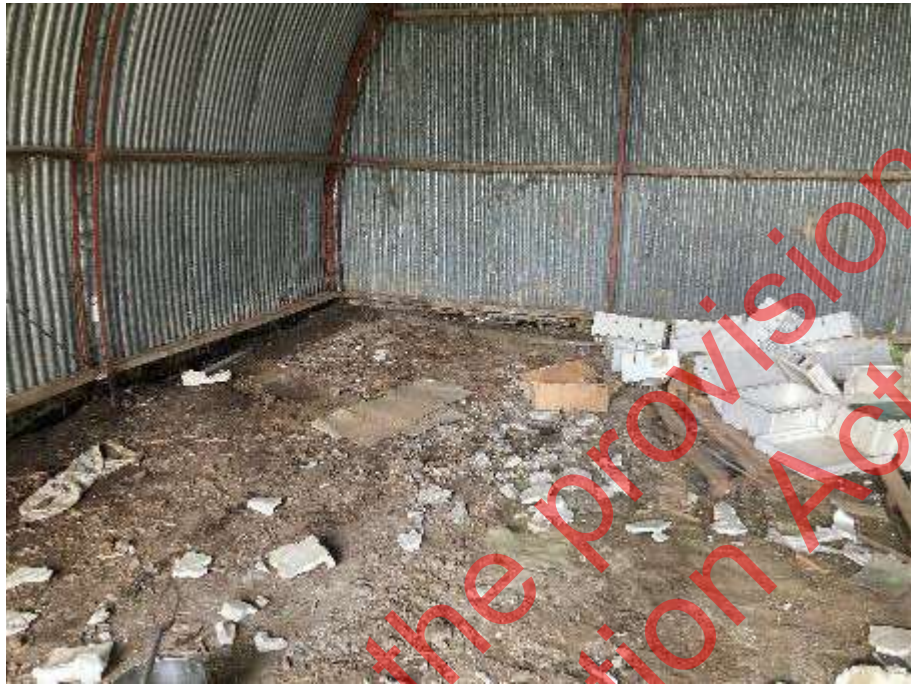
PLATE 1: INTERIOR OF BARN ON 6 JULY INSPECTION

At the time of the 6 July inspection GSL personnel met with representatives of Neil Construction Ltd and Hick Bros Civil to discuss the requirements of the SMP. At the time of the inspection the machinery and vehicles had been removed from the barn, two soil samples were collected from the earth floor within the shed. Minor surficial staining was noted in areas where vehicles and machinery had been stored, no hydrocarbon odours or indications of gross hydrocarbon contamination were noted within the barn.

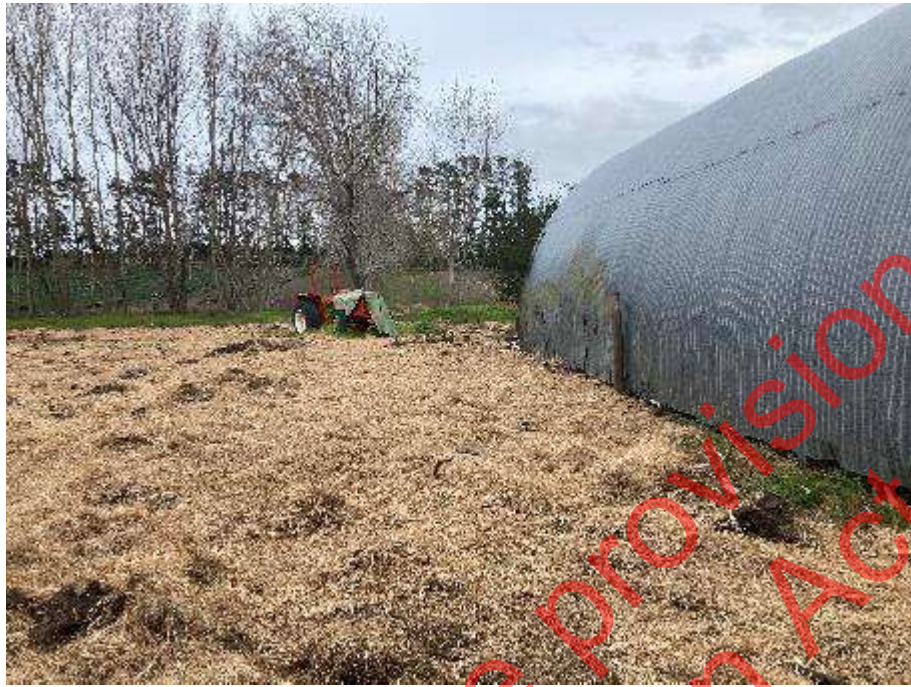
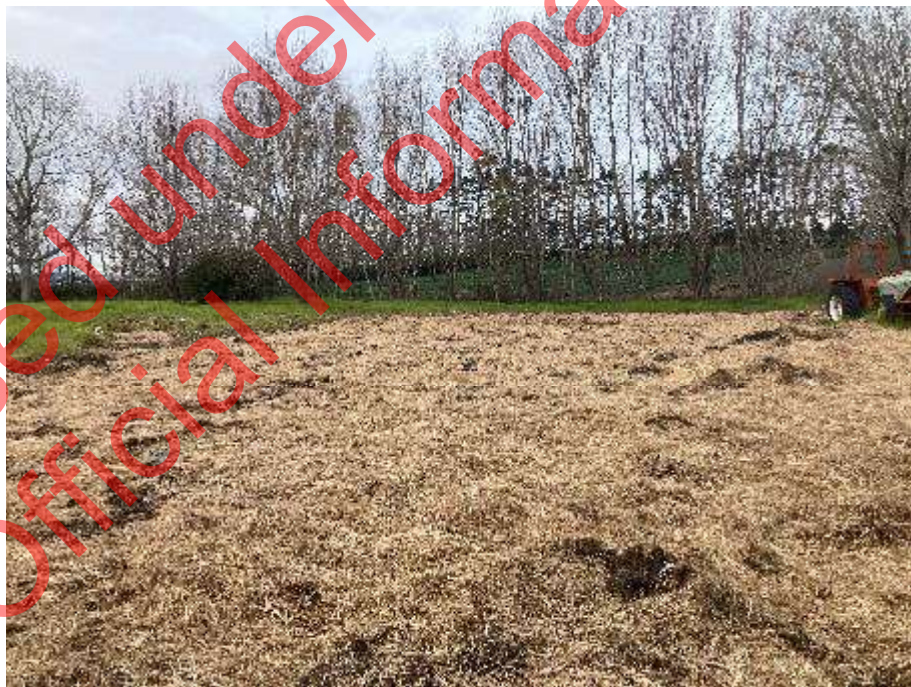
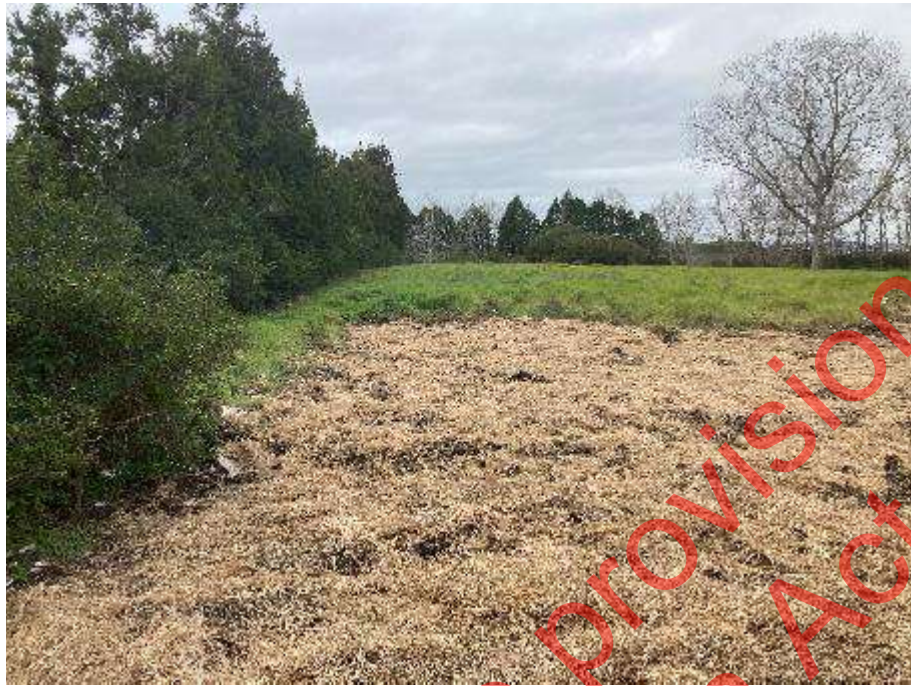
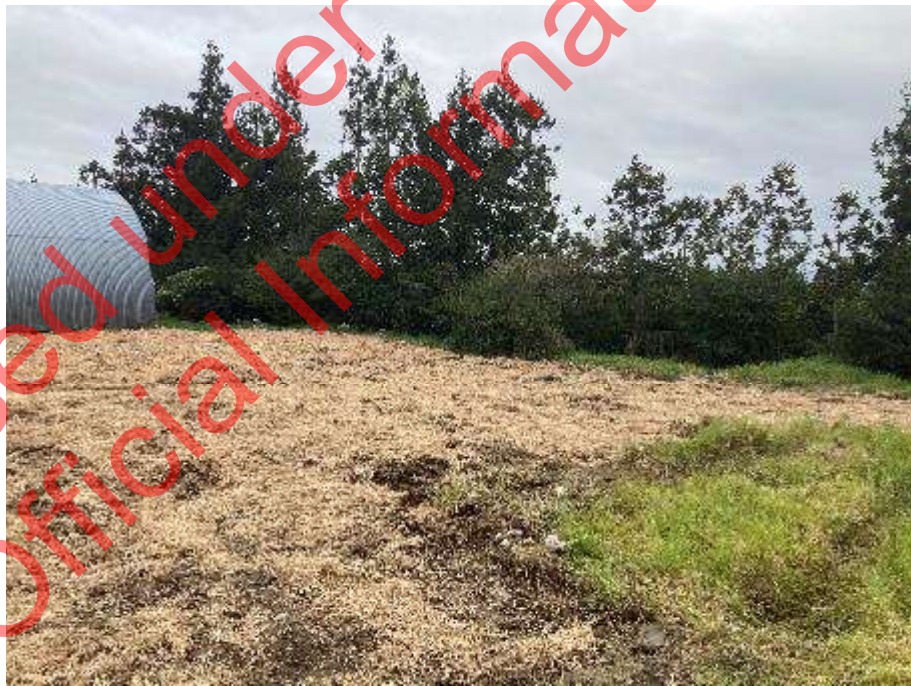
PLATE 3: AREA OF INVESTIGATION FOLLOWING CLEARANCE AND STRAW STABILISATION

PLATE 4: AREA OF INVESTIGATION FOLLOWING CLEARANCE AND STRAW STABILISATION

PLATE 5: AREA OF INVESTIGATION FOLLOWING CLEARANCE AND STRAW STABILISATION

PLATE 6: AREA OF INVESTIGATION FOLLOWING CLEARANCE AND STRAW STABILISATION
