**To:** The Neil Group

**Subject:** Brigham Creek Road: Ecology Assessment

The Neil Group are proposing a sub-division encompassing multiple properties at Brigham Creek Road, Whenuapai (the Site), with each property hereafter referred to as the 'Southern Site' and Northern Site' (Appendix I). This memorandum provides a high-level assessment of ecological effects for the aforementioned development.

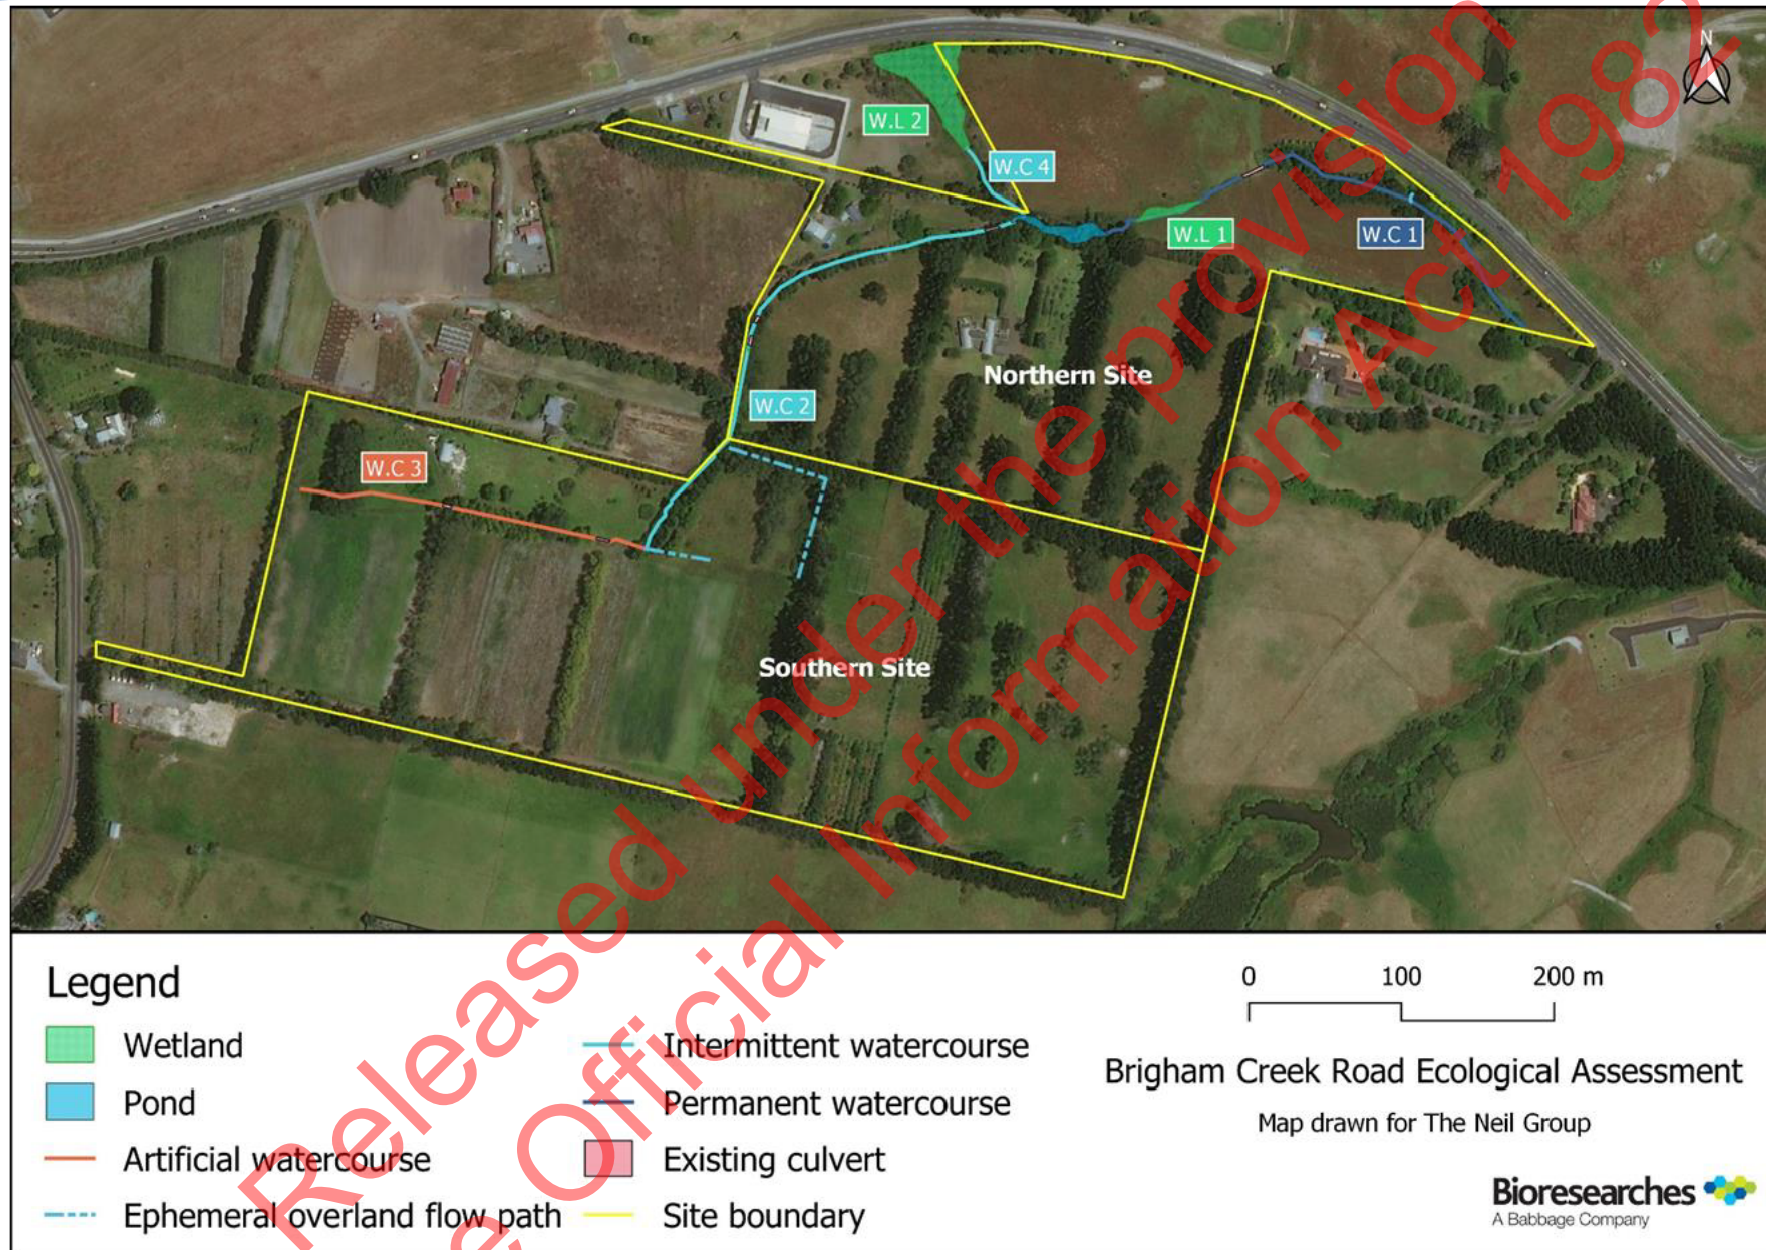
Appendix I: Identified Ecological Features

Wetlands were identified within the Site as per the definitions and criteria laid out in the National Policy Statement for Freshwater Management 2020 (NPS-FM). The aquatic habitat was then qualitatively assessed. The identified ecological features within the Site are presented in Appendix I and photos of these features are provided in Appendix III.

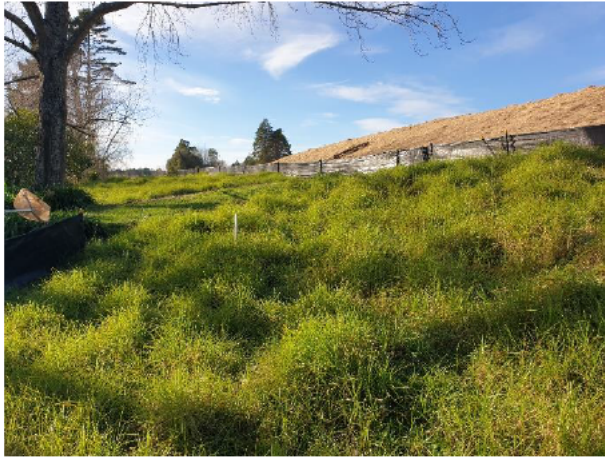
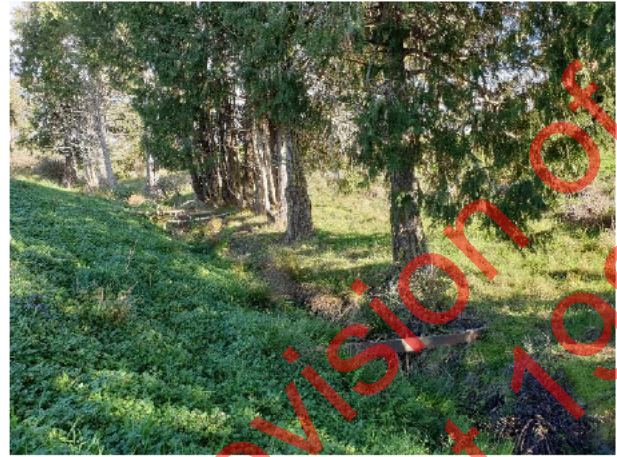
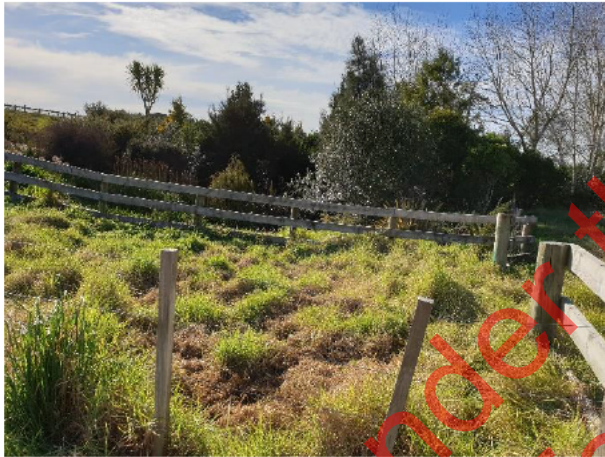
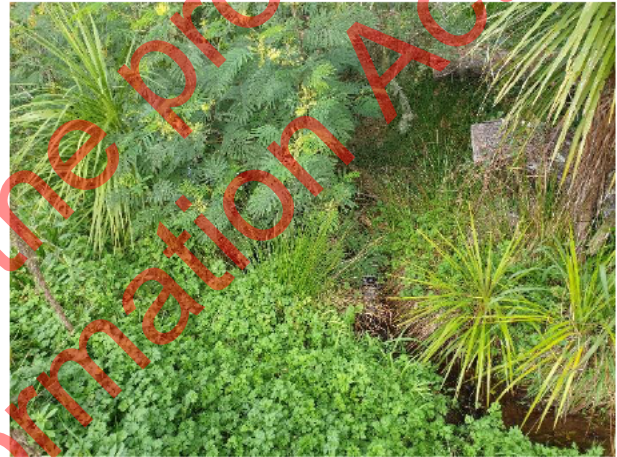
The botanic value of the native vegetation was **Low**, consisting of low-stature, common native trees (e.g. pōnga, harakeke, tarata and tōtara) sparsely established in the riparian margins with a damaged understorey. The vegetation provides low-quality fauna habitat as the vegetation is of low stature, lacked ecological complexity and is subject to high edge-effects and limited terrestrial connectivity.

*Exotic vegetation and few native trees present within the Northern Site*

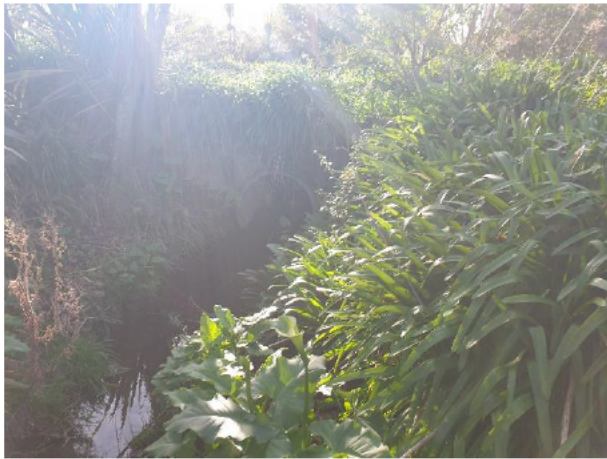
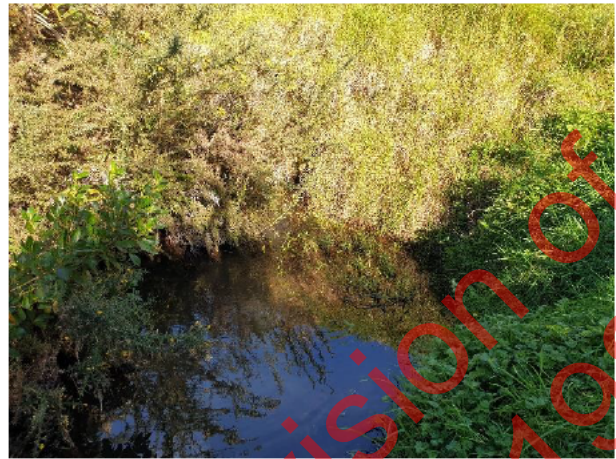
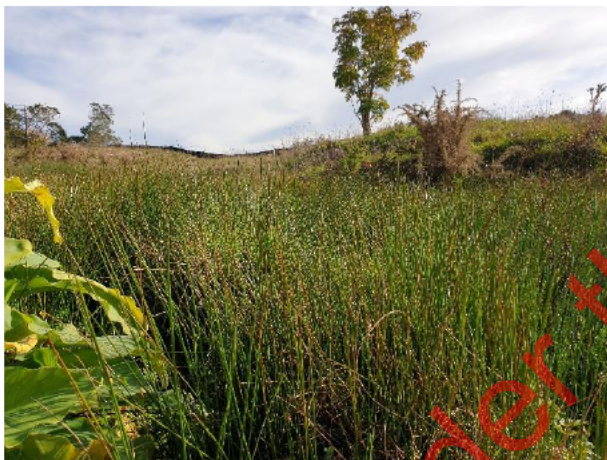
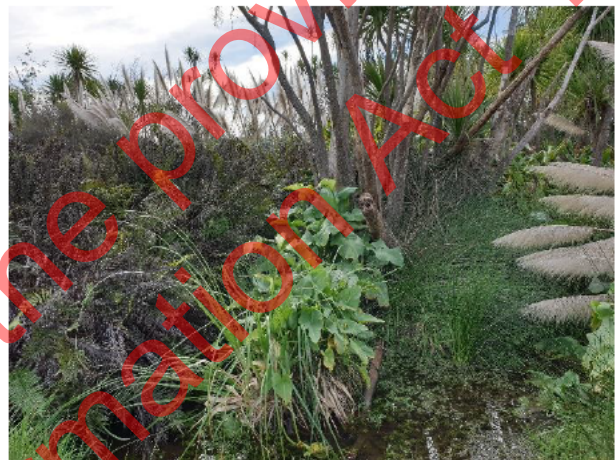
The two wetlands were located within the Northern Site and contained wetland hydric vegetation and typical wetland hydrology at time of site assessment. A large natural wetland (Wetland 2) was within the headwaters of the Watercourse 4 with a portion falling within the site boundary. Wetland 1 was located within a section of the floodplain of Watercourse 1. Each wetland contained hydric vegetation (Table 1) and hydrology (e.g. standing water, high water table and soil saturation). The surrounding areas of the wetland was dominated by pasture grass.

Of the nine species identified throughout the two wetlands; three species had a wetland indicator status of 'Facultative wetland', and six species classified as 'Facultative'. Mānuka and kiokio were the only two native species were observed, with the remaining vegetation was exotic, including two pest plant species. Due to the presence of 'facultative wetland' species and the dominance test and prevalence index being met for each (2.37 and 2.75, respectively), the areas were classified as natural wetlands under the NPS-FM. The wetlands were assessed to be of **Low** ecological value due to their dominance of exotic plants and pest plants, and provision of low-quality habitat for indigenous freshwater and terrestrial fauna. No other natural wetlands were identified within the Site.

*Aquatic features within the Northern Site including an intermittent stream, permanent stream and two wetlands*

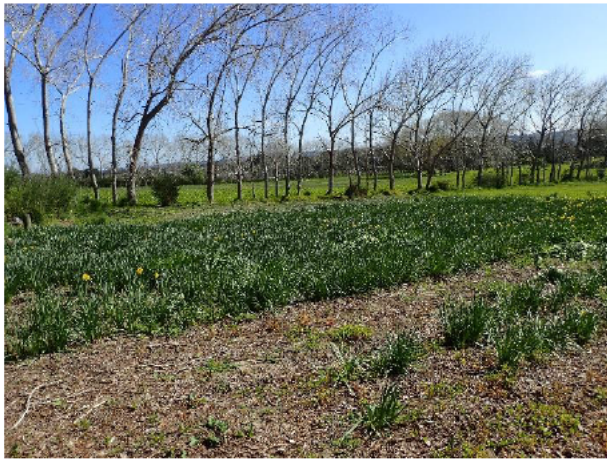
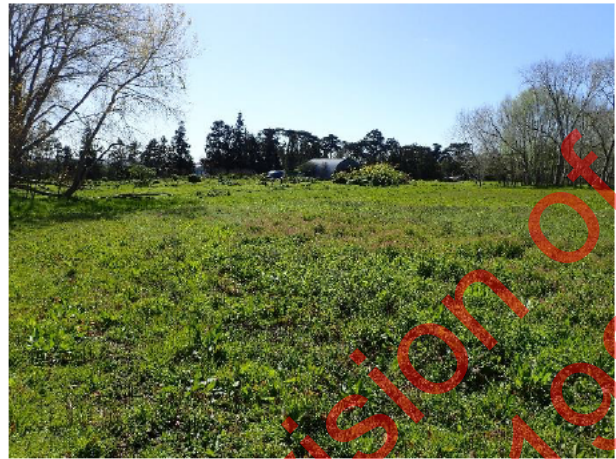
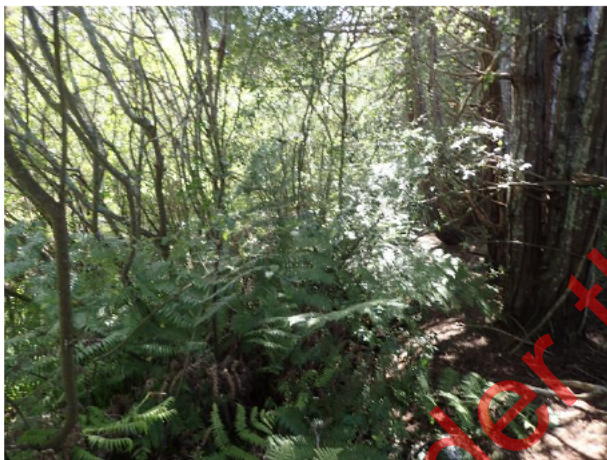
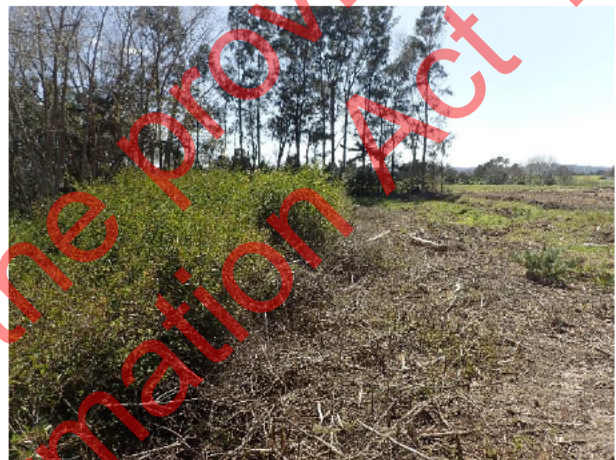
The site predominantly consists of earth-worked land and fallow pasture/crops and pest plants with associated exotic shelter belts and overgrown amenity planting. Within the Southern Site, the land had been utilised as a daffodil farm with rows of poplars tree established throughout the property in addition to established shelter belts. Native vegetation throughout the entirety of the site was sparse, with natives predominantly established within the riparian margins.

*Exotic vegetation and sparse native vegetation within the Southern Site*

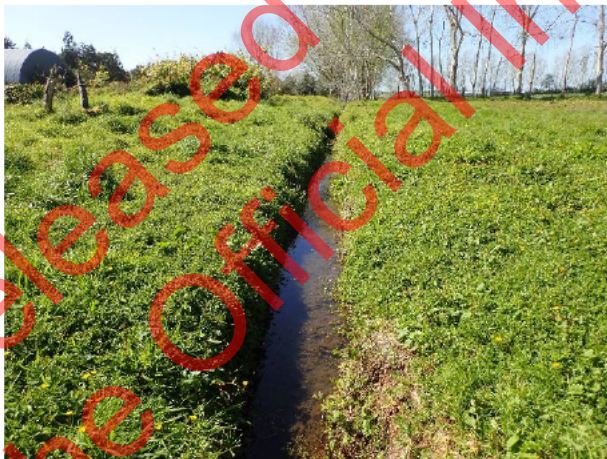
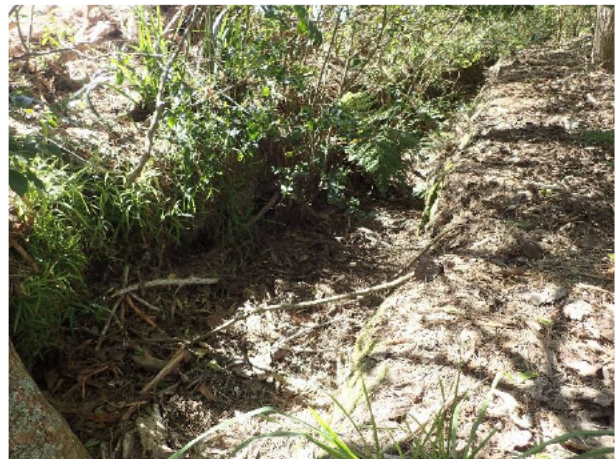
Within the site, watercourses flowed in a general south to east direction. The southern reach originates as an artificial drainage channel (Watercourse 3) and was considered to be an artificial channel as no natural headwaters were observed currently or historically, and no natural portions were observed for the entire reach. The watercourse appears to be constructed as it is unnaturally, straight and deep with no meanders, and is not observable in historic aerial images (Appendix IV). Watercourse 3 drains into a natural but modified intermittent stream (Watercourse 2). The watercourse entered a large pond downstream and transitions to a permanent watercourse further downstream within the property (Watercourse 1). A second intermittent stream (Watercourse 4) was present just beyond the northern property boundary and flowed into the pond, before joining Watercourse 1. Watercourse 1 flowed through the site in an eastern direction before exiting the site through a culvert.

All other overland flow paths were classified as ephemeral reaches, due to their lack of surface water, evidence of substrate sorting processes, and pools and debris within the floodplain, however the reaches often contained well-defined channels due to artificial modifications. The eastern portion of the Southern Site has been entirely earth-worked and remains an active site under an existing consent (Appendix II). No aquatic features (watercourses or wetlands) are present within the eastern portion of the Southern Site.

*Aquatic habitats within the Southern Site showing artificial channel (left) intermittent and ephemeral overland flow path which has been deepened (right).*

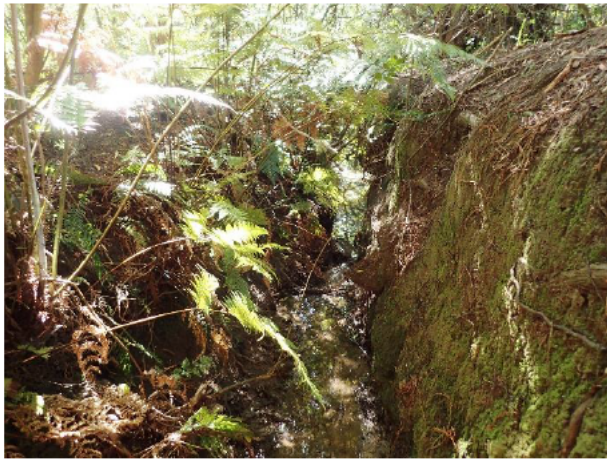
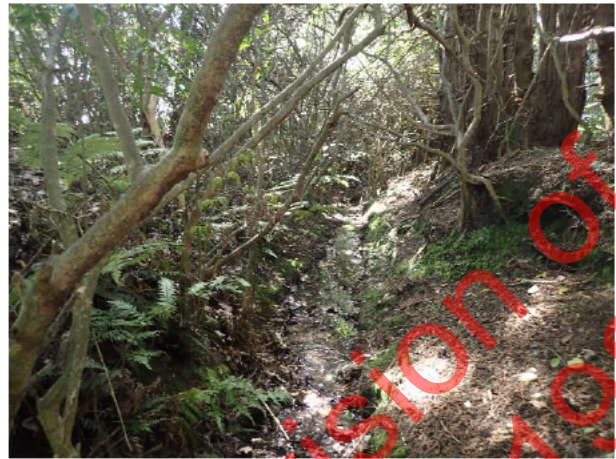
All streams contained similar characteristics with slight variation in riparian vegetation and have been highly degraded through land-use practices. The dominant substrate throughout each reach consisted of fine silt with the upstream reach of Watercourse 2 containing compact clay banks and bed. The upstream reach of Watercourse 2 and the downstream reach of Watercourse 1 were considered to have moderate shading functions provided by riparian vegetation, however within the remaining reaches, riparian vegetation largely consisted of rank long grass providing low shading functions, with macrophytes observed growing within the reaches with low shade.

*Intermittent stream within the Southern Site*

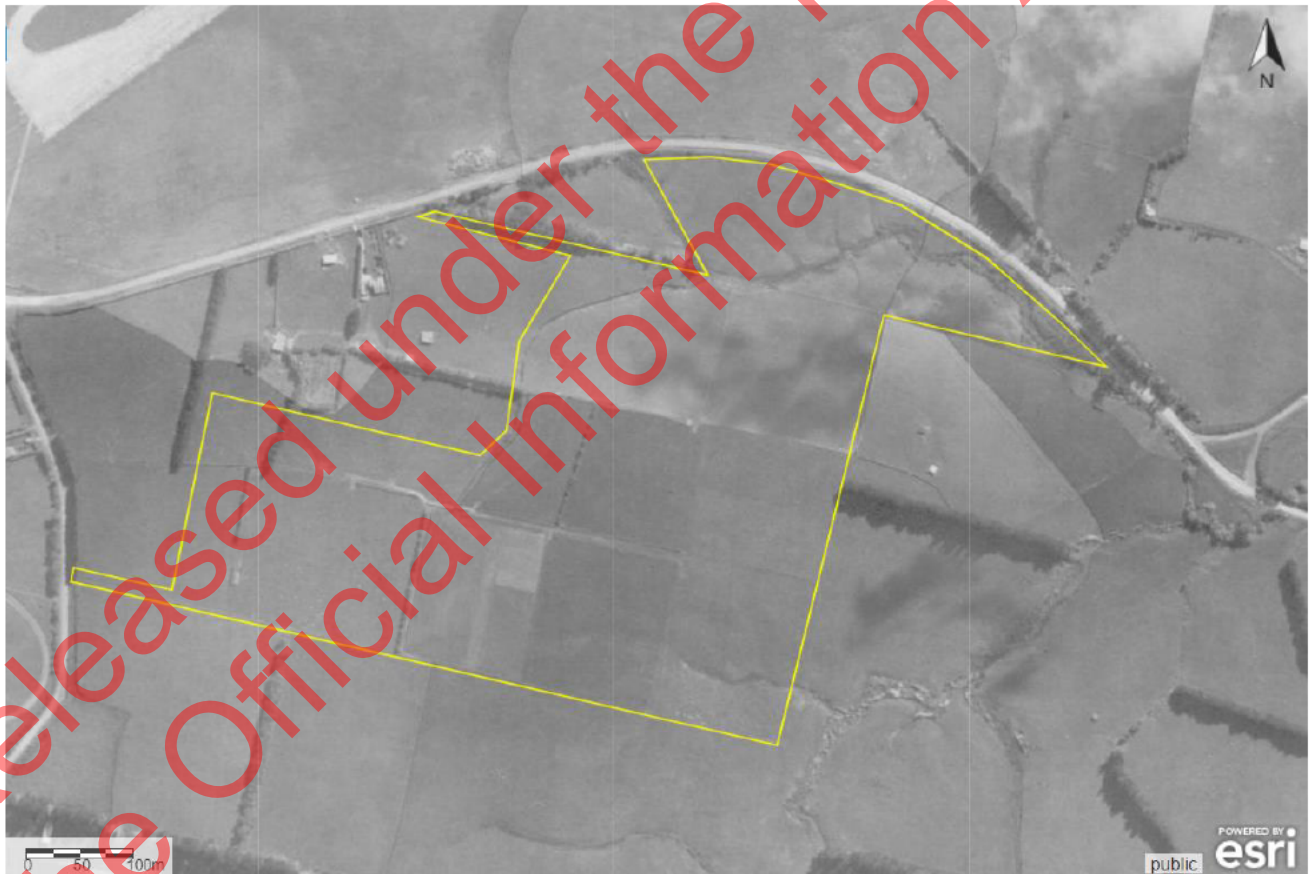
Appendix IV: 1959 Aerial Image

The Site is within the Tāmaki Ecological District of the Auckland Region and is approximately 33 hectares in size. Historically (pre-human), the area would have comprised the forest ecosystem type 'Pūriri forest' (WF7) and would have supported a diverse range of invertebrates, amphibians, reptiles, birds and bats (Singers *et al.*, 2017). WF7 ecosystems have a regional International Union for Conservation of Nature (IUCN) threat status of "Critically Endangered". Earliest historical aerials available indicate that the Site and much of the surrounding landscape has been devoid of native vegetation and managed as agricultural land for at least 60 years (Appendix IV).
