Geotechnical Report

AOKAUTERE SUBDIVISION – PACIFIC DRIVE - PROPOSED RETIREMENT
VILLAGE - PALMERSTON NORTH

09/07/2021

Retirement Village Geotechnical Report, Pacific Drive, Palmerston North

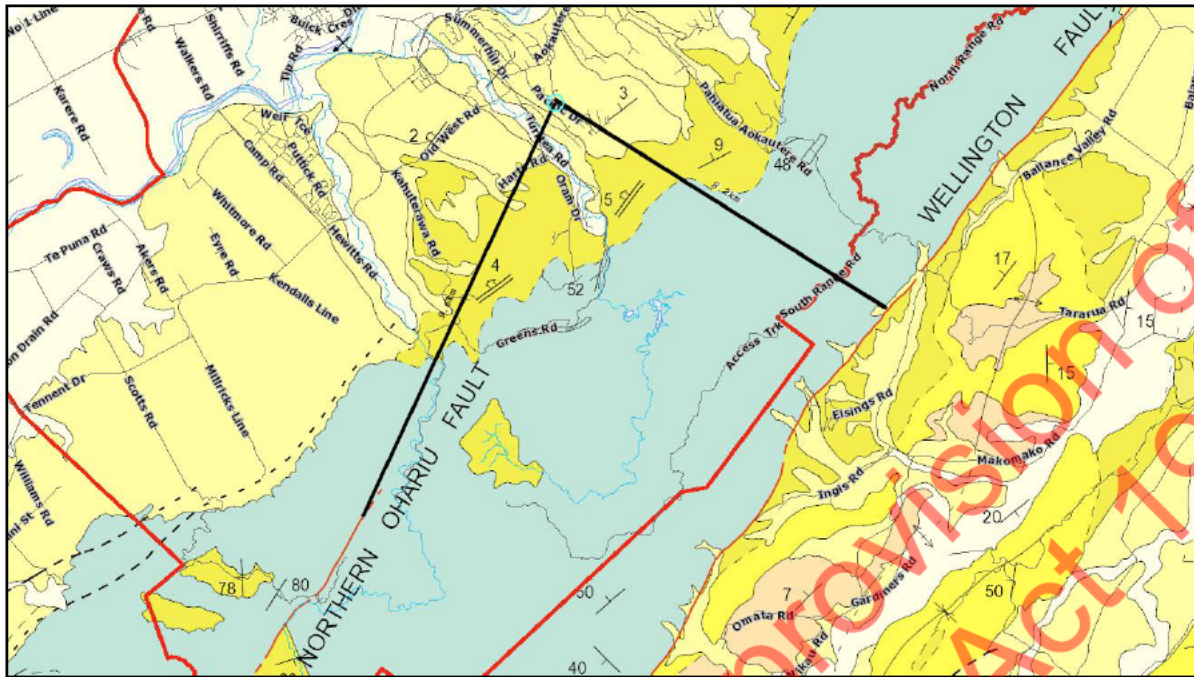
FIGURE 4: SITE LOCATION APPROXIMATELY AT BLUE CIRCLE RELATIVE TO ACTIVE FAULTS SHOWN AS PINK LINES, (GNS DATABASE)

The fault proximity data was obtained from the GNS database. The database shows that there are two active faults in proximity, these active faults are:

- Wellington Fault (8.2km), and
- Northern Ohariu Fault (9.6km)

Figure 4 overleaf is a plan from the PNCC GIS database illustrating the sites' location relative to the active faults.

- **The Wellington Fault** has an estimated 840-year recurrence interval and an estimated 5m maximum single event displacement under a magnitude 7.0 event.
- **Northern Ohariu Fault** has an estimated 2550-year recurrence interval and an estimated 3.8m maximum single event displacement under a magnitude 7.4 event.

It is also of note that the trend line of the northern Ohariu fault is heading towards the site. The justification for the termination is unknown.

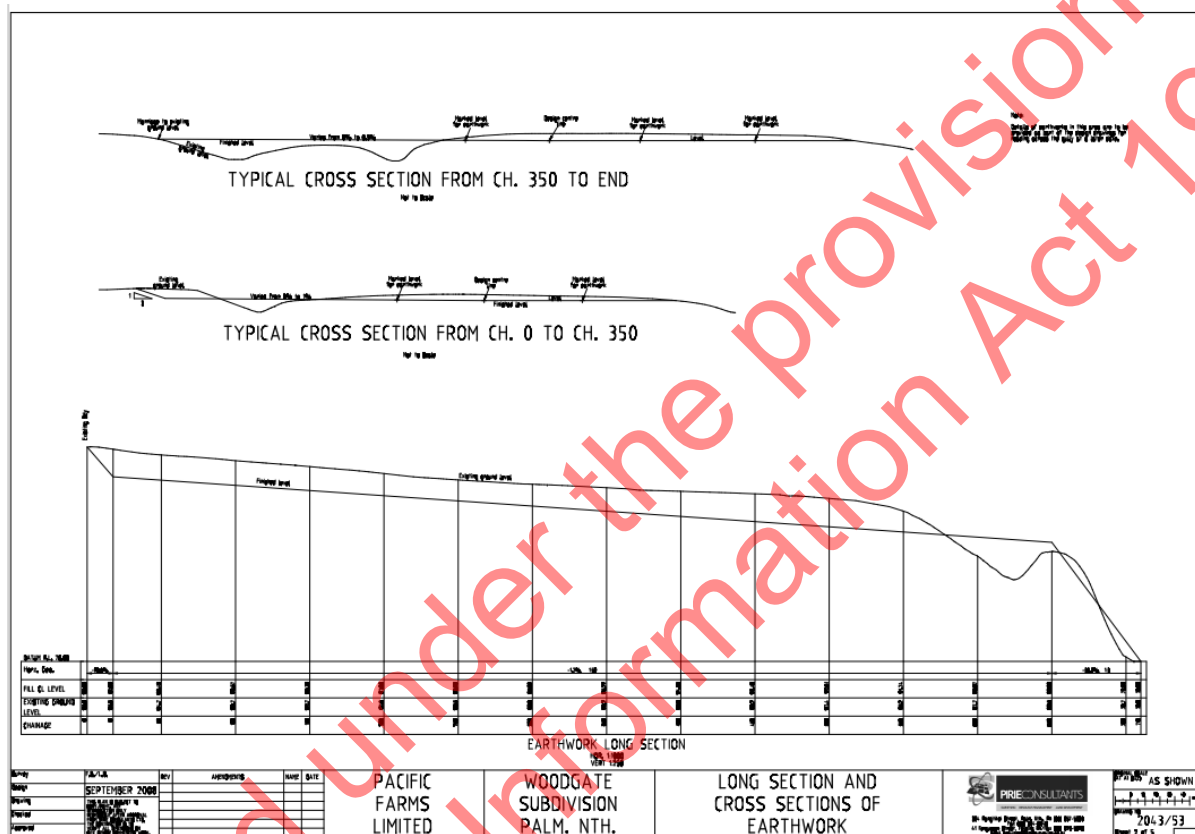
FIGURE 5. LOCATION OF 3X SECTIONS FROM 6G1

There has been substantial filling applied to the main gully which passes through the proposed site. This is identified in the earthworks control plan as per Figure 5 below.

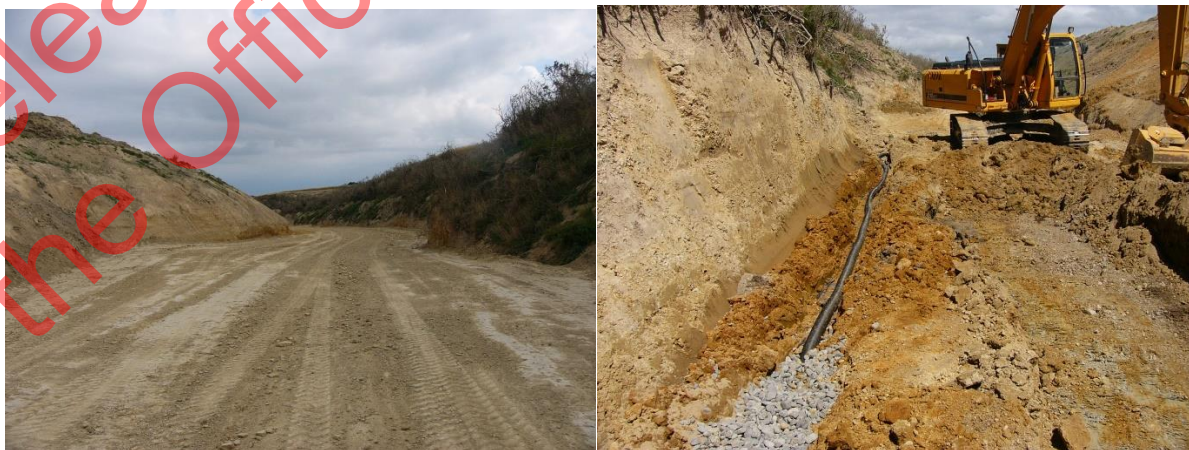
FIGURE 6. SITE EARTHWORKS.

The earthworks were undertaken using appropriate heavy plant and monitoring to determine good consolidation. Subsoil drains were also included prior to the gully filling, Figure 6.

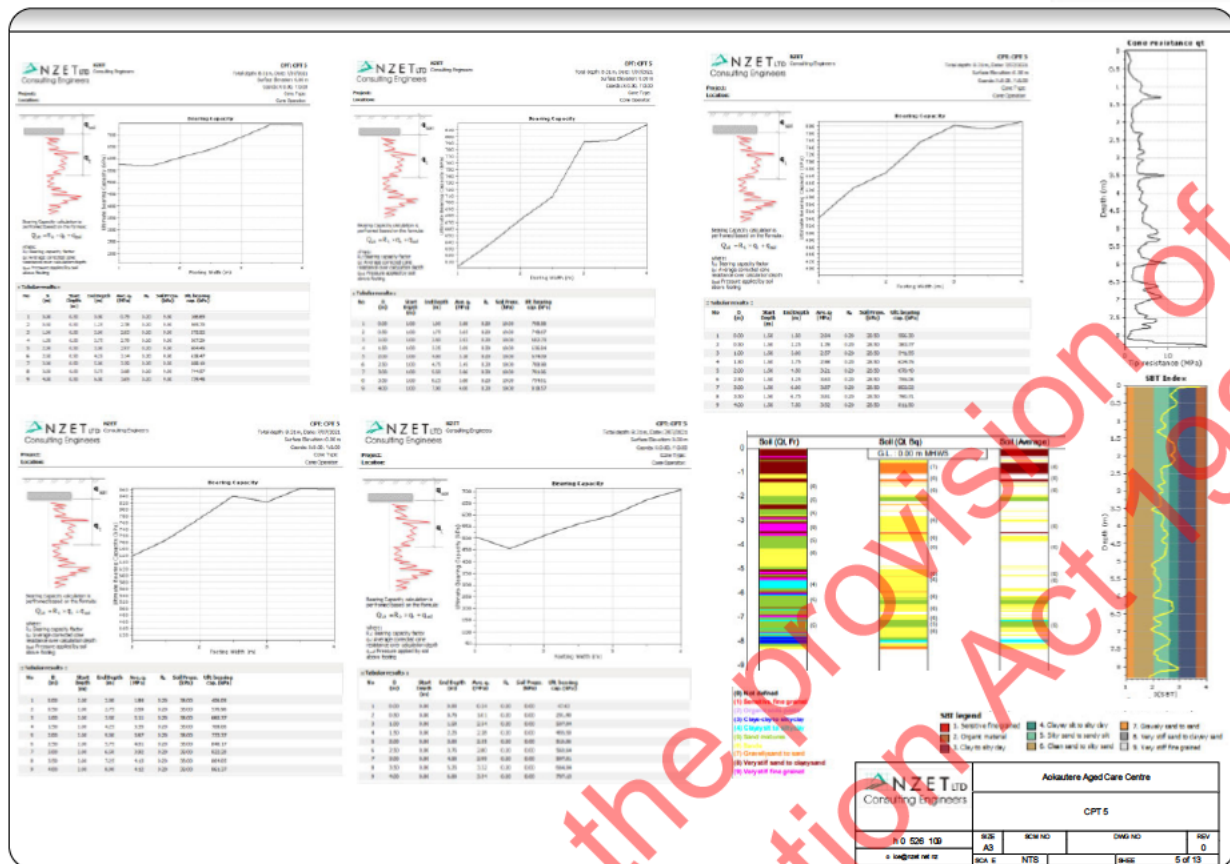
FIGURE 8. EXAMPLE OF CPT RESULTS AND INTERPRETATION.

The CPT results are attached as Annex A to this report. An example of the 13 test holes, hole 5 in the location of the main building is shown in Figure 8 below. Each plot shows the tip resistance as a chart in the top right, in interpretation as to soil type using NZET's Cpet-It software below (titled SBT index), interpretation of the soil type based on Geocivil's software, (3 coloured charts and coloured legend centre right, and associated ultimate capacity foundation strengths using NZET's Cpet-IT software (multiple charts).
