# Geotechnical Report for Subdivision

1 Hansen Road  
Queenstown

**November 2016**

**GeoSolve Ref: 160488**

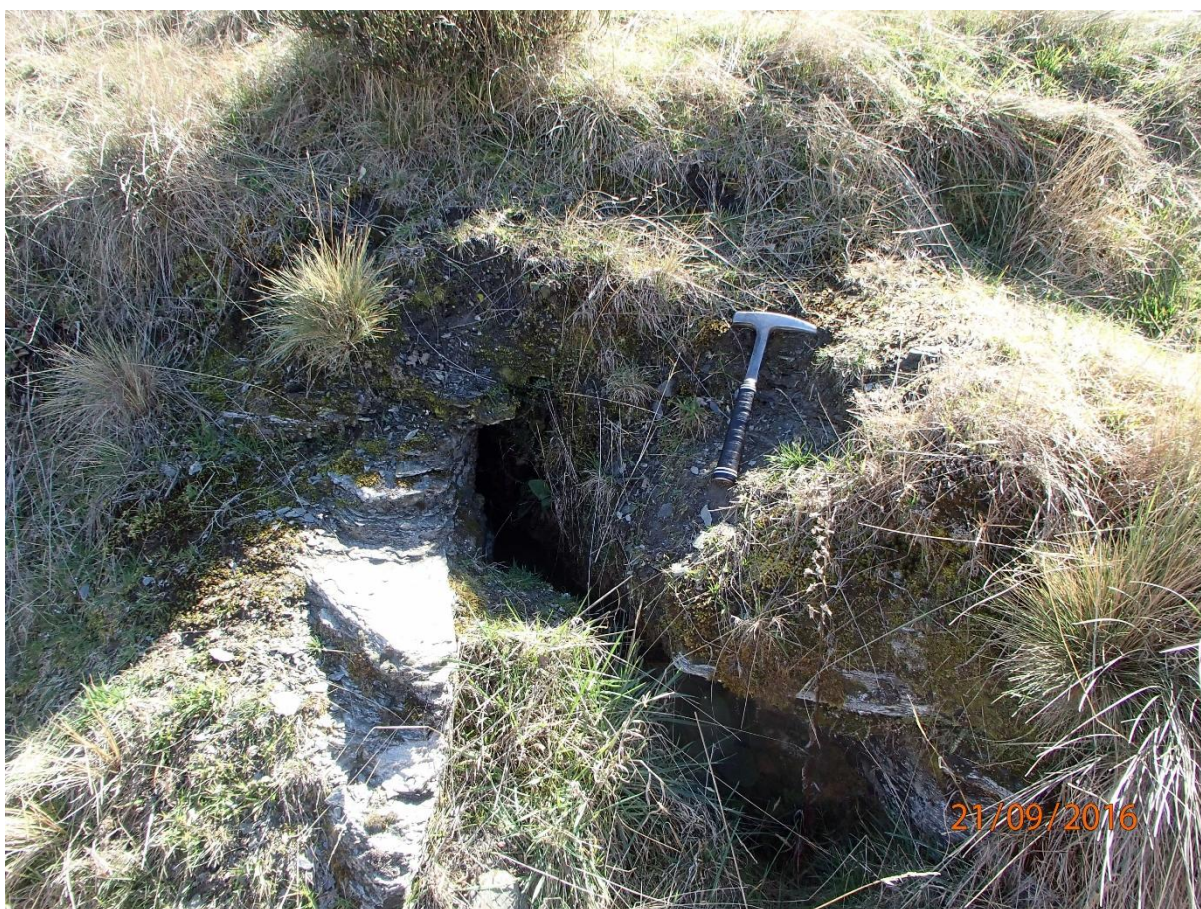
Photo 1: Open fissure in the landslide debris upslope of the proposed development.

The landslide surface north of the water race is densely vegetated with bush and well established pine trees with topsoil exposures. Historic landslide scarps were observed across the slope, north of the proposed subdivision area. The mapped landslide scarps are subdued with no sign of active slumping or erosion. A small open fissure, which looks relatively recent, was observed at the base of the scarp at the western edge of the mapped area (see Photo 1 and Figure 2, Appendix A). Along the water race a small scarp feature was observed on the upslope side, to the east of the water race tunnel. This scarp is localised and is the result of undercutting of the landslide debris by the water race. Schist exposures were observed across the slope with a chaotic concentration of schist boulders located above the water race tunnel.

The site mapping indicated minor active scarps, however no active erosion or recent activity on a large scale was observed. It is expected that slow surficial creep will occur across the slope to the north of the development area. Under extreme rainfall events some accelerate creep may be observed, however no rapid deep-seated movement is expected.

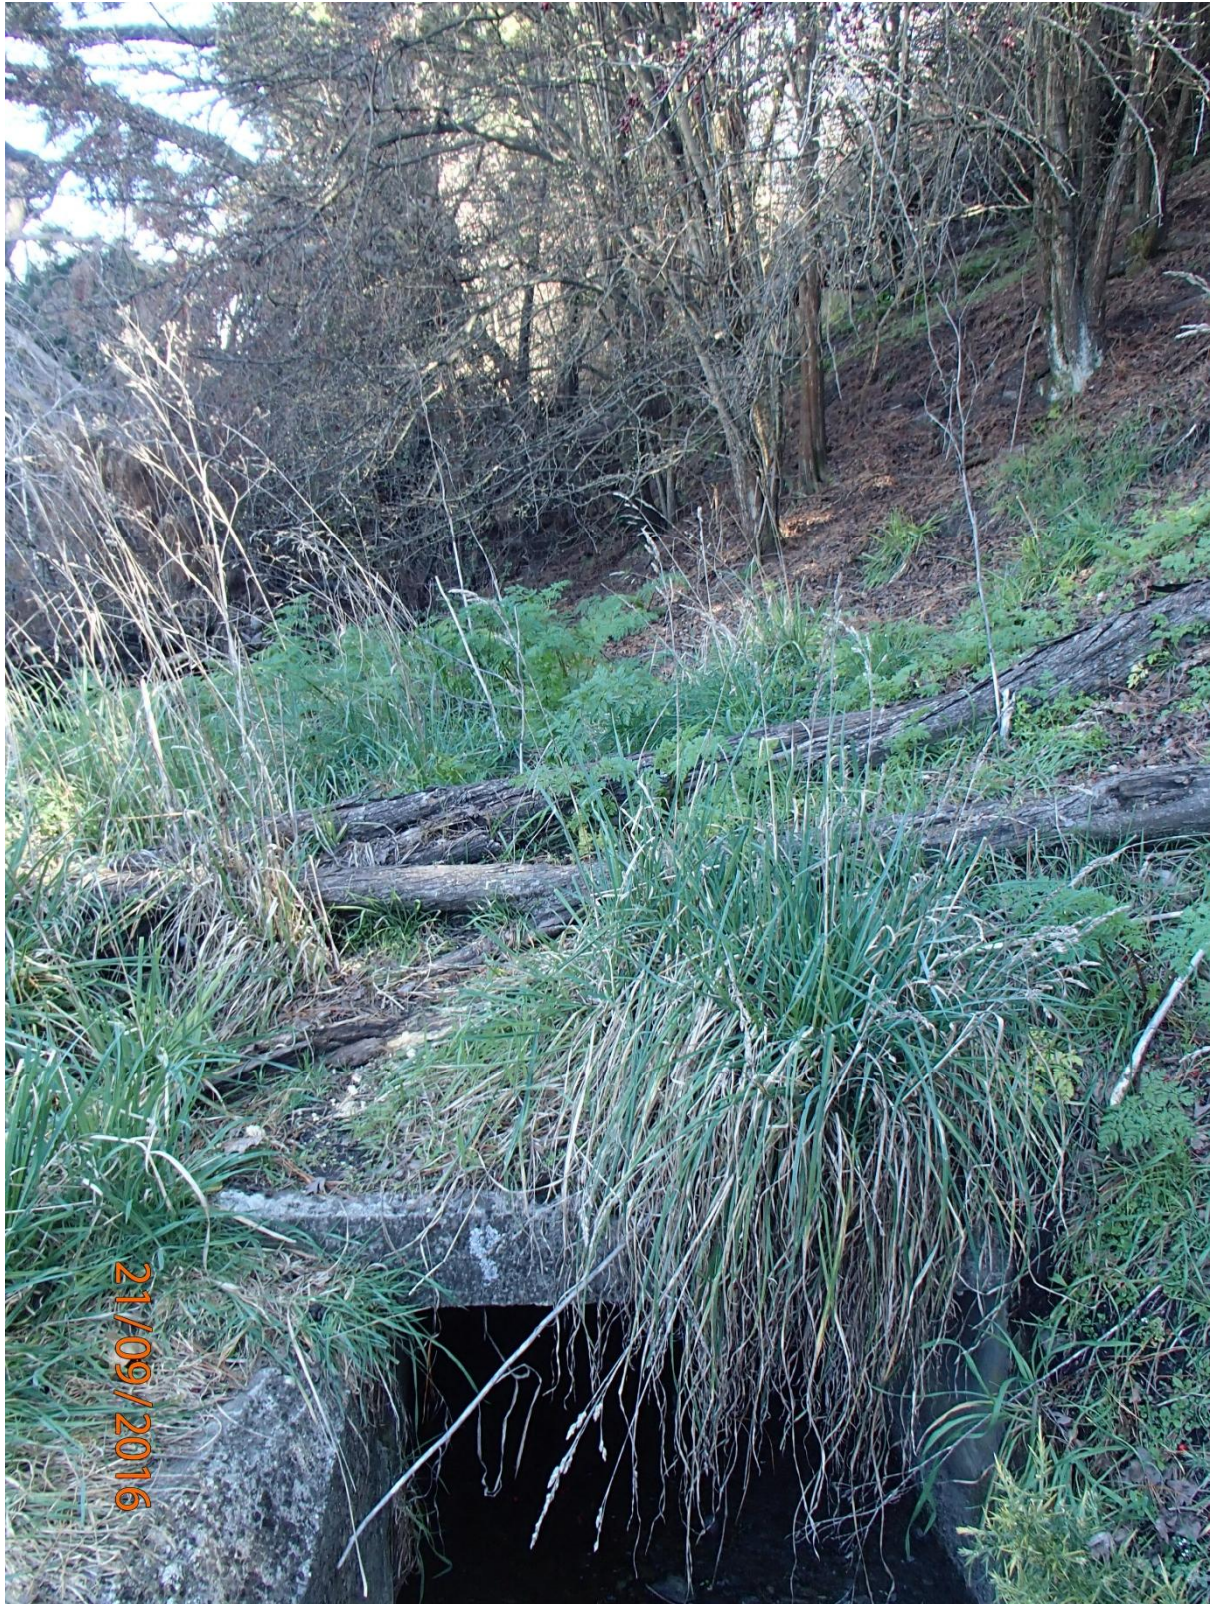
Photo 2: Lined and covered concrete tunnel over water race.

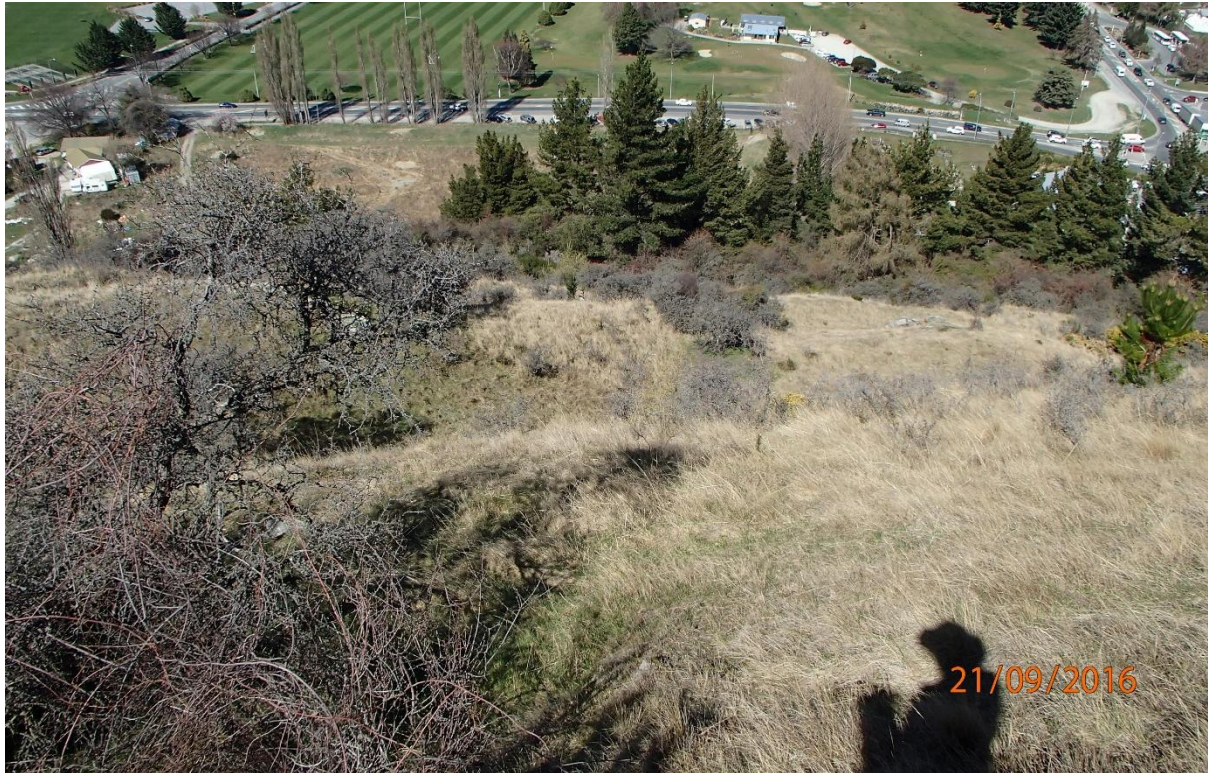
Photo 3: Photo looking southeast down slope, towards the proposed development site.

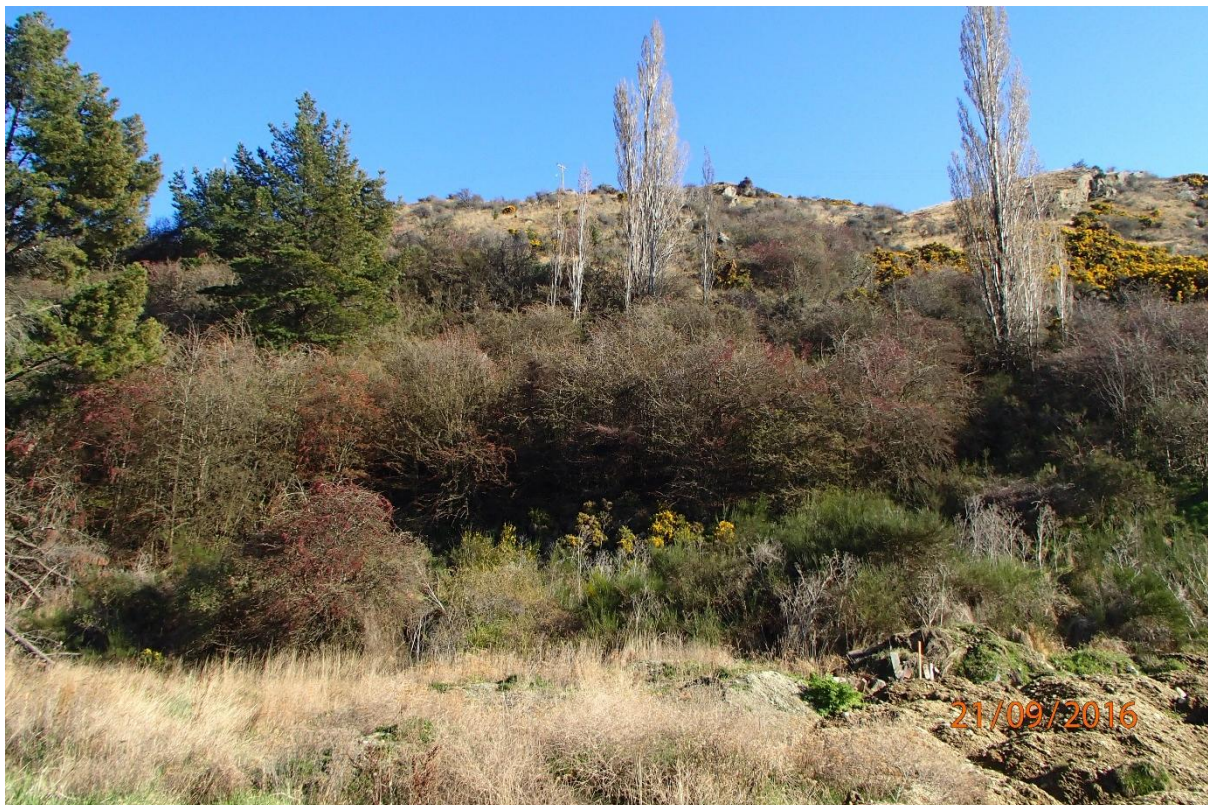
Photo 4: Photo looking northwest up slope at the schist debris landslide.

A schist debris landslide has been identified to the north of the proposed development area, as mapped on the QLDC hazard register, see Figure 2, Appendix A. The toe of the landslide follows the contour along the base of the slope and extends upslope beyond the northern boundary of the site. The proposed development is located approximately 15 m from the toe of the landslide with a proposed road alignment situated between the development and the base of the slope.
