**Date:** 9 November 2020

**Job No:** 63907

**Subject:** 98 & 100-102 Totara Road, Whenuapai – Watercourse Classification

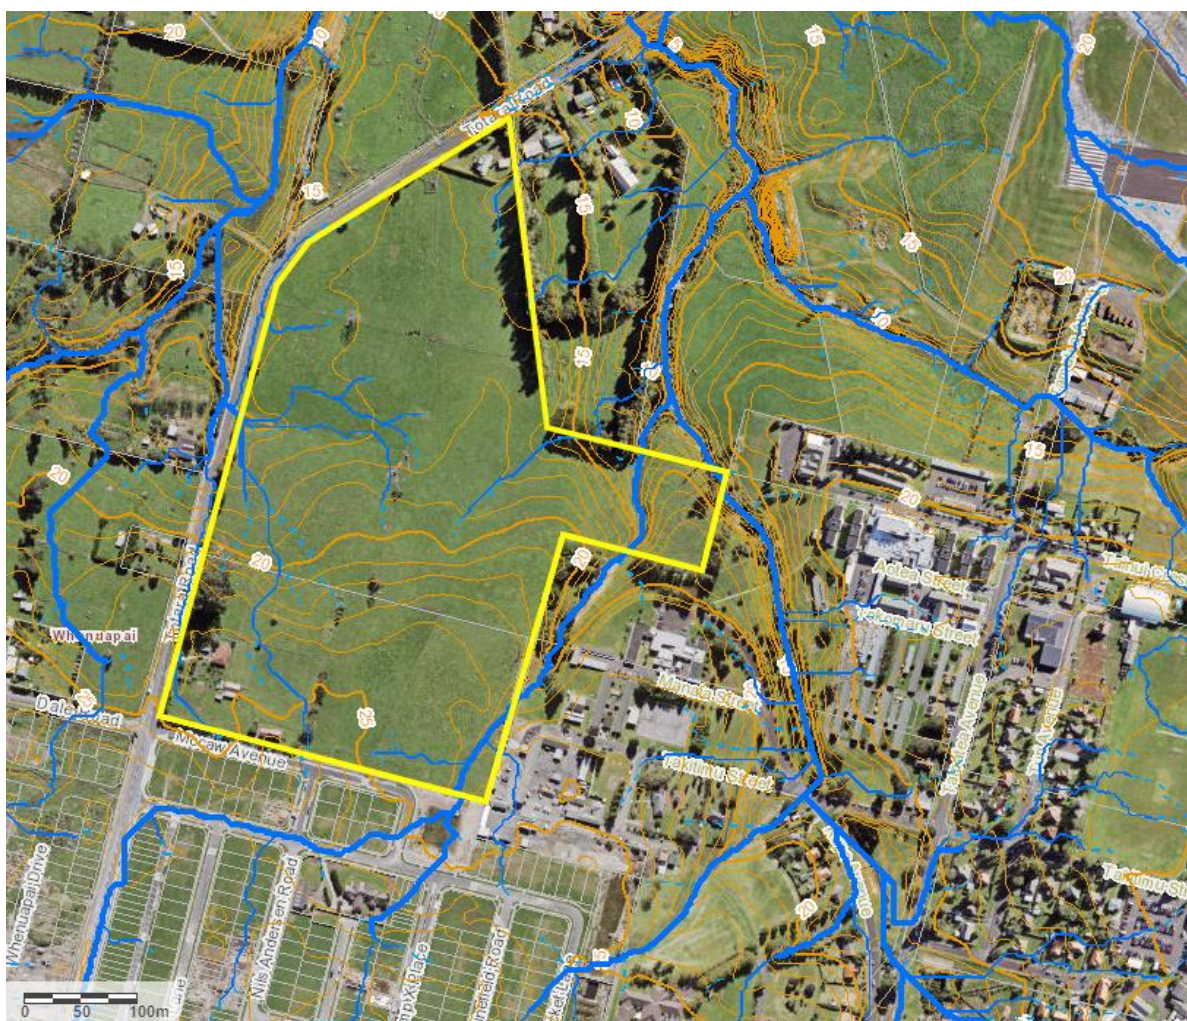
**Figure 1.** A map of the site showing indicated watercourses from Auckland Council's GIS viewer (dark blue lines) and land contours (orange lines). The yellow polygon shows the property boundary of 98 and 100-102 Totara Road, Whenuapai.

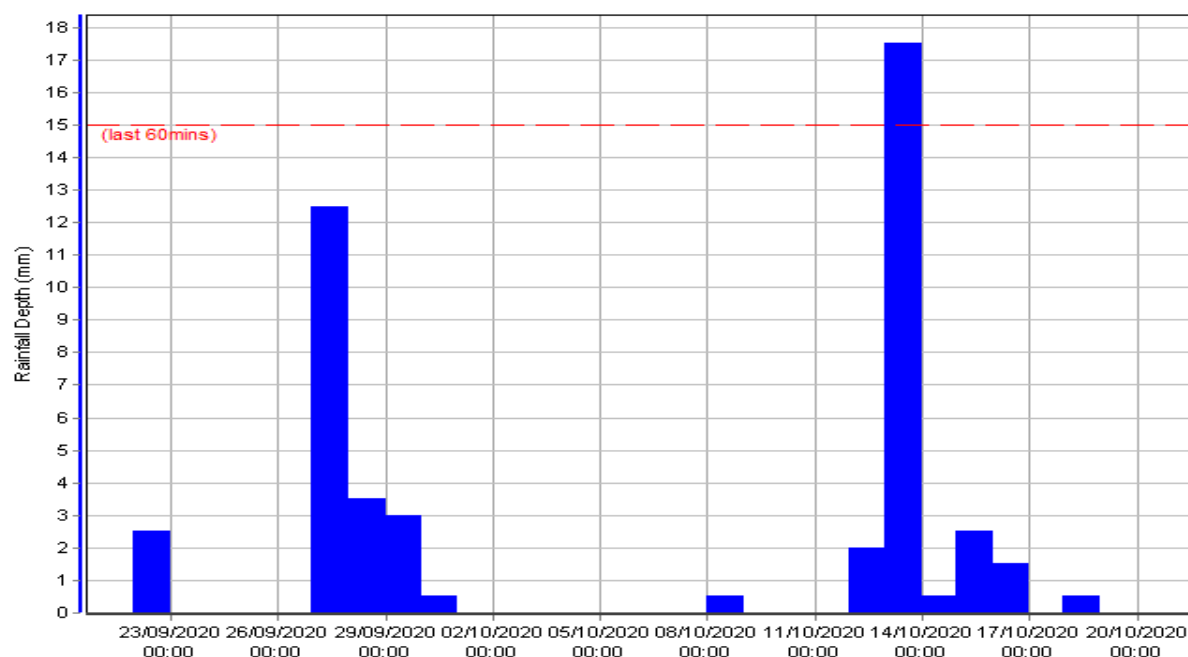
No significant rainfall events (>25mm) occurred in the month prior to the site assessment. Rainfall in the week immediately preceding the site assessment was low to moderate with 0mm to 17.5mm falling on each day, indicating the catchment was at least partially saturated (Figure 2). There was a very low rainfall event (<1mm) 48 hours prior to site assessment (Auckland Council Environmental Monitoring Site: Whenuapai @ Airbase).

**Figure 2. Total rainfall depth (mm) between 21/09/2020 - 21/10/2020. Data sourced from Auckland Council rainfall monitoring site Whenuapai @ Airbase**
