Project Ref: #2355055

**Silver Creek Geotechnical Letter to Supplement Fast Track Consent**

**GEOTECHNICAL FEASIBILITY ASSESSMENT OF THE MIDDLETON  
BLOCK FOR FUTURE RESIDENTIAL DEVELOPMENT**

REF: R4726-1B  
DATE: 26 JANUARY 2021

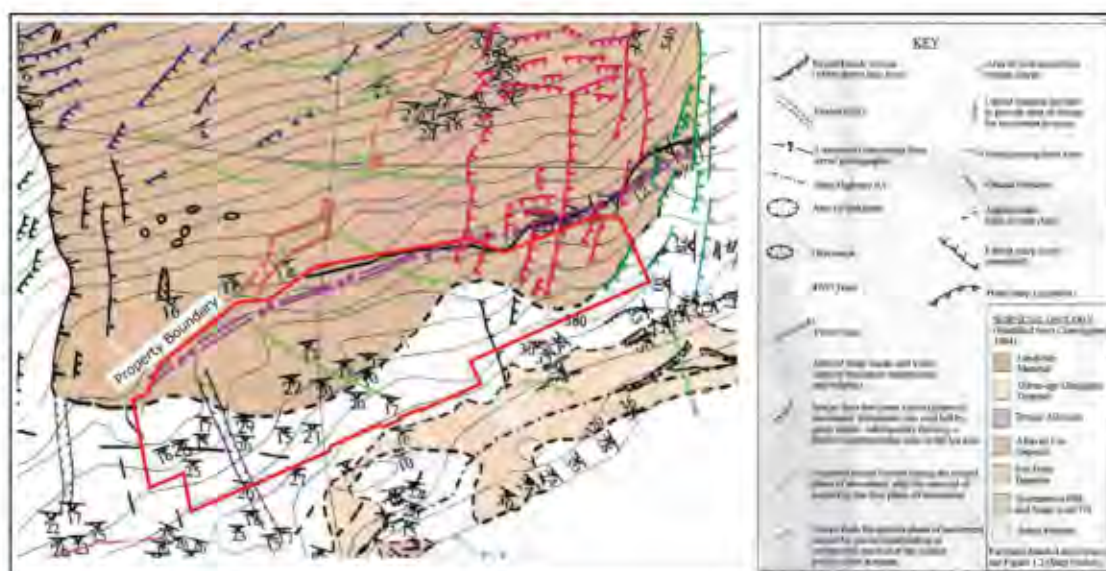
FIGURE 1: EXCERPT FROM STOSSEL, 1999. QUEENSTOWN HILL LANDSLIDE MAPPING

A sensitivity analysis using simplified failure models indicates that low friction angles within foliation shear zones (below 20 to 25°) may trigger instability. Failure may be initiated along foliation shears and crushed schist particularly when ground water is at least half the depth of the landslide mass. Elevated ground water levels were feasible following glaciation resulting in increased weathering, alteration and erosion of the platy micaceous minerals contained within the pelitic schist horizons, causing failure along the pre-existing foliation shear zones. Seismic triggers could have been the final initiating failure mechanism.

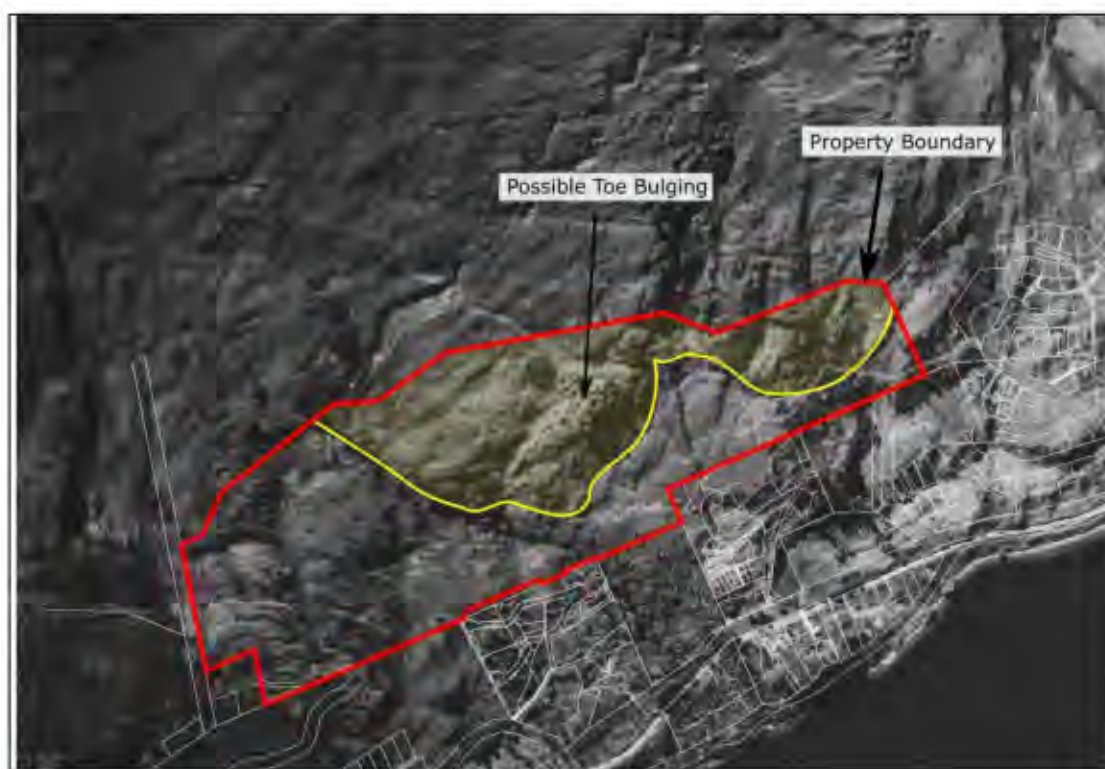
FIGURE 2: EXCERPT FROM BGL, 2018. EXTENT OF QUEENSTOWN HILL LANDSLIDE

Figure 2 below shows the extent of the Queenstown Hill Landslide provided by BGL.

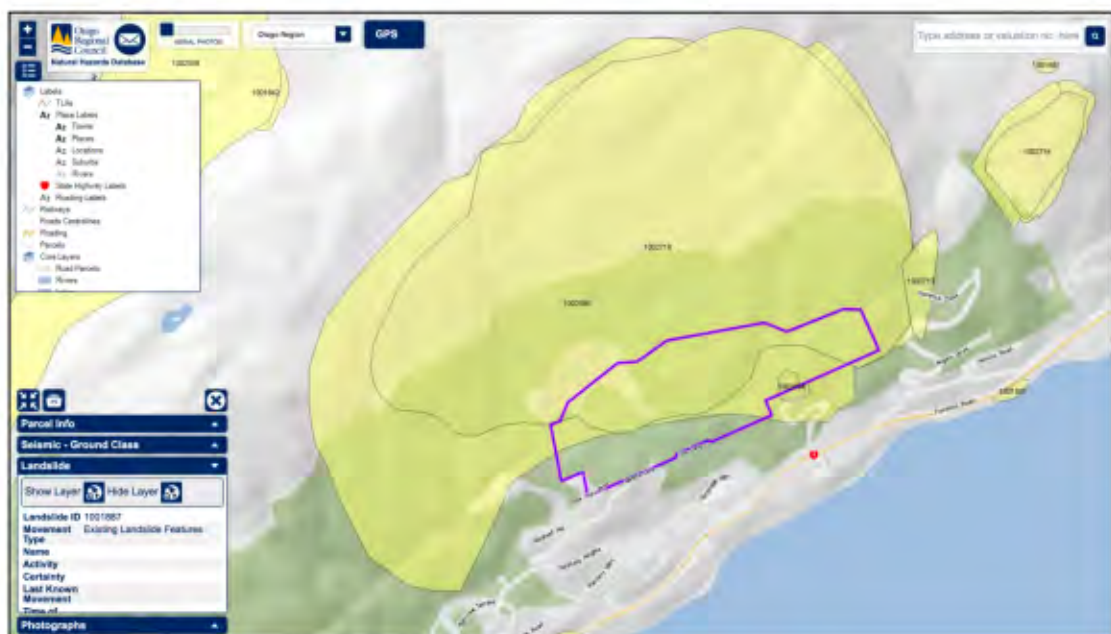
FIGURE 4: ORC LANDSLIDE HAZARD MAPPING

The ORC and QLDC GIS hazard mapping shows the Queenstown Hill Landslide. The mapped extent of the landslide differs between the hazard maps, with QLDC indicating a landslide toe which approximately matches D Stossel (1999) and BGL (2018) and ORC providing a significantly larger footprint comprising both smaller and larger landslides. The landslide hazard mapping is presented below.

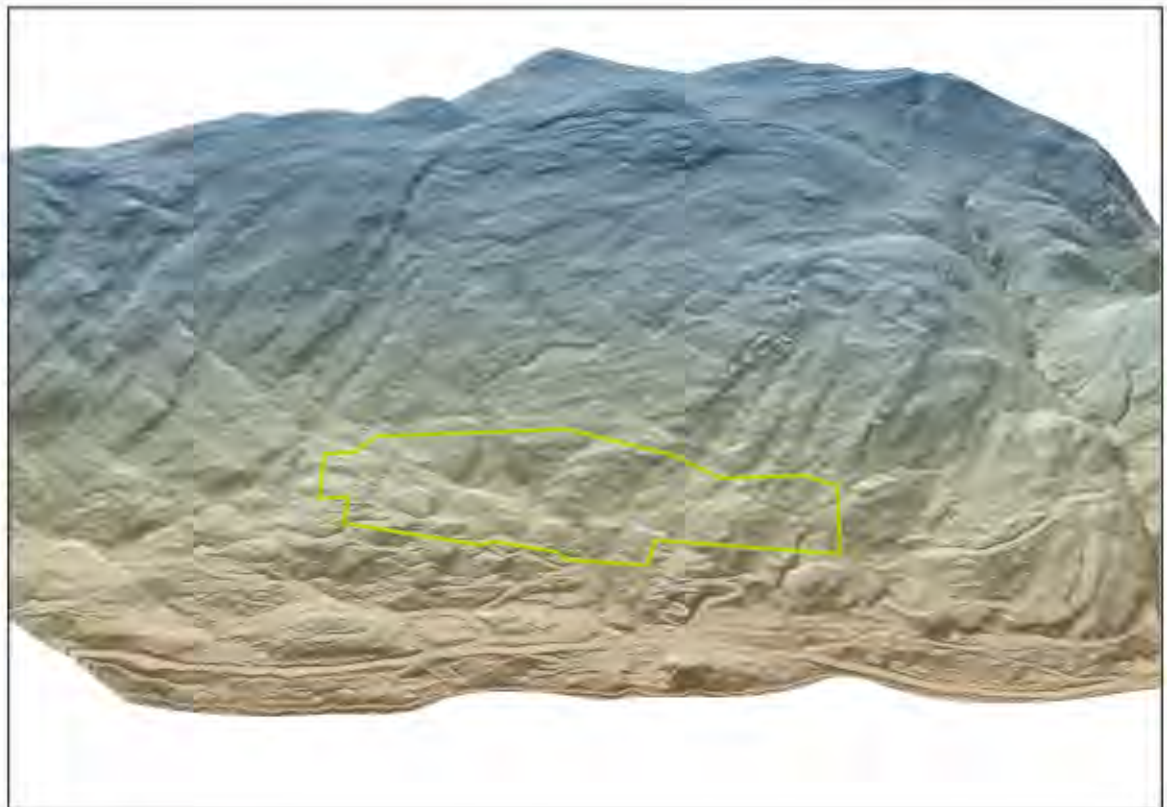
FIGURE 5: LIDAR DATA SHOWING 3D VIEW OF SITE AND SURROUNDS

LIDAR data provides accurate topographical information and removes the effect of vegetation and structure cover such as dwellings. The LiDAR data has been utilised to accurately map geomorphological features and in particular scarps, lineations, disturbed ground, bluffs / rock lines, overland flow paths, gullies and existing site development features. Site mapping has been utilized in conjunction with LiDAR data to effectively ground truth the analysis undertaken. An excerpt from the LiDAR data is shown below.

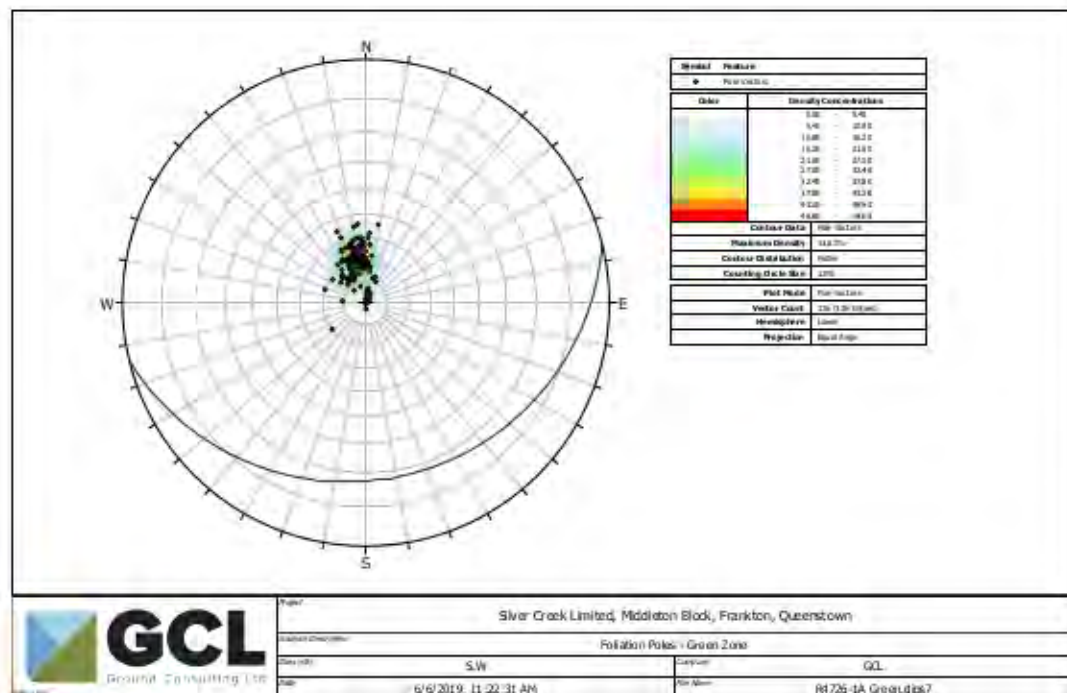
FIGURE 7: PLOT OF FOLIATION POLES – GREEN ZONE

- All three plots show a general grouping of foliation poles with an associated average dip to the S to SSW at 18°. This is consistent with the local foliation strike and dip measured by D Stossel (1999) and others within the undisturbed Goldfield Heights and Potters Hill Drive subdivisions.
- The undisturbed "green zone" provides a much tighter cluster of poles than the orange and red zones. The red zone located in the vicinity of the toe bulge provides the largest scatter of foliation poles. This is consistent with the disturbed rock profile in this zone where a number of large schist blocks have partially rotated.
