470 Great South Road, Papakura – Ground Contamination Review

Project no: WWLA0472
 Document title: Preliminary and Detailed Site Investigation (Ground Contamination)
 Revision: 1
 Date: 3 November 2021
 Client name: Greg Hayhow
 Project manager: Wendi Williamson
 Author(s): Lauren Windross
 File name: s 9(2)(a)

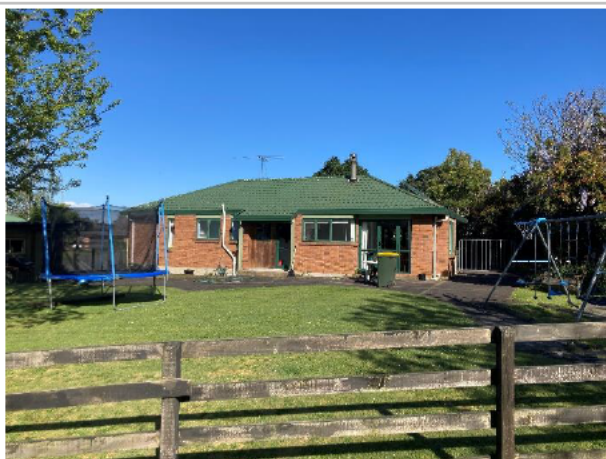
- The property is occupied by a modern brick home (**Photograph 1**) near the road frontage with a similarly modern garage (aluminium construction) on the northern boundary. A strip of land between the garage and the road is used for temporary storage of scaffolding by the neighbour.
- A small concrete platform, previously occupied by a sleepout, is located immediately south of the garage (**Photograph 2**).
- The eastern half of the property is overgrown garden and trees. Cattle from 476 Great South Road and 8 Gatland Road are able to graze within this area.

Photograph 1: House at 470 Great South Rd

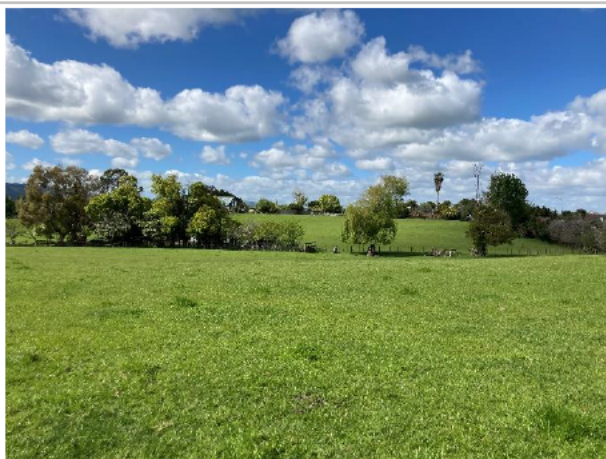
- This property is predominantly grazing land, accessed via a long driveway from Great South Road (**Photograph 3**).
- At the eastern boundary is a stormwater pond (**Photograph 4**). A small dinghy is stored in the lake and small wooden structures including a playhouse are located on its margins.

Photograph 3: General site view at 476 Great South Rd

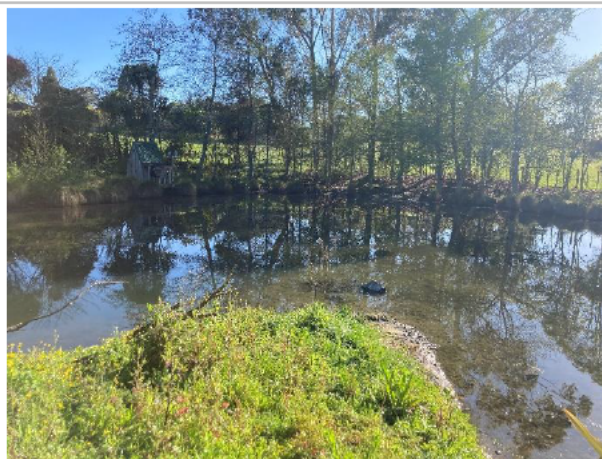
Photograph 4: Stormwater pond

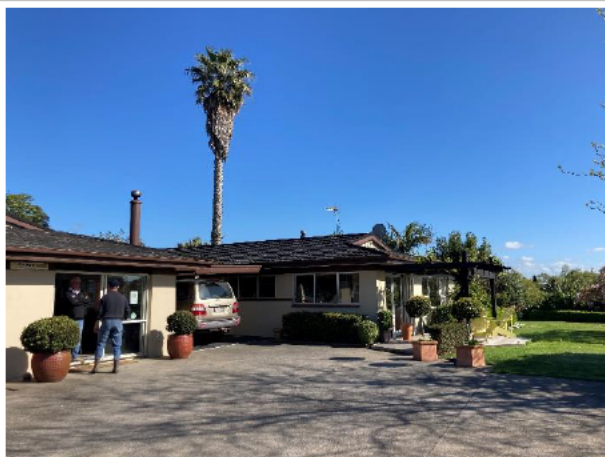
- 2 Gatland Road is a residential property occupied by a house with attached carport, separate office and a swimming pool with changing rooms (**Photograph 6 and 7**).
- The house has potential asbestos soffits and roofing tiles, both being well maintained and the soffits painted.
- Surrounding the house are landscaped gardens, concrete paths/ pool surrounds, and decking.

Photograph 6: Dwelling at 2 Gatland Road

During earthworks procedures in the attached SMP (**Appendix C**) shall be followed. An asbestos survey of 2 Gatland Road should be undertaken before demolition to confirm if asbestos is present so if it is, it can be safely removed. Soil clearance may be required by a SQEP following demolition.

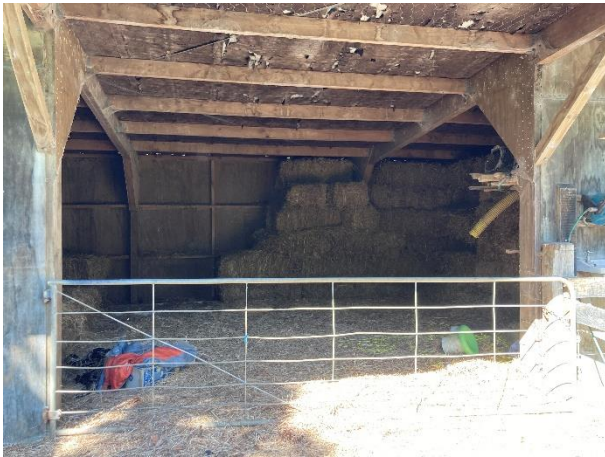
Photograph 8: Hay shed

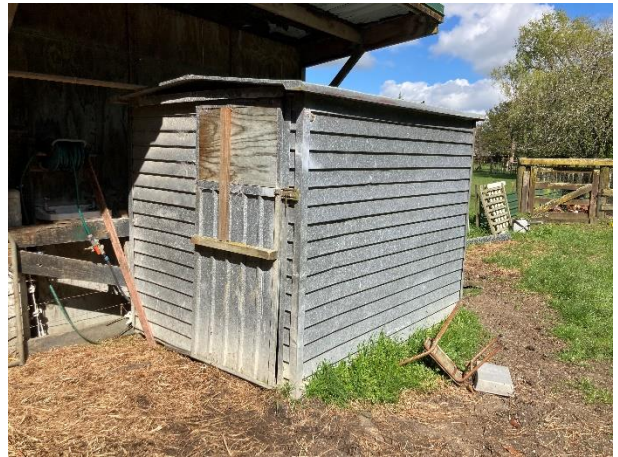
Photograph 9: Aluminium shed with aluminium floor

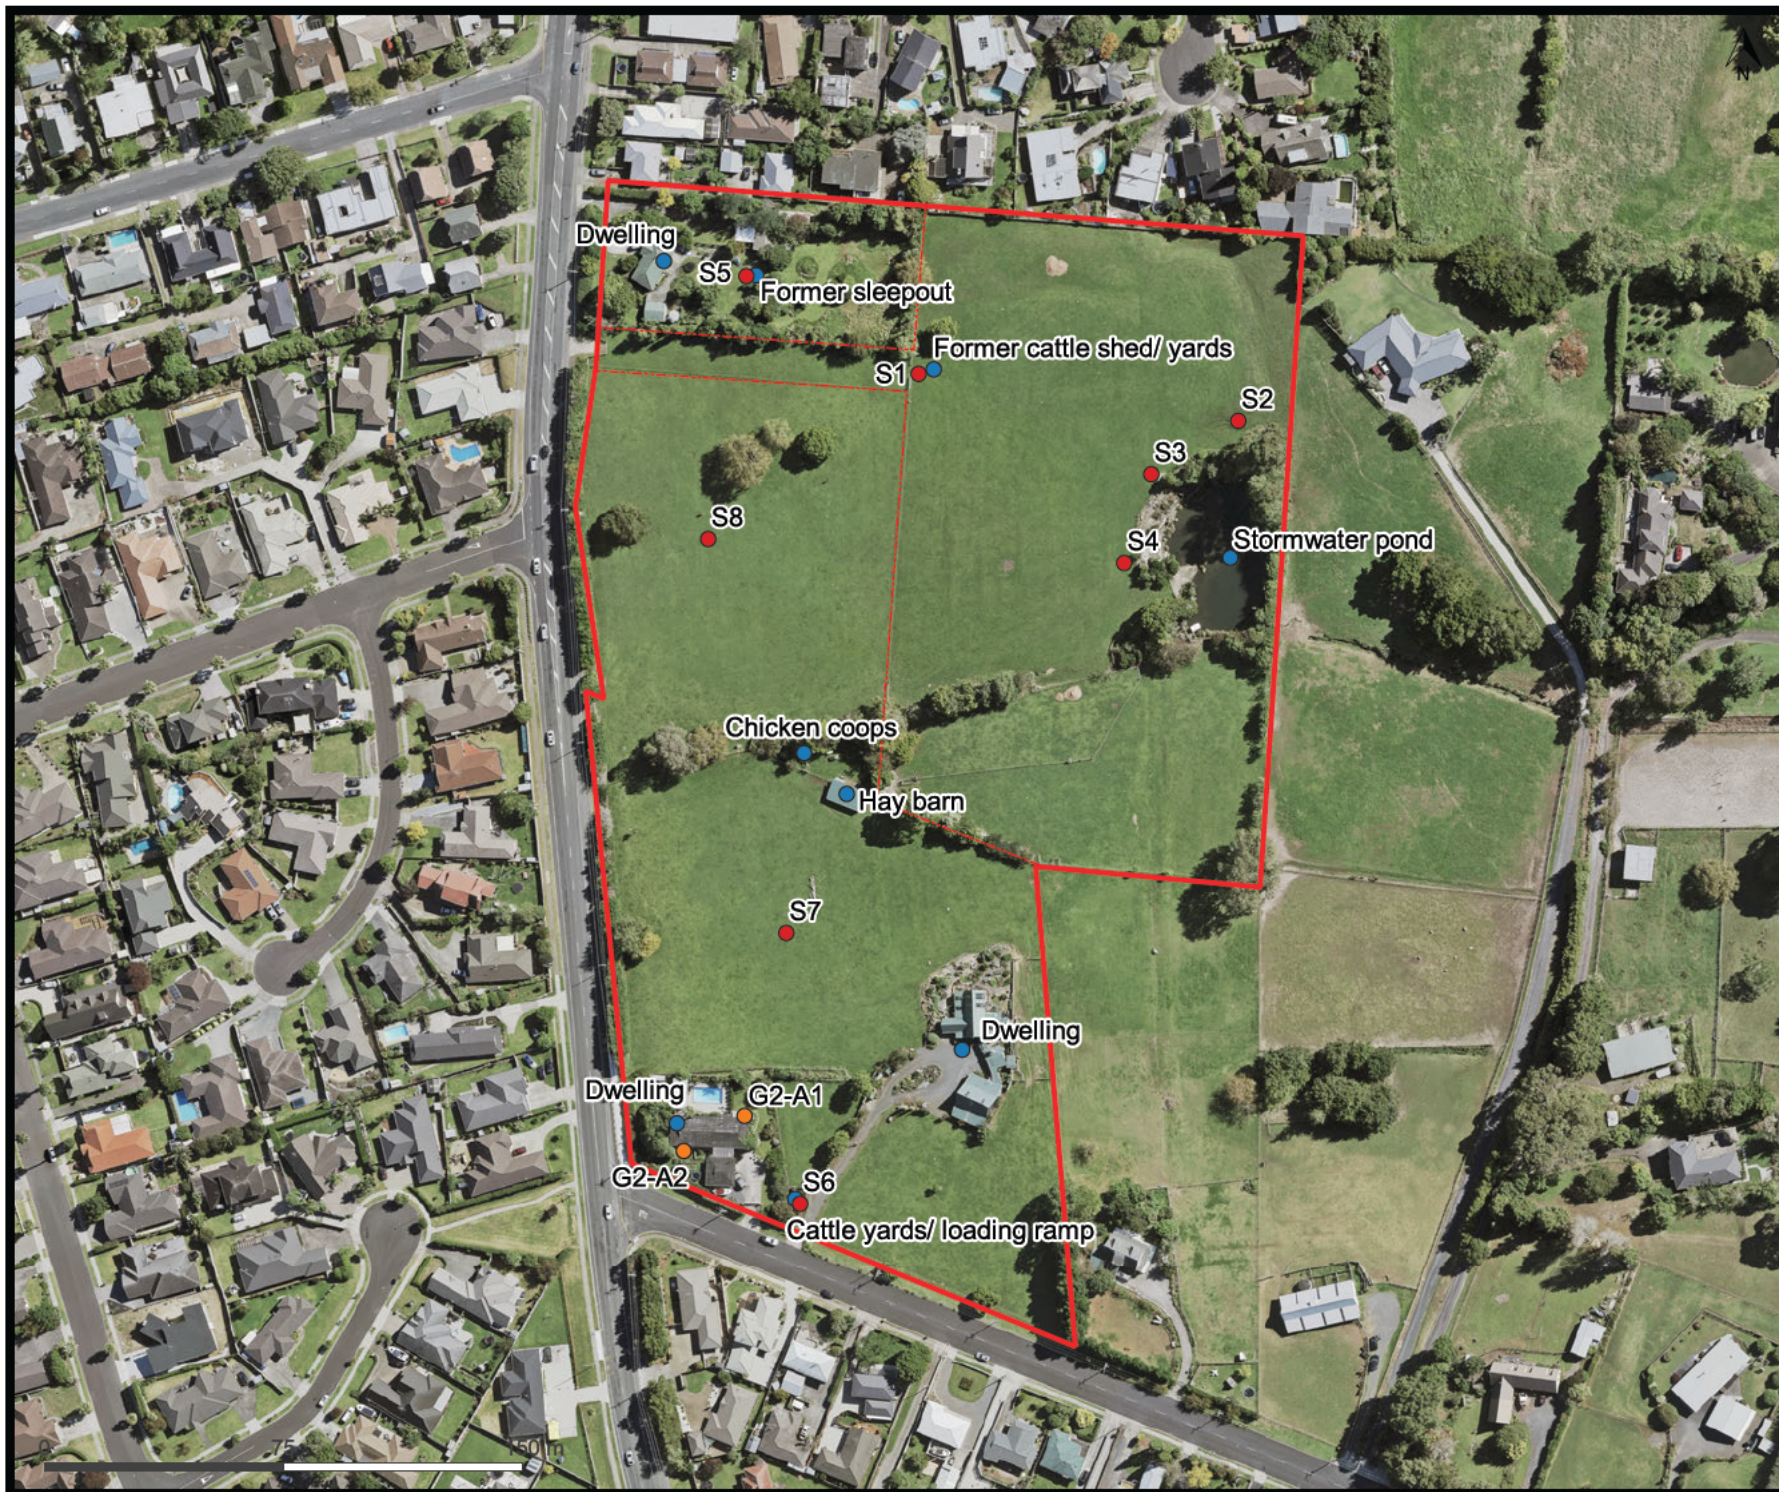
Figure 3.

- The location of the former sheds in the centre of the site could not be identified (refer aerial review in **Section 3.1.1**). However a fragment of a concrete footing indicates the location of the former cattle shed and yards (also **Section 3.1.1** and **Figure 3**)

Feature (refer Figure 3)	Sampling and laboratory testing rationale	Sample locations (refer Figure 3)
Pesticide use for cattle drenching	<ul style="list-style-type: none"> • Surface soil (topsoil) samples collected in areas of current and former yards • Laboratory testing for metals and OCPs. 	S1, S6
Asbestos use on former and current buildings	<ul style="list-style-type: none"> • Sampling across a 1 m square area in the vicinity of the former cattle shed, the former sleepout, and the existing dwelling with confirmed ACM. Topsoil sampled. • Laboratory testing for presence/ absence of asbestos. 	S1, S5, G2-A1, G2-A2
Placement of Fill	<ul style="list-style-type: none"> • Surface and near-surface sampling of fill material surrounding pond. • Laboratory testing for metals and PAH. 	S2, S3, S4
Lead paint and leaching from treated timber structures or zinc roofing.	<ul style="list-style-type: none"> • Composite samples of topsoil around former sleepout and cattle shed. • Laboratory testing for metals. 	S1, S5
