**To:** Neil Construction Limited

**Job No:** 63907

**Subject:** 98 & 100-102 Totara Road, Whenuapai – Watercourse Classification

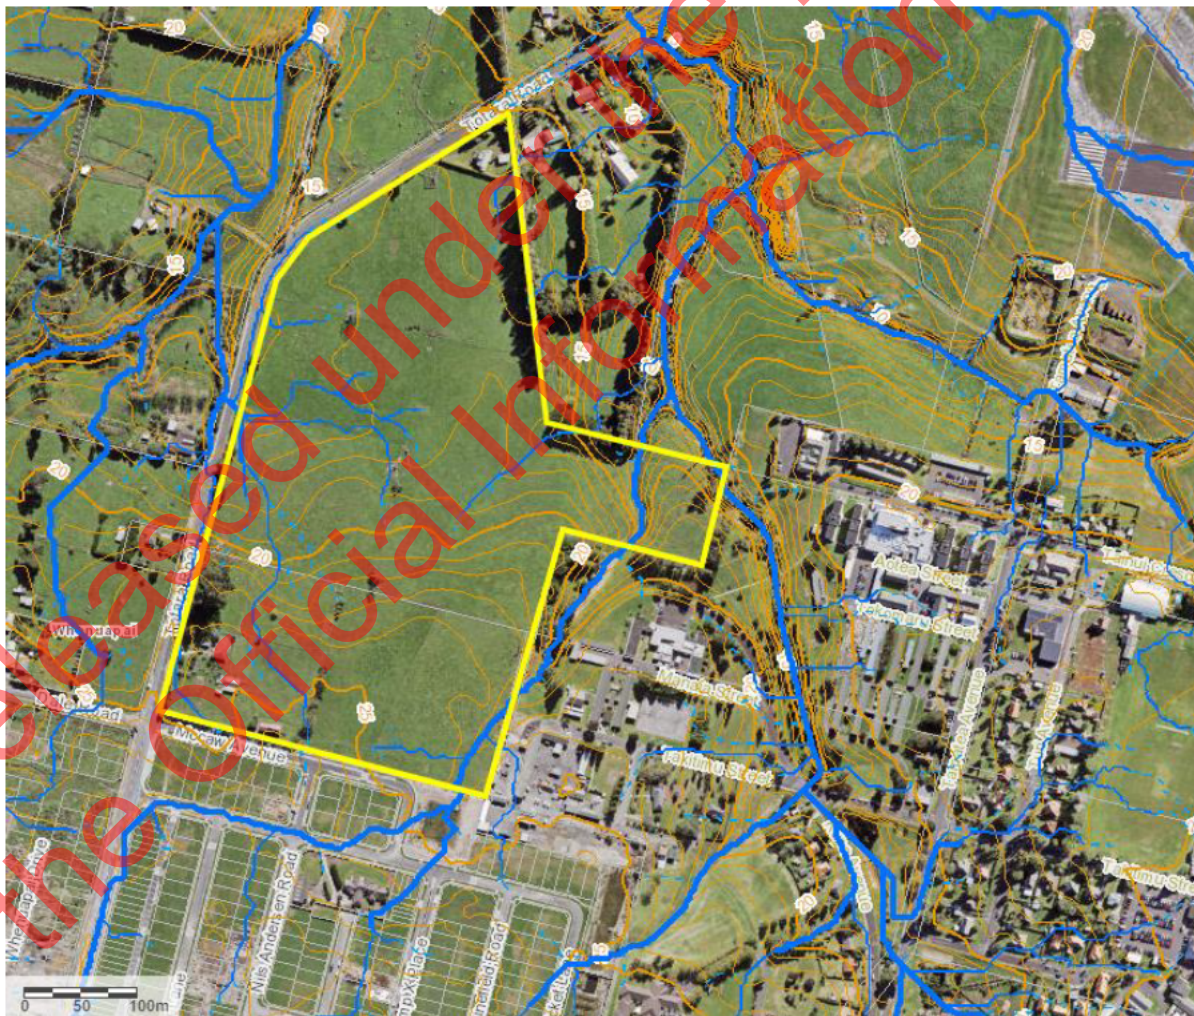
*Figure 1. A map of the site showing indicated watercourses from Auckland Council's GIS viewer (dark blue lines) and land contours (orange lines). The yellow polygon shows the property boundary of 98 and 100-102 Totara Road, Whenuapai.*

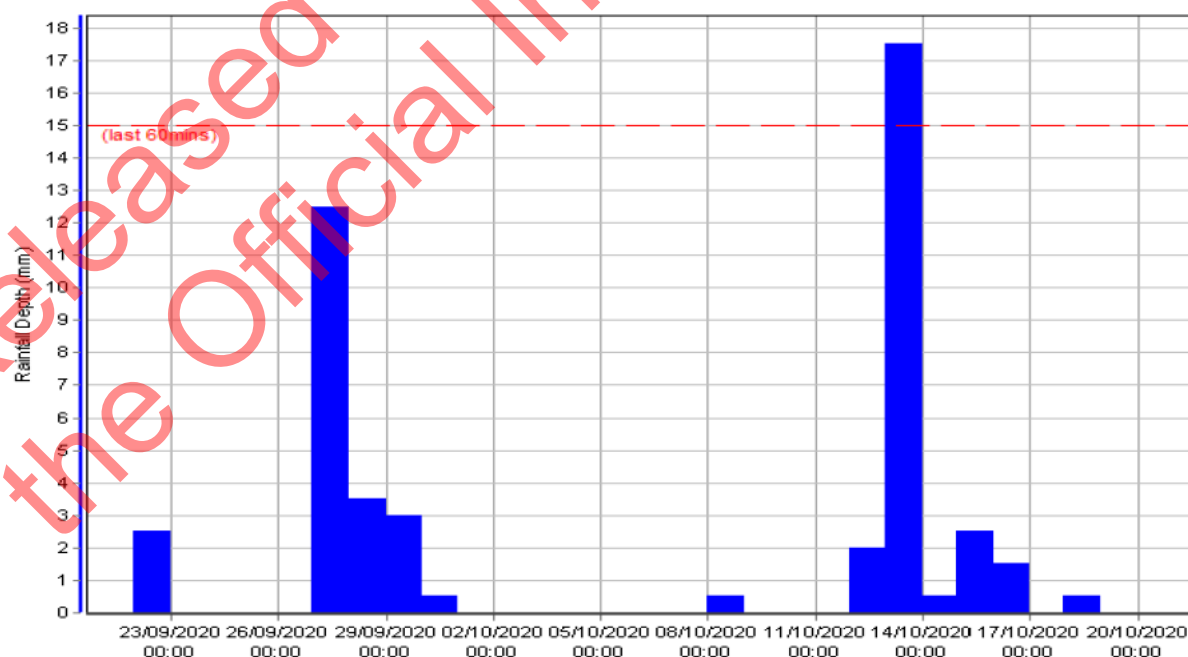
No significant rainfall events (>25mm) occurred in the month prior to the site assessment. Rainfall in the week immediately preceding the site assessment was low to moderate with 0mm to 17.5mm falling on each day, indicating the catchment was at least partially saturated (Figure 2). There was a very low rainfall event (<1mm) 48 hours prior to site assessment (Auckland Council Environmental Monitoring Site: Whenuapai @ Airbase).

**Figure 2. Total rainfall depth (mm) between 21/09/2020 - 21/10/2020. Data sourced from Auckland Council rainfall monitoring site Whenuapai @ Airbase**

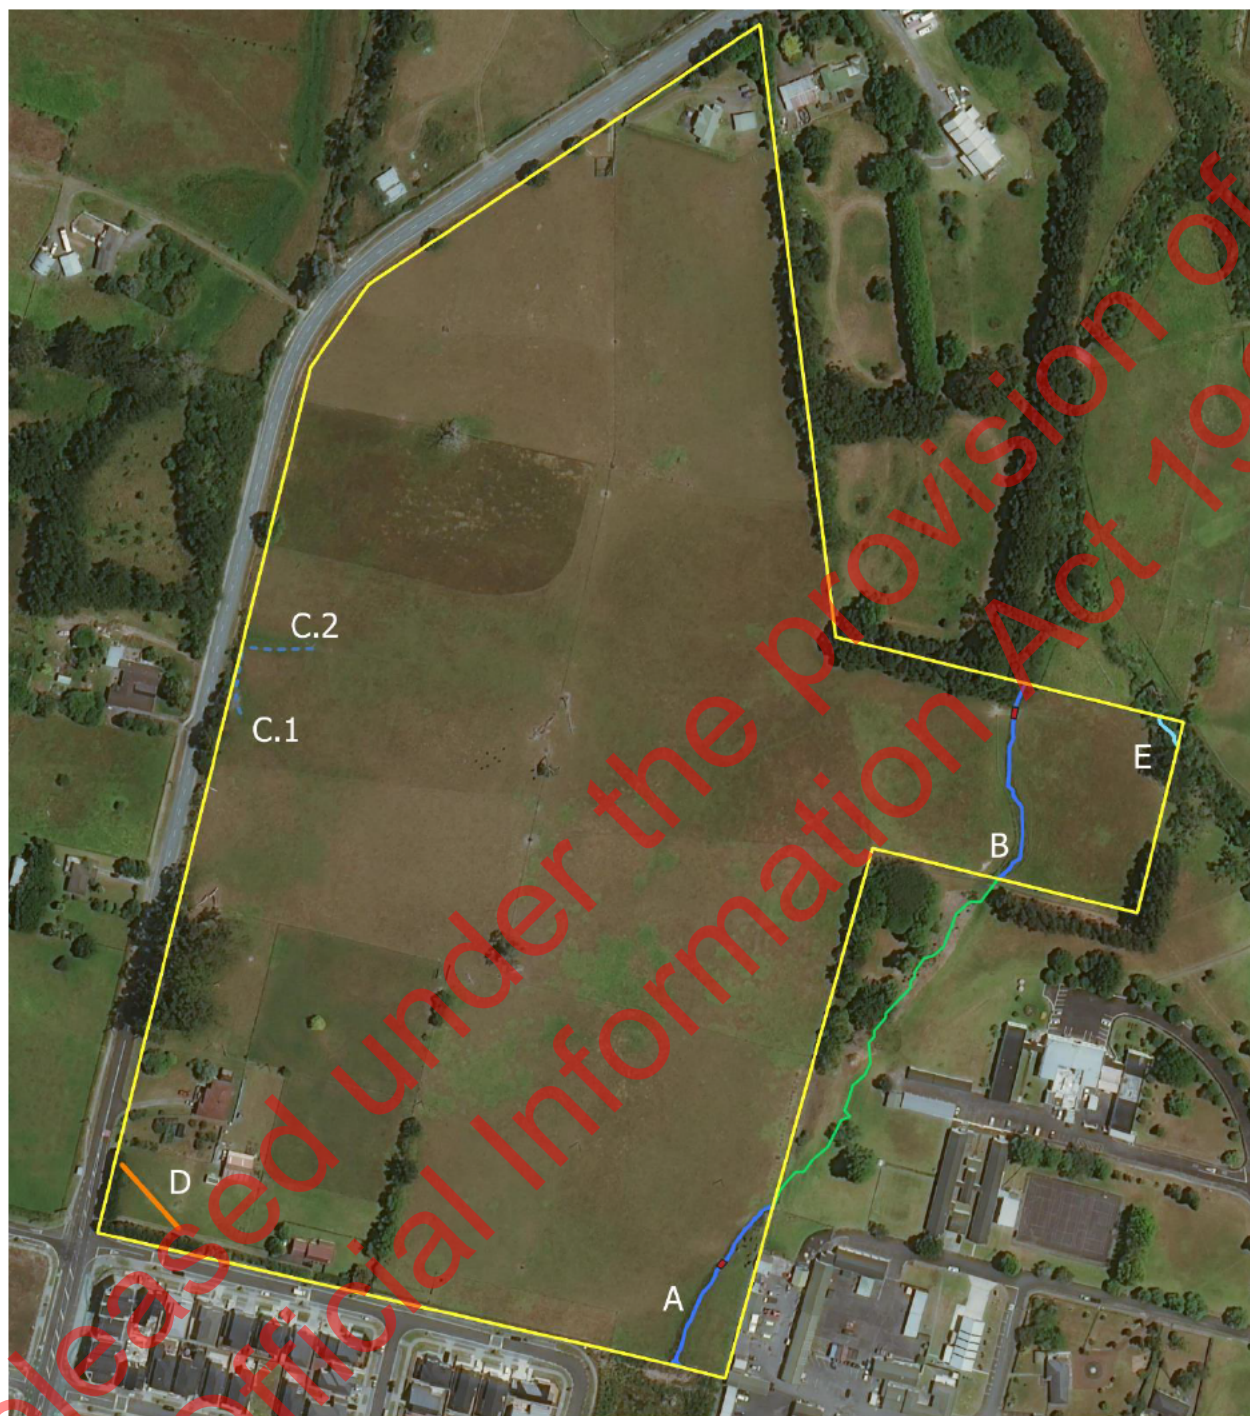
Watercourse A was entered the site at the south-western boundary of the property (Figure 3), through two culverts (Photo 1). The watercourse had a somewhat defined channel that had been degraded by stock access. It ran through the site for approximately 90m before flowing into the neighbouring property, then re-entering the site approximately 160m downstream (forming Watercourse B). The wetted width and depth of the channel was variable (between 0.1m to >1m wide and 0.05m to 0.20m deep) (Photo 2), mainly due to highly degraded banks caused by livestock pugging (Photo 3).

Watercourse B entered the site through a pipe and is a downstream reach of Watercourse A (Figure 3). Watercourse B flowed through the site for approximately 100m through highly variable hydrological conditions, with the wetted width of the channel ranging from 0.15m to >1.5m (Photo 6; Photo 10). Upstream, the low flow path was wide and the channel was not well-defined however a clear flow path could be observed with two large, deep pools. Whilst the channel was not well-defined in the upstream portion of the reach, this is likely due to channel damage through livestock access (Photo 8). One pool was located less than 1m downstream of the pipe (Photo 5) and the other approximately 64m downstream. The largest of these pools was the downstream pool and was approximately 2.5m wide and 0.20m deep (Photo 6). The dominant aquatic vegetation present included buttercup (*Ranunculus* spp.), water celery (*Apium nodiflora*), starwort (*Callitiche stagnalis*) and heavily grazed soft-rush (*Juncus effusus*), no riparian planting was established along Watercourse B. The riparian yard and channel banks were dominated<sup>1</sup> by terrestrial exotic pasture grass.

Auckland Council GIS Viewer indicated an overland flow path to be present in the lower south-western side of the property (Figure 3). During the site visit, this was deemed to be an artificially created depression, that was likely originally a farm drainage channel. The shallow depression was completely straight and the depth of the depression was consistent for the whole length (Photo 16). No water was present in the channel and rooted terrestrial vegetation could be seen throughout. The edges of the banks have been damaged through pugging by livestock (Photo 17). Furthermore, land contours do not indicate any naturally occurring flow paths and no head waters were historically present.
