Arboricultural report

To: Paul Kleynhams, Project Engineer, Cato Bolam Consultants s 9(2)(a)
From: Andrew Barrell, Consultant Arborist Tree 3 Ltd s 9(2)(a)
Date: 13 April 2021
Re: Brigham Creek Road & Kauri Road, Whenuapai – trees in riparian yard and wetland area
Arboricultural assessment & recommendations

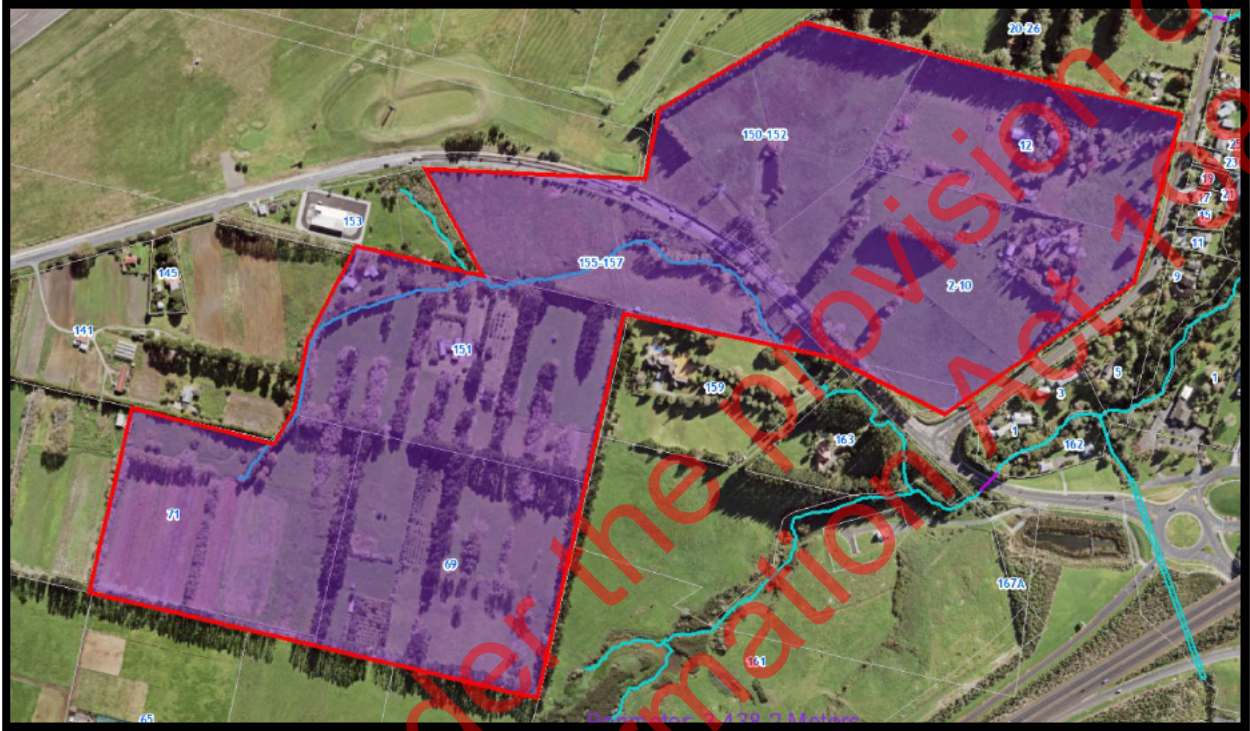
Figure 1 – Extent of area of assessment (purple shading within red outline).

- 6) The area in question is shown on the image in Figure 1 below and represented by the purple shading. The majority of the assessments in this report relate to land located to the south of Brigham Creek Road (numbers 69, 71, 151 and 155-157). Assessments relating to the land to the north of Brigham Creek Road are less detailed and relate primarily to the nature and condition of the existing vegetation assemblage.
