Audit of the Remediation of the former Fruitgrowers Chemical Company Site, Mapua

∴ Prepared for
Ministry for the Environment

∴ June 2009

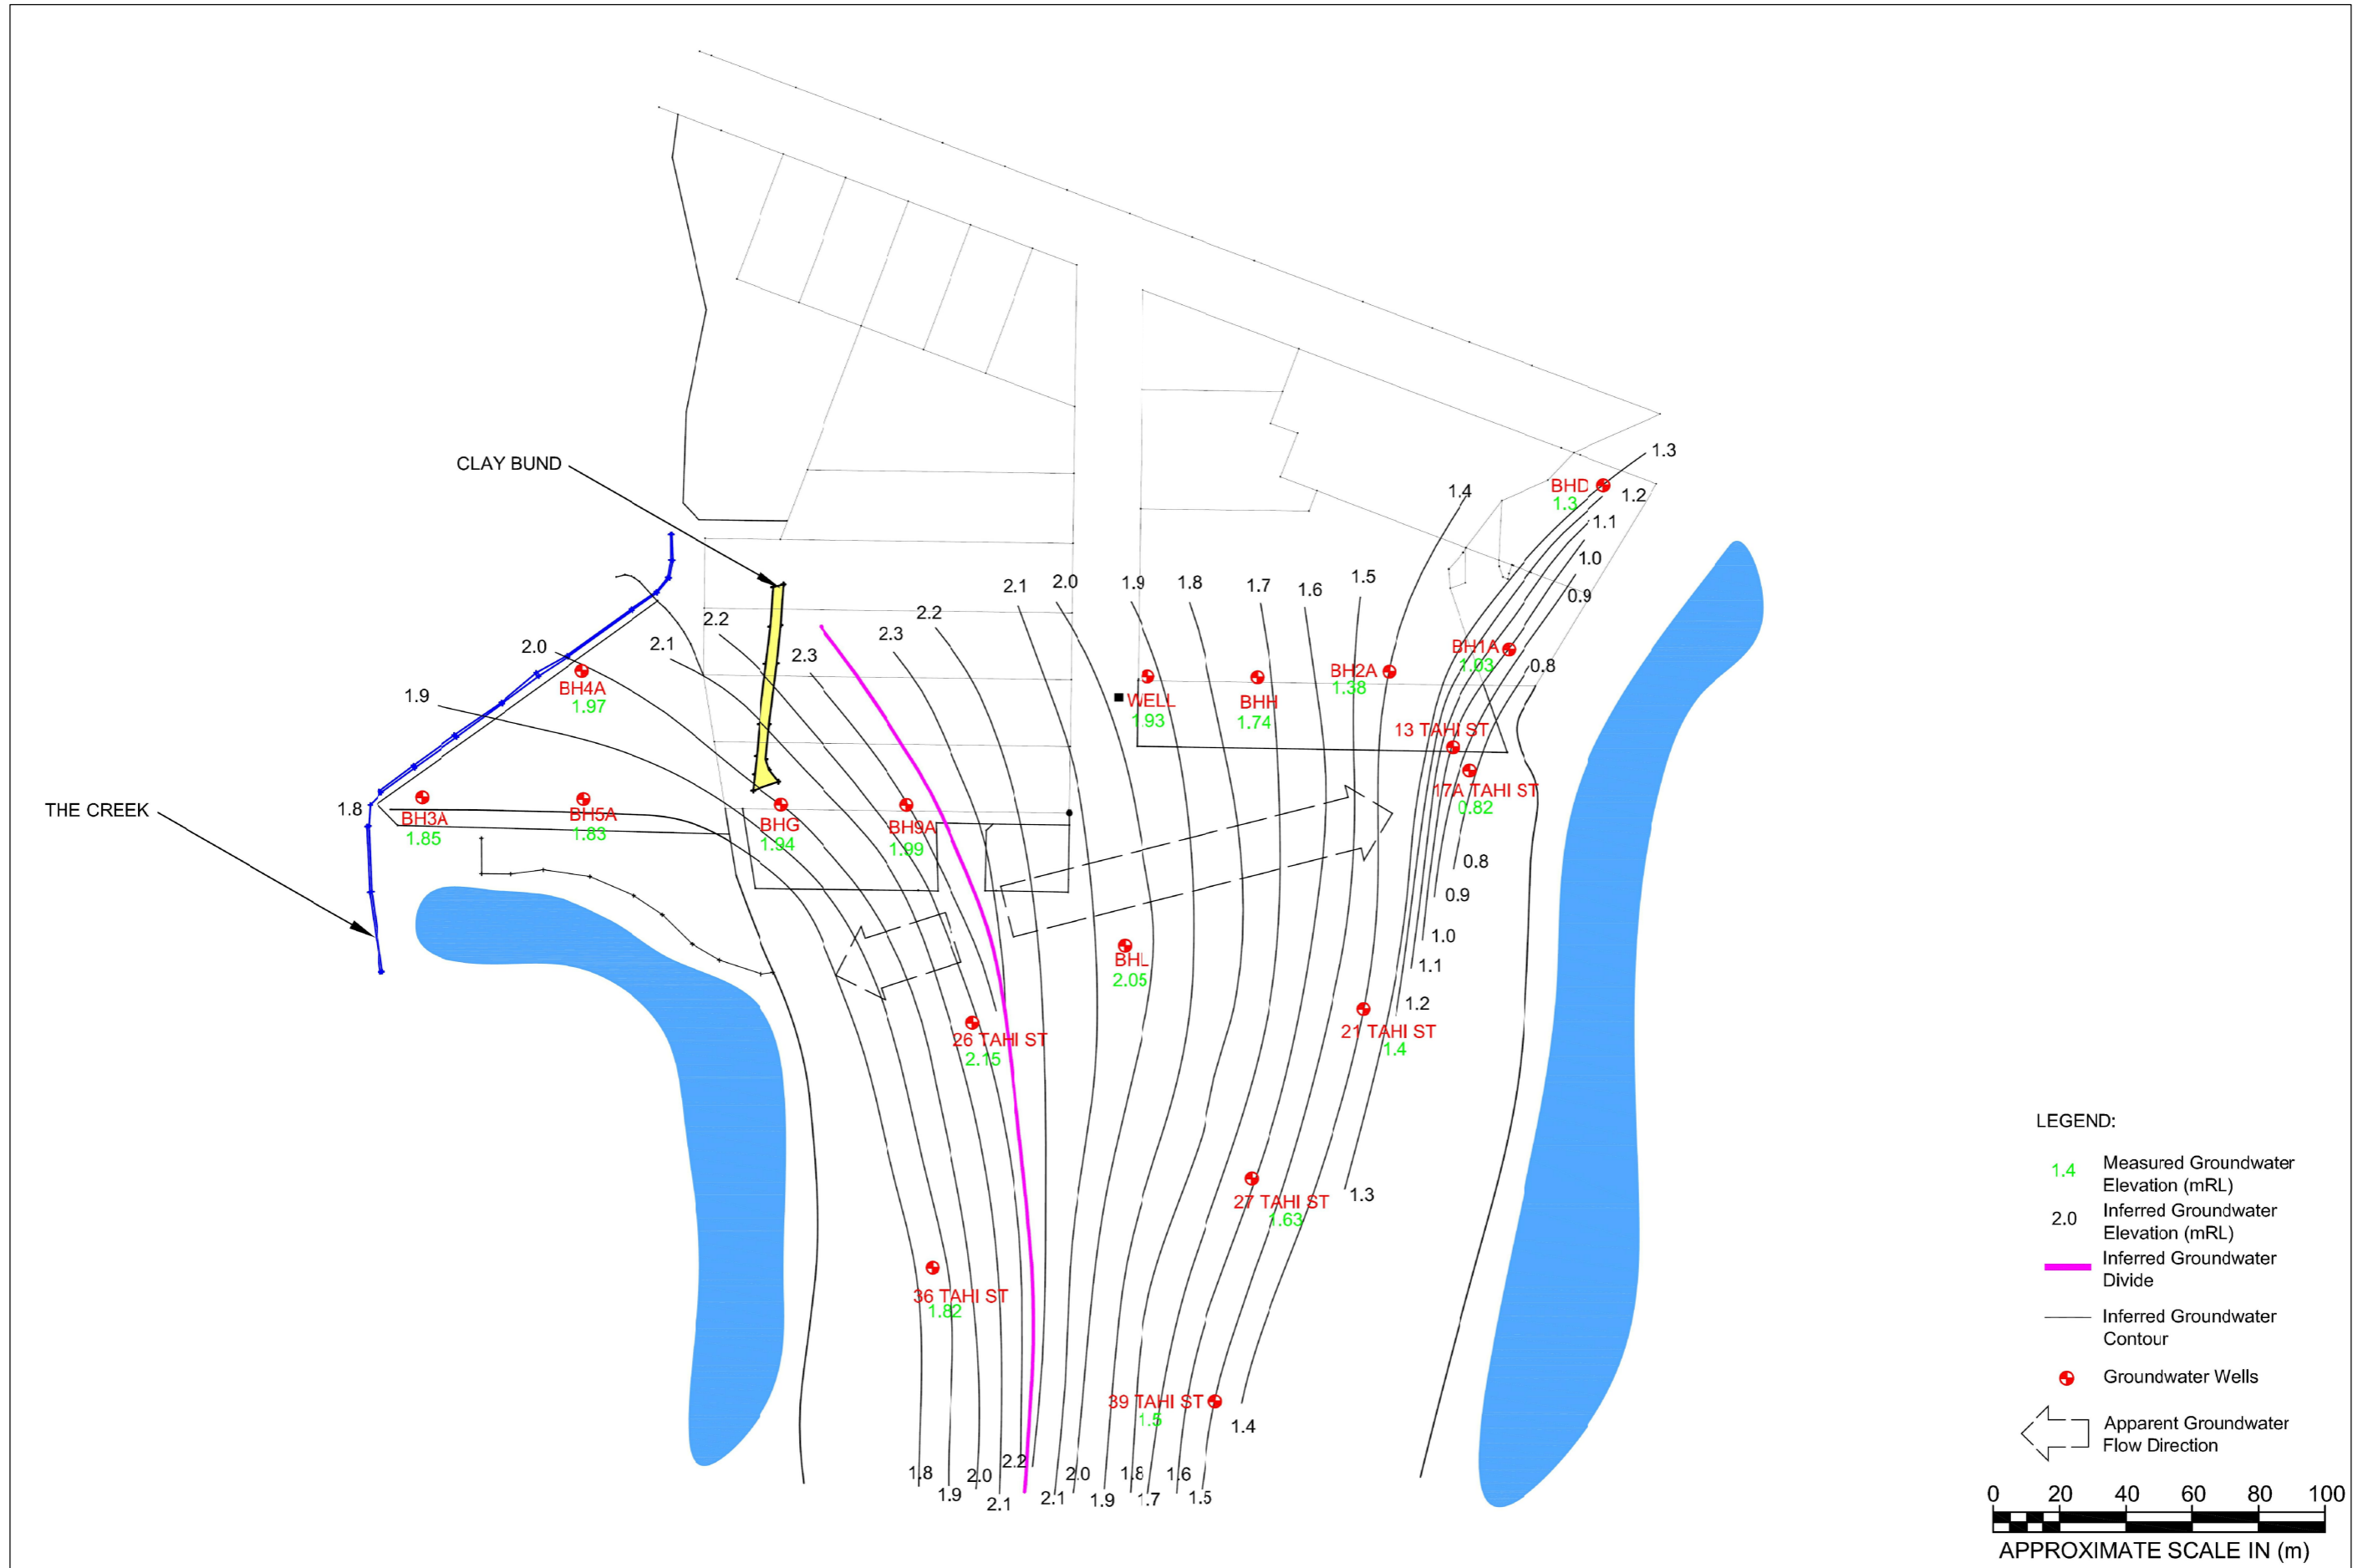
Figure 6 : CH2M HILL (2007) Predicted Groundwater Flow Direction

Source: CH2M HILL 2007 (may not be spatially accurate)

Two slightly different interpretations of groundwater flow directions have been derived from groundwater level measurements in on- and off-site wells post-remediation. CH2M HILL (2007) indicates a groundwater divide runs slightly to the west of Tahi Street, running down the centre line of the peninsula, with groundwater flow both westward and eastward of the divide (Figure 6). Recharge to the site and the peninsular south of the site is inferred to be predominantly from infiltration. CH2M HILL (2007) shows westward and southward groundwater discharge to the creek and FCC West beach and eastward discharge to the FCC East beach.

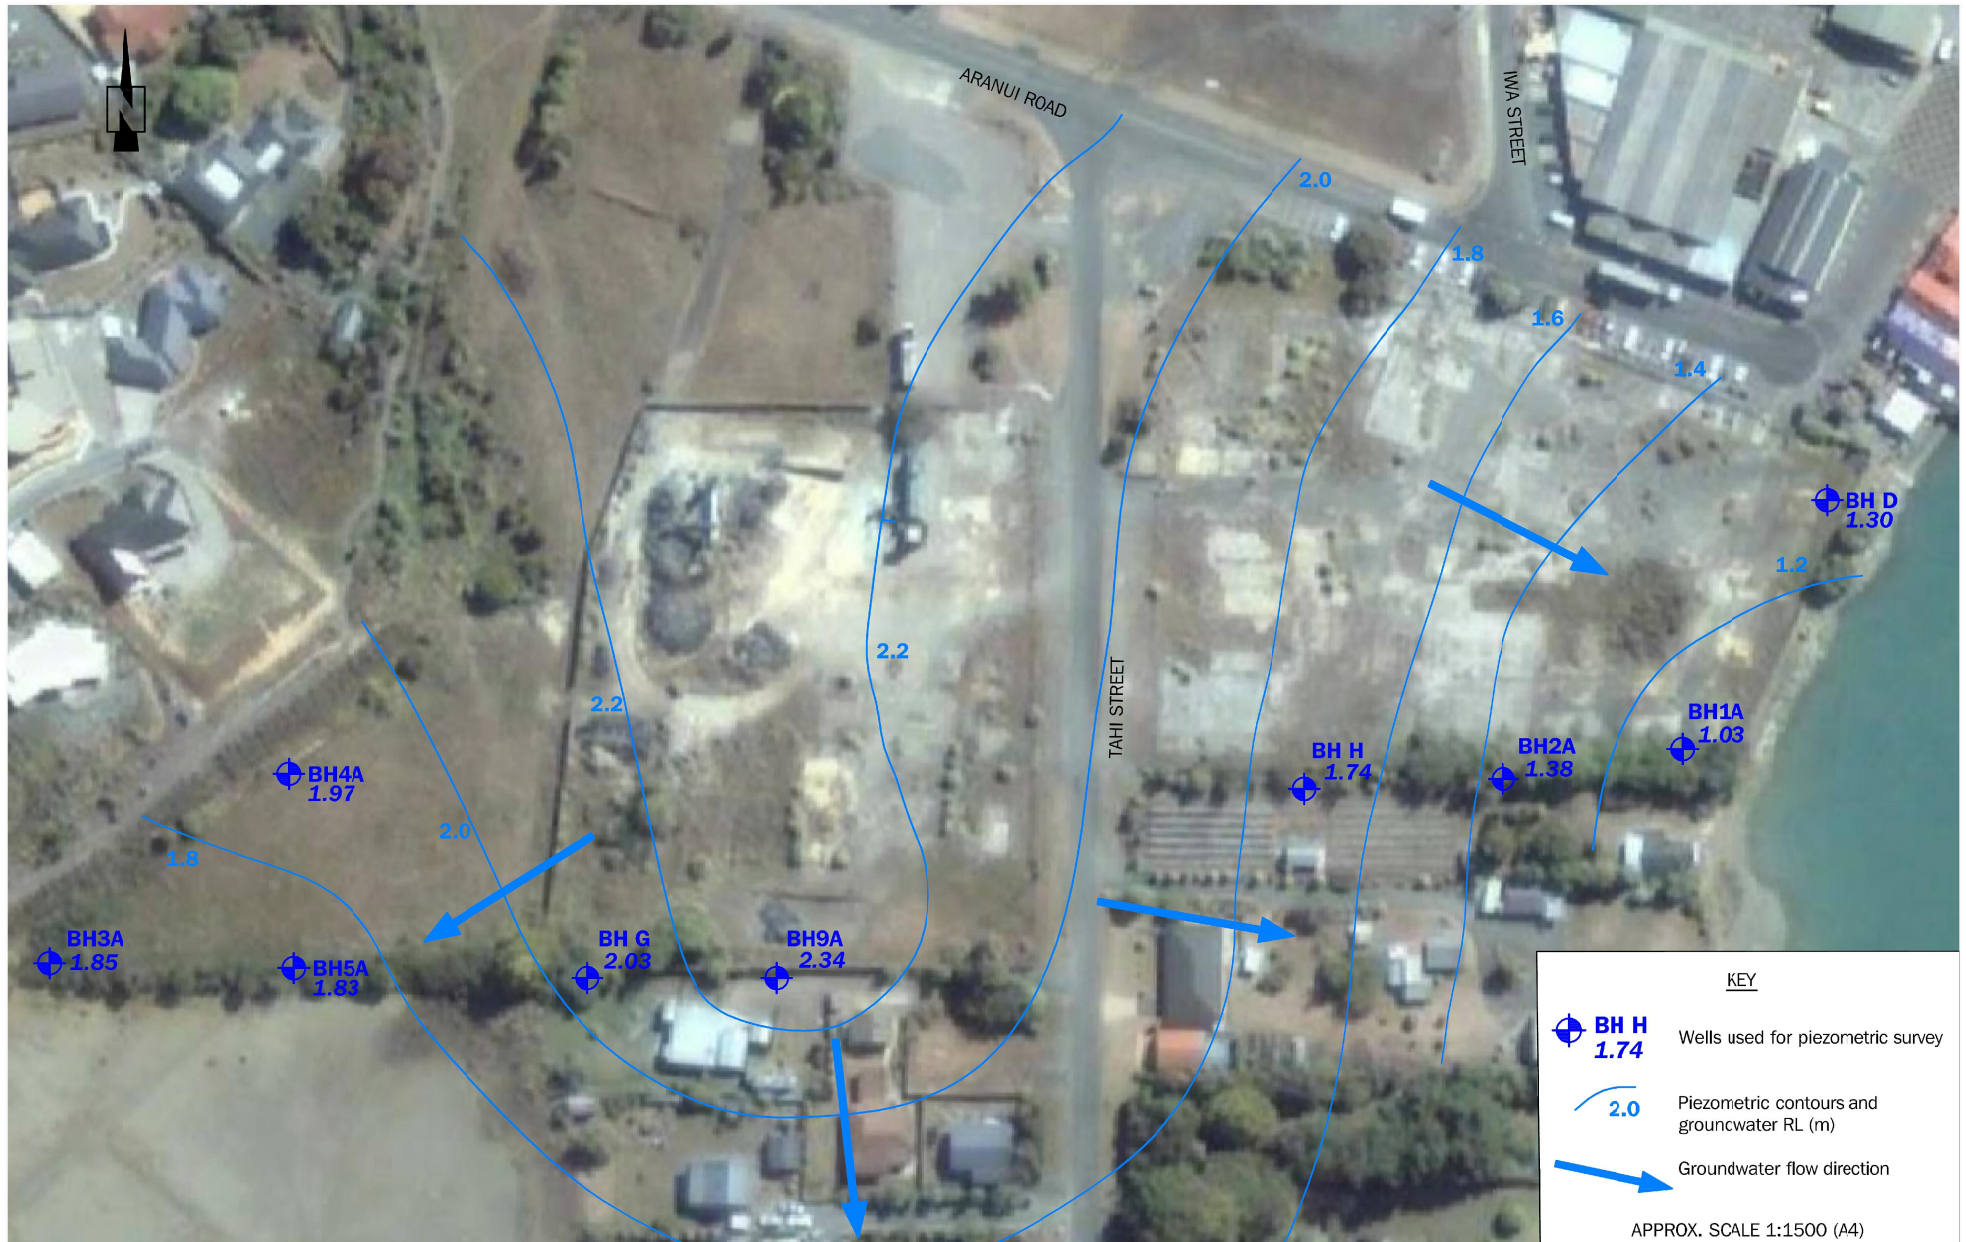
Figure 7 : PDP (2007) Predicted Groundwater Flow Direction

Source: PDP 2007 (may not be spatially accurate).

The PDP (2007) reinterpretation of the CH2M HILL data (Figure 7) shows a southerly component to groundwater flow crossing the southern boundary of the site in addition to the eastward and westward components. This difference in interpretation is important because if no southerly component exists, private bores in various properties along Tahī Street should not be at great risk from contaminants migrating from the site. If a southerly component exists, the off-site wells could be at risk.
